AMERISPEC[®] INSPECTION SERVICES

Doc #:	20519B	Inspector:	Todd Newman
Date:	2/4/2019		
Dwelling Address:	102 Smith Bardstown KY 40004		
Client Name:	D Stuart		
Client's Agent:	Tammy Gowin	Real Estate Company:	Goldmark Realtors

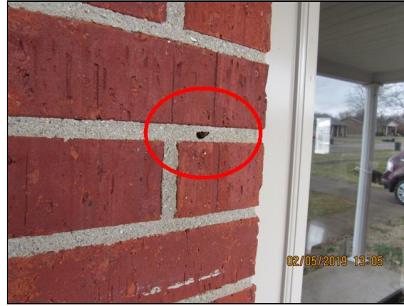
1.2 Item 3(Picture)

(2) Damaged/deteriorated mortar observed at front of home; suggest tuck pointing as necessary to prevent further damage.

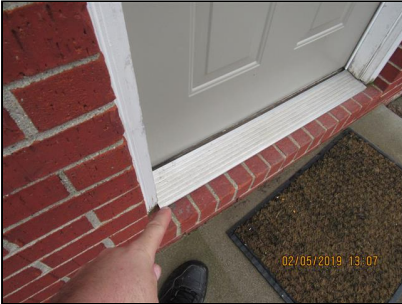
1.5 Item 3(Picture)

(3) Wood deterioration observed at the entry right side of home. Suggest repairs/replacement as needed.

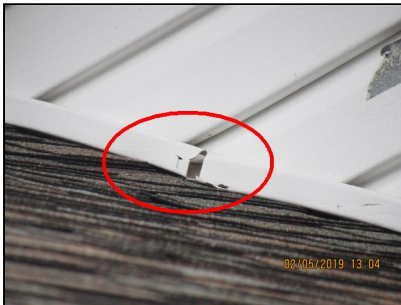
2.1 Item 1(Picture)

Flashings are damaged/deteriorated at left side. Suggest review by a licensed roofer prior to closing for repairs/replacement as needed.

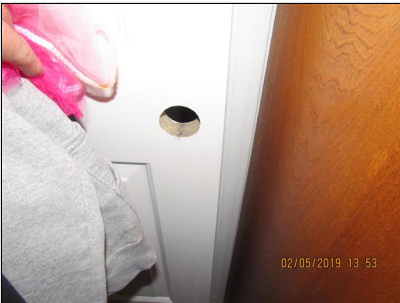
14.3 Item 1(Picture)

The doorknob is missing on the door in the left bedroom. Recommend replacement for proper operation.

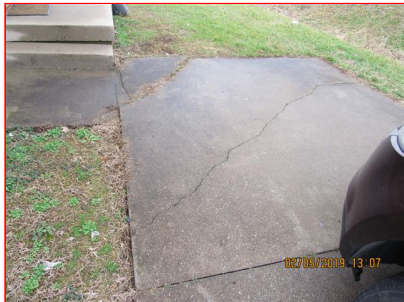
1.0 Item 1(Picture)

Common cracks observed, primarily a cosmetic concern. We suggest sealing all cracks in concrete/asphalt/brick surfaces to prevent water penetration as a routine maintenance effort.

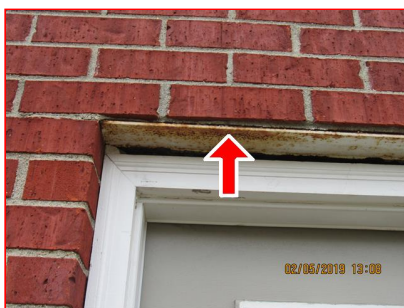
1.5 Item 4(Picture)

(5) Caulking should be applied around all windows, doors, and any voids where necessary.
