## Home Inspection Report

Prepared exclusively for  
**Grace Lutheran Church C/O Chad DuLac**

PROPERTY INSPECTED:  
**1408 Washington Street  
Wenatchee, WA 98801**

**Date of Inspection: 05/04/2022**

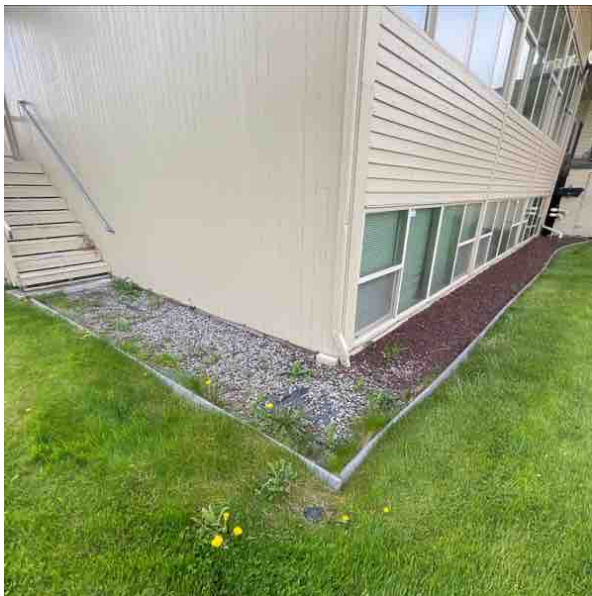
- Exterior East
- Exterior North
- Exterior West

3.4.3 Siding or trim is in contact/close contact with the ground/landscaping. This is a conducive condition for water absorption, wood rot, rodent access. It is recommended to create a 6 inch gap between the siding and the ground to limit deterioration of the siding and possible rodent access. When removing dirt/landscaping, further investigate and repair as needed.

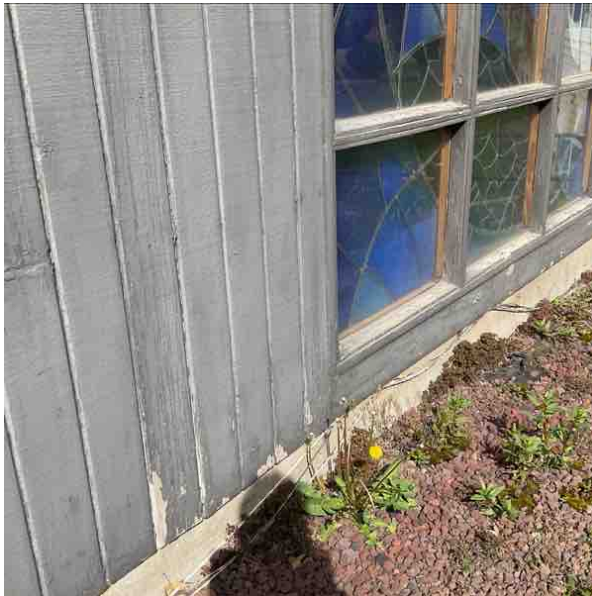
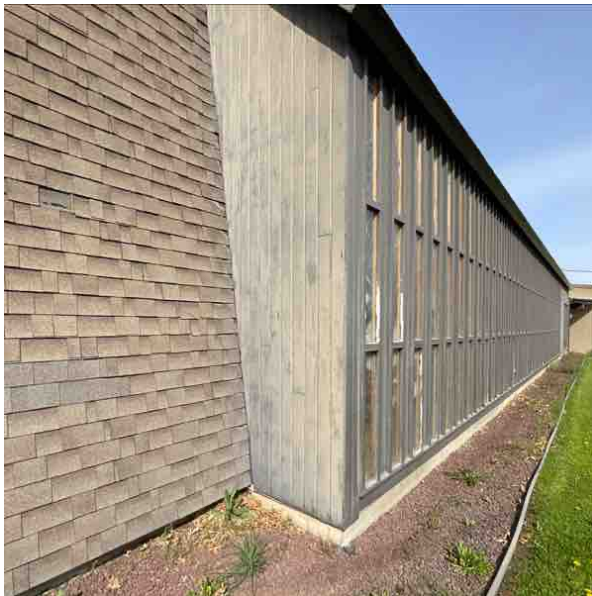
- Exterior East
- Exterior South

3.4.4 Peeling / fading paint noted. Caulk gaps and paint all exposed siding, for water protection.

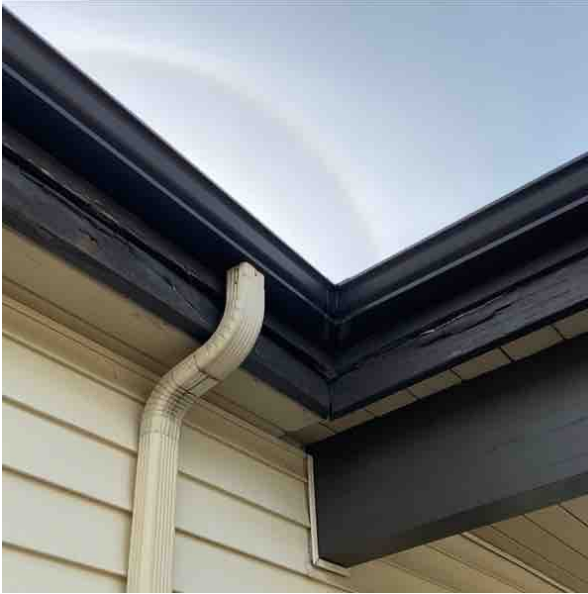
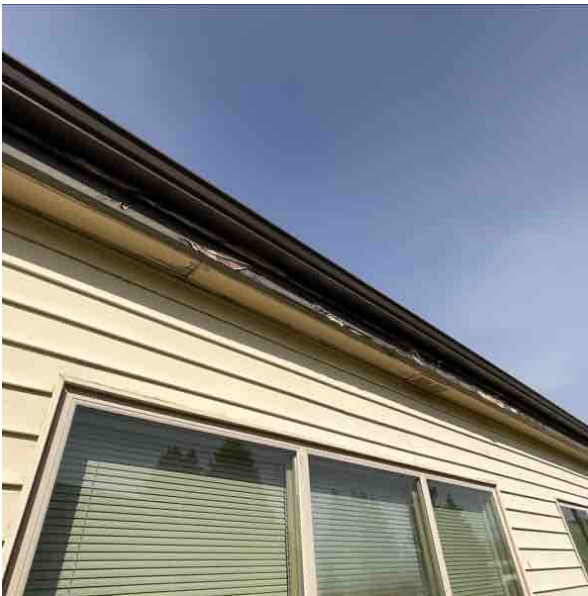
- Exterior East
- Exterior North
- Exterior South
- Exterior West

3.5.1 Fascia and soffit boards show signs of water absorption/deterioration. Peeling paint observed. We recommend caulking and painting for water protection. Repair damage for continued function.

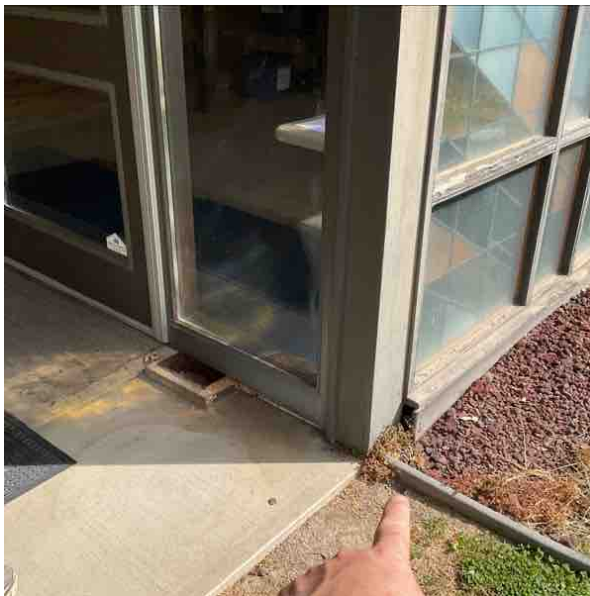
Gaps below the metal trim can allow for pest access/activity. **(Exterior West)**

3.6.3 Repair loose trim to reduce potential pest access near the west main entrance.

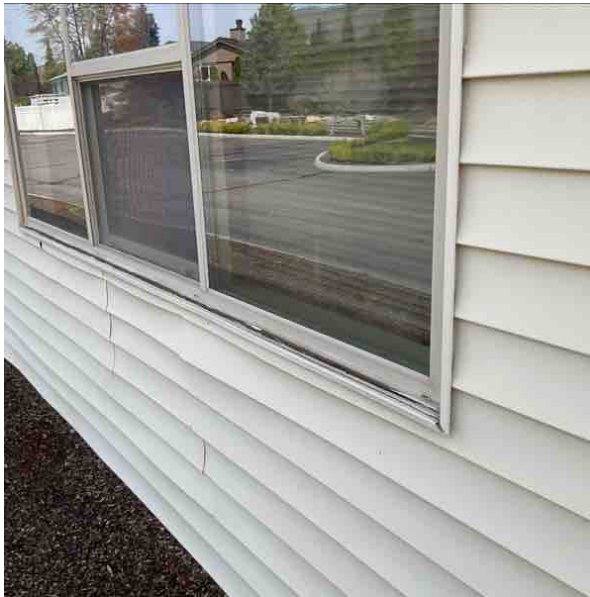
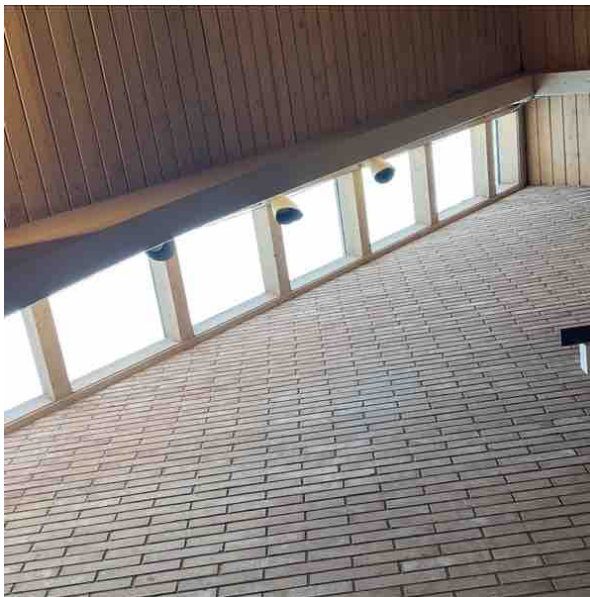
- Exterior North
- Exterior South
- Exterior West

3.7.3 Although determining the condition of thermal window seals is outside the scope of a the inspection, it appears that some windows have moisture between the panes of glass. This is generally considered a cosmetic condition. To repair, windows have to be replaced . Consult a window contractor for further evaluation and repair.

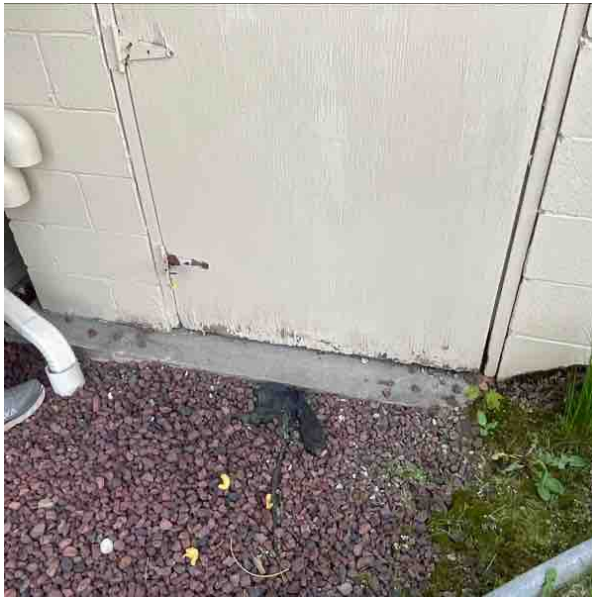
-All gaps should be sealed to limit pest access. **(Exterior North)**

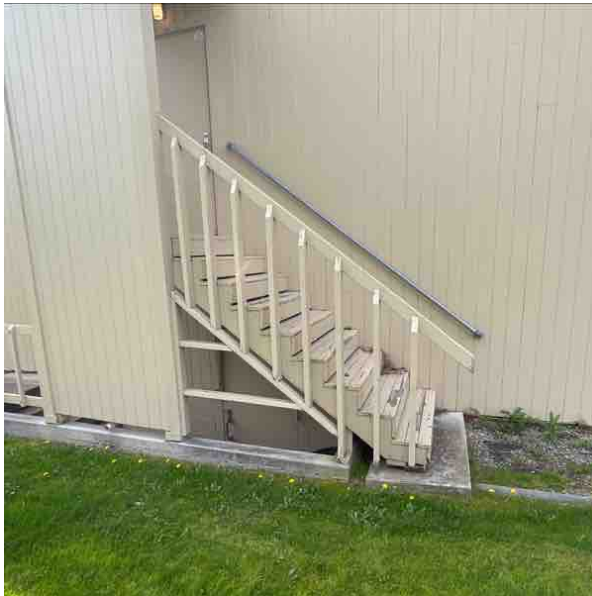
3.11.1 Spacing between balusters should be no more than 4 inches apart for safety. Repair as needed.

Protruding nails should be reset for safety and function. **(Exterior North)**

Maintenance at steps recommended. Paint/stain as needed.

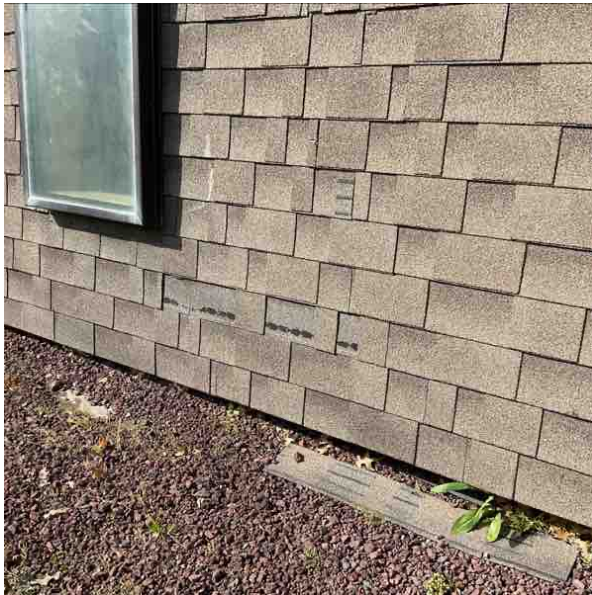
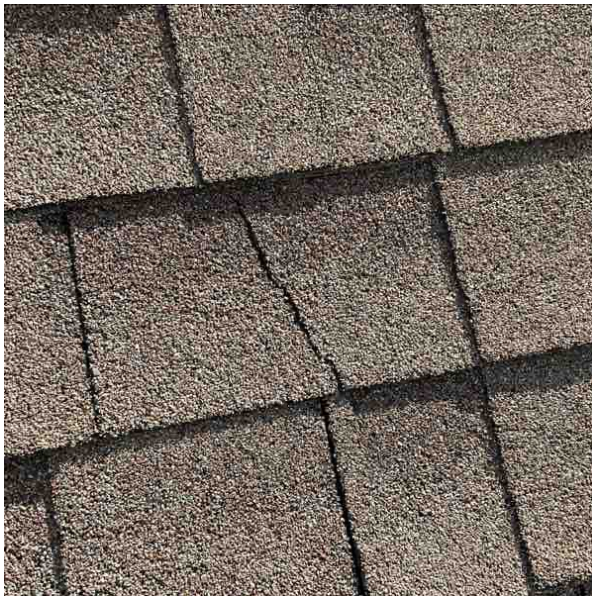
4.4.1 **Repair damaged/missing shingles for water protection and to reduce further damage/deterioration. Consult a roofer for further evaluation and repair.**

**-There are several shingles with small cracks. These should be sealed for continued water protection.  
(Exterior East)**

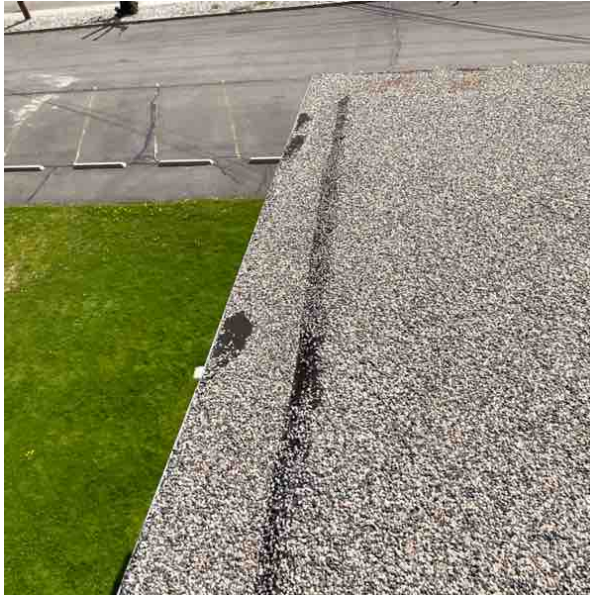
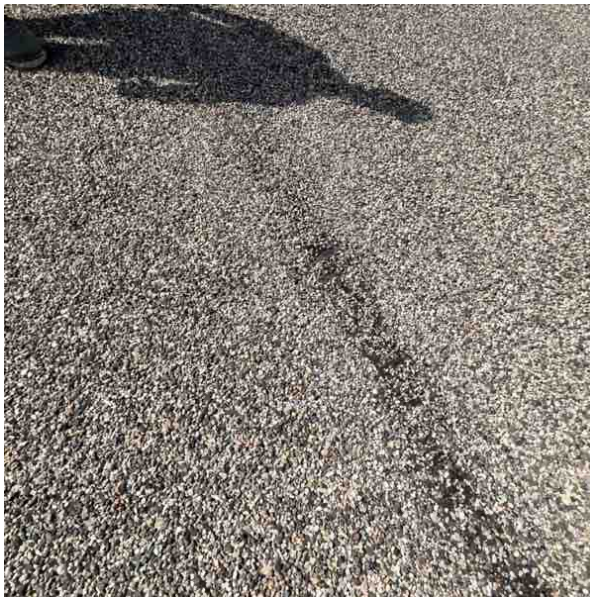
**4.5 Flat Surface(s)****4.5.1 Built up roofing at the north wing of the building.**

There are several areas of the roof where the gravel has worn away, and the roof surface is showing wear/alligator cracking. Further evaluation/patching recommended for intended/continued function.

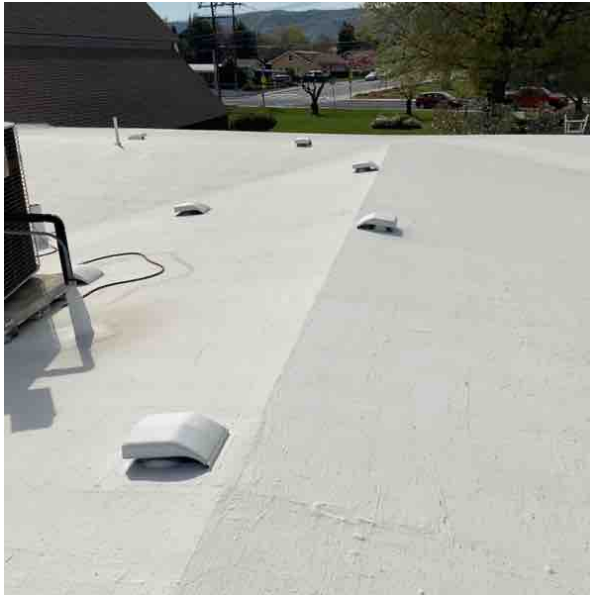
4.5.2 The roof at the northwest wing appears to be constructed of plywood, which is coated with a protective paint/sealant. This roof appears to be in generally good condition. Monitor and maintain for continued function.

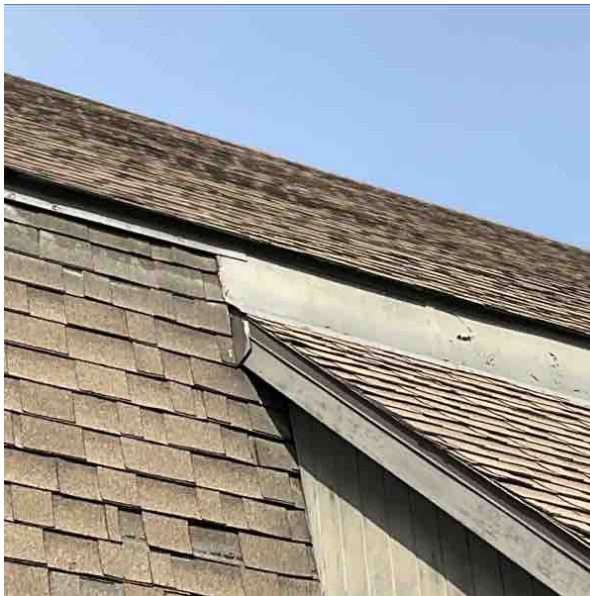
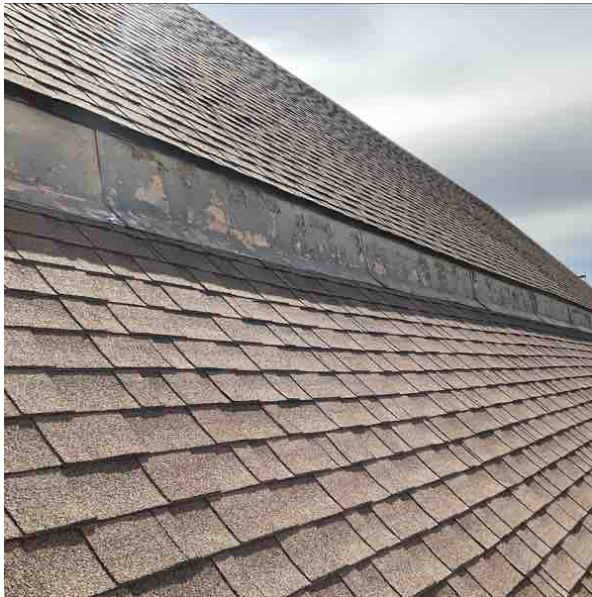
4.6.1 Secure flashing for continued function. Some loose nails/fasteners observed.

- Exterior East
- Exterior West

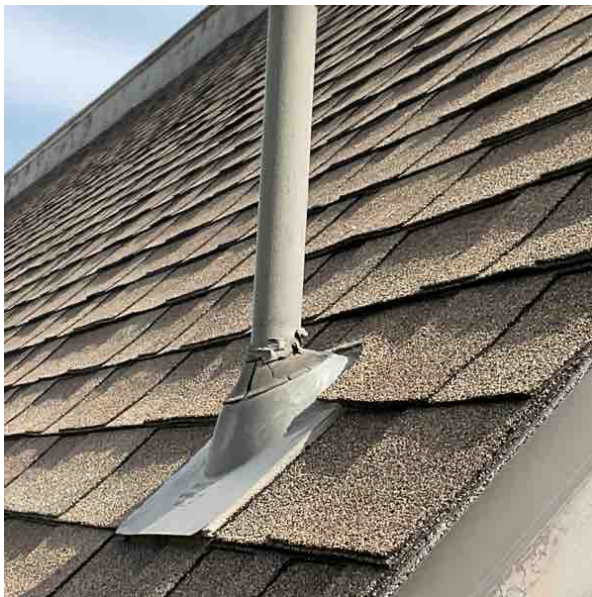
4.6.2 The plumbing stack boot should be replaced to limit water intrusion into the building, preventing water damage. **(Exterior West)**

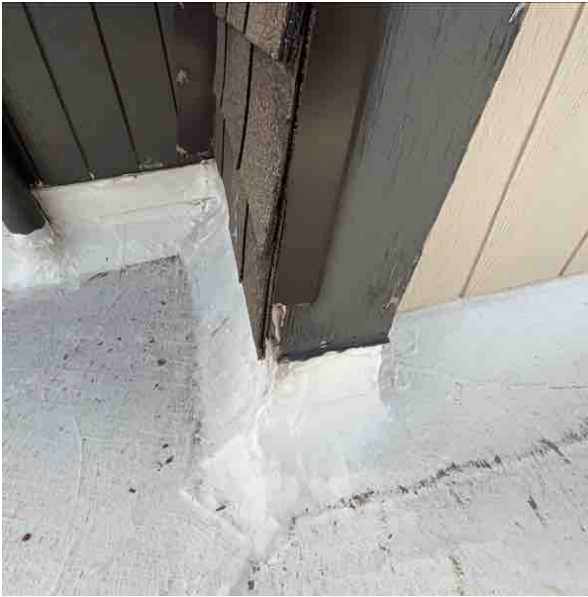
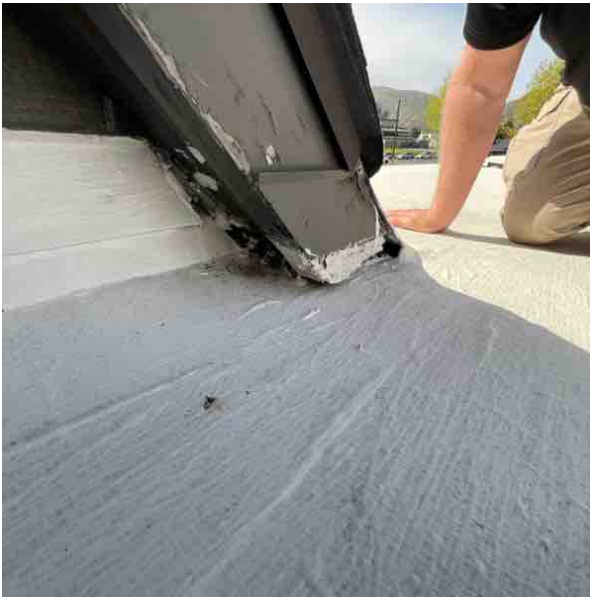
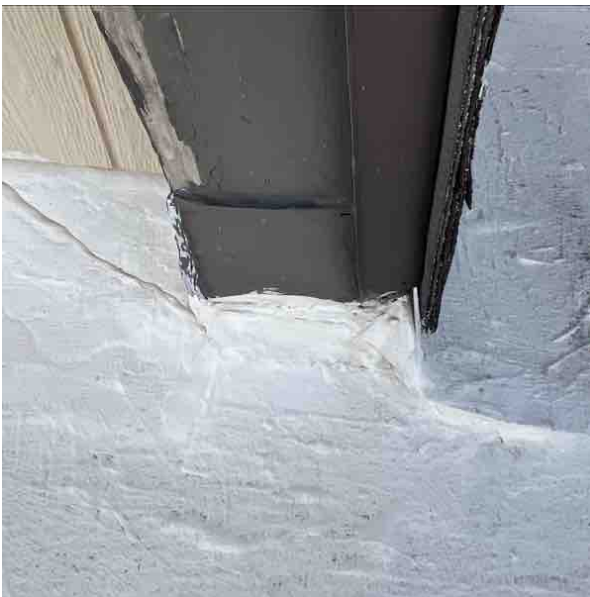
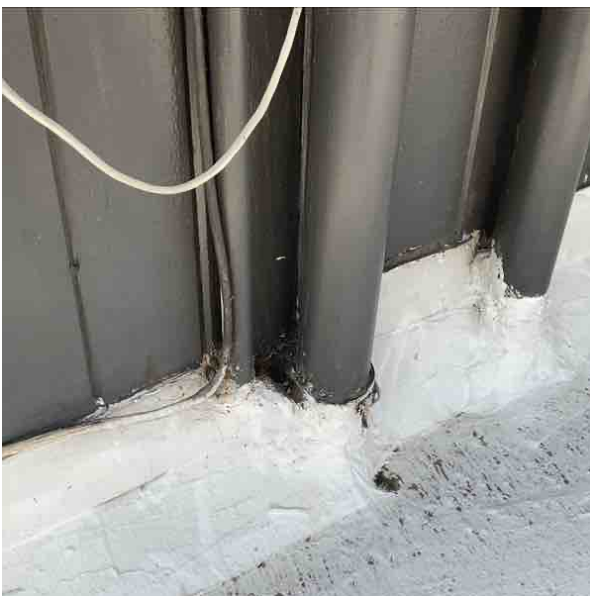
4.6.3 **Small gaps in roof to wall flashing/sealant could allow for water entry into the structure. Repair recommended.**

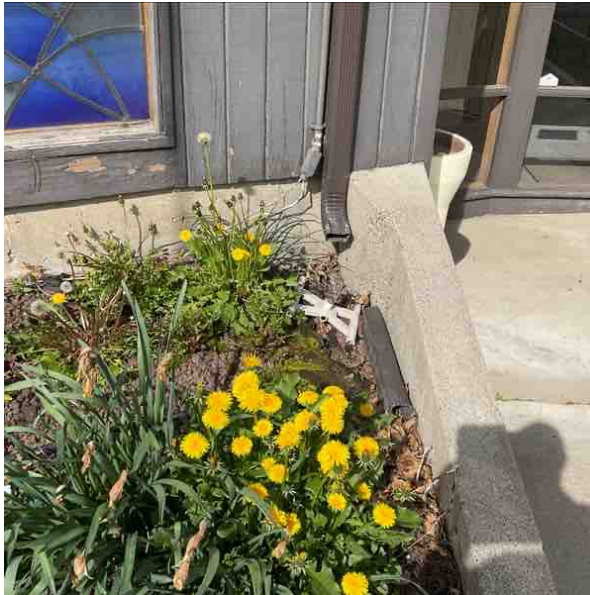
4.7.1 Ensure gutter joints and areas behind gutters are sealed to promote intended drainage. Evidence of leaking around the building observed.

Downspouts is/are discharging water near the foundation. It is recommended to install downspout extensions to drain water away from the home, to help prevent water entry into the foundation and crawlspace / basement and to protect from possible subsequent water related issues or damage. Splash blocks are not recommended, as they tend to slope back toward the house over time.

- Exterior East
- Exterior North
- Exterior South
- Exterior West

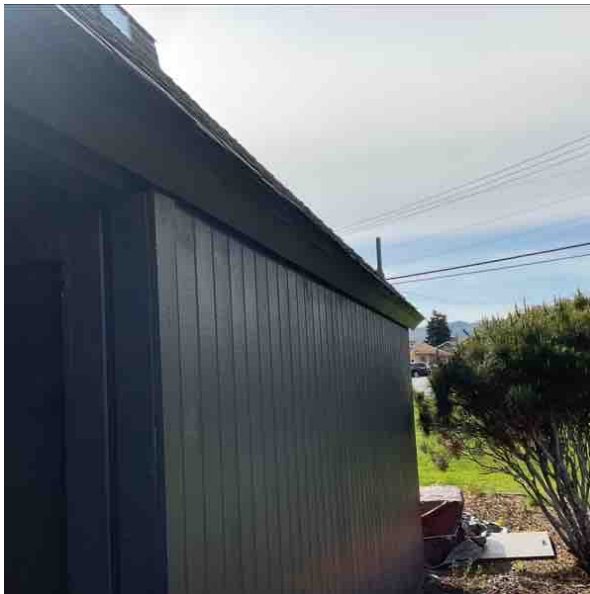
4.7.2 Consider having gutters and downspouts with extensions installed to help drain water off of the roof and away from the structure.

- Exterior East
- Exterior West

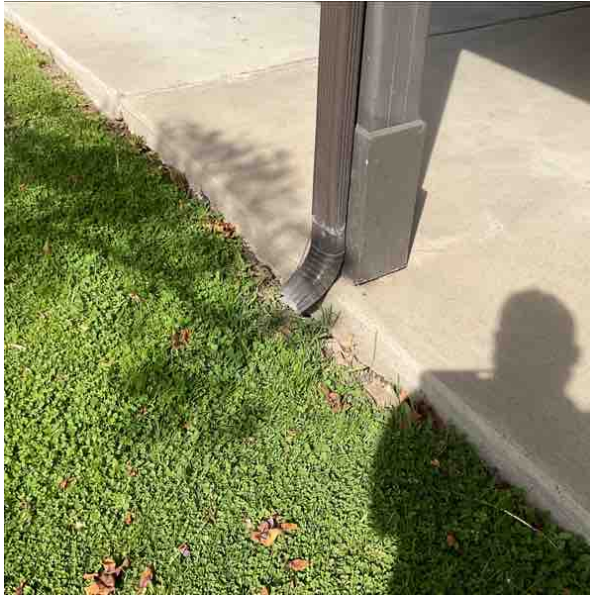
4.7.3 Downspouts is/are discharging water near the foundation or walkways. It is recommended to install downspout extensions to drain water away from the structure, to help prevent water entry into the foundation or concrete and to protect from possible subsequent water related issues or damage. Splash blocks are not recommended, as they tend to slope back toward the house over time. **(Exterior West)**

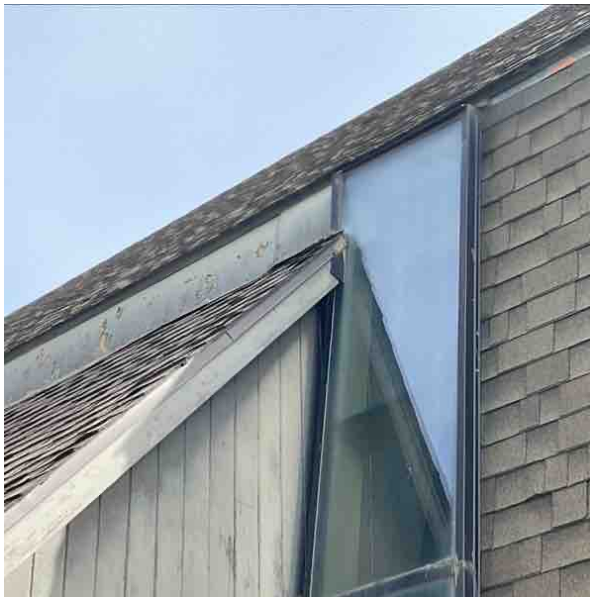
4.8.1 Heavy sealant has been used near the skylights, on the south end of the sanctuary. These areas should be monitored for effectiveness.

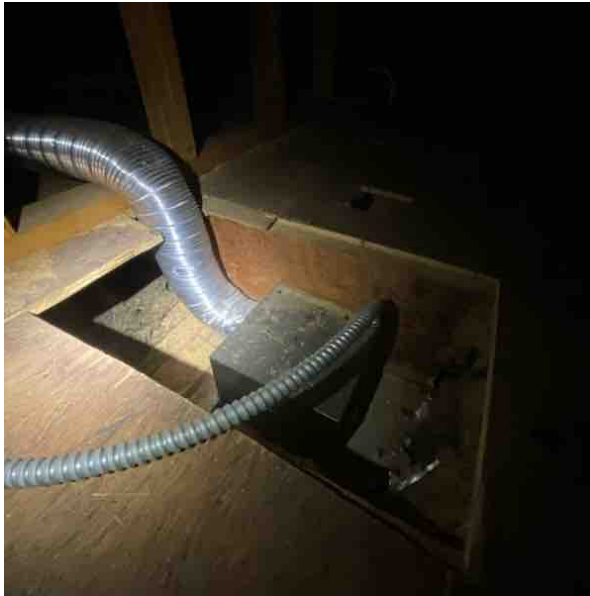
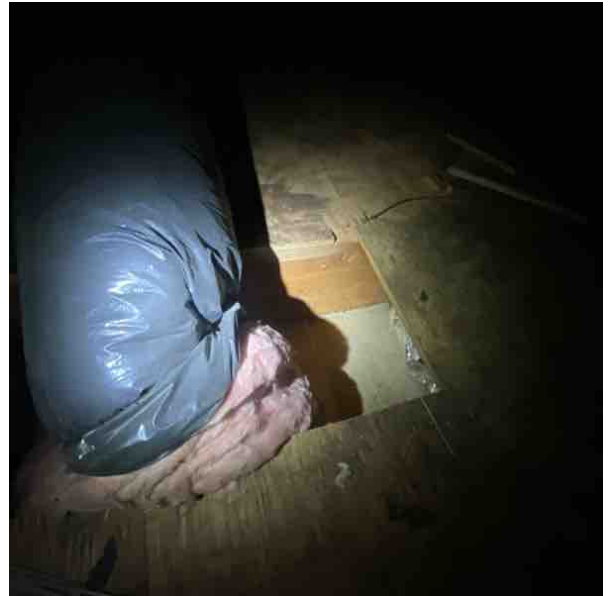
5.4.1 Install insulation around ceiling fans and air ducts, to limit heat loss and possible condensation in the attic.

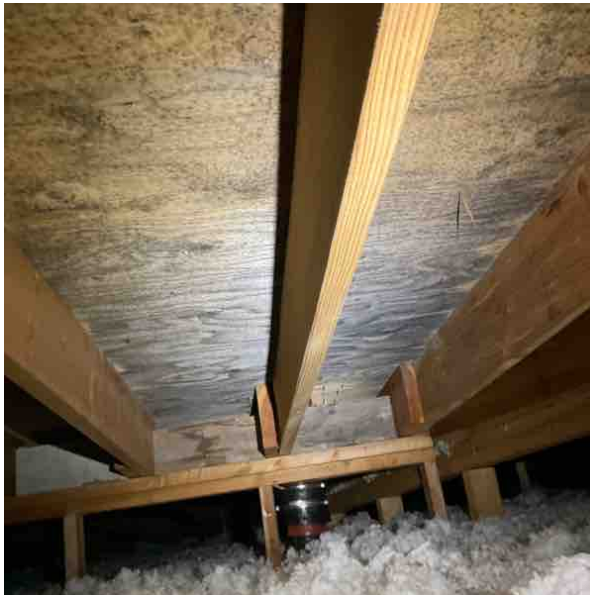
5.5.2 **The underside of the roof sheathing (middle section of addition, above kitchen and foyer areas, shows signs of excess moisture in the attic (mildew/mold). Consult a contractor for further evaluation.**

5.7.1 **Mold/mildew noted on the attic sheathing (above the kitchen and foyer areas). This can be caused due to several past or present circumstances, including inadequate ventilation, loose exhaust ducts, inadequate insulation, air leaks from the interior of the house into the attic, can lights, past or present roof leaks, or a combination of several items. The color of mold is due to the type of material the mold is digesting for nutrients and is not a good indicator of the type of mold. Further evaluation/treatment recommended by a mold remediation contractor. It is recommended to have the sheathing treated to kill off any possible living mold/mildew and further evaluation/repairs performed by a licensed contractor to reduce the chance of future growth. Over time, moisture can weaken the attic sheathing. Further investigation and repair is recommended by (a) licensed contractor(s). Mold grows when moisture is present, but will cease to grow in dry conditions.**

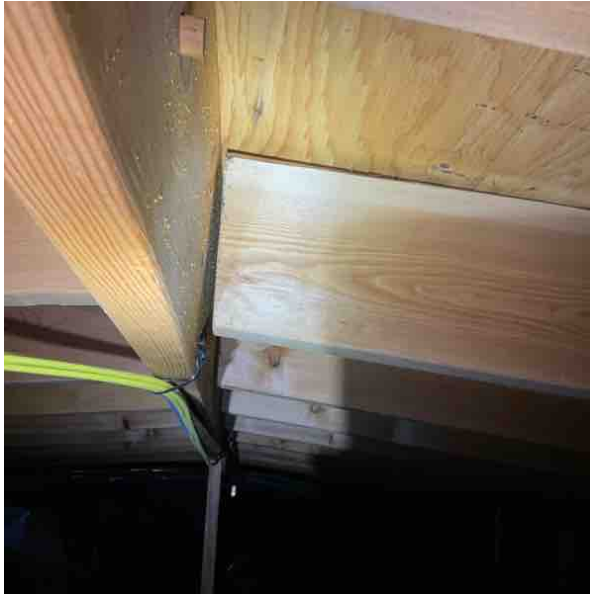
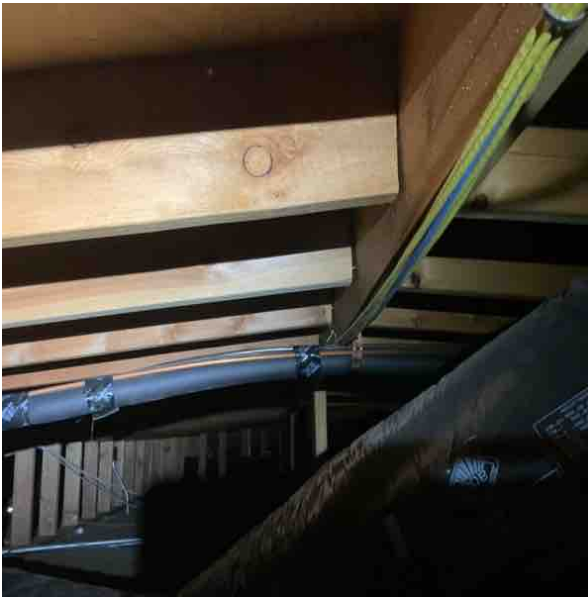
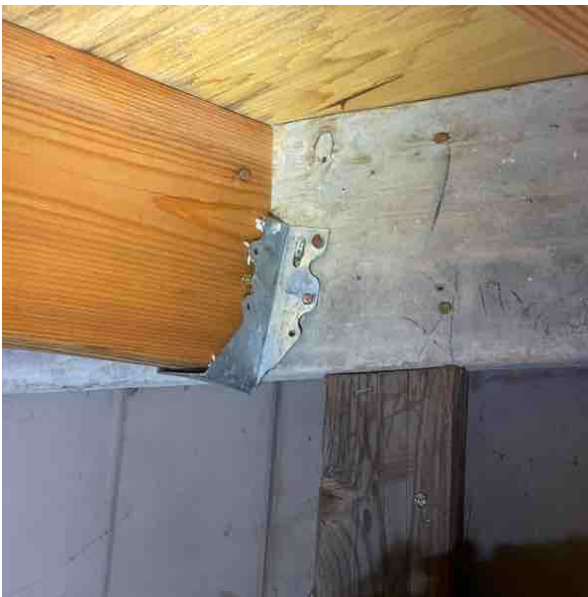
6.7.1 In some locations over the northwest wing there are gaps between the rafters and ridge board. It is possible that rafters were cut short, or that some movement has occurred over time. Further evaluation recommended. Secure rafters as needed. A couple of the rafters were not nailed/secured to the ridge board.

Brackets were used above the foyer to attach the roof rafters to the ledger board at the wall. It is recommended that fasteners fill all holes for intended support.

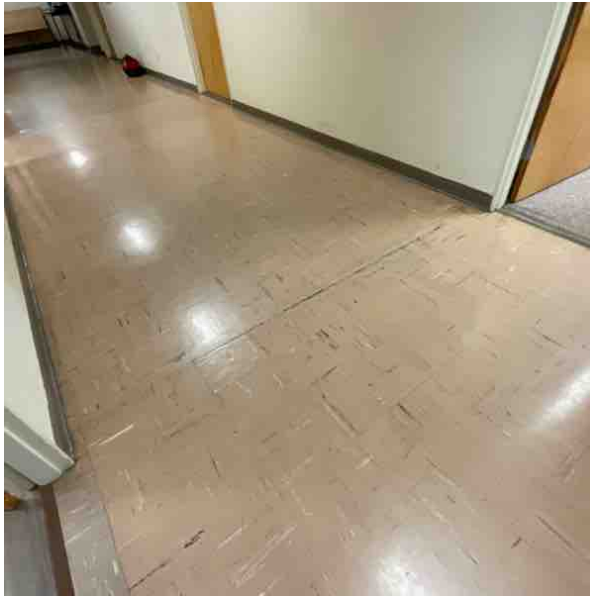
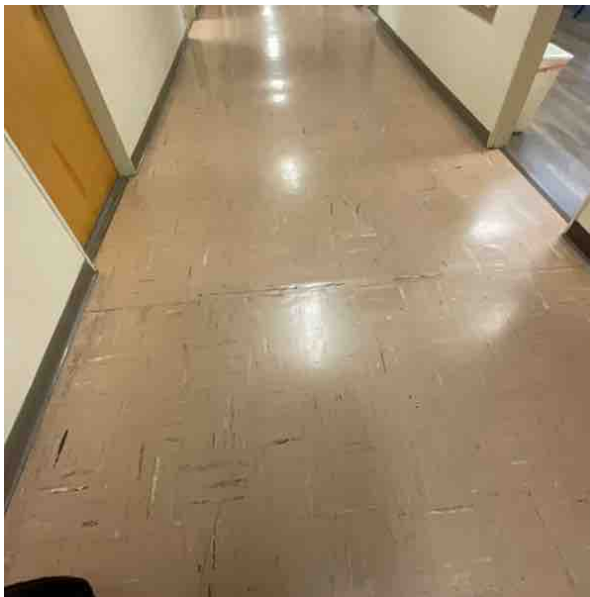
6.10.2 Minor cracks could be a sign of some minor settling. These do not appear to be a structural concern.  
(Various locations)

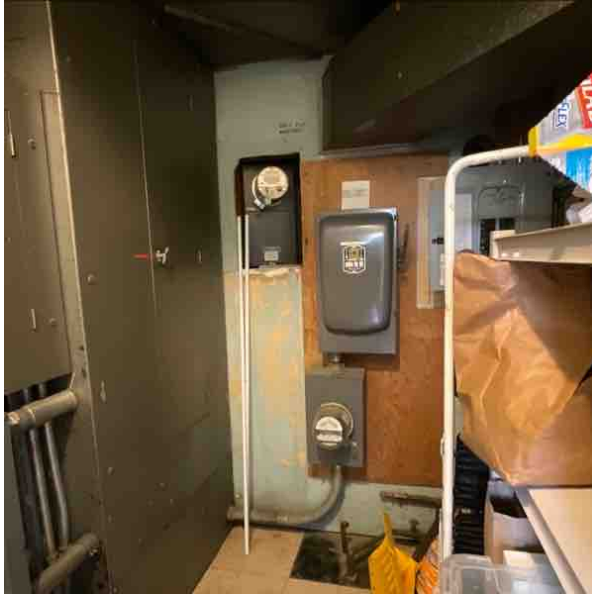
**7.3.2 Electric meters are located in the basement electrical room. It is the inspectors understanding that these should be located at the exterior of the building, for access by the utility company. If building modifications are made, this could be a required update. (Basement Electrical Room)**

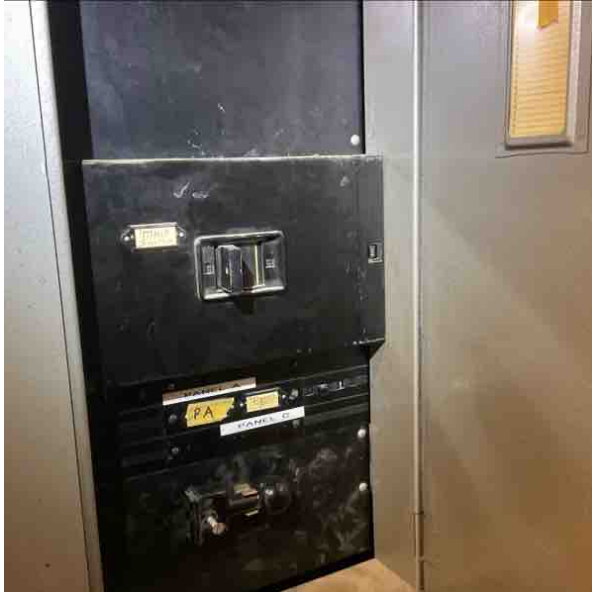
7.5.1 The main disconnects are located in the electrical room. **(Basement Electrical Room)**

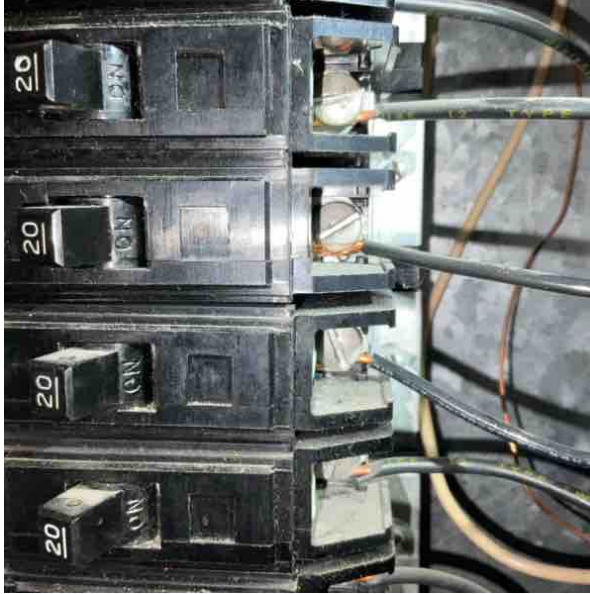
Undersized wire/s was/were identified at one or more breakers. It is recommended to have correctly sized wire installed, or correctly size breakers to reduce the chance of electrical overheating/damage.

Stranded wire does not appear to have a good connection at breaker #8. (Sanctuary front storage rm.)

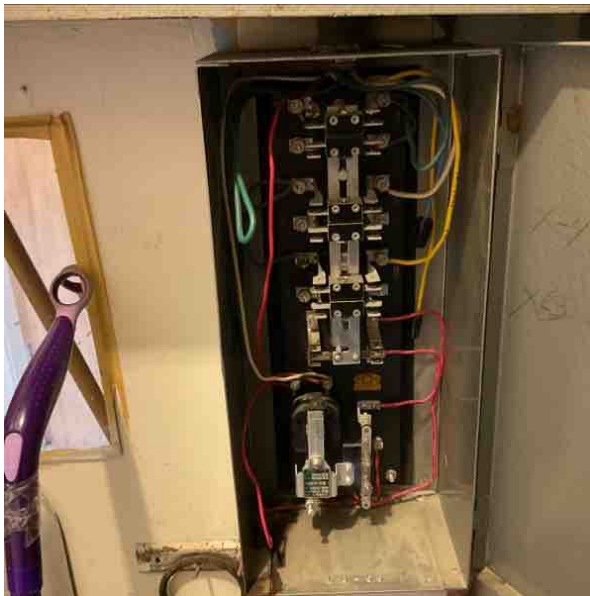
7.6.2 There was an electrical buzzing noise coming from the box marked as transfer-switch. The inspector is uncertain as to what would cause this buzzing sound, or what the box is for. Some of the contacts inside the panel showed some wear/deterioration. Further evaluation recommended. **(Basement Electrical Room)**

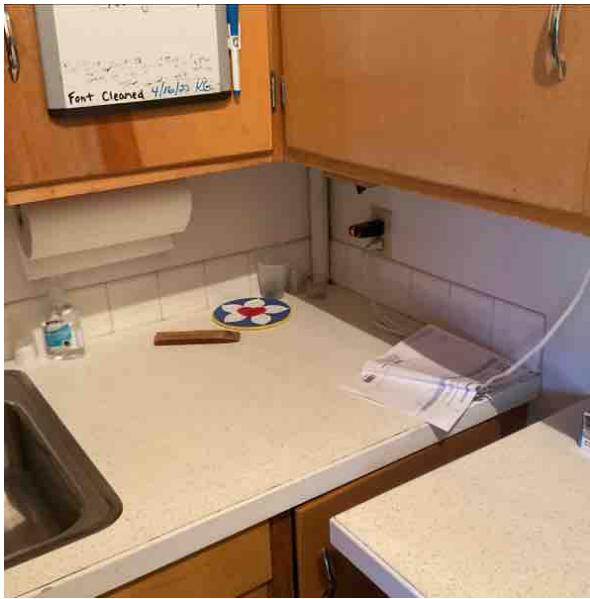
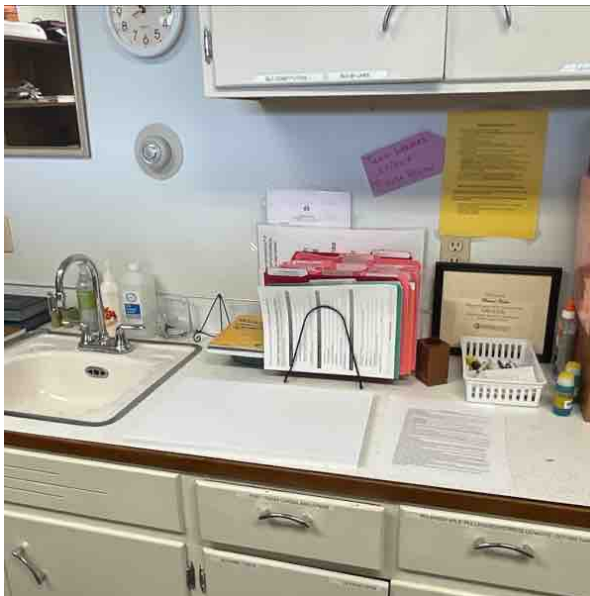
7.8.1 **GFCI protection missing in one or more areas. For improved safety it is recommended to install GFCI protected receptacles at potentially wet locations.**

**\* GFCI protection should be installed at the copy room, if use of the sink is restored.**

- Basement Electrical Room
- Copy Room
- HVAC room
- Kitchen
- Multi-purpose room
- Sanctuary front storage rm.

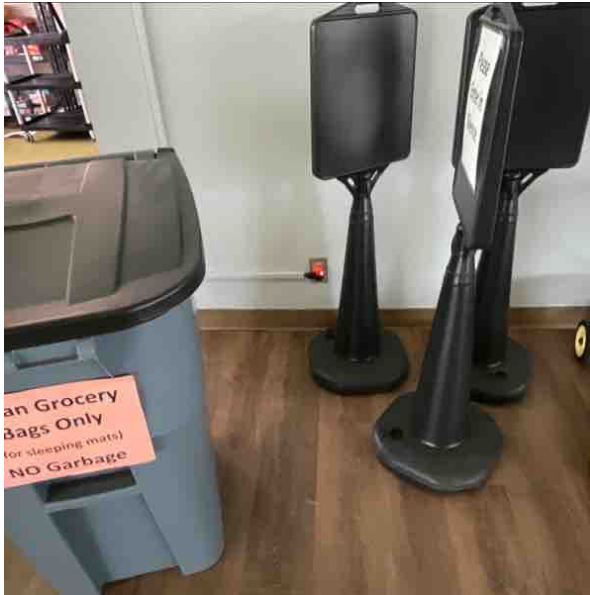
7.8.3 Receptacles with loose contacts noted. We recommend updating with tamper resistant receptacles for intended function and safety.

\* Consider updating all receptacles over time.

- Basement room 1
- Basement room 5-6
- East hall
- Fellowship Hall

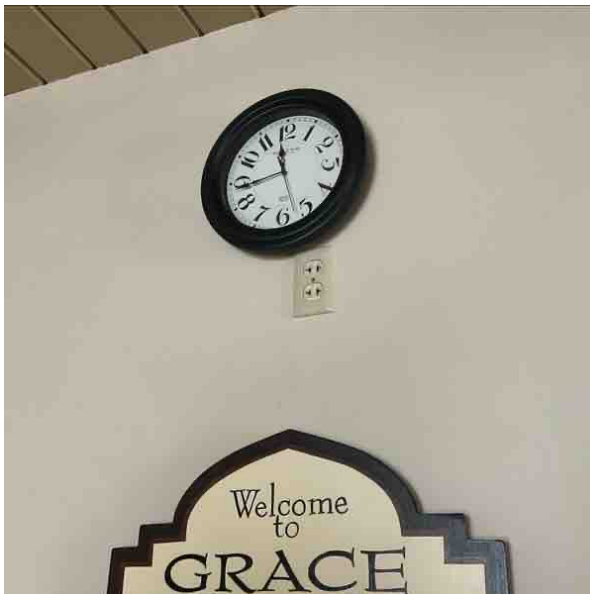
7.8.4 Two pronged (ungrounded) receptacles noted. This is common for a house of this age. It is recommended to consult an electrician to update receptacles and wiring to today's standards, for safety and protection of equipment that may need ground protection. Installing GFCI protection at ungrounded receptacles will provide personal protection. Any equipment that has a three prong plug in should be installed in grounded receptacles for equipment protection. **(Foyer)**

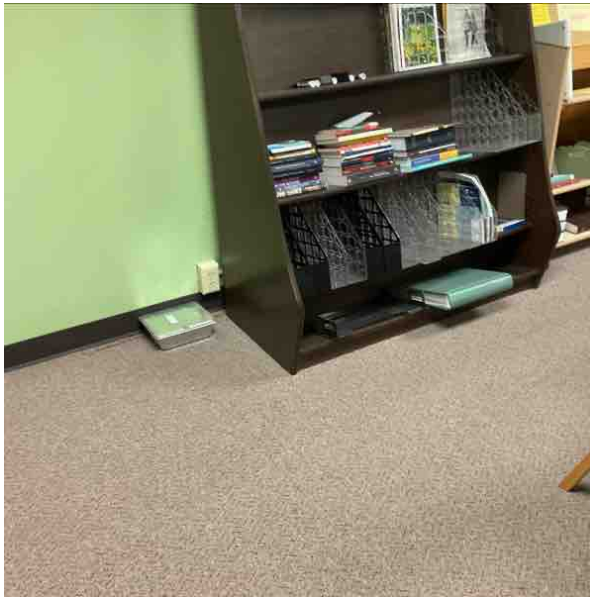
**7.8.5 Non-functioning receptacles noted. Further investigation and repair recommended. (library)**

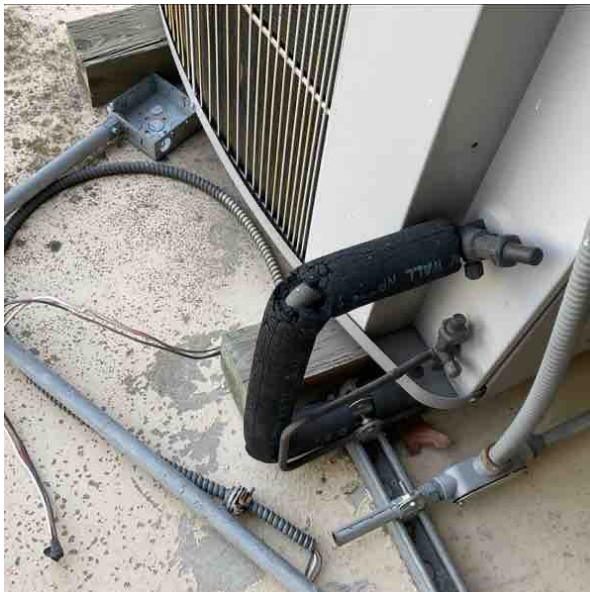
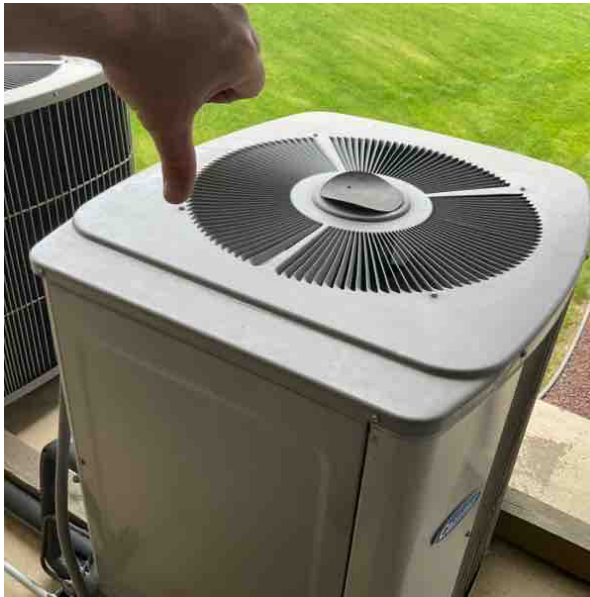
**8.5.1 Both air conditioning units at the north side of the building or manufactured in 1991. Further evaluation/repair recommended. Neither one of the air conditioning units would activate at the time of the inspection, although the thermostat indicated that they were on.**

**Replace worn/missing insulation on the suction line, to help with system efficiency.**

**Because the air conditioners use the older R22 refrigerant, if replacing the A/C units, it may also be necessary to replace the furnaces and air handlers. (Exterior North)**

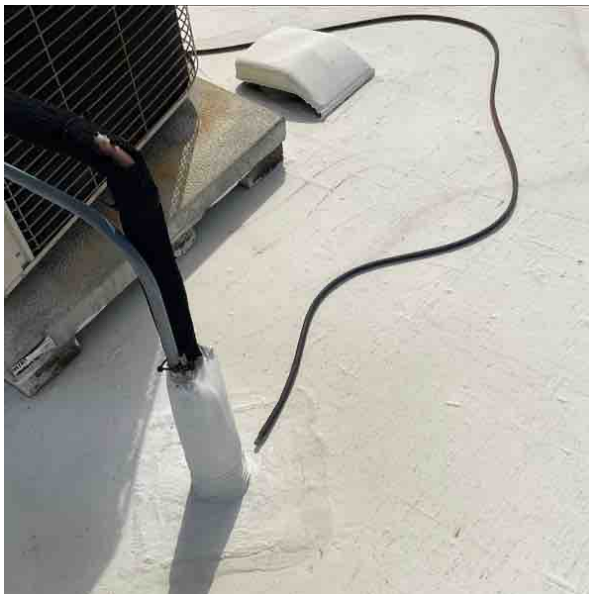
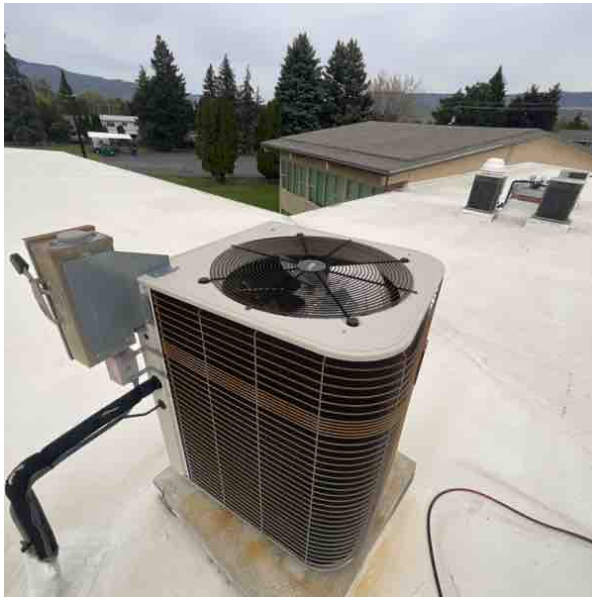
**8.5.2 The large air conditioner on the northwest wing of the roof was manufactured in 2004. Further evaluation/repair recommended.**

**Because the air conditioner uses the older R22 refrigerant, if replacing the A/C unit, it may also be necessary to replace the furnace and air handler.**

**The condensate line has been disconnected and deteriorated. Repair for intended function.**

**Replace worn/missing insulation on the suction line, to help with system efficiency.**

**The large air conditioner, over the north west wing was not functional at the time of the inspection. The AC unit kept cycling on and off, and the suction line was beginning to ice up. (Roof)**

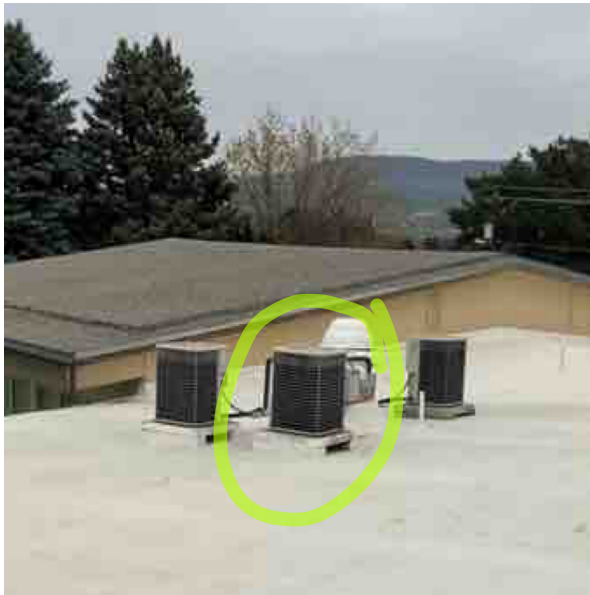
**8.5.3 There are three air-conditioning units, located in the central part of the roof system. Two of the units were manufactured in 1997, and the other in 2003. Further evaluation/Repair recommended. The middle AC was not working as intended at the time of the inspection.**

**Because the air conditioner uses the older R22 refrigerant, if replacing the A/C units, it may also be necessary to replace the furnaces and air handlers.**

**Replace worn/missing insulation on the suction line, to help with system efficiency. (Roof)**

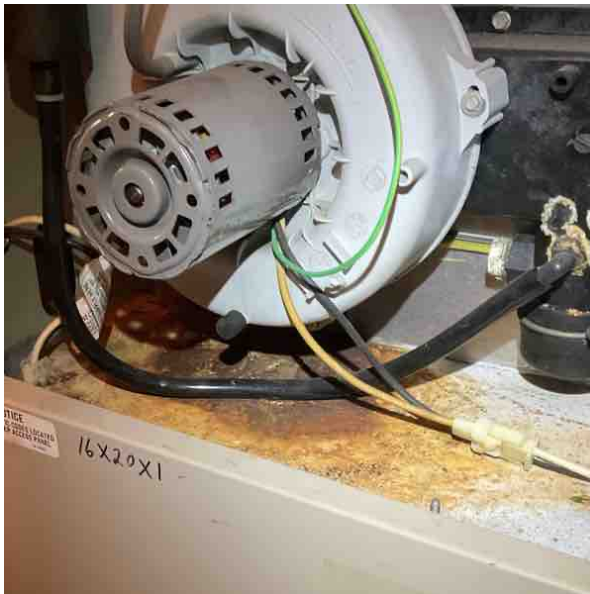
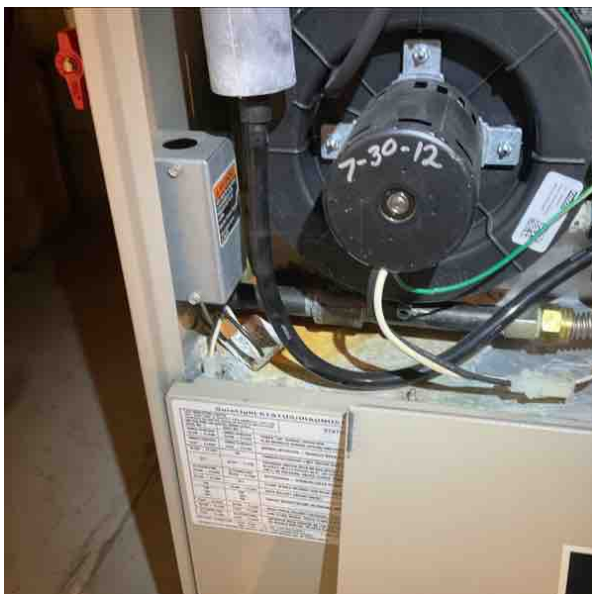
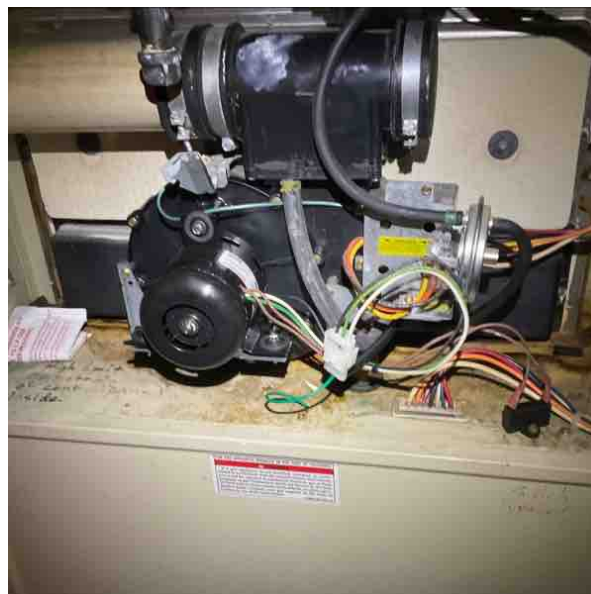
8.6.3 Some of the furnaces show signs of water/condensation near the exhaust fans. Service recommended for intended exhaust/function. **(HVAC room)**

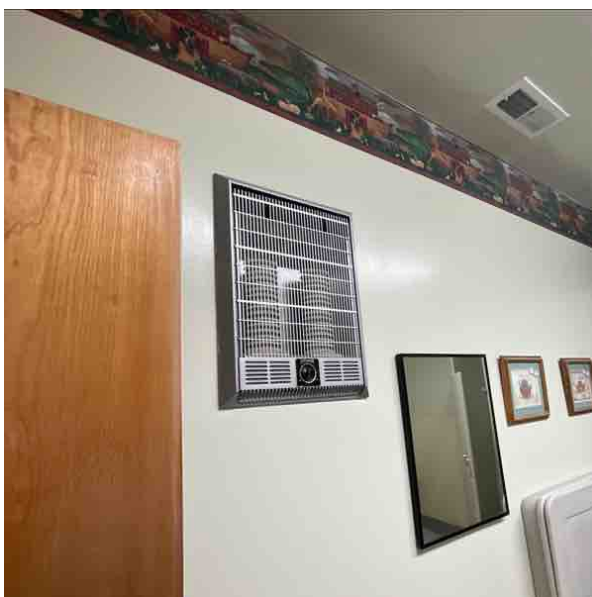
- Boys bathroom (east hall)
- Girls bathroom (east hall)

8.7.1 Installed wall heaters were not functional at the time of the inspection. Further investigate/repair for function.

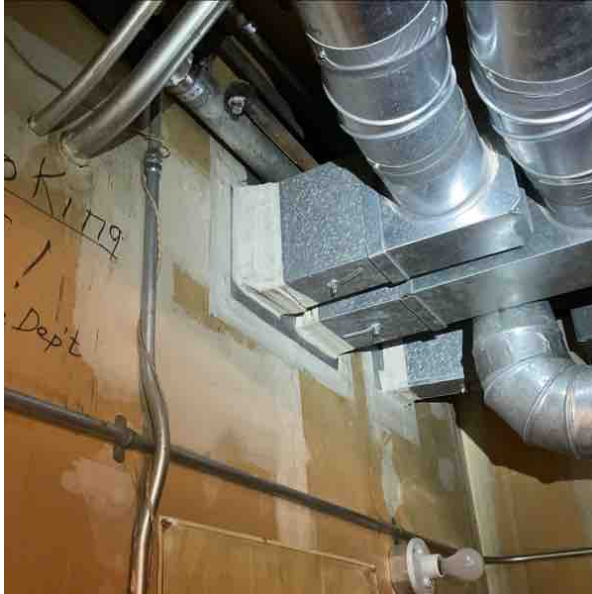
8.8.1 White tape on ductwork could contain asbestos material. Consult an asbestos contractor for further evaluation.

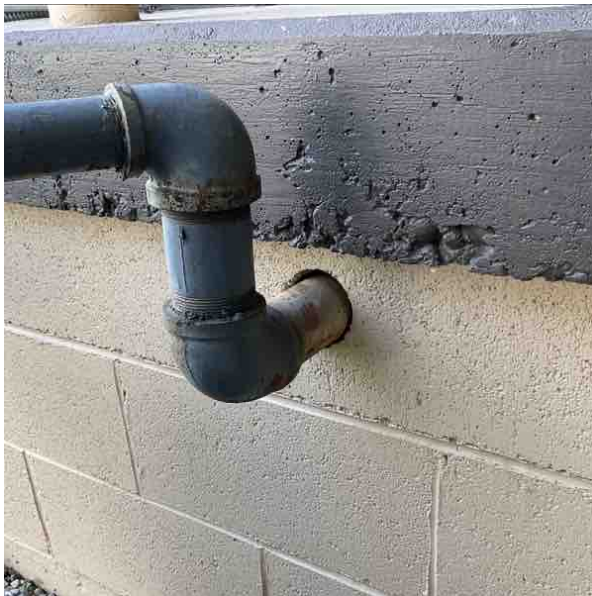
8.9.1 Seal gaps to reduce pest access. **(Exterior North)**

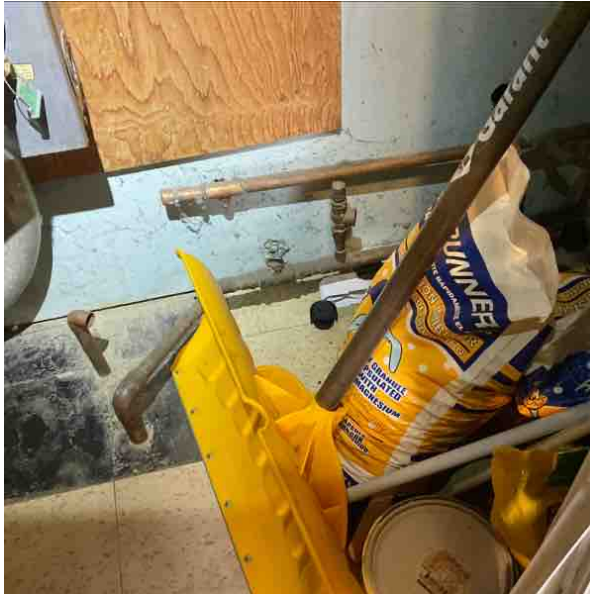
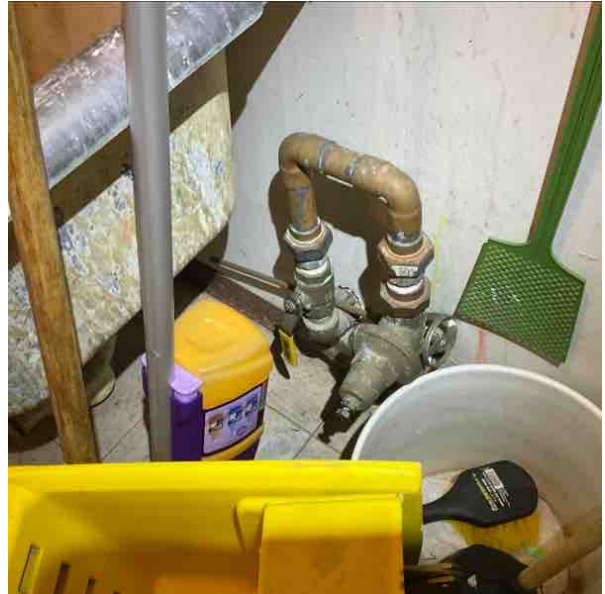
9.3.2 The main shut offs are located in the electrical room. **(Basement Electrical Room)**
