## Home Inspection Report

Prepared exclusively for  
**Grace Lutheran Church C/O Chad DuLac**

PROPERTY INSPECTED:  
**1408 Washington Street  
Wenatchee, WA 98801**

**Date of Inspection: 05/04/2022**

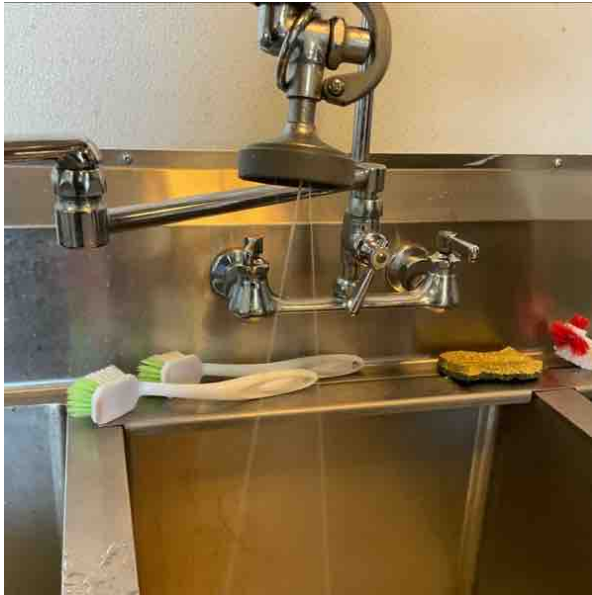
9.8.1 Clean, repair or replace sink sprayer for function. **(Kitchen)**

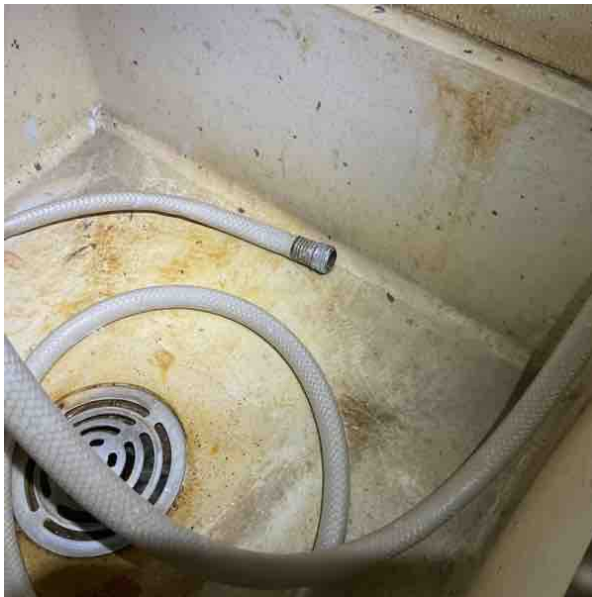
9.8.2 There is a drip/leak at the sink faucet. Repair valves reduce water loss. **(Custodial supply room)**

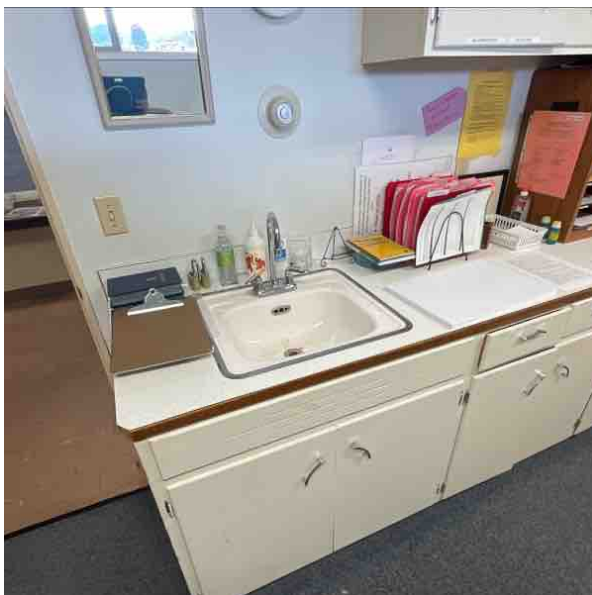
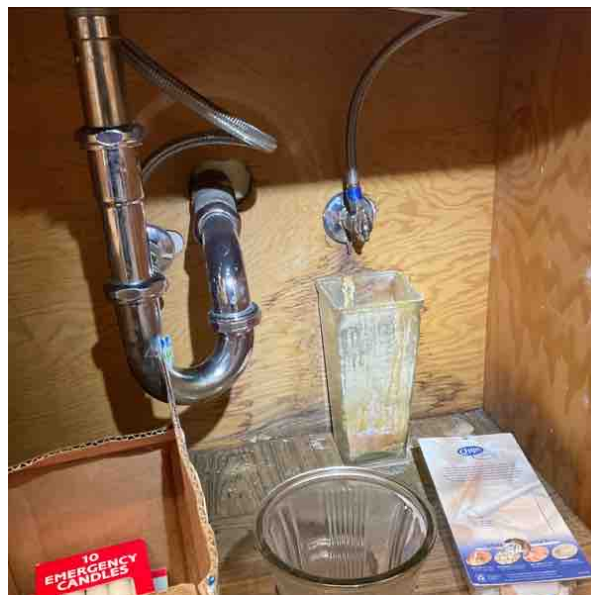
9.8.3 Water was turned off to the sink in the copy room. It appears that there has been a past leak. Repair as needed. **(Copy Room)**

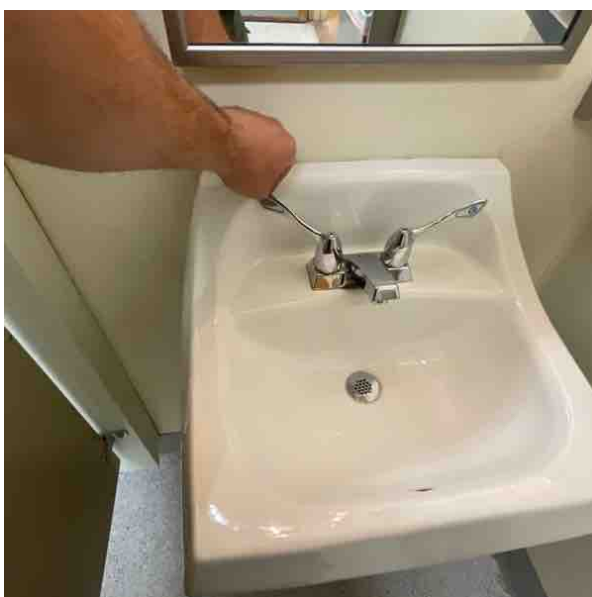
9.8.4 The hot water sink handle is functional, but can be pushed back further than the cold handle. Monitor for continued function. **(Girls bathroom (east hall))**

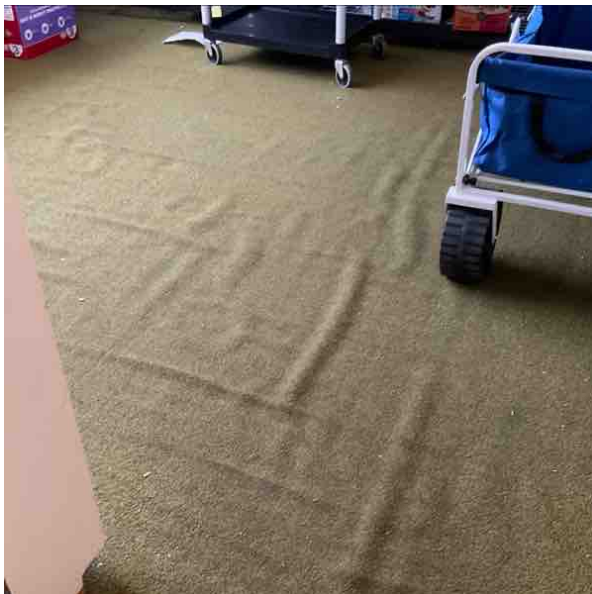
10.3.1 Carpet stretching recommended to limit wear and tear and possible trip hazards. **(Pantry)**

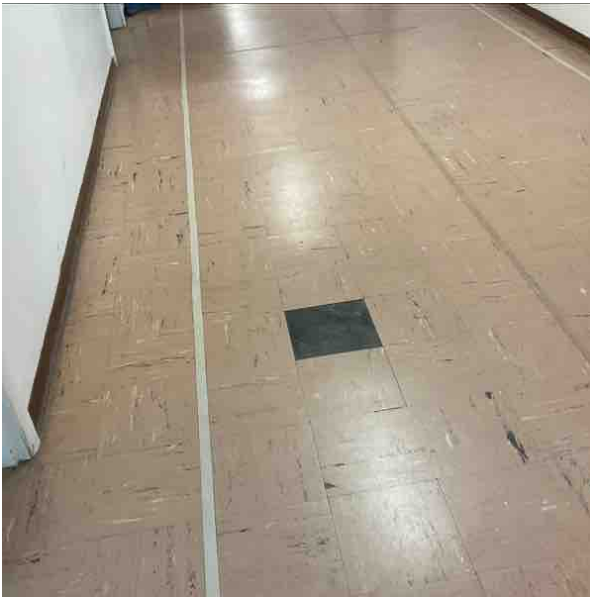
10.3.2 Some floor tiles are missing or show minor damage. Repair/replace as desired. **(Various locations)**

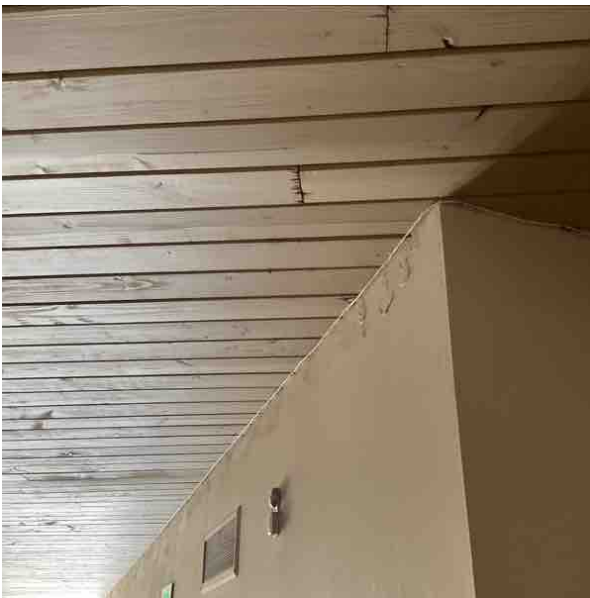
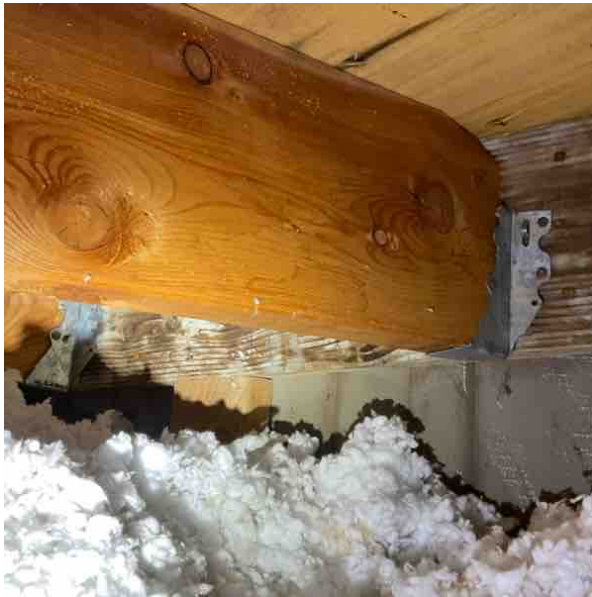
10.4.1 Evidence of past water entry at the east entrance/foyer. At this time there is no sign of current moisture on the wall or in the attic. **(Foyer)**

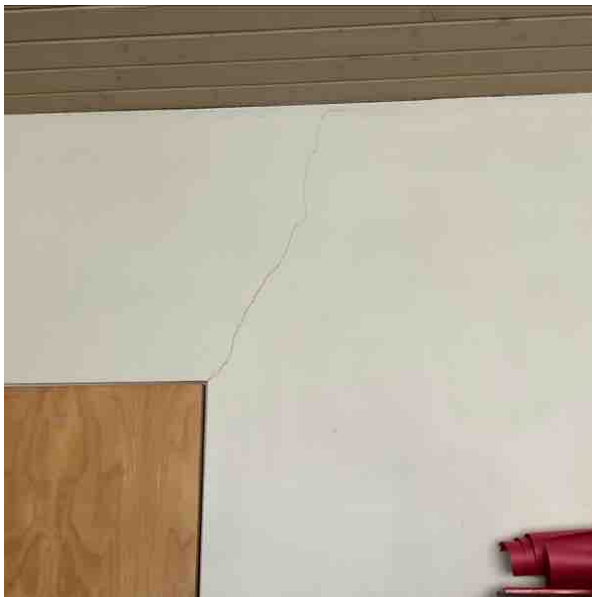
10.4.2 Minor drywall cracks observed. These do not appear to be structurally Significant. Consult a drywall contractor to repair as desired. **(Pantry)**

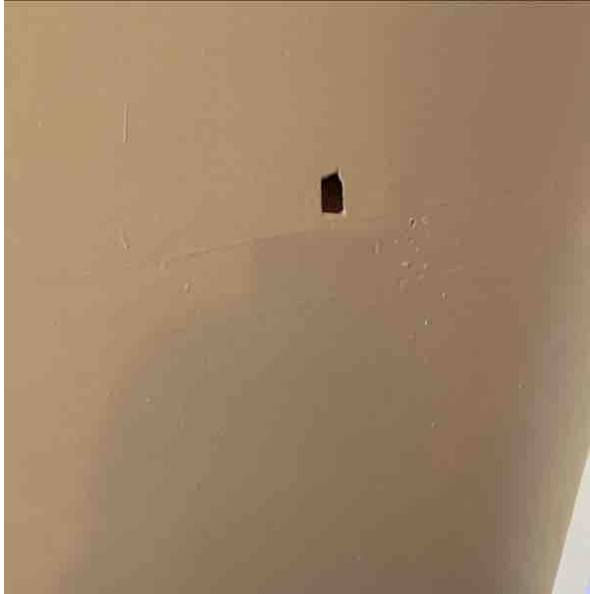
- Basement room 1
- Basement room 5-6

10.4.4 Repair minor wall/ceiling damage as desired.

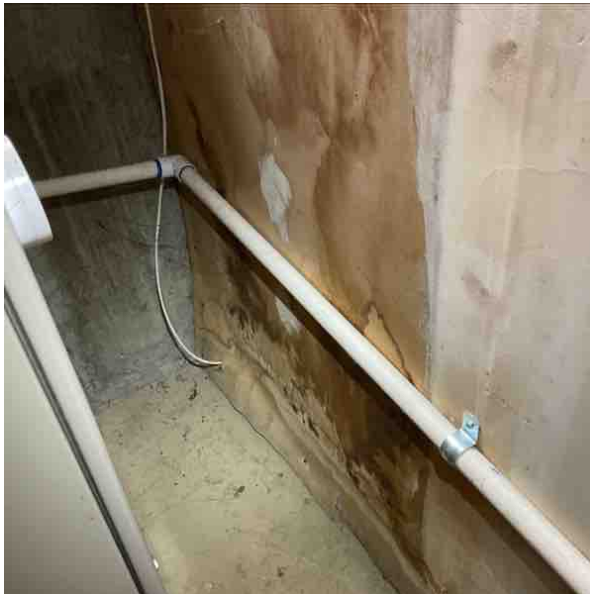
10.4.5 Interior walls show damage and show signs of past water entry/mold and mildew. Repair recommended to promote health. **(HVAC room)**

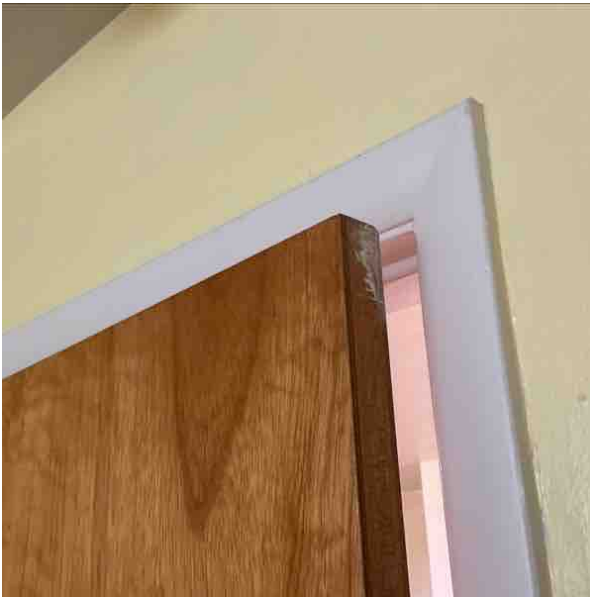
- Basement room 1
- Basement room 5-6
- Copy Room
- Meeting 3
- Sanctuary
- Sanctuary front storage rm.

10.6.1 Repair or adjust door hardware for intended function.

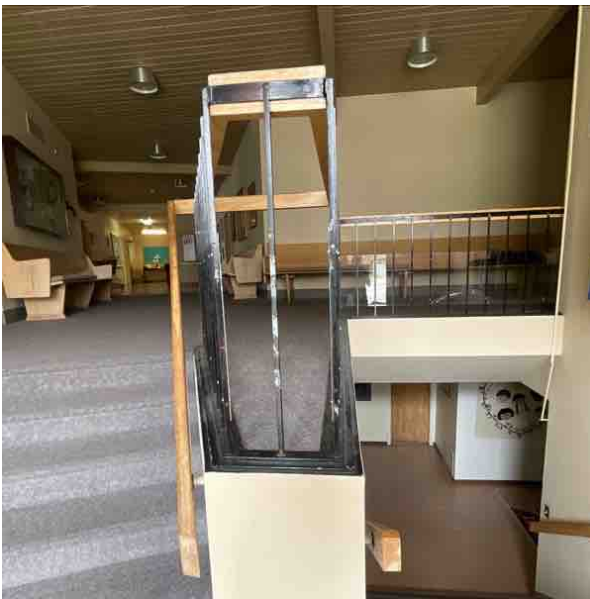
- East entrance
- Foyer

10.7.1 It is recommended that spacing between balusters be no greater than 4 inches for safety. Consult a contractor for repair.

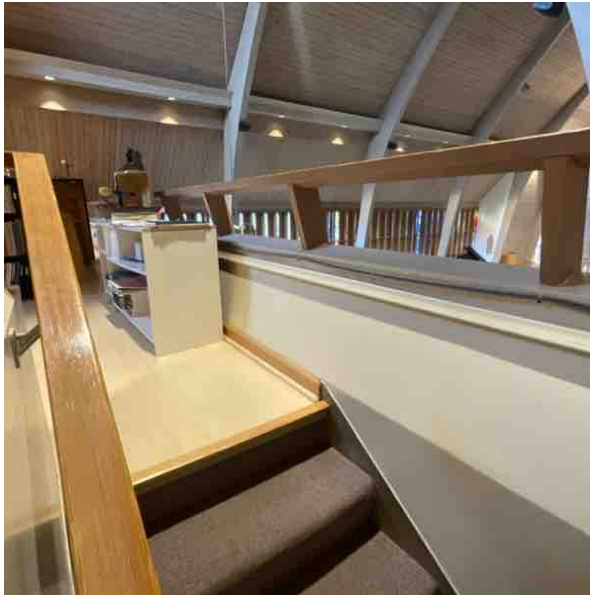
10.7.2 The guardrail/wall could be considered a safety hazard, due to the wall height below the top rail.  
Repair recommended for improved safety. **(Balcony)**
