Inspection reference: 3028

GENERAL INFORMATION

41649 W. Sesame Street.
Maricopa AZ 85138.

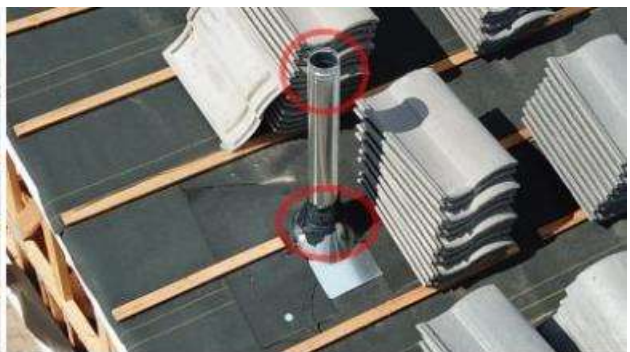
MISSING VENT CAPS AND STORM COLLARS.

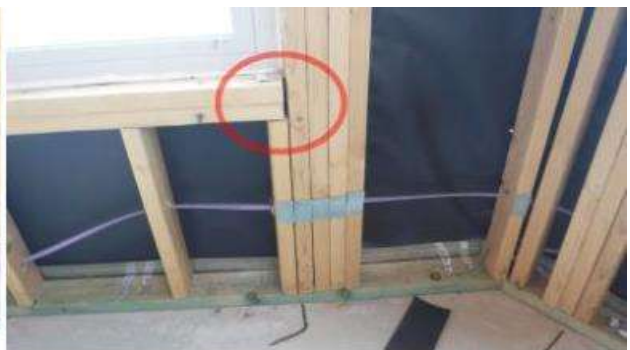
4. Missing nail protection for wiring / plumbing; north guest east wall, master bathroom west at DWV pipe.
5. Uneven reveals, framing not square at windows noted; northwest guest, master bedroom, dining room, family room.

SEPARATIONS AT WINDOW FRAMING.
