SUMMARY OF INSPECTION REPORT

Summary A: The following is a list of items / conditions that are typically considered significant and / or safety related, and usually will need further evaluation or repair by appropriately Licensed Contractors.

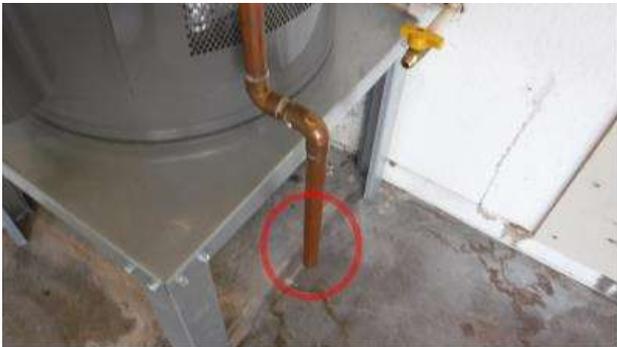
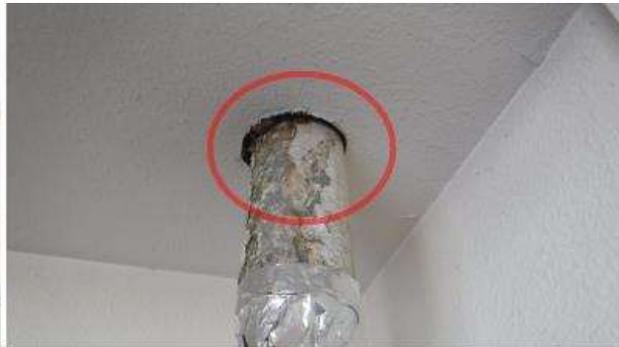
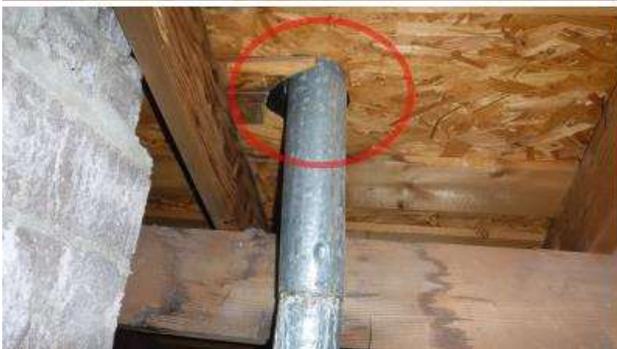
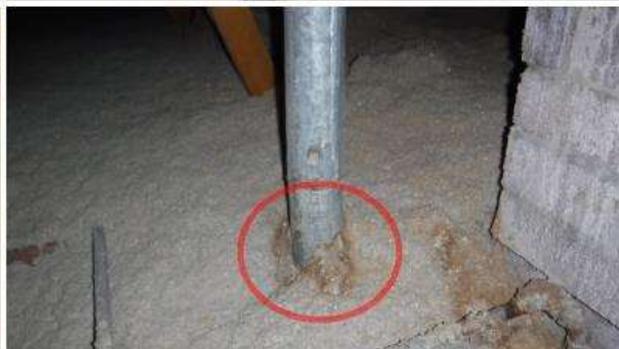
7.

6. Drain pan is recommended. Gas/Pilot is Off - Could not fully inspect, Pressure relief valve and pipe noted, not tested. Poor termination of TPR pipe noted Flue vent intact, missing trim ring at ceiling. Improper clearance to combustibles, Minimum 1 inch clearance needed from combustibles at double wall B-vent. A water shutoff valve is installed. Thermal coupler is present. Manufacture date / approximate age- 1/16/2017.

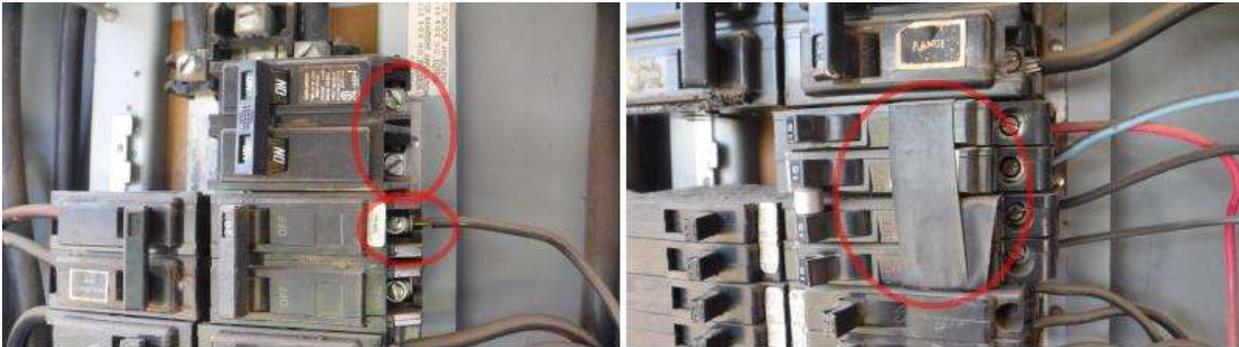
12.

11. Circuit and wire sizing correct so far as visible. Triple lugging at ground/neutral bar noted, typically rated for only two wires. Missing knockouts viewed at panel. Single pole in use at 20 amp 240 volt breaker. Abandoned breaker noted. Different brand breakers are installed, not recommended. NOTE: Six or fewer breakers in one location do not usually require a main breaker. Anti oxidant recommended on aluminum 240 volt connections. Electrical tape around some breakers is noted. Electrical system appears outdated by today's standards. Upgrade should be considered. Have a licensed electrician make further evaluation and corrections as needed.
