Building Inspection Report

7904 Main Street, Anytown, NC

12/3/2010

[Triangle Home Inspection, LLC](#)

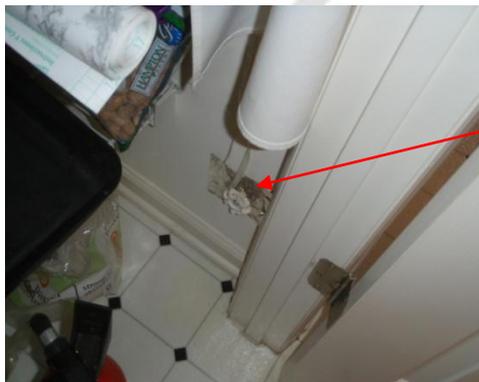
Water shut-off valve

The main water shut-off is located in the kitchen pantry. This valve shuts off all of the water to the home. All repairs listed below should be performed by a licensed plumbing contractor. The installation of carbon monoxide detectors is advisable. A carbon monoxide detector offers protection from the dangers of carbon monoxide.
