Marine Survey Report For [REDACTED]

## 1988 Brewer 44' Cutter

24044

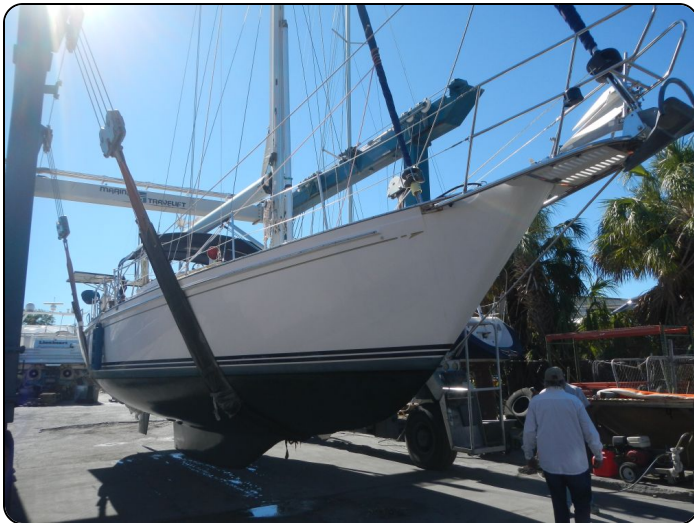
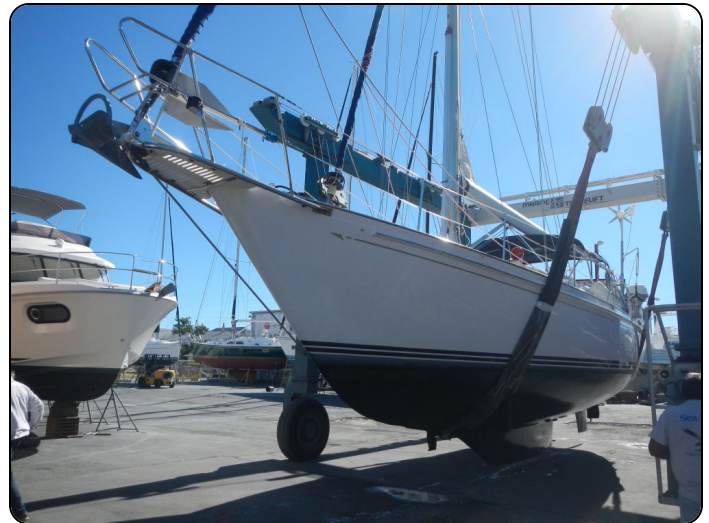
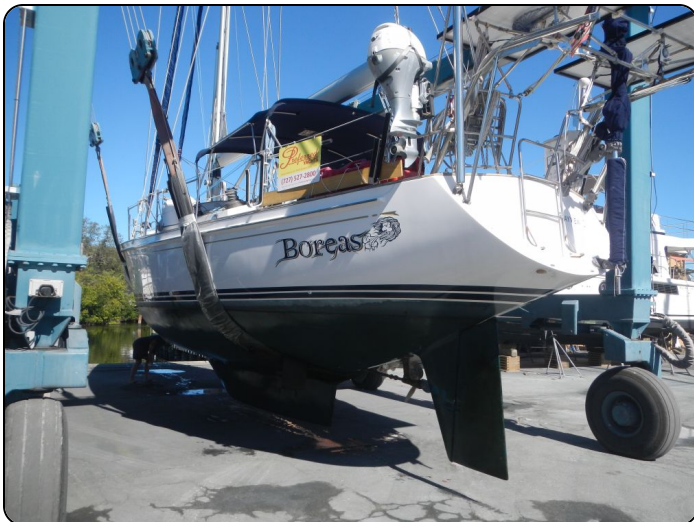
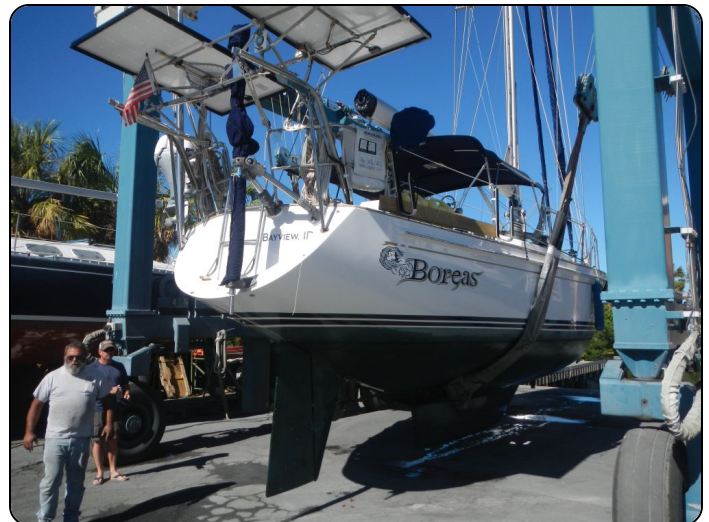
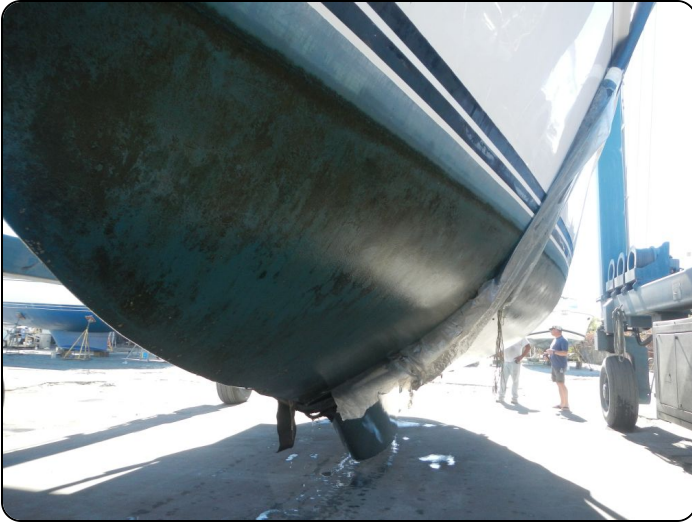
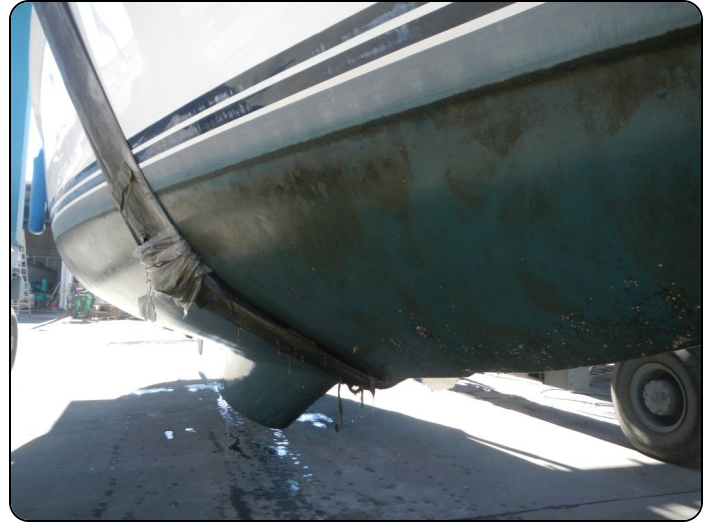
**FINDING B-1****KEEL TYPE**

FRP encapsulated lead ballast fin keel.

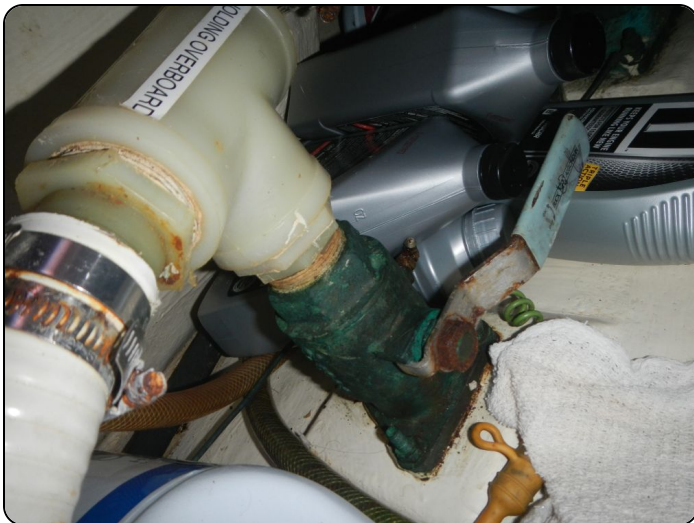
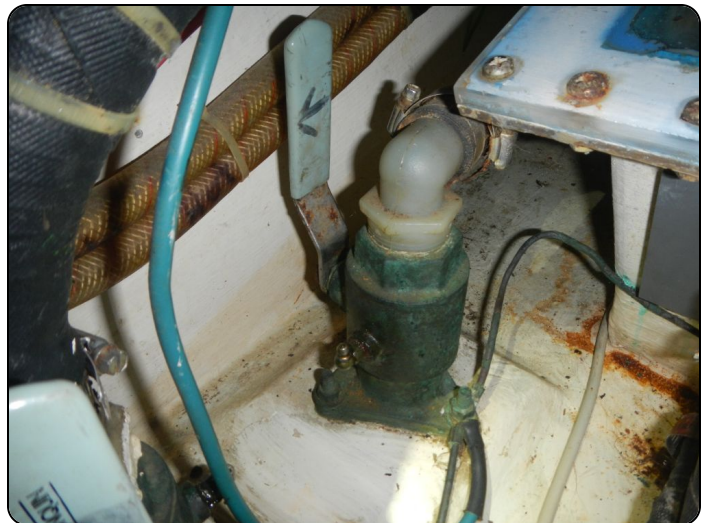
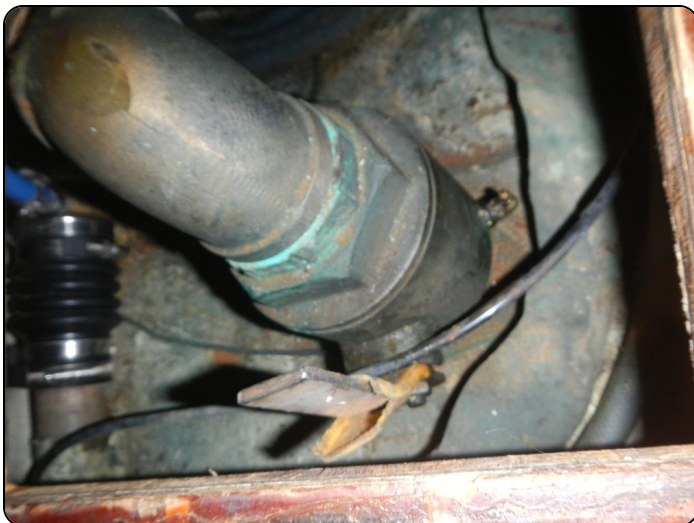
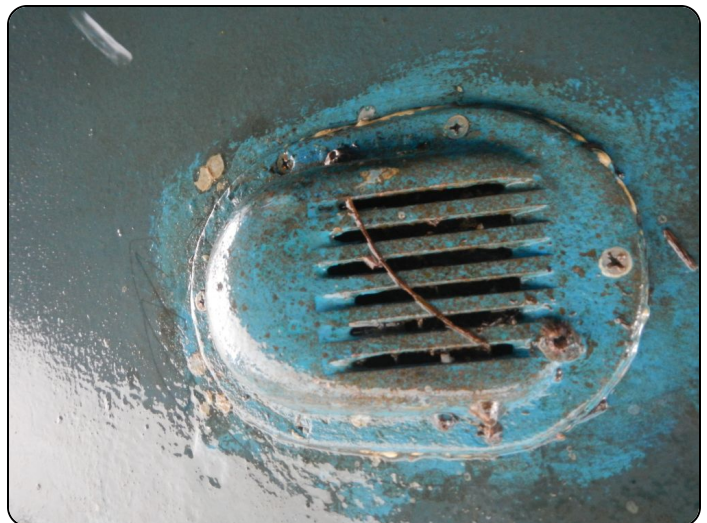
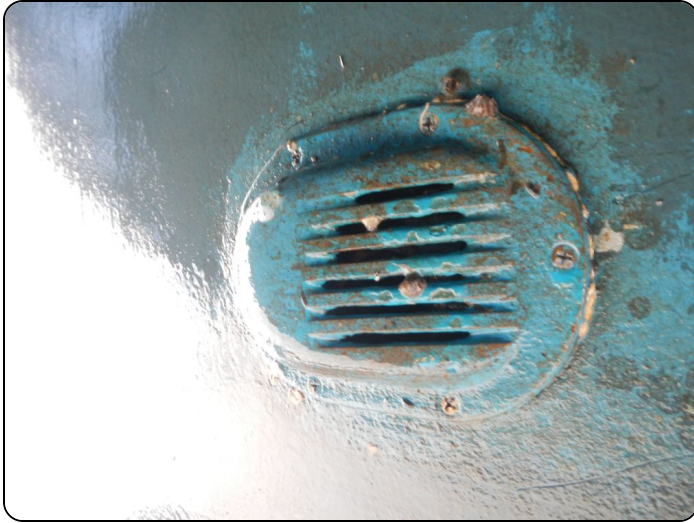
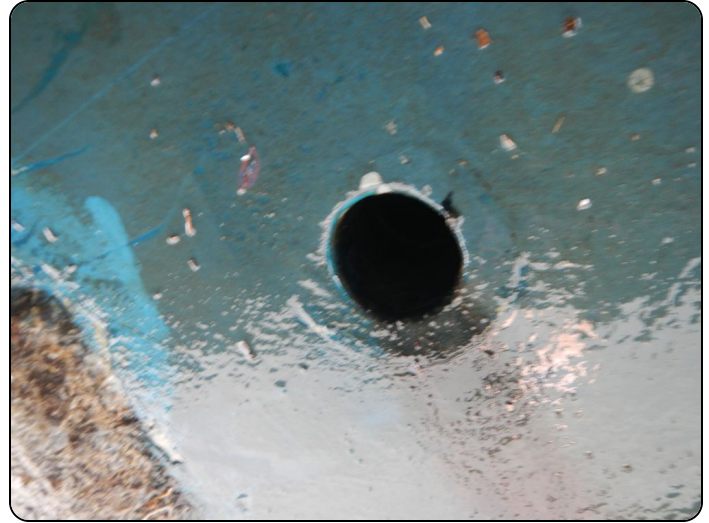
Bronze sea cocks with mounting flanges. Valves were tested and some found to be inoperable. See Findings & Recommendations.

In apparent serviceable condition except as noted in the Findings & Recommendations.

This company suggests the sea cock/ sea valves be serviced according to the manufactures recommendations as a preventative measure upon purchasing a used vessel and thereafter as recommended by the sea cock/ sea valve manufacturer or more frequently as a part of the vessel's regular maintenance program. We also strongly recommend that if the vessel is left unattended that all below waterline sea valves be closed with the exception of scuppers, bilge pump discharge, or other valves that are required to be in the open position to prevent flooding of the vessel during inclement weather. This provides an extra measure of safety for the vessel as well as the added benefit of familiarizing the crew with safety valve locations and to exercise the valves to prevent seizure.

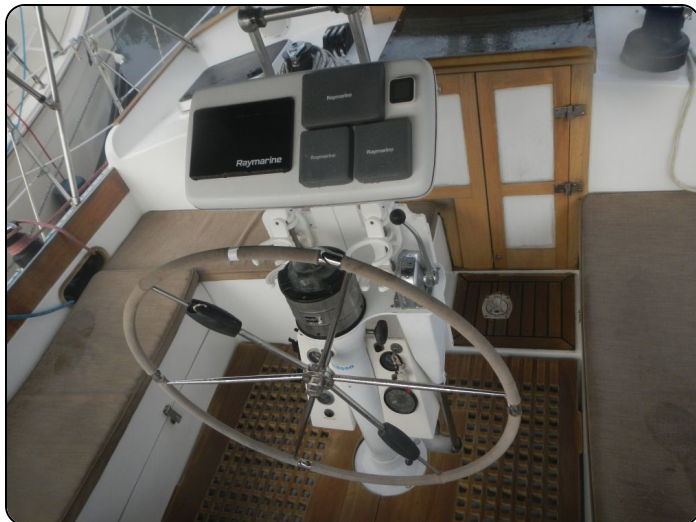
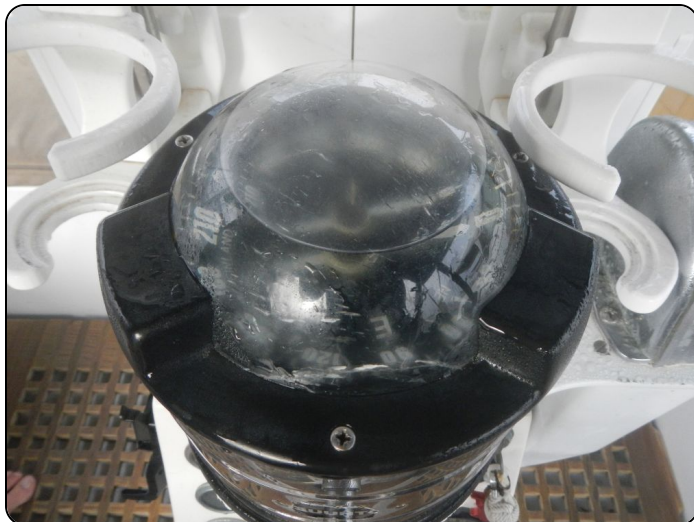
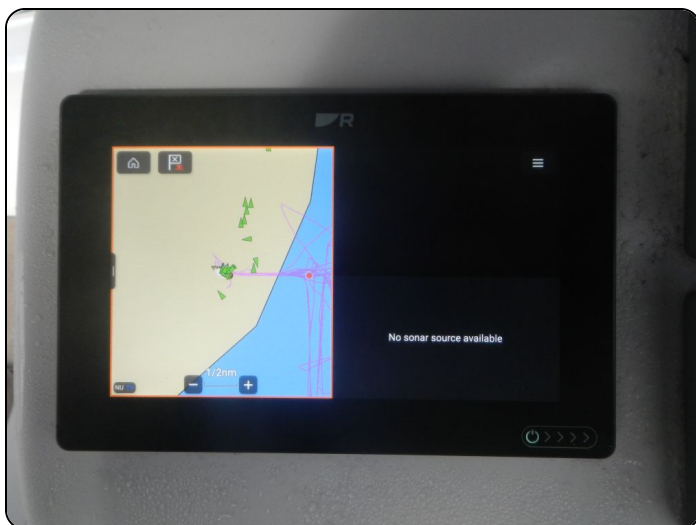
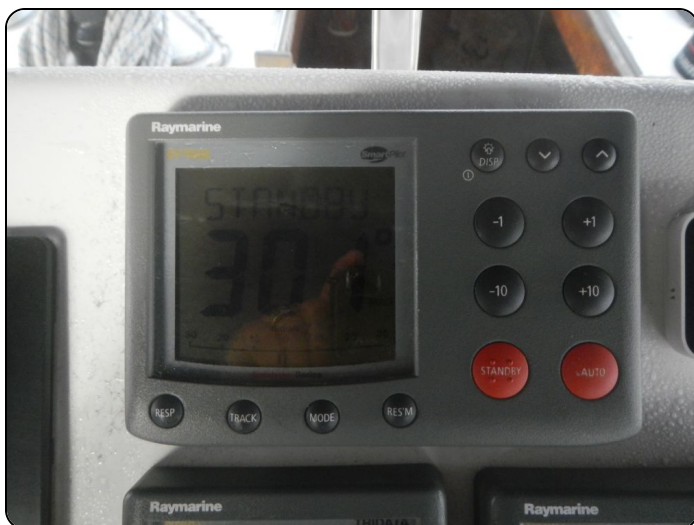
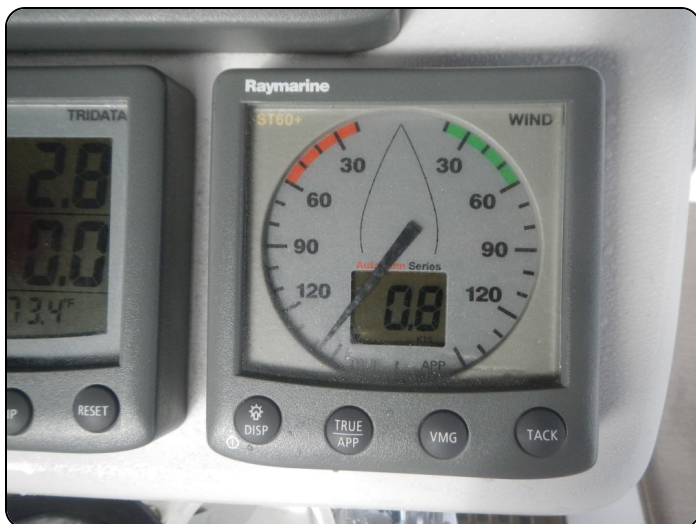
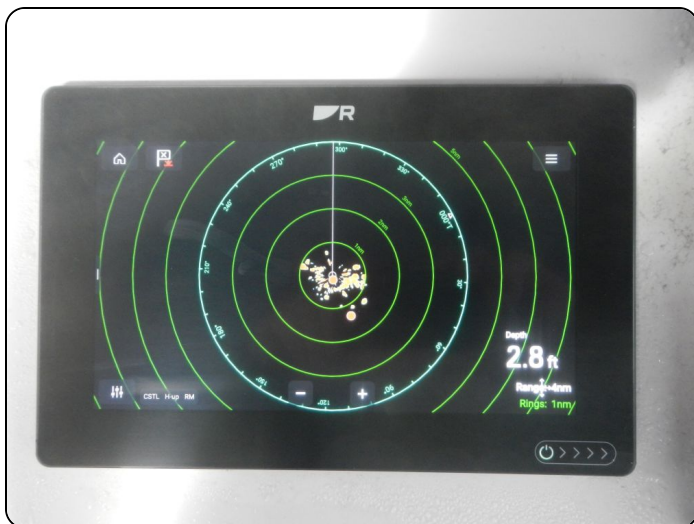
FINDING B-5

Electronics mounted on the cockpit Binnacle. A 4" compass showing some damage and not easily readable. The accuracy of the compass was not verified. A Raymarine chart Plotter with navigational charts, sonar and radar that powered up, A multi gauge depth/wind/speed digital displays, A Raymarine Autohelm system with digital display that was proven during the trial run. In addition there is an ICOM IC-M802 SSB (Single Side band) radio that powered on and a SIMRAD VHF radio mounted near the Main power panel with (2) wireless handheld units that powered up and received transmission through the NOAA weather service. All of the equipment powered on and was operable unless otherwise noted. See Findings & Recommendations.

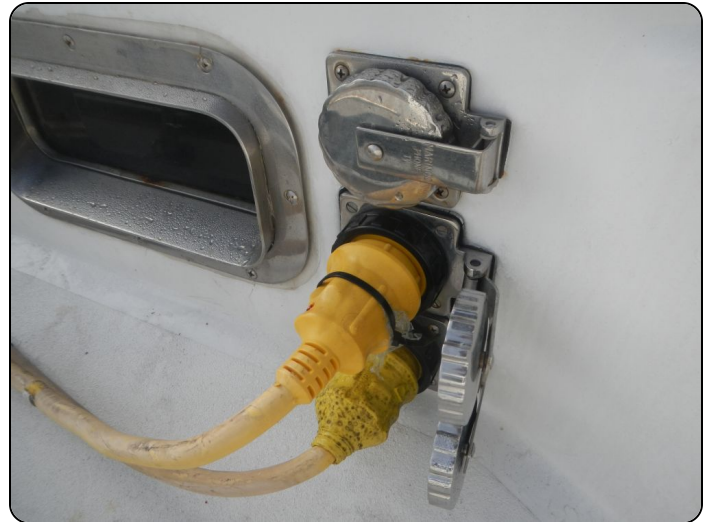
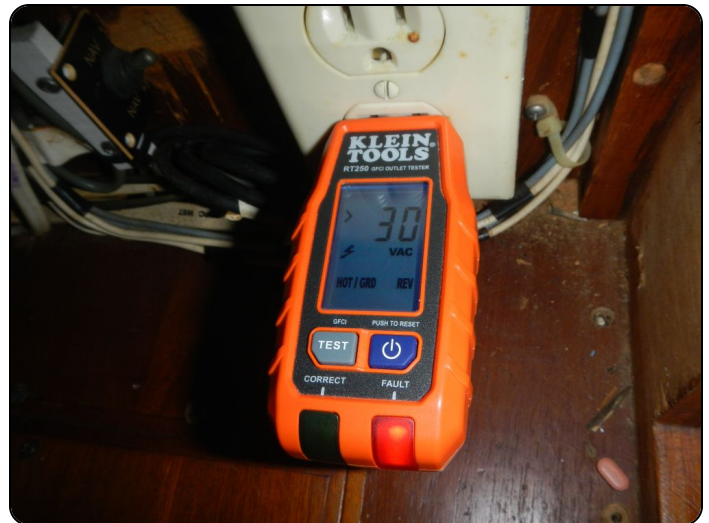
**FINDING B-18****ALTERNATIVE CURRENT (A.C.) SYSTEM(S)**

The vessel was equipped with (2) 120 VAC Hubbel 30A single phase Ac system receptacles. The vessel shore power connections were located on the starboard outside aft deck in a gunwale locker. The operable main shore power circuit breaker is located in the starboard side lazarette. All breakers were operable and analog volt and amp gauges were installed at the power panel. Overcurrent protection was provided for with individual branch circuit breakers in addition to the main shore power circuit breaker installed on the panel board. An operable main circuit breaker was also installed at the generator, and the generator/shore power selector switch at the panelboard in the cabin was an operable make or break type switch. Where accessible and visible, the shore powers system's consisted of multi-stranded copper conductors with plastic-type insulation, and the terminal's consisted of ring terminals and butt splices. The system's wiring in so far as could be determined did not appear to be modified from its factory installation, and no indications of overheating of the visible portion's of the wiring insulation was found. The AC panel board was fitted with reverse polarity indicators which were functioning. GFCI protected AC receptacles were installed in the vessel. The systems impedance, voltage drop, polarity and GFCI function were tested at each AC receptacle with a Klientools device with shore power and generator supplied power and tested normal except as indicated in the Findings & Recommendations. As far as could be determined by general examination without making disassemblies, the system was found to be in apparently good working order. See Findings & Recommendations.

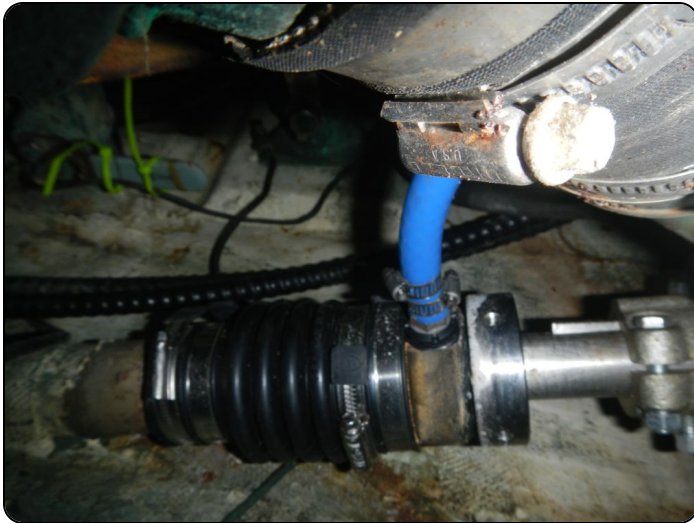
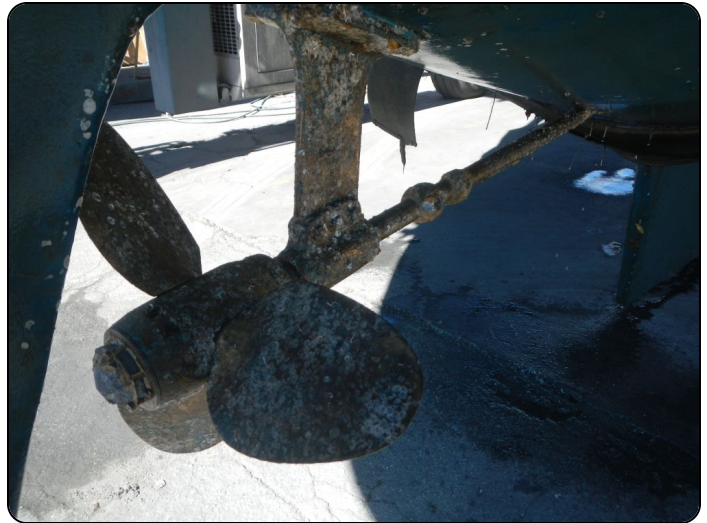
Single bronze 3-Blade PYI Max-Prop feathering propeller with an 1-1/4" diameter stainless steel shaft supported by a bronze strut and a cutlass bearing. Dripless type packing gland attached to FRP shaft logs exiting the hull. Equipment has average wear for the age of the vessel with little to no play.

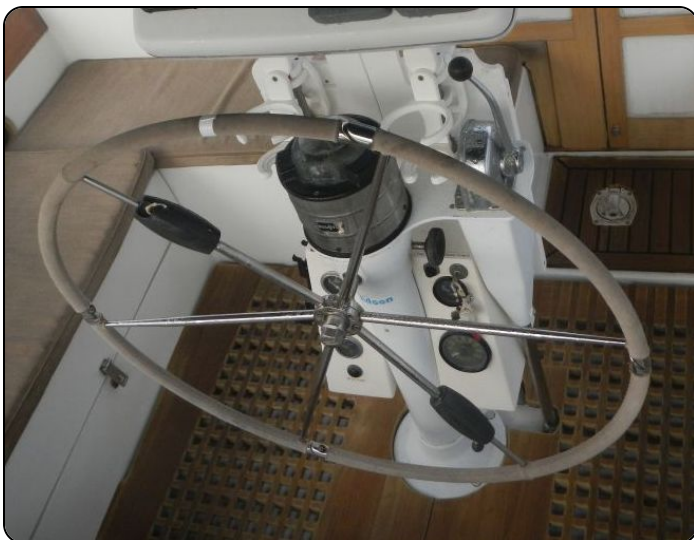
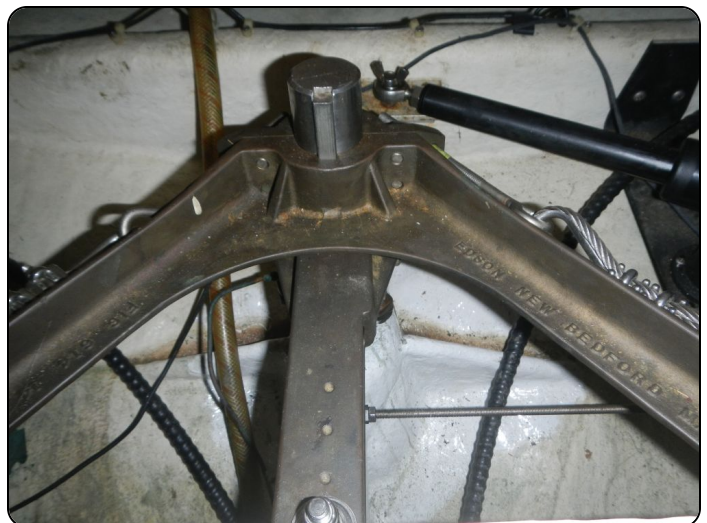
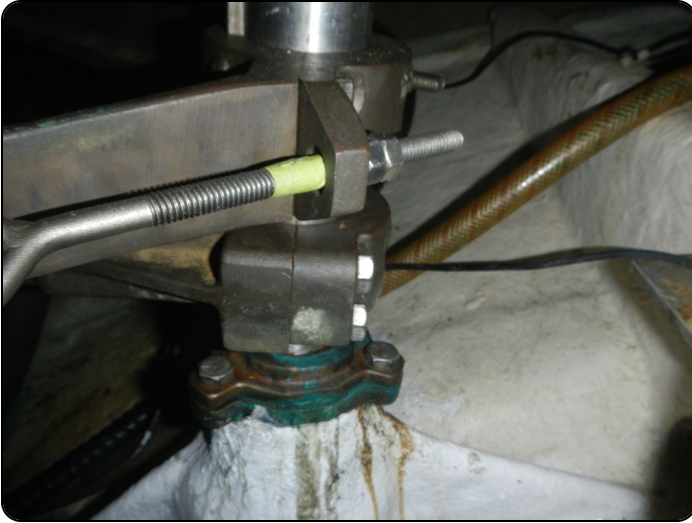
Pedestal with stainless steel spoked collapsible steering wheel, stainless steel cable to pulleys and a bronze steering quadrant attached to the rudder shaft. Also attached to the quadrant was an autopilot reference sensor. Operational, Intact and serviceable. In addition to the main steering system there is a Hydrovane brand wind vane steering system that was intact however not operated during the survey. See Findings & Recommendations.

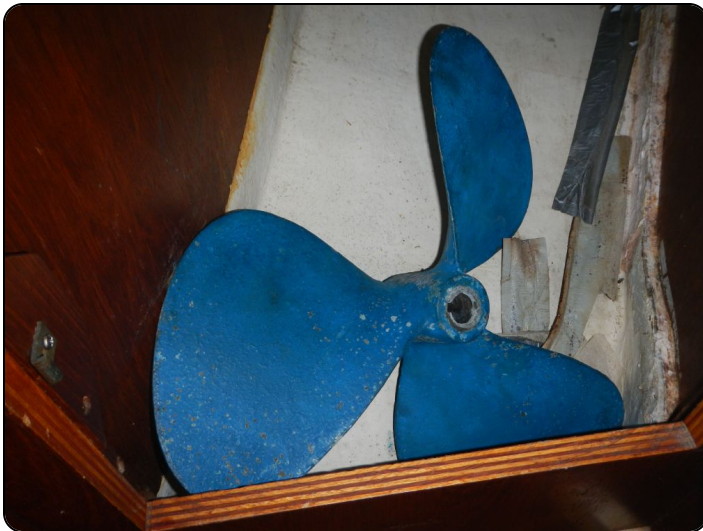
Spare 3-Blade Bronze fixed blade propeller stowed in a locker in the aft cabin on the port side.

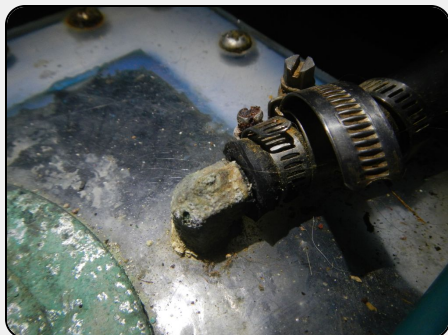
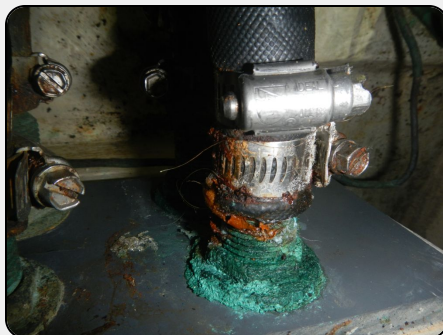
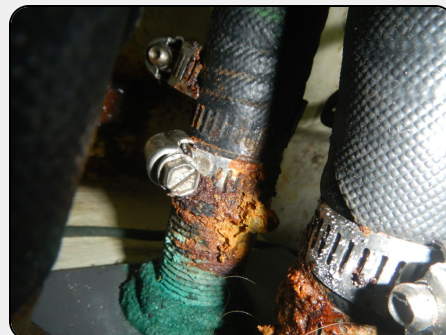
Several connections and bronze fittings showing heavy corrosion at the sea chest.

Replace all corroded fittings.
