# CONEJOS RIVER

## DIVERSION INFRASTRUCTURE INVENTORY

**Structure Name:** EAST BEND NO 2 D

**Date:** April 16, 2019

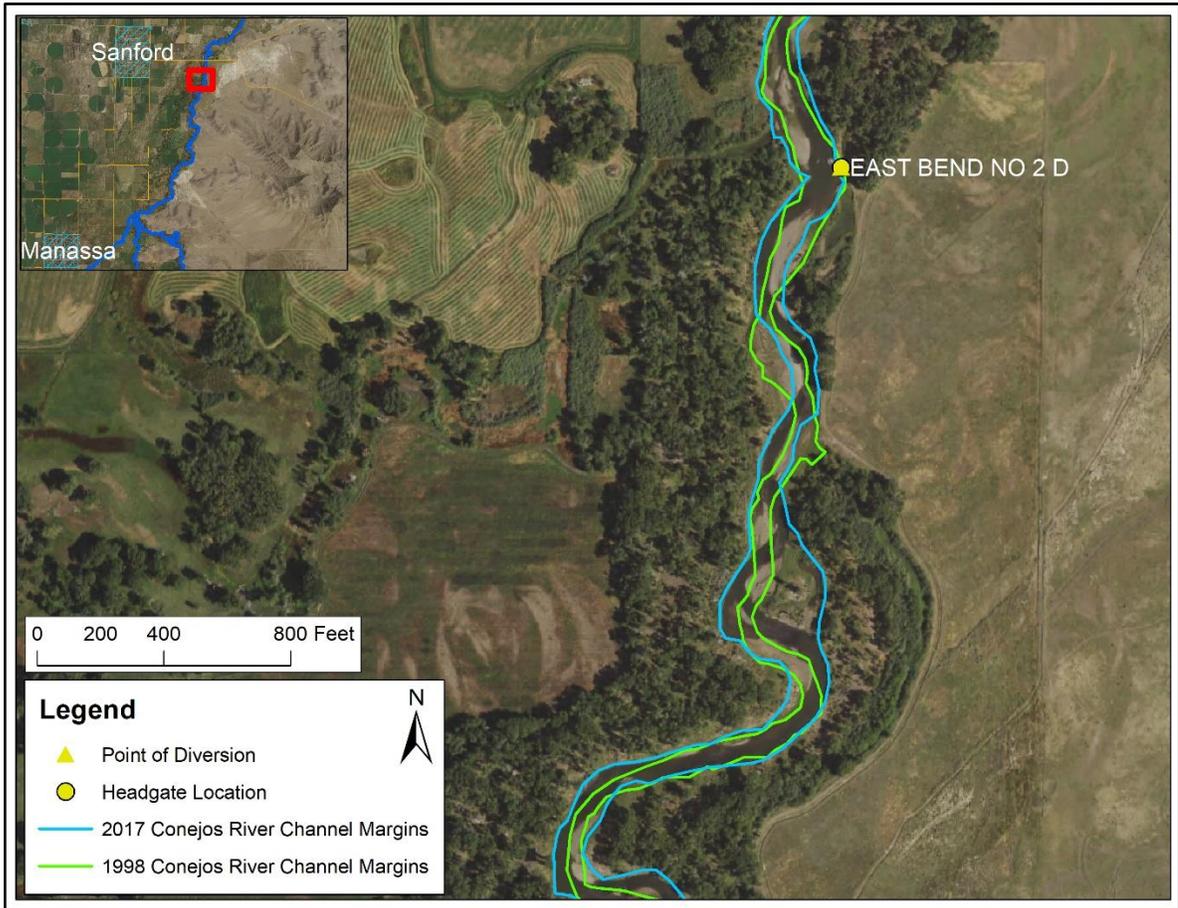
**Structure Description:** The meanders upstream of the diversion have tightened over the last 45 years and channel avulsion may occur at high flows. A minimal stacked rock diversion dam directs water to the headgate, which is located on the east bank of the river. The head wall is made up of a combination of boards, concrete and grouted rock. The headgate has plywood covering the opening to reduce leakage.

Map of headgate location with 1998 and 2015 channel margins overlaid

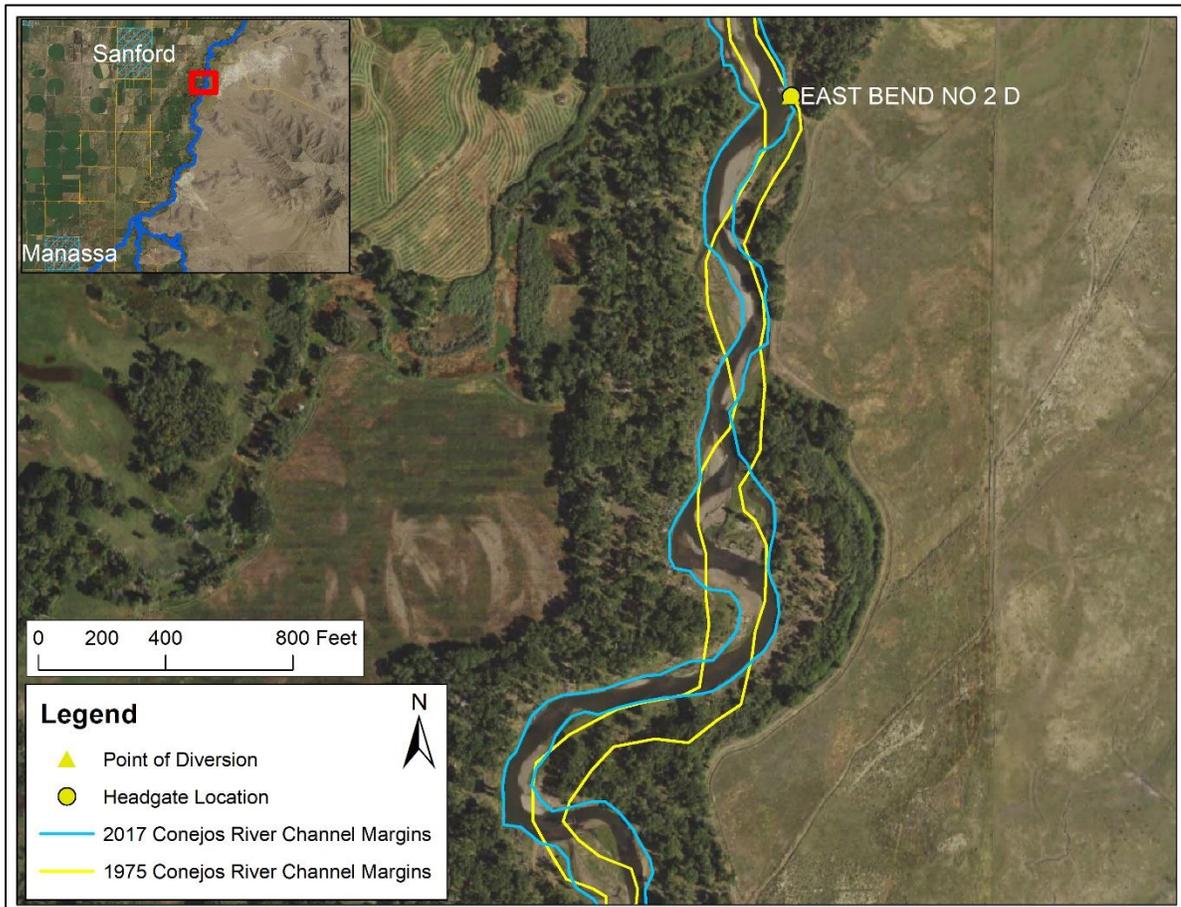
Map of headgate location with 1975 and 2015 channel margins overlaid
