Conejos River Stream Management Plan

Rio Grande Basin Roundtable and the
Stream Management Plan Technical Advisory Team

2020

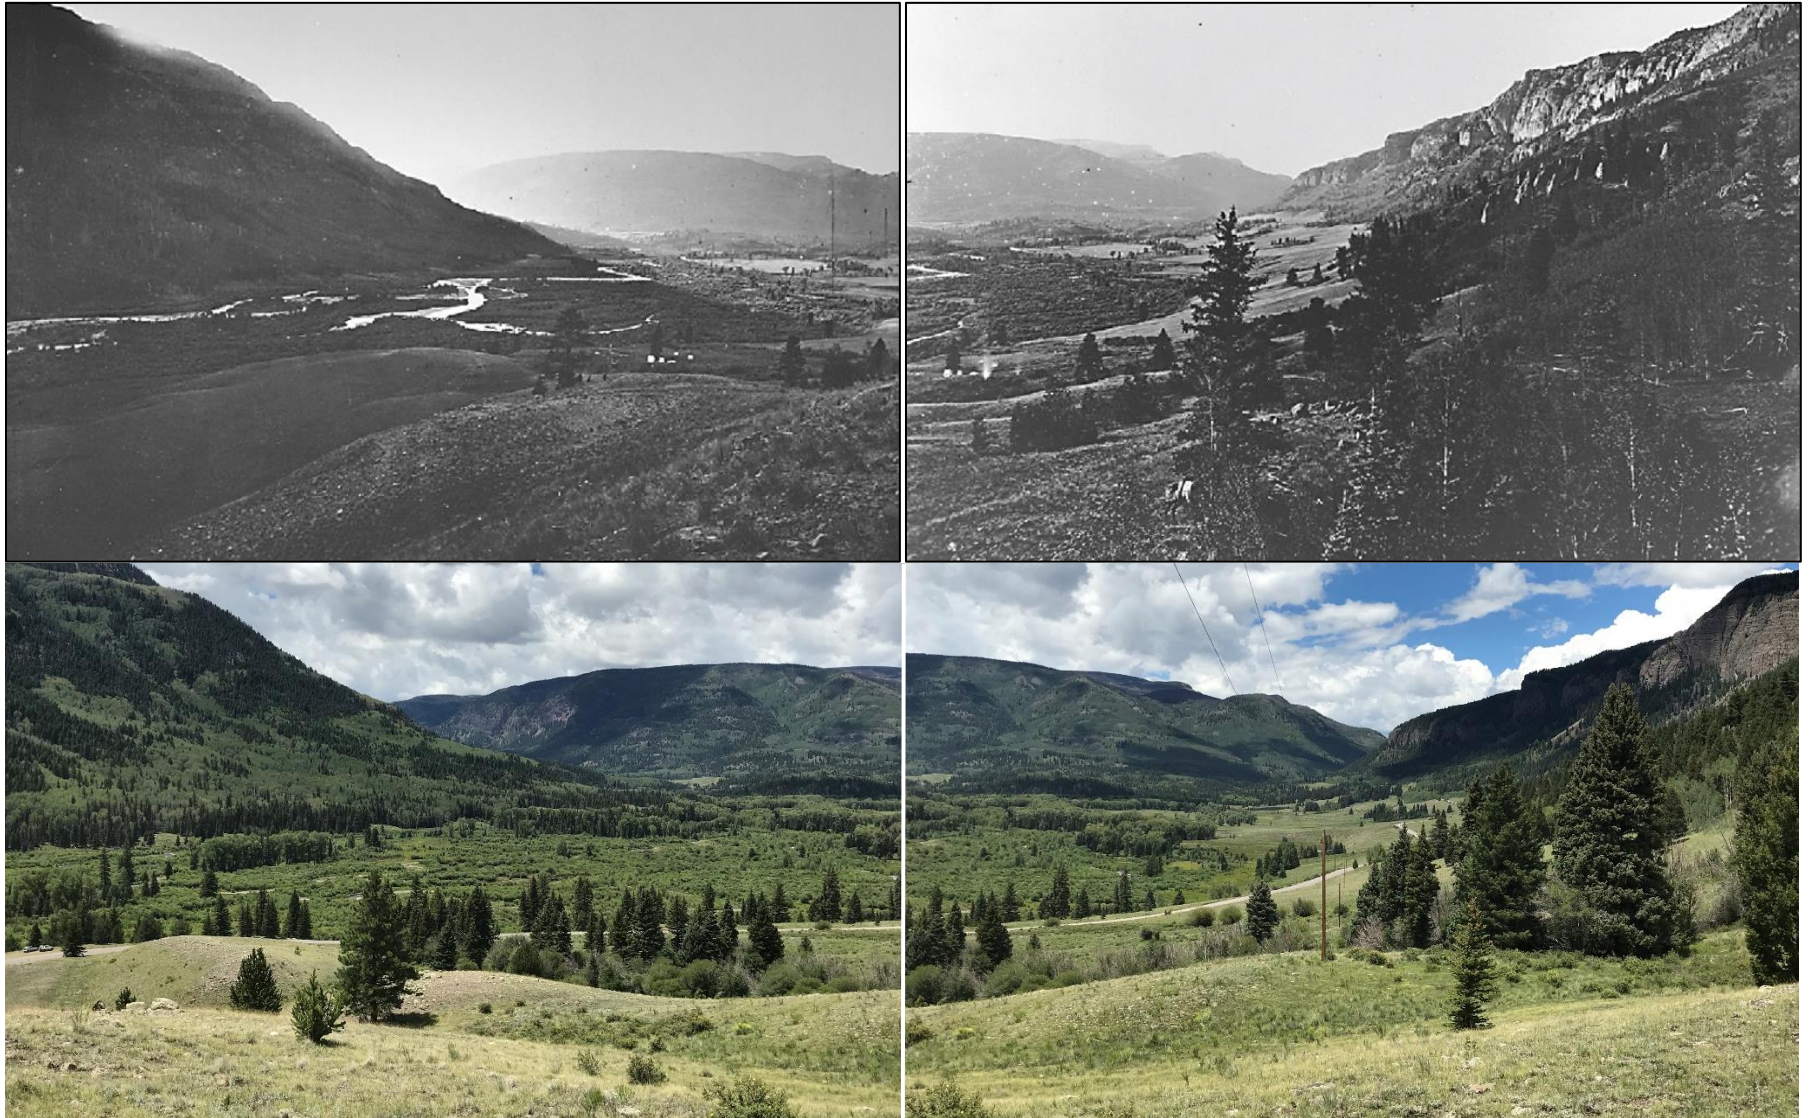
Figure 3.4: Conejos River immediately downstream of the confluence with the South Fork Conejos River. Photograph from Volume IV of the Wheeler railroad surveys, which were conducted during the 1870s (top) and Conejos River in 2020 (bottom [Wheeler, 1878]).

Figure 3.4 shows current and historic (1870s) photographs of the Conejos River mainstem immediately downstream of its confluence with the South Fork Conejos River. These images confirm and illustrate the findings from the riparian vegetation assessment, which found large portions of Conejos River’s riparian zones have remained largely unaltered from natural, or “reference” condition (Wheeler, 1878).

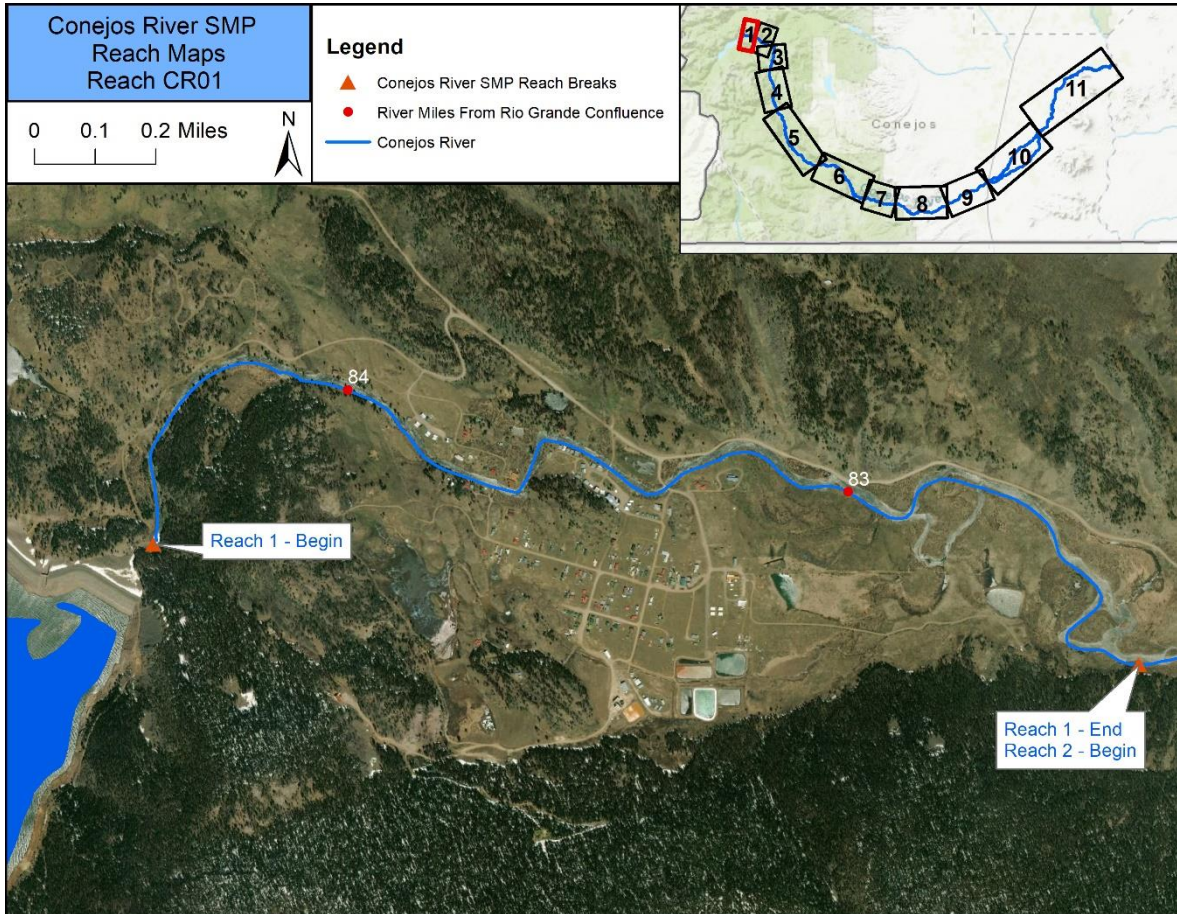
Representative Reach Photo

Overall, this site (CRVeg01) appears to be in good condition with an overall EIA rating of B- (2.99). The lowest individual metric ratings it received were for Contiguous Natural Land Cover (C), Width of Natural Buffer (C), Condition of Natural Buffer – Vegetation (C), and Native Plant Species Cover (C-) (Table 3.7).

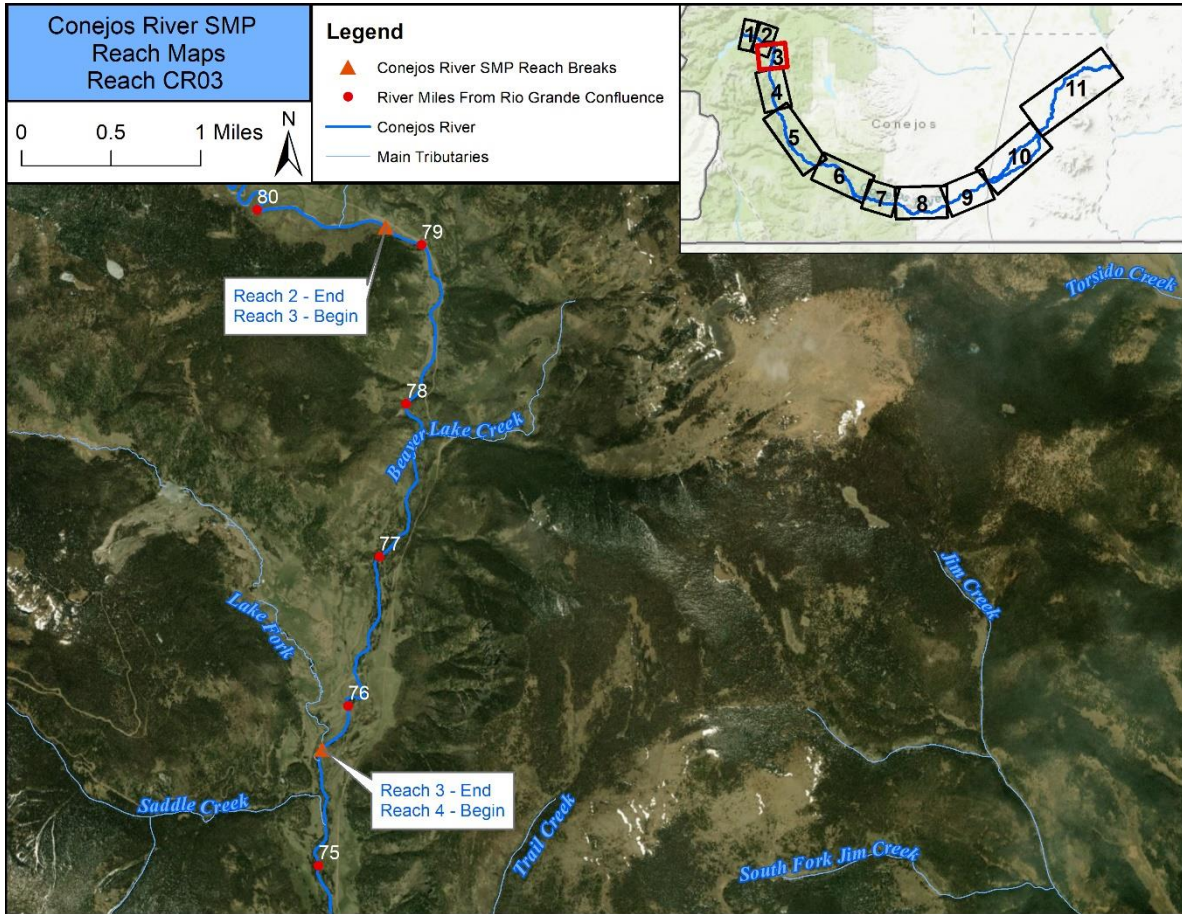
Representative Reach Photo

Overall, this site (CRVeg03) appears to be in very good condition with an overall EIA rating of B+ (3.32). The lowest individual metric ratings it received were for Width of Natural Buffer (C), and Native Plant Species Cover (C-) (Table 3.8).

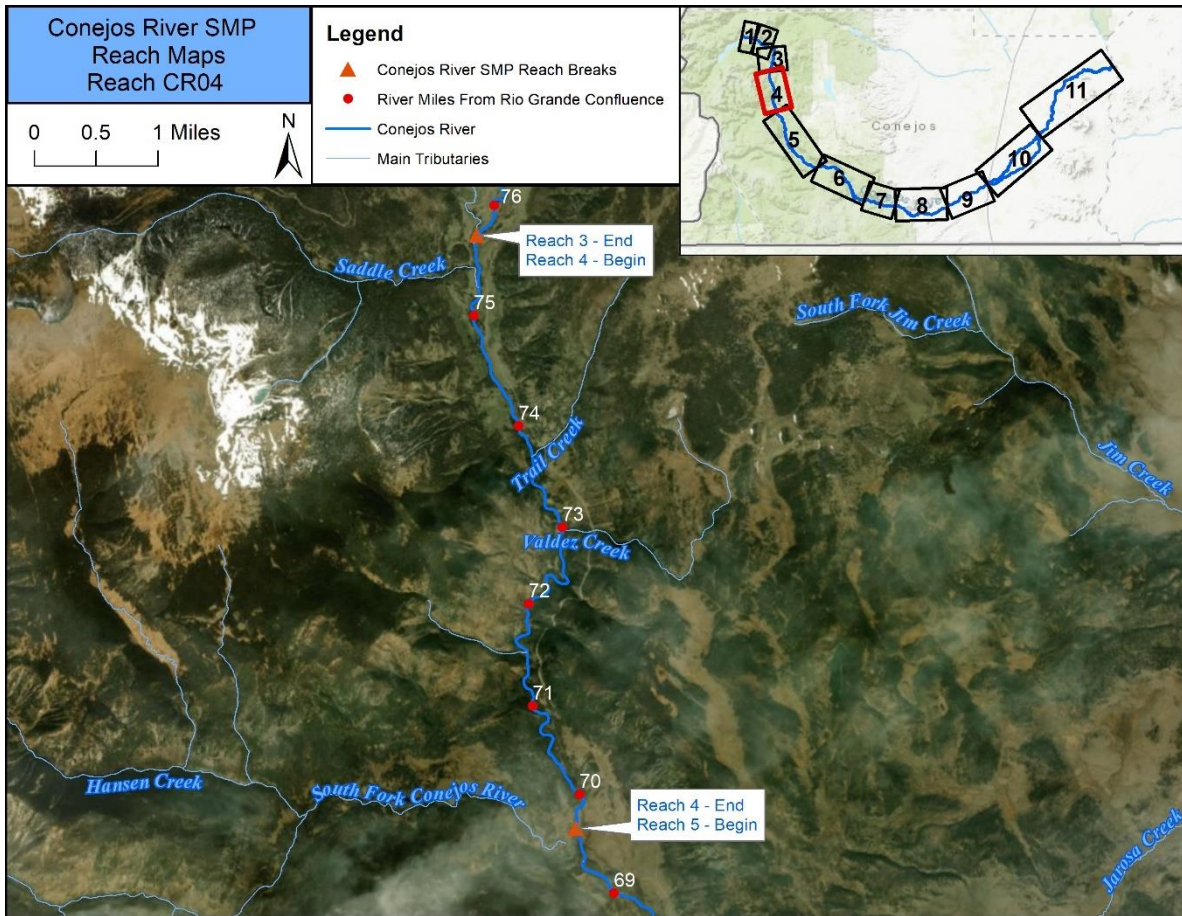
Representative Reach Photo

Overall, this site (CRVeg04) appears to be in very good condition, receiving an overall EIA rating of B+ (3.33). The lowest individual metric rating was for Condition of Natural Buffer – Vegetation and Native Plant Species Cover (C-) (Table 3.9).

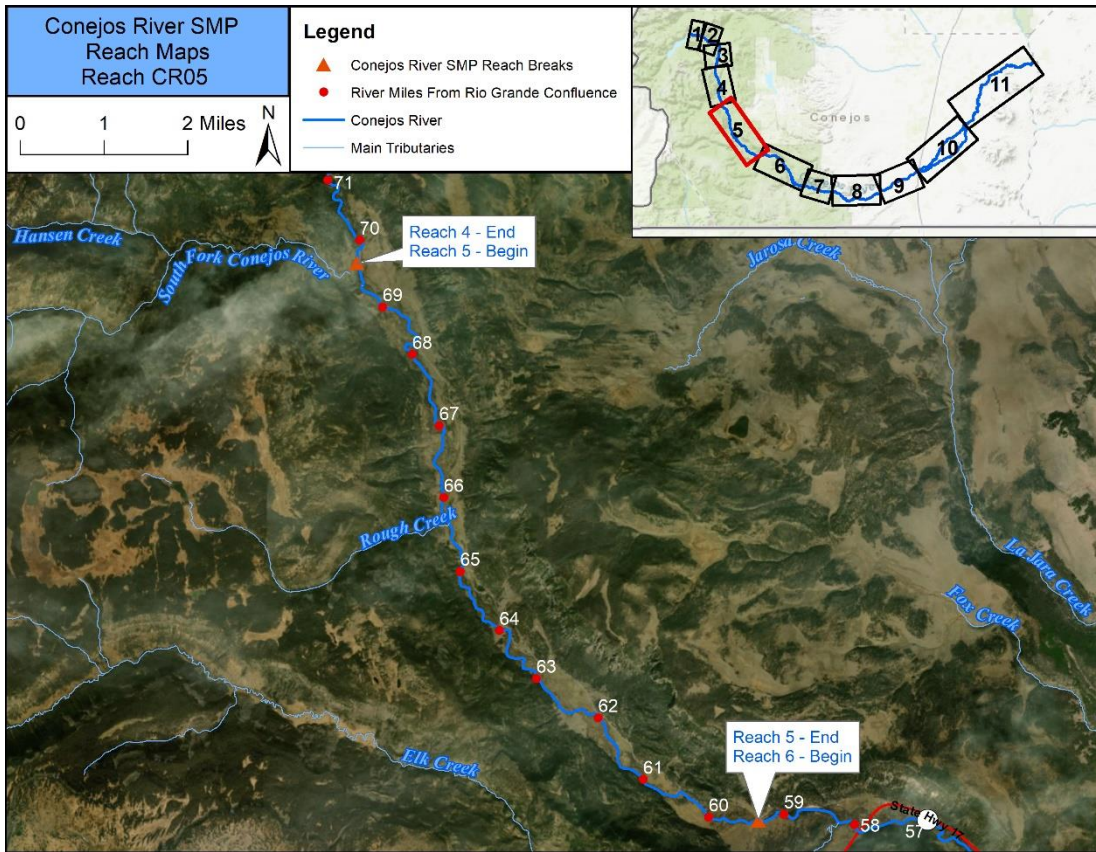
Representative Reach Photo

CRVeg05a: Overall, this site appears to be in very good condition with an overall EIA rating of B+ (3.34). The lowest individual metric ratings it received were for Condition of Natural Buffer – Vegetation (C), and Native Plant Species Cover (C-) (Table 3.10).

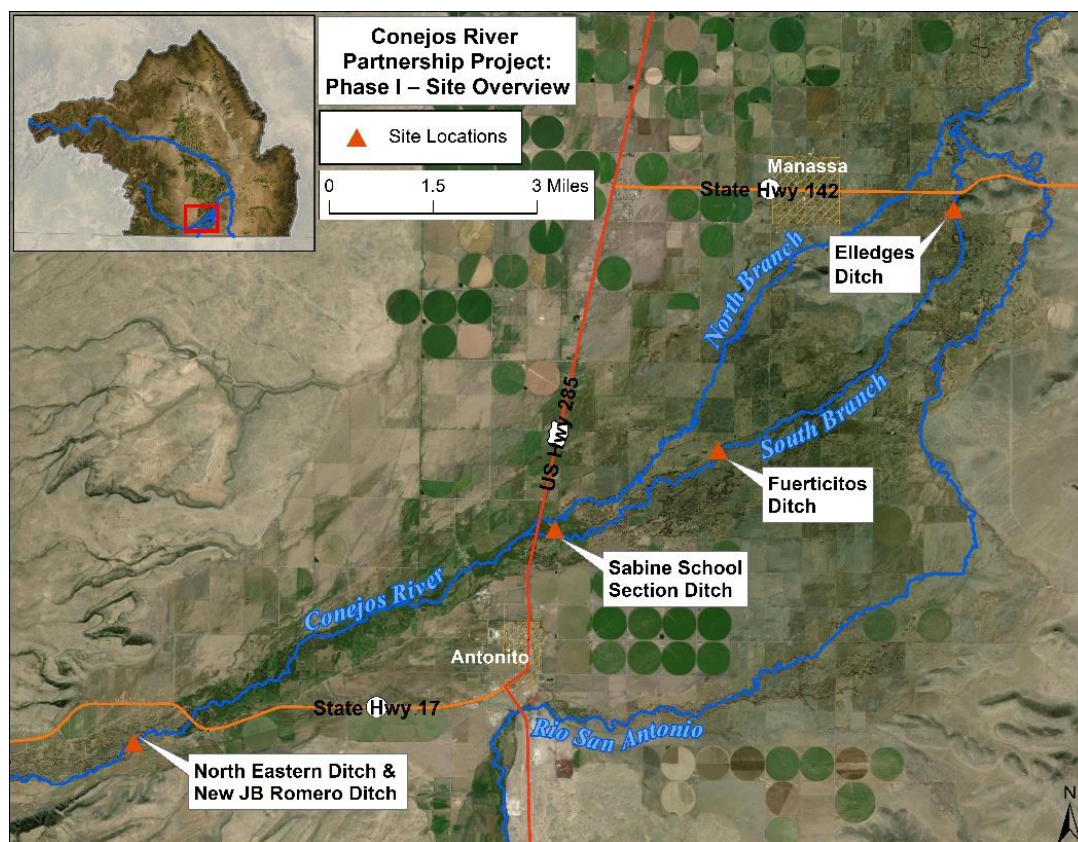
Figure 4.1: Proposed diversion structure locations included in the Conejos River Partnership Project (CRPP) – Phase 1.

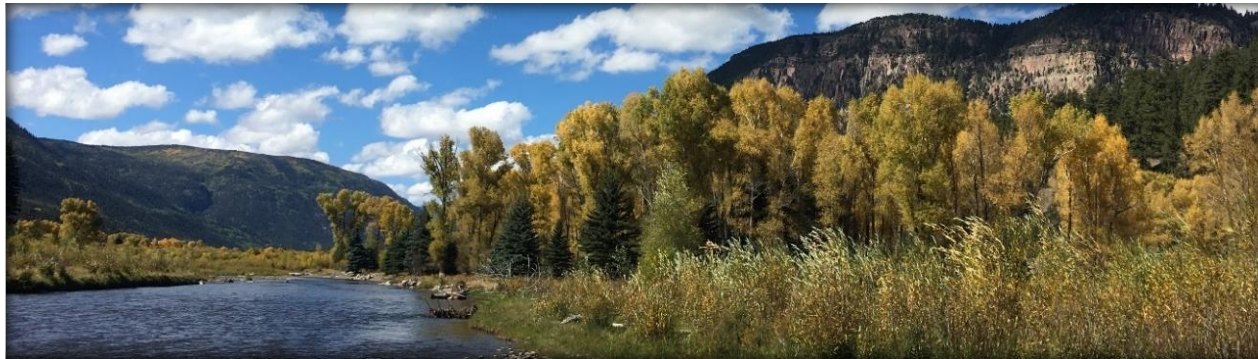
Figure 4.3: Conejos River riparian vegetation in the “fly water” (reach CR06).

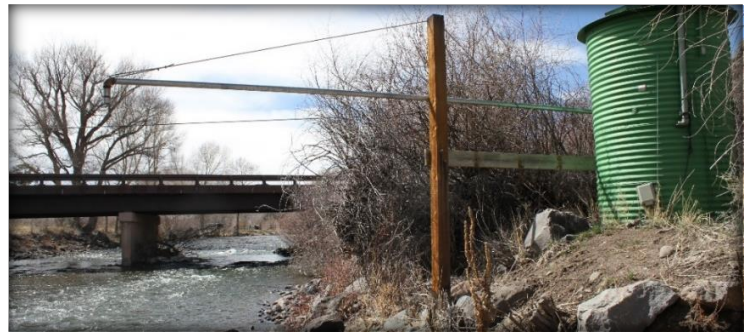
Figure 4.5: Conejos River Near Mogote, CO (CONMOGCO) stream gage.
