RIO GRANDE DIVERSION INFRASTRUCTURE INVENTORY

COCHRAN PIONEER DITCH

PHOTO LOG

Rio Grande Stream Management Plan

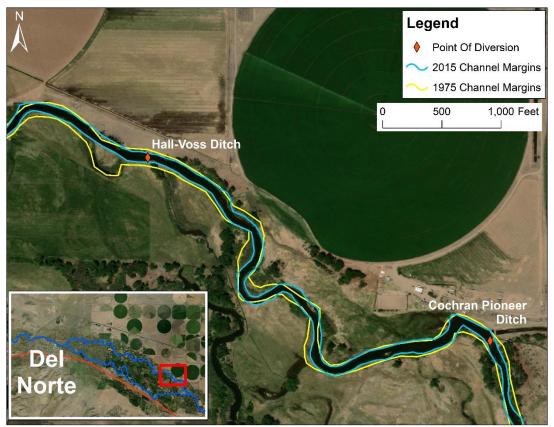
Map of headgate location with 1975 and 2015 channel margins overlaid

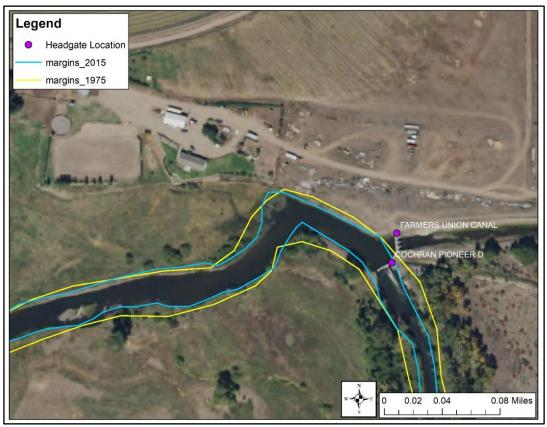
Map showing diversion dam and headgate location for Cochran Pioneer Ditch and Farmers Union Canal with 1975 and 2015 channel margins overlaid.
