RIO GRANDE DIVERSION INFRASTRUCTURE INVENTORY

Structure Name: HUBBARD D

Date: April 1, 2019

HUBBARD DITCH

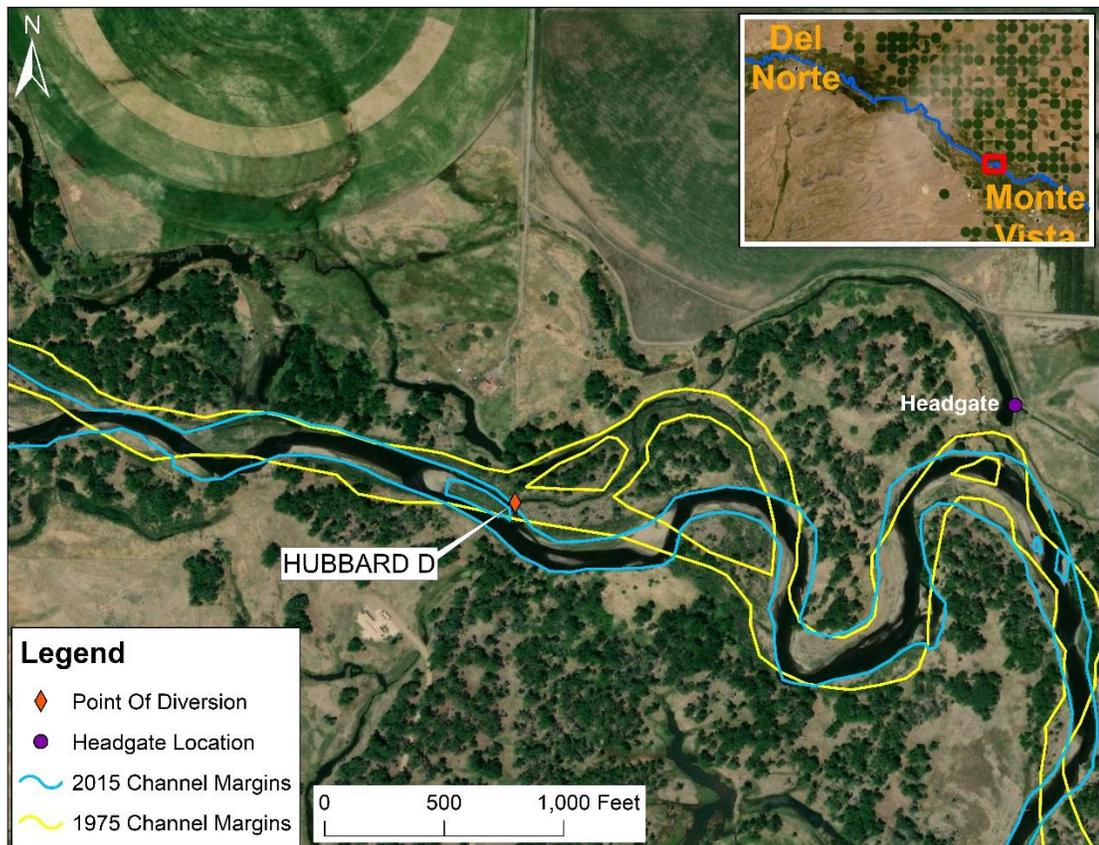
Structure Description: The channel in this area has shown signs of past avulsion. For example, a meander was cut off between 1975 and 1998. The existing feeder channel follows this historic channel (see map below). A small stacked rock diversion dam on the Rio Grande directs water to a long feeder channel. Approximately 0.25 miles down the feeder channel is a primary headgate and return flow structure. An additional 0.45 miles downstream (a total of approximately 0.7 miles from the diversion dam) is the main headgate. A culvert return flow structure with check boards also serves as a diversion dam for the main headgate.

Map showing point of diversion and headgate locations for the Hubbard Ditch with 1975 and 2015 channel margins overlaid.

Repair(s) or Improvement(s) Currently Needed: Sediment and debris accumulation in the feeder channel and headgate are major issues for this ditch. Because a trash rack is not likely to ameliorate this issue, the Technical Advisory Team (TAT) recommends regular debris clearing in the feeder channel and culvert upstream of the headgate. Alternatively, the point of diversion could be relocated downstream to reduce maintenance needs in the feeder channel.
