# RIO GRANDE DIVERSION INFRASTRUCTURE INVENTORY

**Structure Name:** RIO GRANDE CANAL

**Date:** April 9, 2019

Rio Grande Stream Management Plan

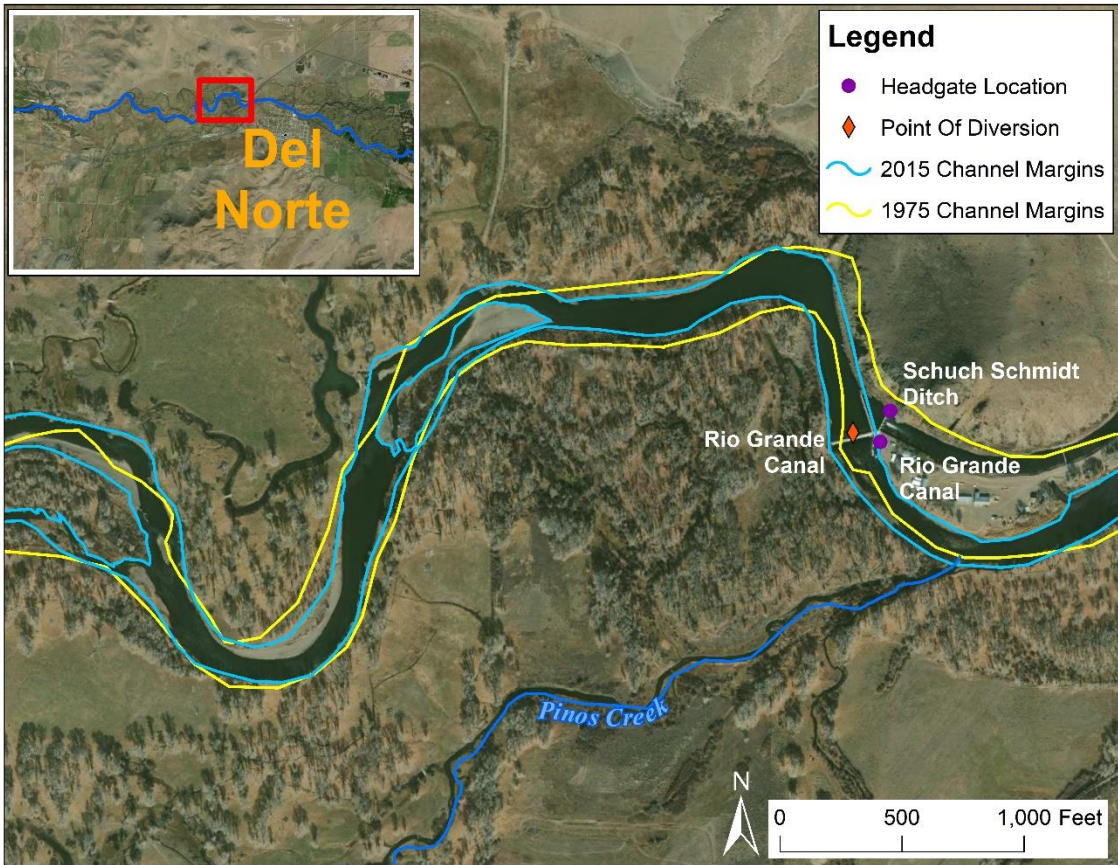
Map showing Rio Grande Canal diversion dam and headgate location. 1975 and 2015 channel margins show little channel migration.

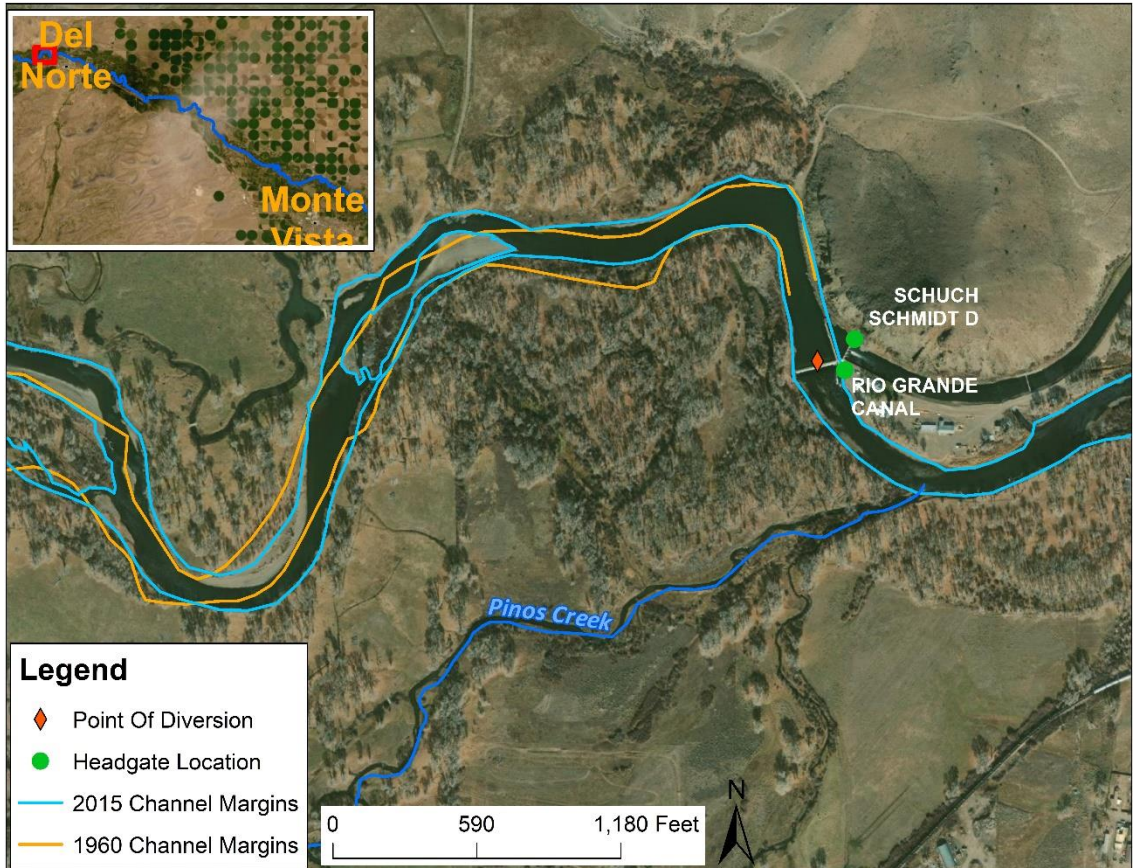
Map of Rio Grande Canal diversion dam and headgate with 1960 and 2015 channel margins overlaid.
