SAGUACHE CREEK DIVERSION INFRASTRUCTURE INVENTORY

CARRUTHERS DITCH

Saguache Creek Stream Management Plan

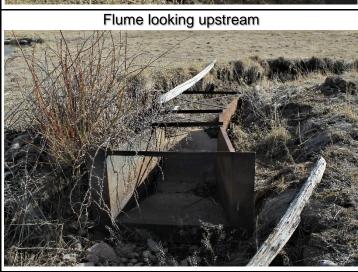
Structure Name: CARRUTHERS D				
Reported By: Daniel Boyes				
Date : April 4, 2019				
Headgate Location:	Latitude 38.118874	Longitude -106.473297		
Headgate Type: Manually operated 2' screw gate				
Headgate Condition:		on and A □ Condition: B □ C ⊠ D □ F □	Stream Miles from Saguache Creek Terminus (Point of Diversion): 69.0 mi	Structure Yes □ Submerged: No ⊠
Structure Description: A boulder diversion dam directs water to the headgate, which is located on the west bank of the stream. The diversion is located in the transition zone between two meanders. The headgate is tilted and is being eroded. The stream is disconnected from its floodplain in some areas of this reach.				
Repair(s) or Improvement(s) Currently Needed: The SMP Technical Advisory Team (TAT) recommends resetting the headgate and restoring the bank upstream of this structure. Headgate repair would improve efficiency and reduce maintenance. Bank stabilization and riparian revegetation would help protect the headgate, mitigate erosion, and reconnect the stream with its floodplain.
