# SAGUACHE CREEK DIVERSION INFRASTRUCTURE INVENTORY

**Structure Name:** FULLERTON D1 APD

FULLERTON DITCH 1 APD

Saguache Creek Stream  
Management Plan

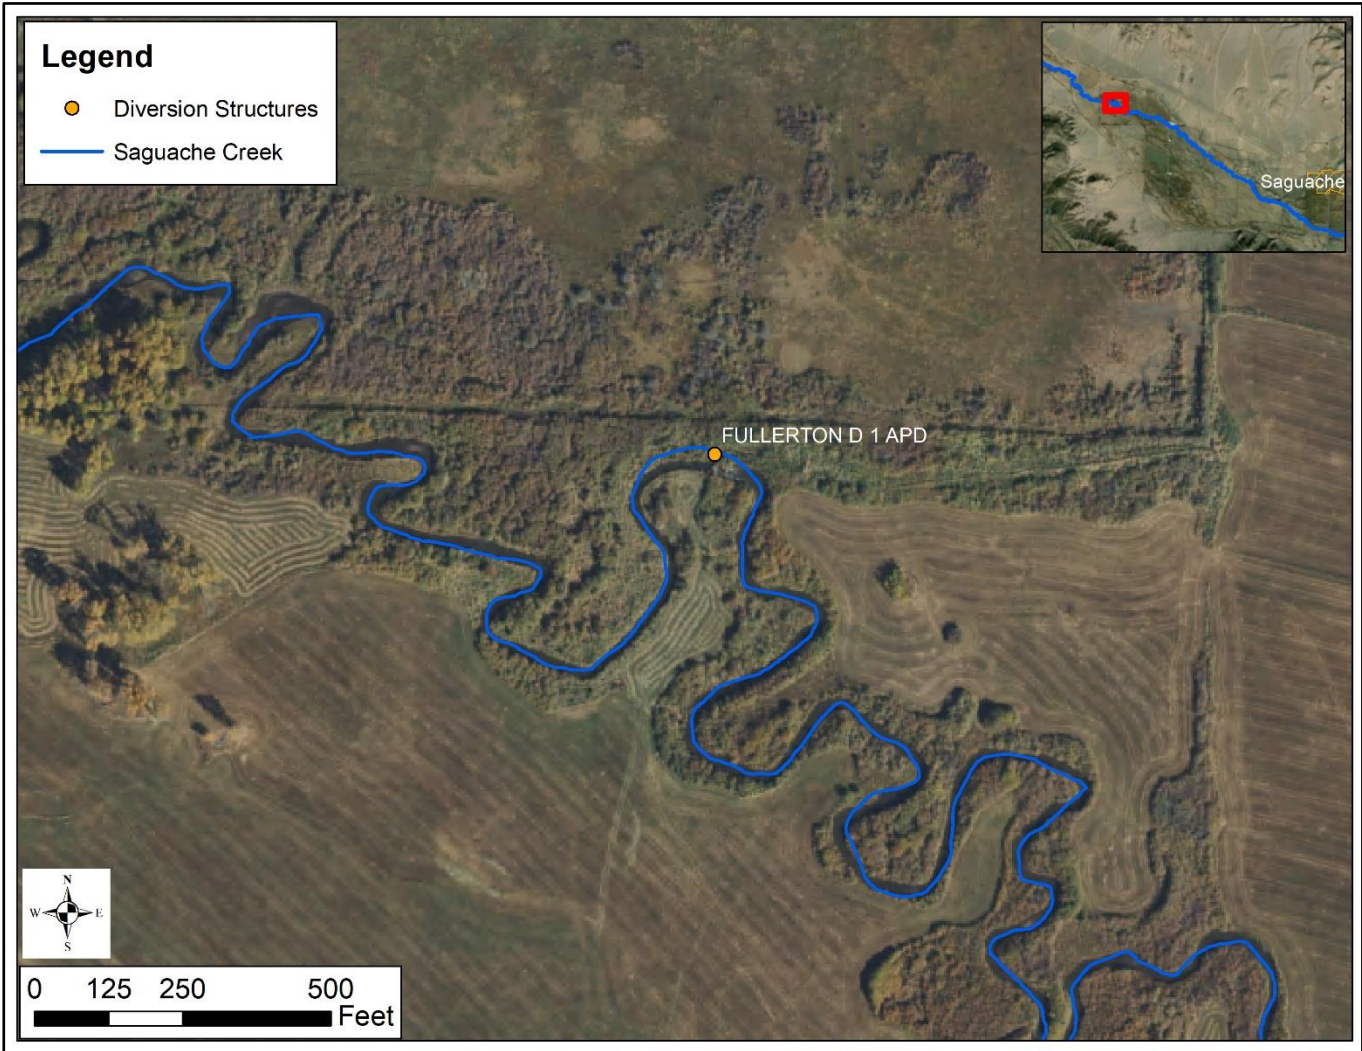
**Structure Description:** This structure is located on the outside of a meander. A stacked rock diversion dam directs water to the headgate, located on the north bank of the stream. The diversion is in an ideal location, but during 2019 spring runoff, it was damaged, with many of the boulders being washed out.

Fullerton D1 APD Ditch point of diversion

**Repair(s) or Improvement(s) Currently Needed:** The SMP Technical Advisory Team (TAT) recommends repairing and improving the diversion and installing a trash rack at the headgate. An improved diversion would prevent future failure during high flows and a trash rack would reduce debris accumulation at the headgate.
