# UNDERSTANDING LITTLE TRAVERSE LAKE WATERSHED RESPONSES TO RAIN EVENTS

Fall 2024 – Spring 2025

*February 2026*

*David Skjaerlund, PhD*

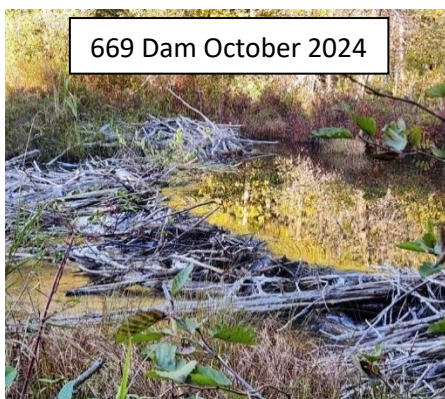
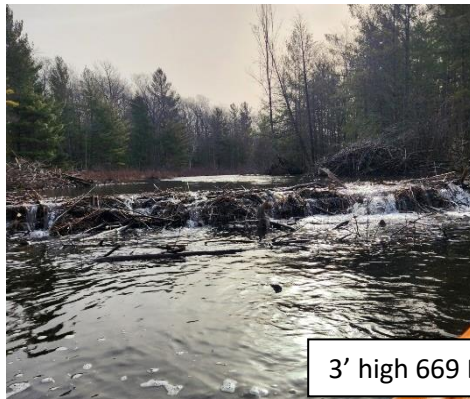
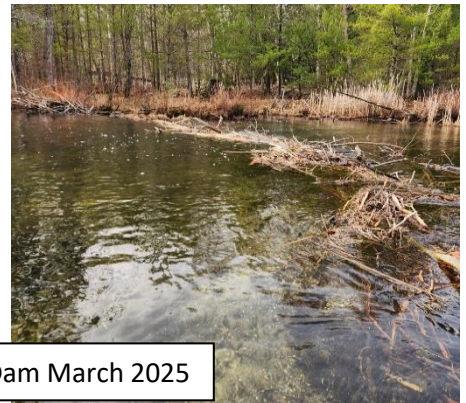
### DAM DOWNSTREAM (WEST) OF CR 669 Bridge

Extreme flooding within the LTL watershed, where shoreline banks overflowed and property was under water, Fall 2012-2014, Fall 2020, and Spring 2025. On all these occasions, large beaver dams in Shalda Creek were present and had elevated water levels prior to a large rainfall event. On these occasions, beaver dams were removed only *after* flooding had occurred, rather than in advance of the rainfall events. This paper is to provide an understanding of the watershed responses that occurred over time between Fall 2024 and Spring 2025.

The abnormally high water levels created negative consequences: 1) water levels rose above the bottom of CR 669 Bridge potentially compromising the road infrastructure and accumulating debris; 2) LTL shoreline property underwater; 3) residential structures impacted by flooding; 4) septic fields challenged by high water levels, potentially impacting water quality; 5) accelerated shoreline erosion and instability/suffocation of tree root structure; and 6) elevated water tables making it difficult for the watershed to absorb additional rainfall events.

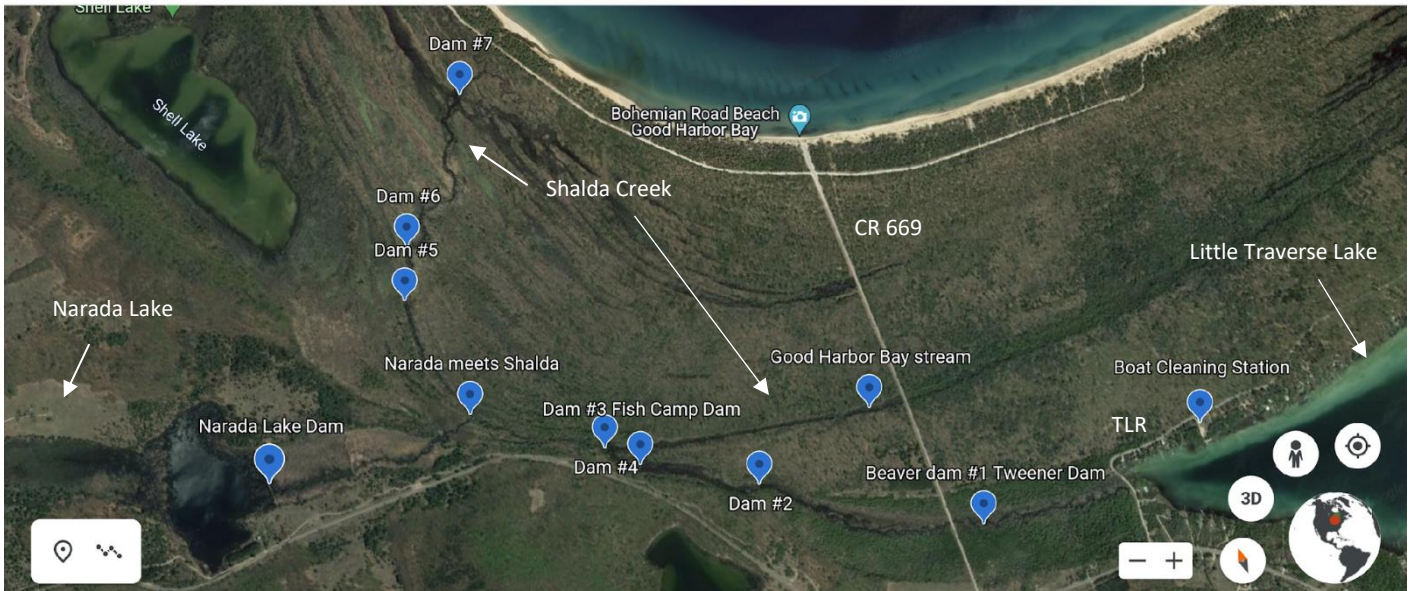
There are several locations where beavers have built dams in Shalda Creek. The locations most critical to LTL watershed is the Tweener Dam (#1), Downstream of CR 669 (#2), and Fish Camp area (#3, #4). When dams are removed at these locations, the tendency is for beavers to attempt to rebuild these locations rather than start in a fresh location. Beavers dams have narrowed the stream channel over the years and have led to accumulation of sediment and debris, visible in aerial photos, and thus altered Shalda Creek stream dynamics over time. Narada Lake was mostly created by a wide beaver dam that accumulated and filled in with sediment, thus leading to Narada Lake as known today. Beaver dams can quickly create watershed saturation upstream due to the shallow and gradual nature of Shalda Creek. Shalda Creek has very little slope, with the 0.43 mile section between TLR and CR 669 dropping only 6.6", representing a 0.024% slope. The 0.71 mile section from CR 669 to Fish Camp dam only has a slope of 0.106%. A slope of 1% is considered adequate for drainage.

Beaver dam #1 is known as "Tweener Dam" located 1,823 ft (one third of a mile) downstream from CR 669. It can be reached via kayak from TRL In this picture, the dam has been torn out with 12' high stacks of sticks on each side following decades of dam removal. Notice the light-colored sediment that has accumulated upstream of the dam and also downstream. This dam has been documented to have a significant and direct impact on Shalda Creek levels at TLR Stream Outlet and on lake levels.

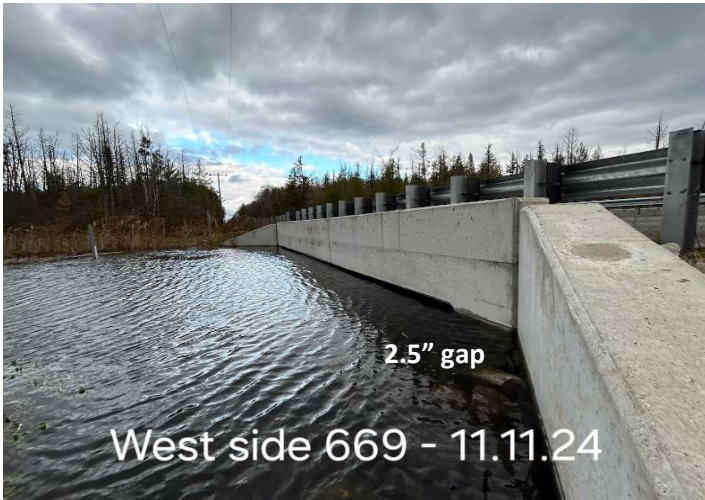
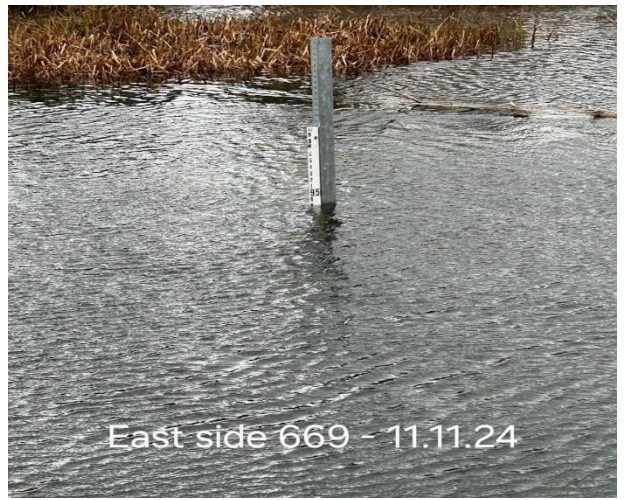
11/11/2024 Beaver dam present September 2024; elevated water levels Fall 2024 – 594.8 on measuring stick; only 2.5" air gap underneath CR 669 Bridge; NPS permission to remove beaver dam not given.

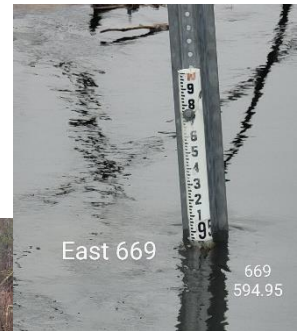
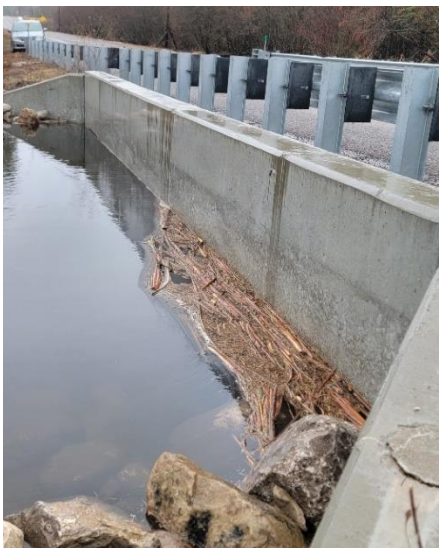
3/29/2025 Beaver dams present spring 2025, increased in size; water levels elevated with additional rainfall events; no air gap underneath CR 669 Bridge, accumulating debris; standing water in surrounding watershed; 594.95 on measuring stick. This is a second time a beaver dam downstream CR 669 has elevated water levels above the bottom of CR 669 Bridge.

When water levels exceed the bottom of the bridge, infrastructure can start to be impacted. Ground saturation behind the box culvert and road bed can be impacted over time with water saturation. The bridge can then start accumulating stream debris. Erosion of banks can take place. CR 669 Bridge span was engineered to be above water.

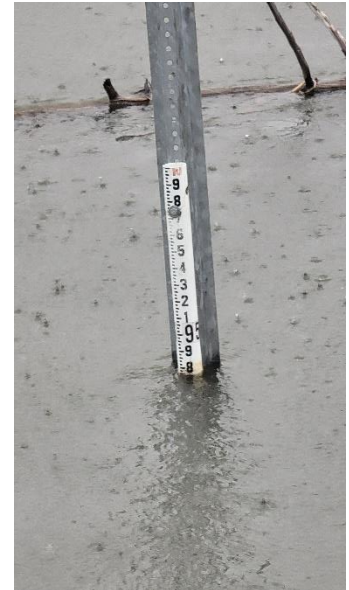
4/2/2025 Beaver dam removed noon 3/30/2025 following NPS permission. 594.75 on measuring stick at 4 pm; 2.5" airgap underneath CR 669 Bridge.

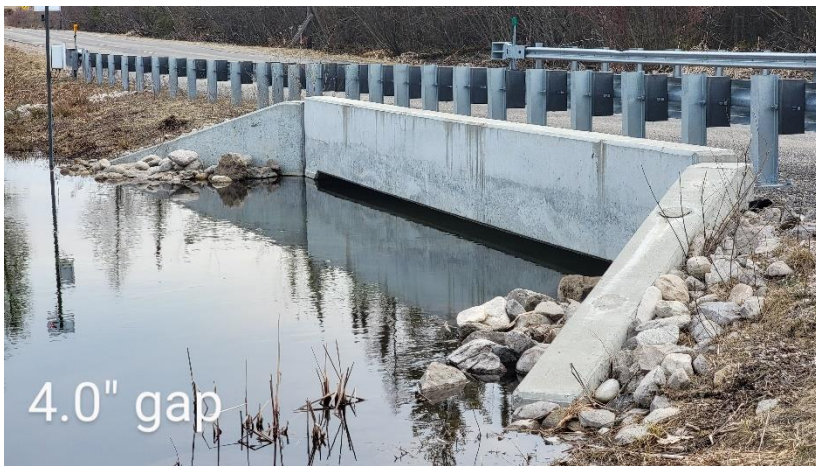
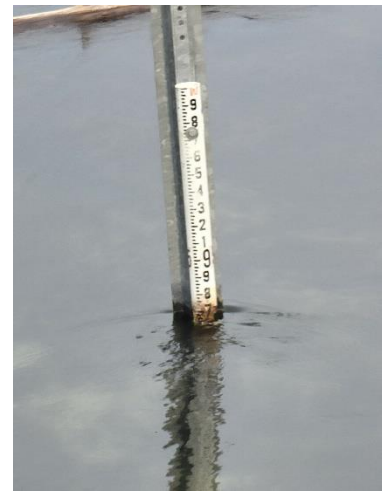
4/9/2025 594.6 on measuring stick, 4.0" air gap underneath CR 669 Bridge.

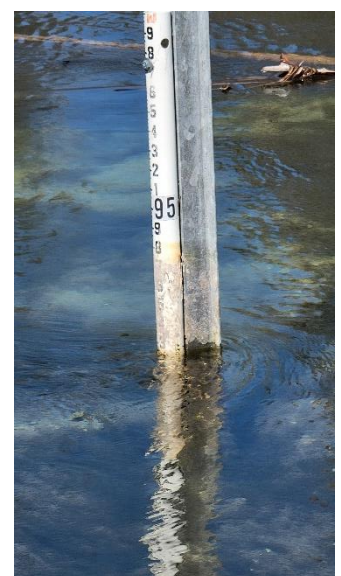
5/4/2025 Dam downstream CR 669 removed March 30, 2025; Water levels drop to 594.25; 9" air gap underneath CR 669 Bridge

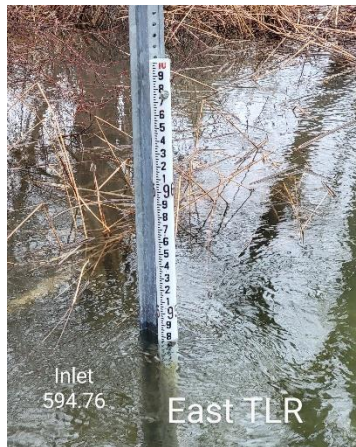
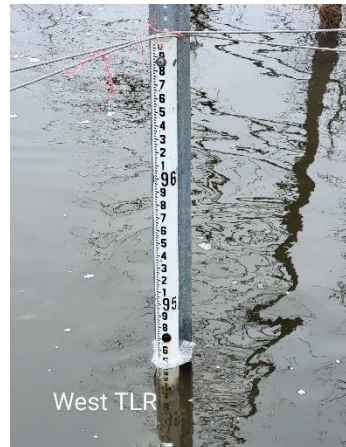
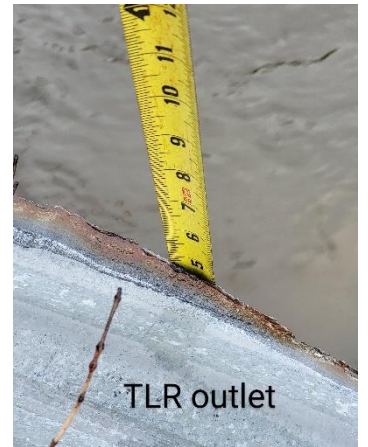
3/29/2025 – TLR Lake  
Inlet: 594.76 on the  
measuring stick. TLR  
Stream Outlet: 594.53  
on measuring stick,  
water 5" from top of  
culvert. Water in  
residential yards.

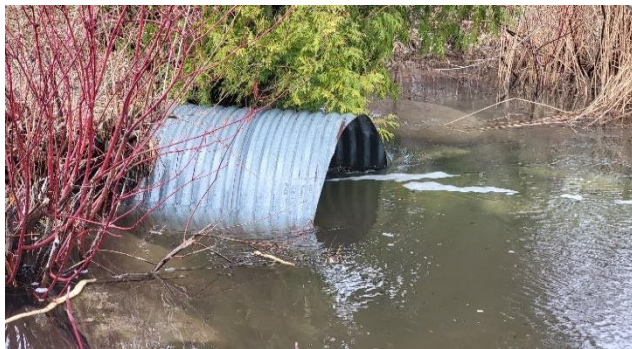
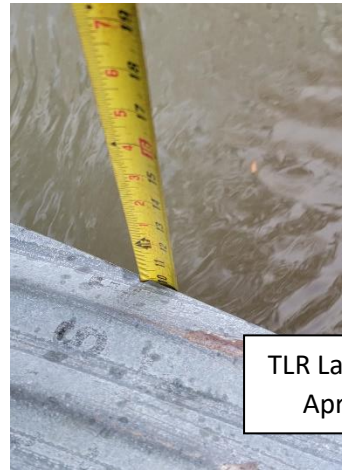
TLR Stream Outlet Side  
April 2, 2025

High water levels on April 2, 2025. TLR outlet side; 4" below top of culvert; 594.6 on measuring stick

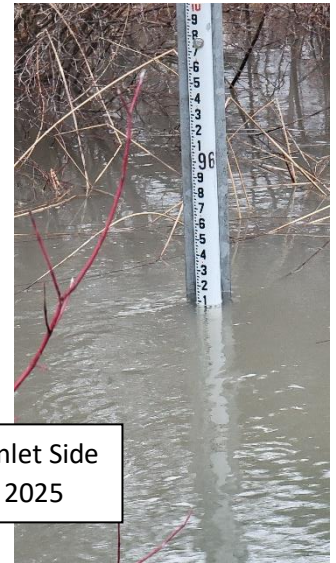
TLR Lake Inlet Side  
April 2, 2025

High water levels on April 2, 2025. TLR Inlet side; 10" below top of culvert; 595.1 on measuring stick. Extensive flooding of residential yards and structures.

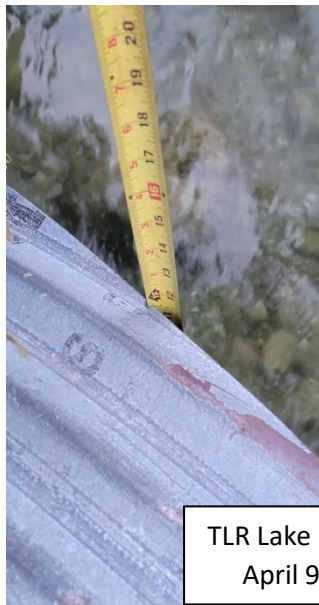
TLR Lake Inlet Side  
April 9, 2025

4/9/2025 Water levels continue to drop a week later. TLR Lake Inlet side level was 594.85 on measuring stick with water 12" from top of culvert. TLR Stream Outlet side level was on 94.45 measuring stick with water 6" from top of culvert. Water still standing in residential yards.

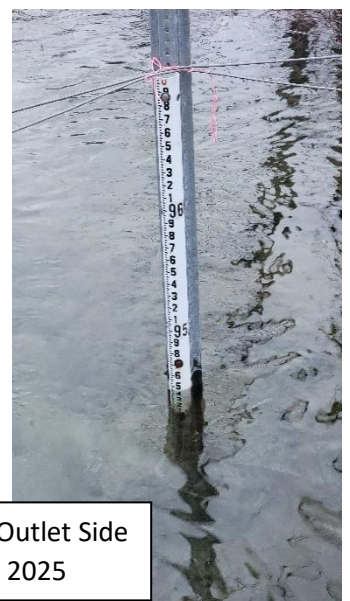
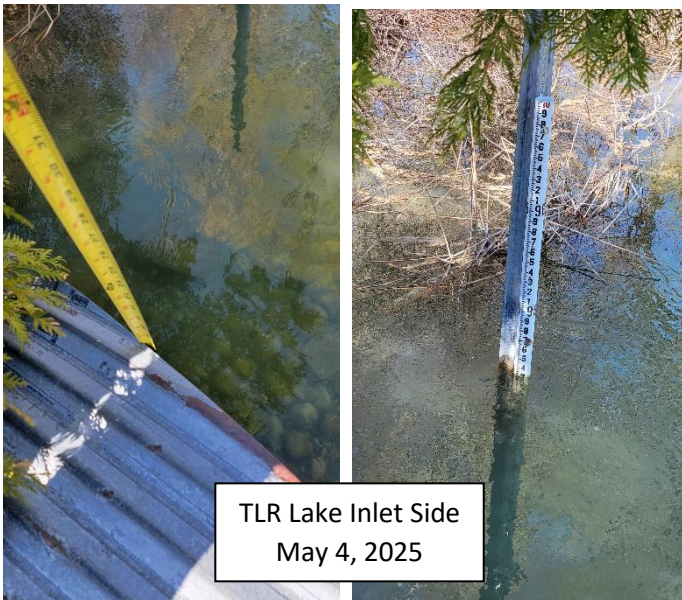
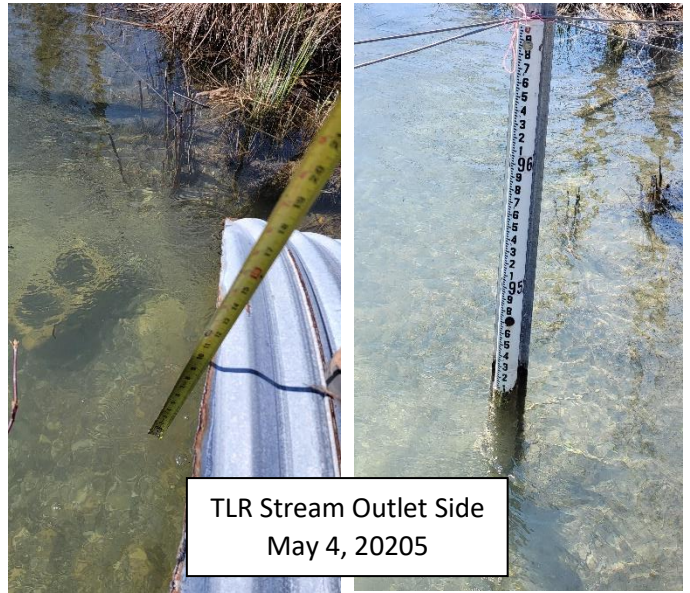
5/4/2025 Water levels returned to more normal levels a month later. TLR Lake Inlet side level was 594.3 on measuring stick with water 18" from top of culvert. TLR Stream Outlet side level was on 593.9 measuring stick with water 10" from top of culvert.

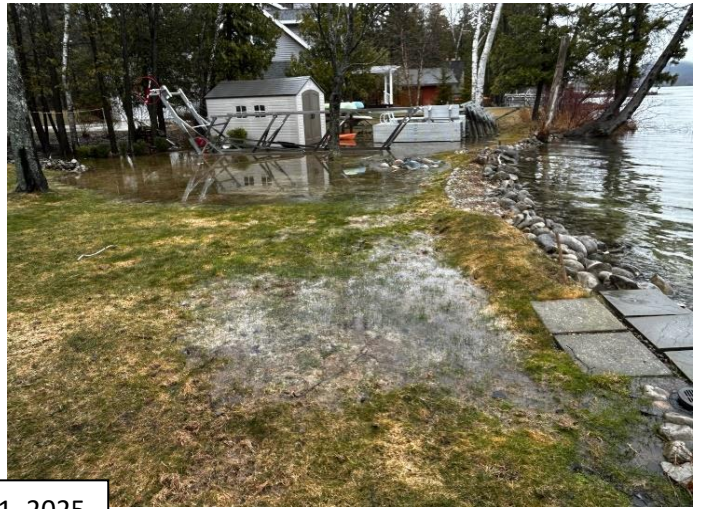
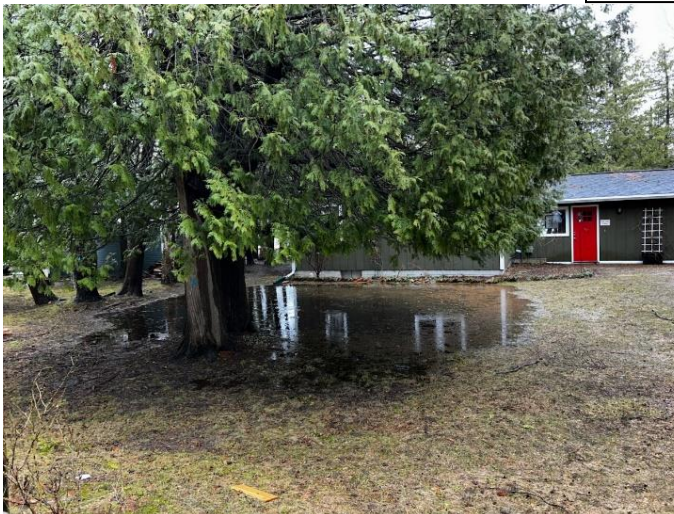
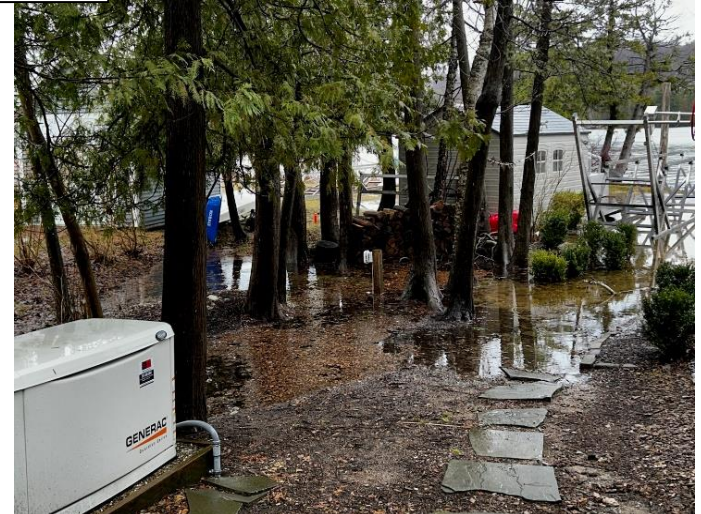
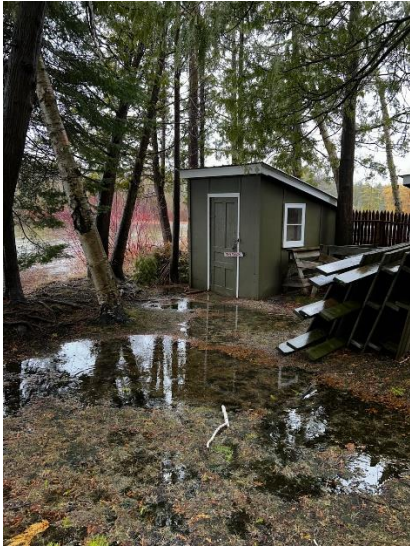
March 31, 2025

Yards had significant water on March 31 with LTL lake levels at 594.76. Flood waters were observed on April 2 with LTL lake levels reaching 595.1. Water was still standing in yards with LTL lake levels at 594.85 on April 9. At that level, water has been known to infiltrate some residential crawl spaces. Concerns about shoreline breaching, especially during high winds and significant wave activity, and elevated water tables begin when LTL levels reach 594.5.

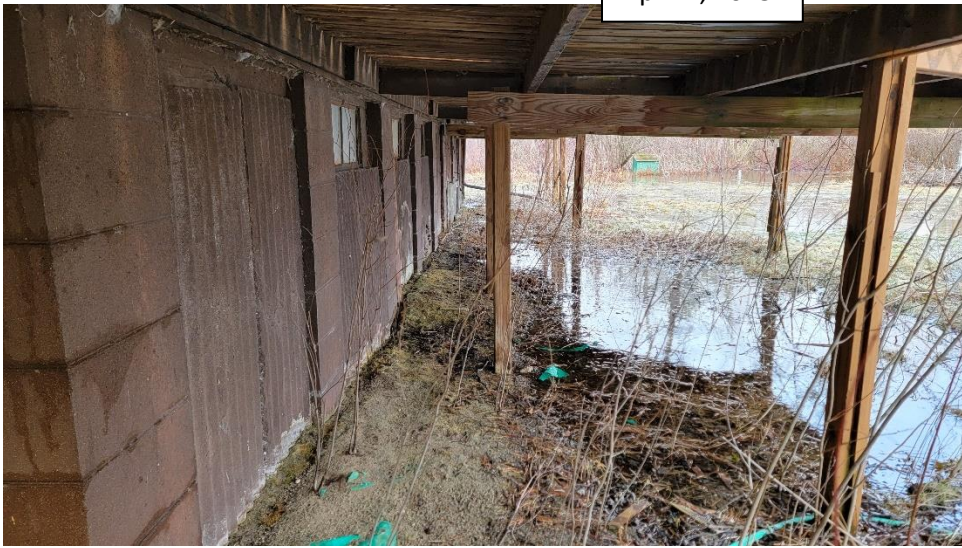
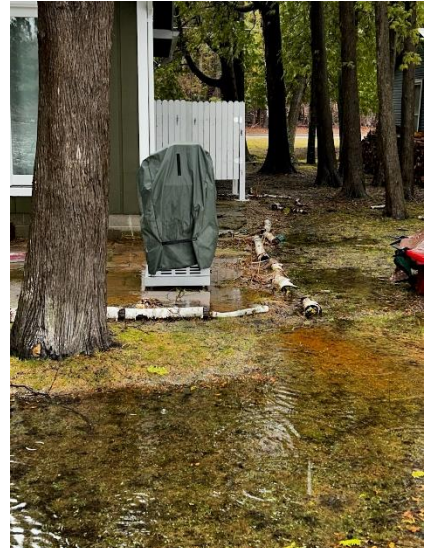
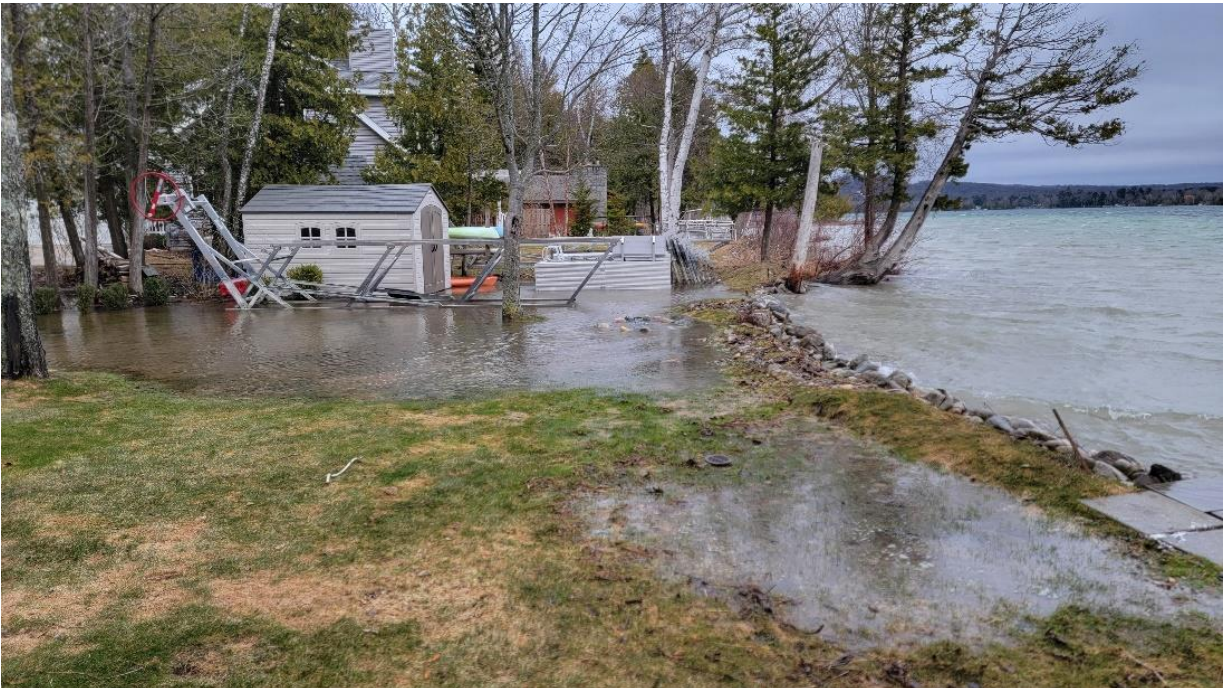
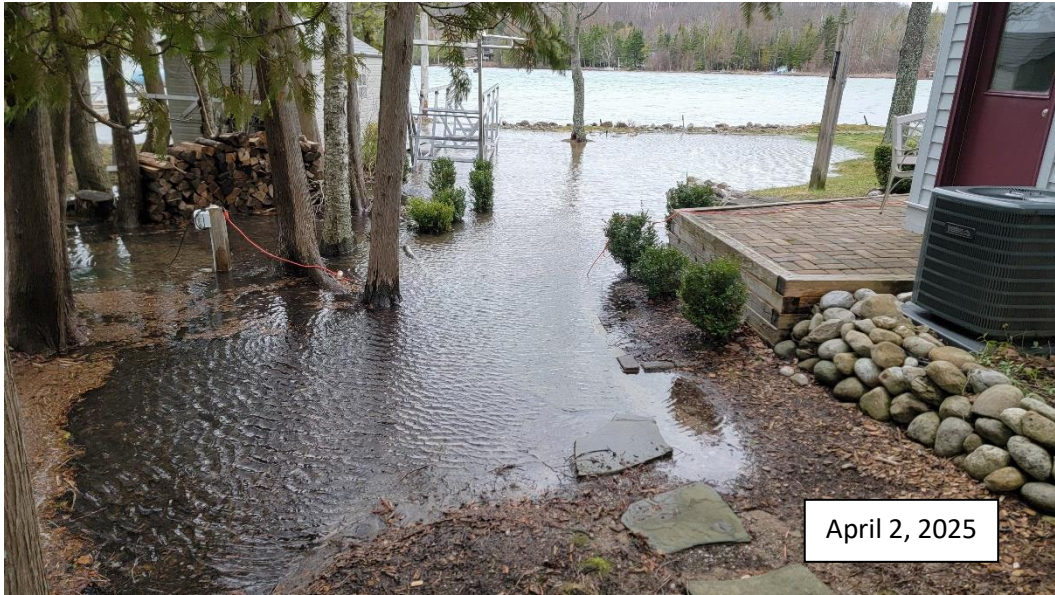
April 2, 2025

Relative comparison: April 2 – water overflowing shoreline bank; April 9 – 4" below shoreline bank; May 4 – 9" below shoreline bank; September 16 – 16" below shoreline bank

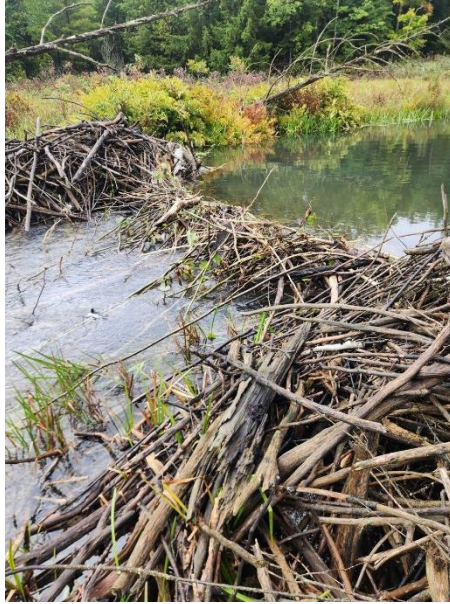
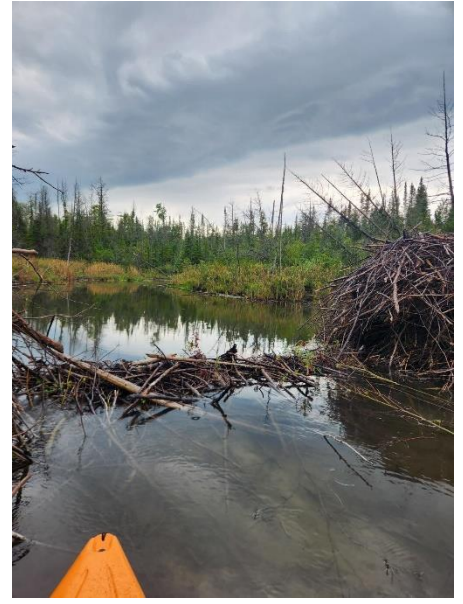
During routine scouting of Shalda Creek early Fall 2025, two dams were located: A tweener dam between TLR and CR 669 and a dam downstream of CR 669 Bridge. Cleveland Township notified NPS but permission was not granted to remove before the winter snowstorms. Once again, clearing of fall rain events has not happened in Shalda Creek and LTL with levels continuing to increase. As of late February, LTL levels are 594.36, only a few inches from when high water levels begin to create problems for riparian owners. And winter snow melt or spring rains have not yet occurred. With substantial winter snows and potential spring rains, will history repeat itself?

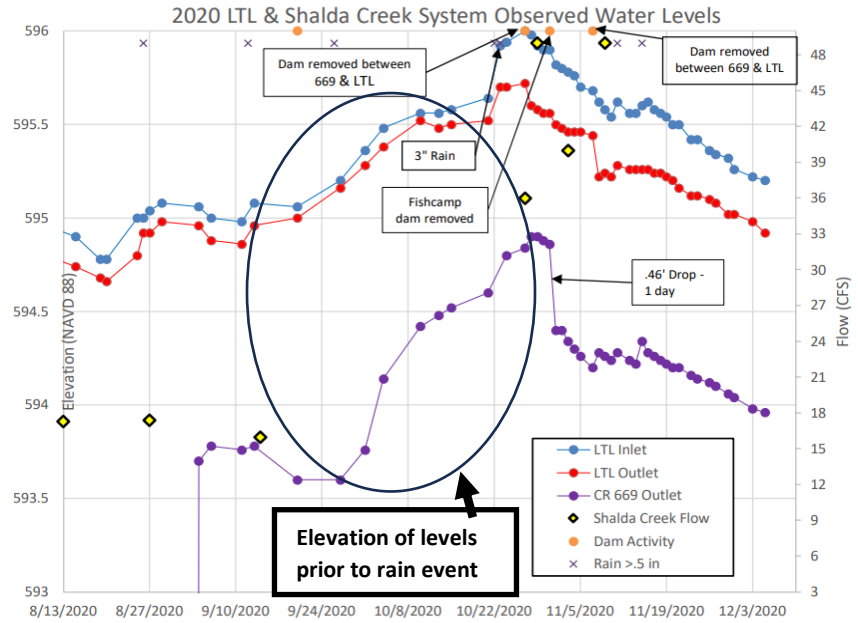
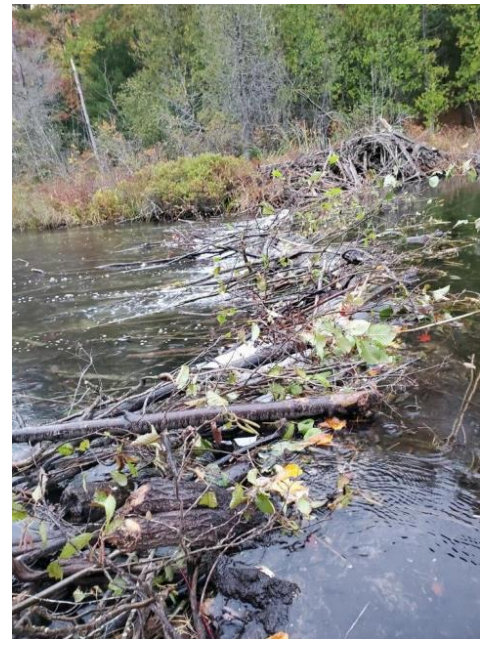
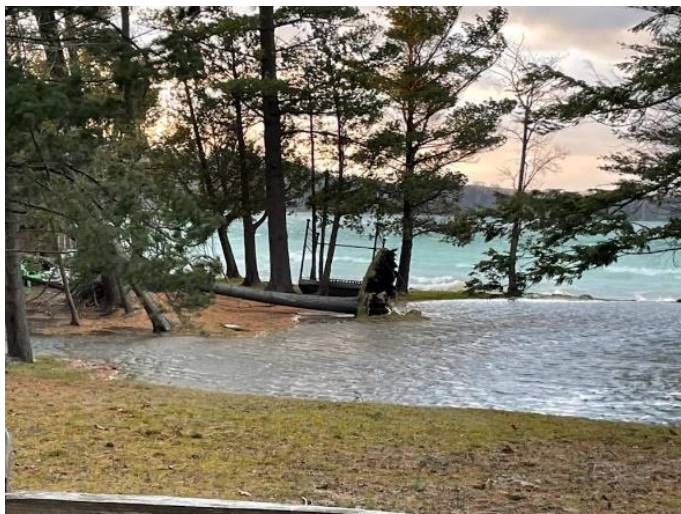
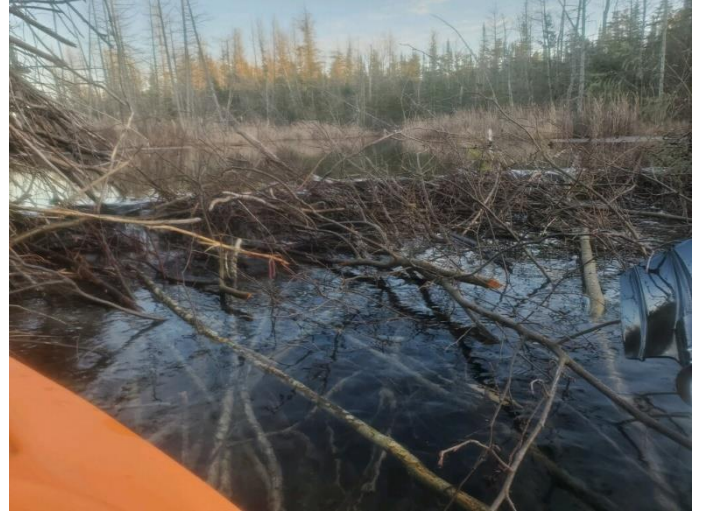
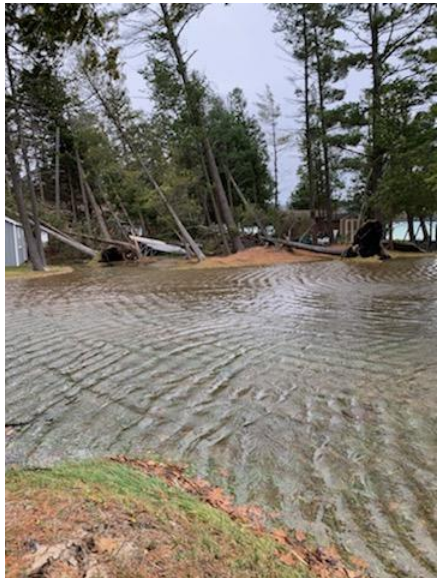
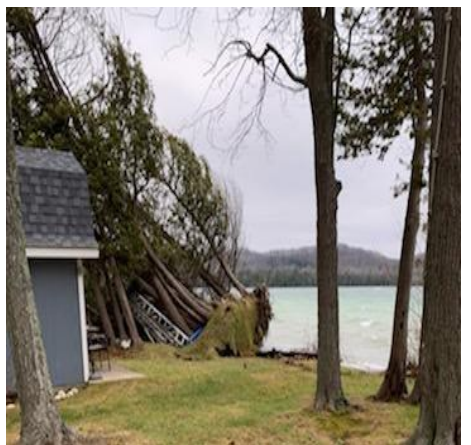
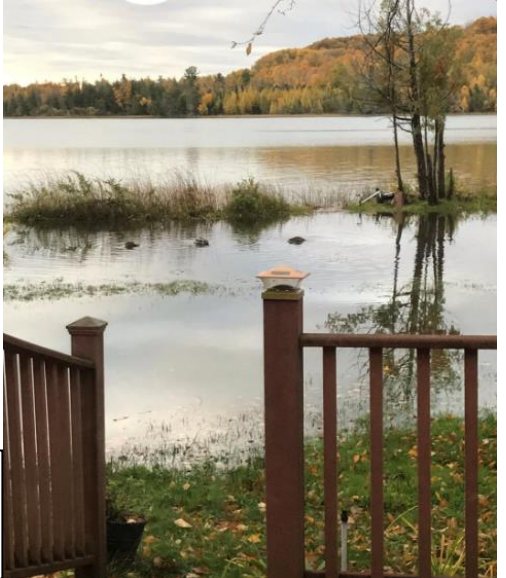
# Remembering Fall 2020 Flooding

The culvert at CR 669 was replaced with a 30’ span bridge in summer of 2020. Leading up to Fall 2020, dams existed between TLR and CR 669 as well as downstream of CR 669. Water levels increased in Shalda Creek and LTL leading up to a 3” rain event that caused significant flooding, at which time the dams were removed. Significant damage occurred including trees blowing over after saturation of root structures during high winds. Gosling Czubak in their December 15, 2020 report (pages 21-23) summarized the 2020 event as follows:

**Dams removed only AFTER flooding. What if beaver dams had not elevated levels leading up to 3" rainfall event?**

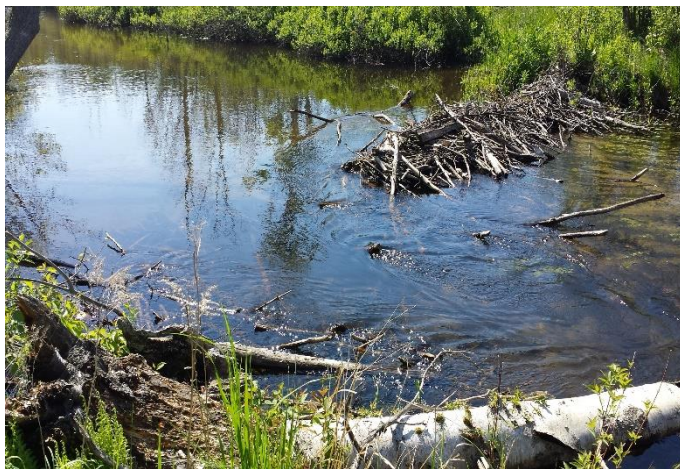
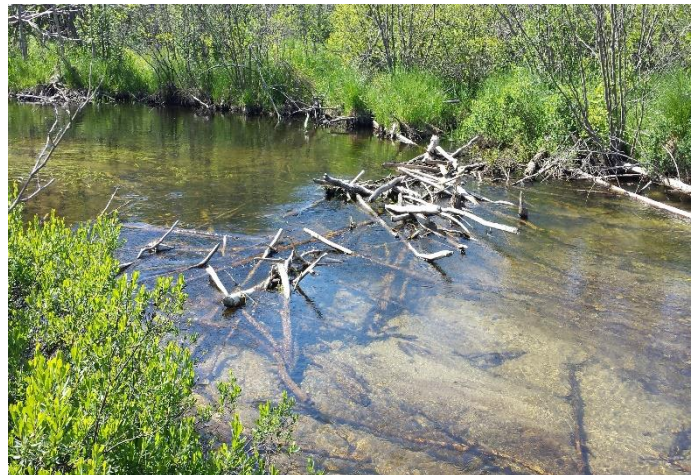
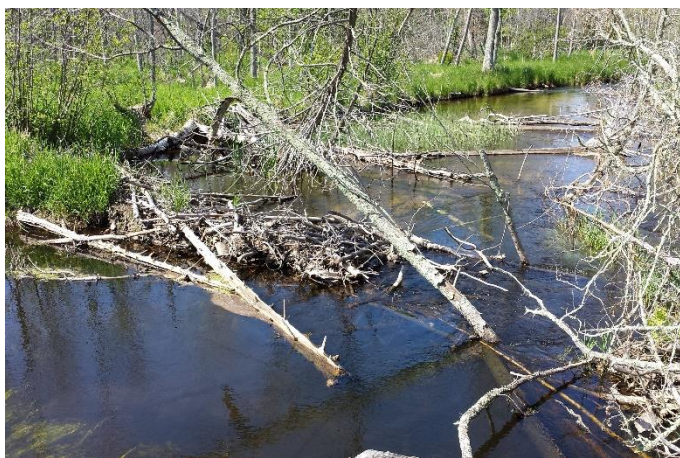
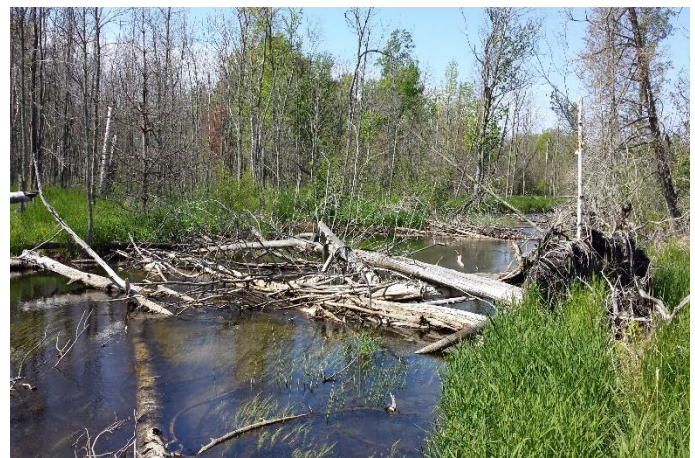
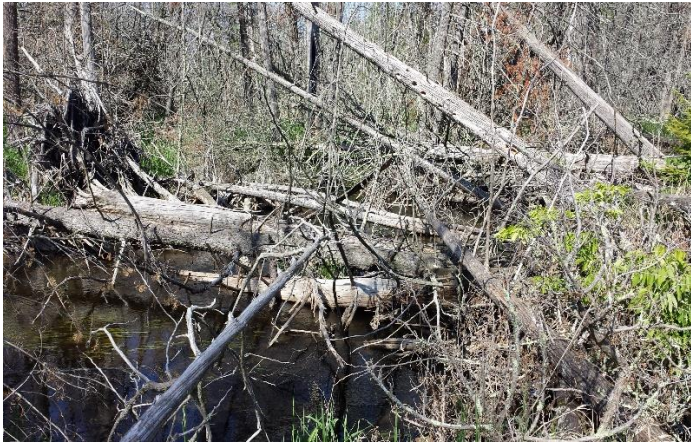
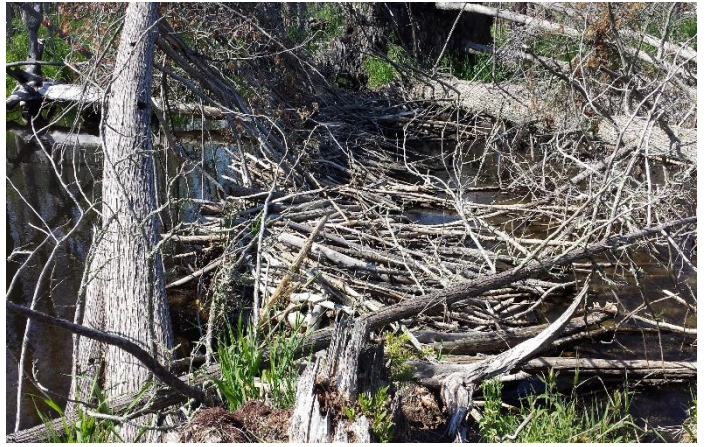
These photos taken June 2014 show the accumulation of debris that exists between Fish Camp and Lake Michigan. Shalda Creek has lots of beaver dam activity as well as tree blow down as trees die out with saturated water tables.

This beaver dam near the Fish Camp area was present June 2014 and finally removed October 2014 as part of the Gosling Czubak study. It is an example of how larger beaver dams can become over time if not maintained. The dams then collect sediment and if left untouched, will drastically alter the ecosystem with standing water upstream that then chokes off trees and creates a saturated and elevated watershed that has little capacity to absorb seasonal rain events, especially if significant. This process created Narada Lake is underway at Kelderhouse Road in Port Oneida.

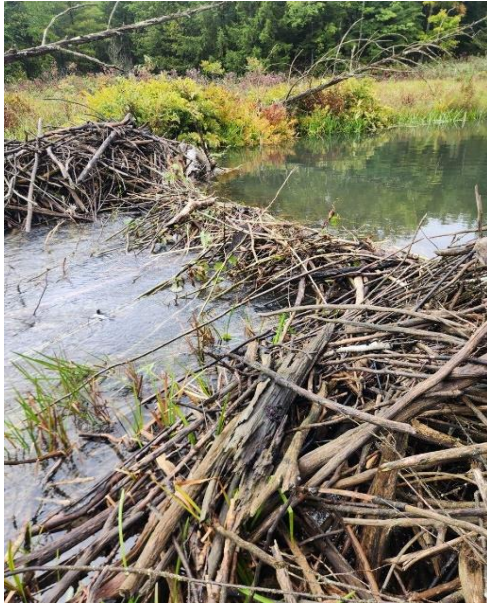
FISH CAMP DAM

During scouting of Shalda Creek at the end of September 2025, two beaver dams were detected – one between TLR and CR 669 (“Tweener Dam”) and one downstream CR 669 at Fish Camp (“Fish Camp Dam”). The National Park Service (NPS) was notified but permission to remove the beaver dams was not granted during Fall 2025.

Permission was finally granted by NPS and both dams were removed on Saturday, March 14, 2026 around 11 am. The Fish Camp Dam was holding back approximately 12" of water. The Tweener Dam was about 3-4' high from stream bottom to top. Water levels in LTL were high, measuring 594.55 on the TLR upstream measuring stick and 594.2 on the Shalda Creek side of TLR. The CR 669 level was 594.4 on the measuring stick.

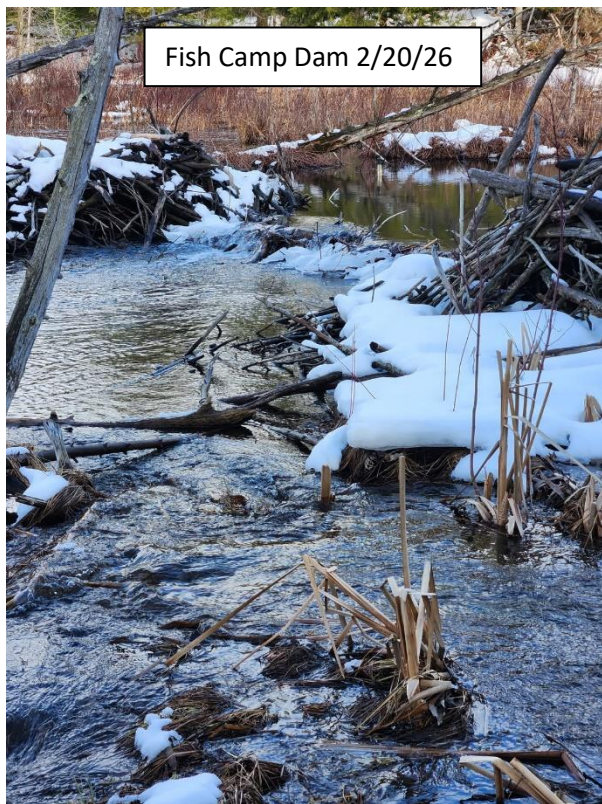
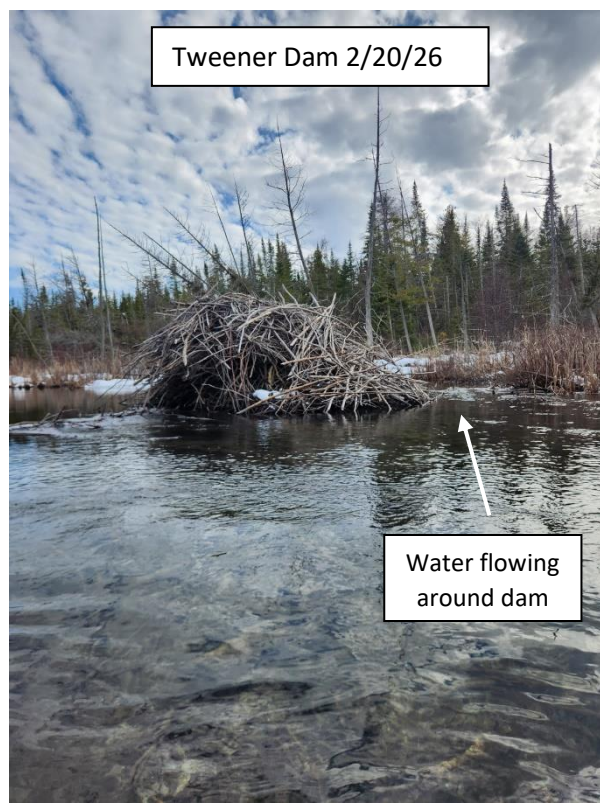
The steady increase in water levels observed in Shalda Creek and LTL was altered around January 20, 2026, when the start of a steady decline in Shalda Creek and LTL levels were observed. There was a two-day surge of water and increase in Shalda Creek levels downstream at CR 669. The trend reversal is evident although the cause is not fully known and is not related to winter precipitation changes at that time. Perhaps there was a breakthrough in combination of snow, ice, and debris blockage. During dam monitoring on February 27, it was noted Shalda Creek had bypassed the Tweener Dam and was flowing over the banks and around the 12' high stack of wood debris from previous dam removals. This has not been historically observed.

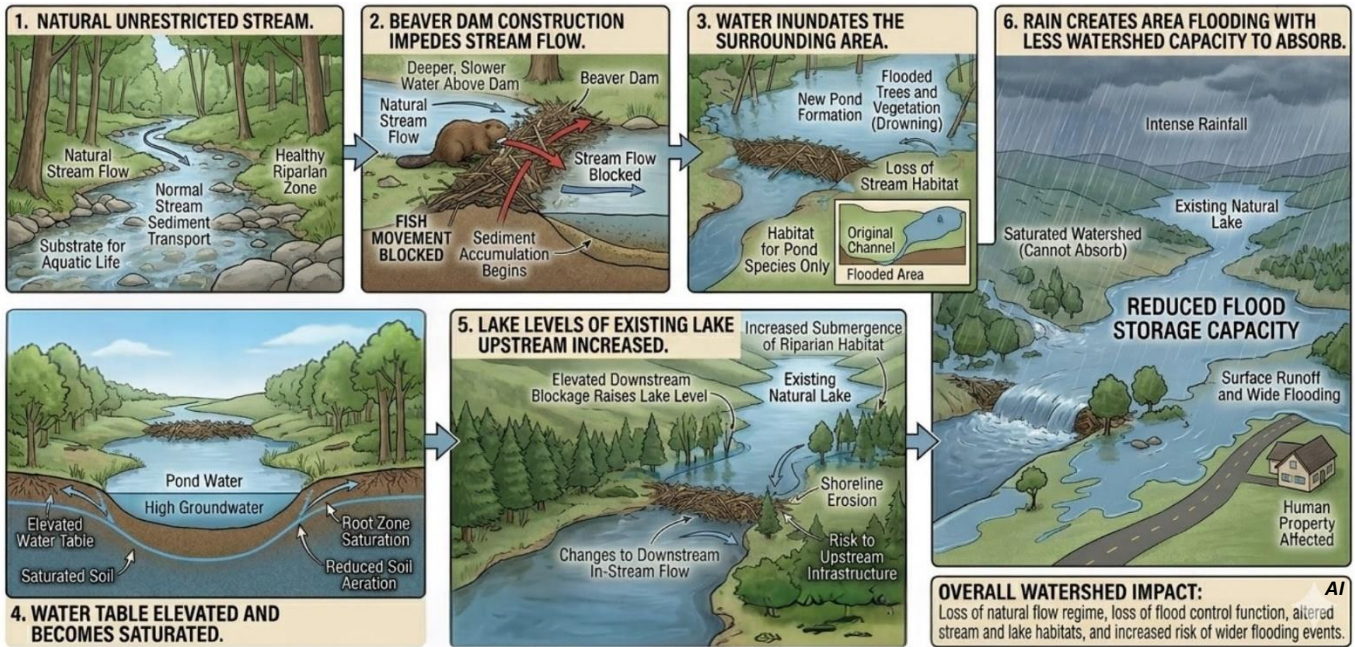
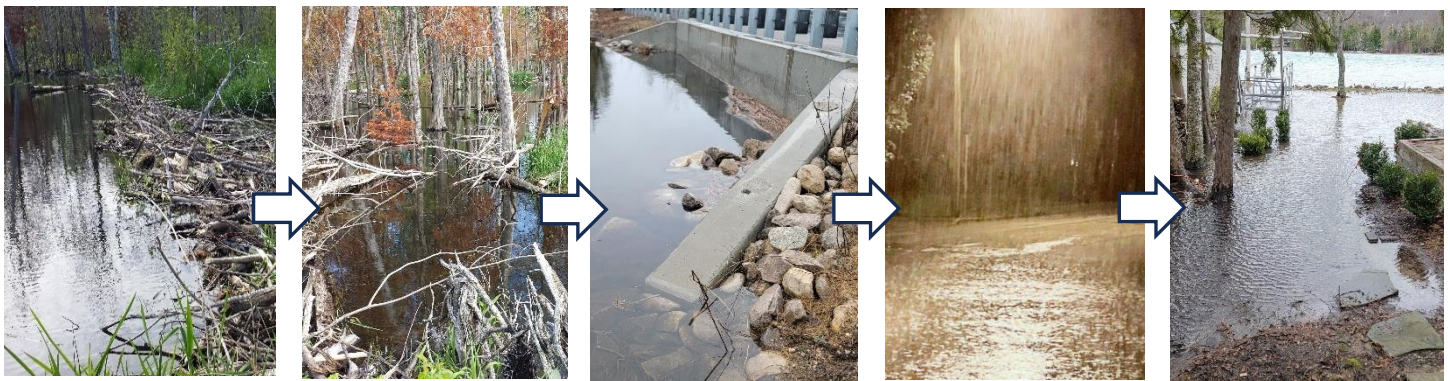
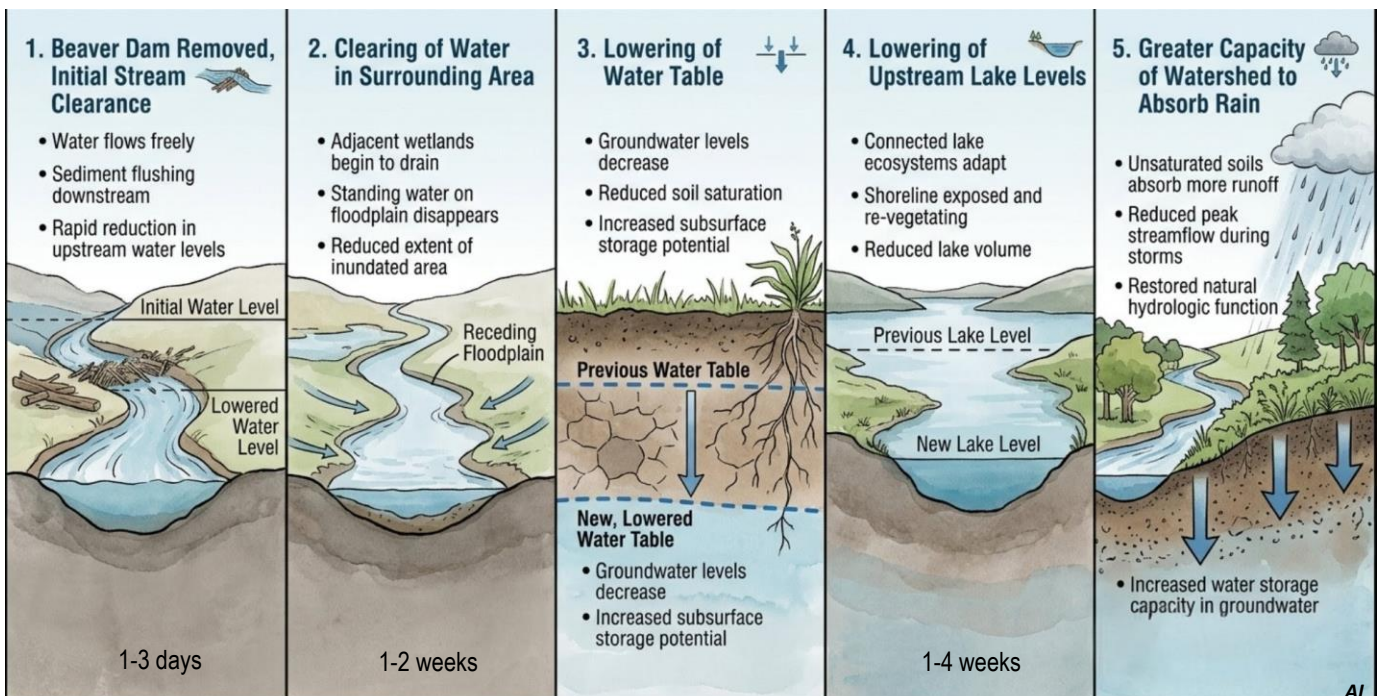
# ILLUSTRATIVE SUMMARY OF LONGER-TERM BEAVER DAMS AND THEIR IMPACTS ON WATERSHED

**THE BENEFICIAL WATERSHED SEQUENCE AFTER BEAVER DAM REMOVAL:** A process of hydrological restoration and increased resiliency
