# LITTLE TRAVERSE LAKE WATER LEVEL INVESTIGATION

7/15/2014

Little Traverse Lake Property Owners  
Association

Prepared by: Gosling Czubak Engineering Sciences, Inc  
1280 Business Park Dr.  
Traverse City, MI 49686  
231-946-9191

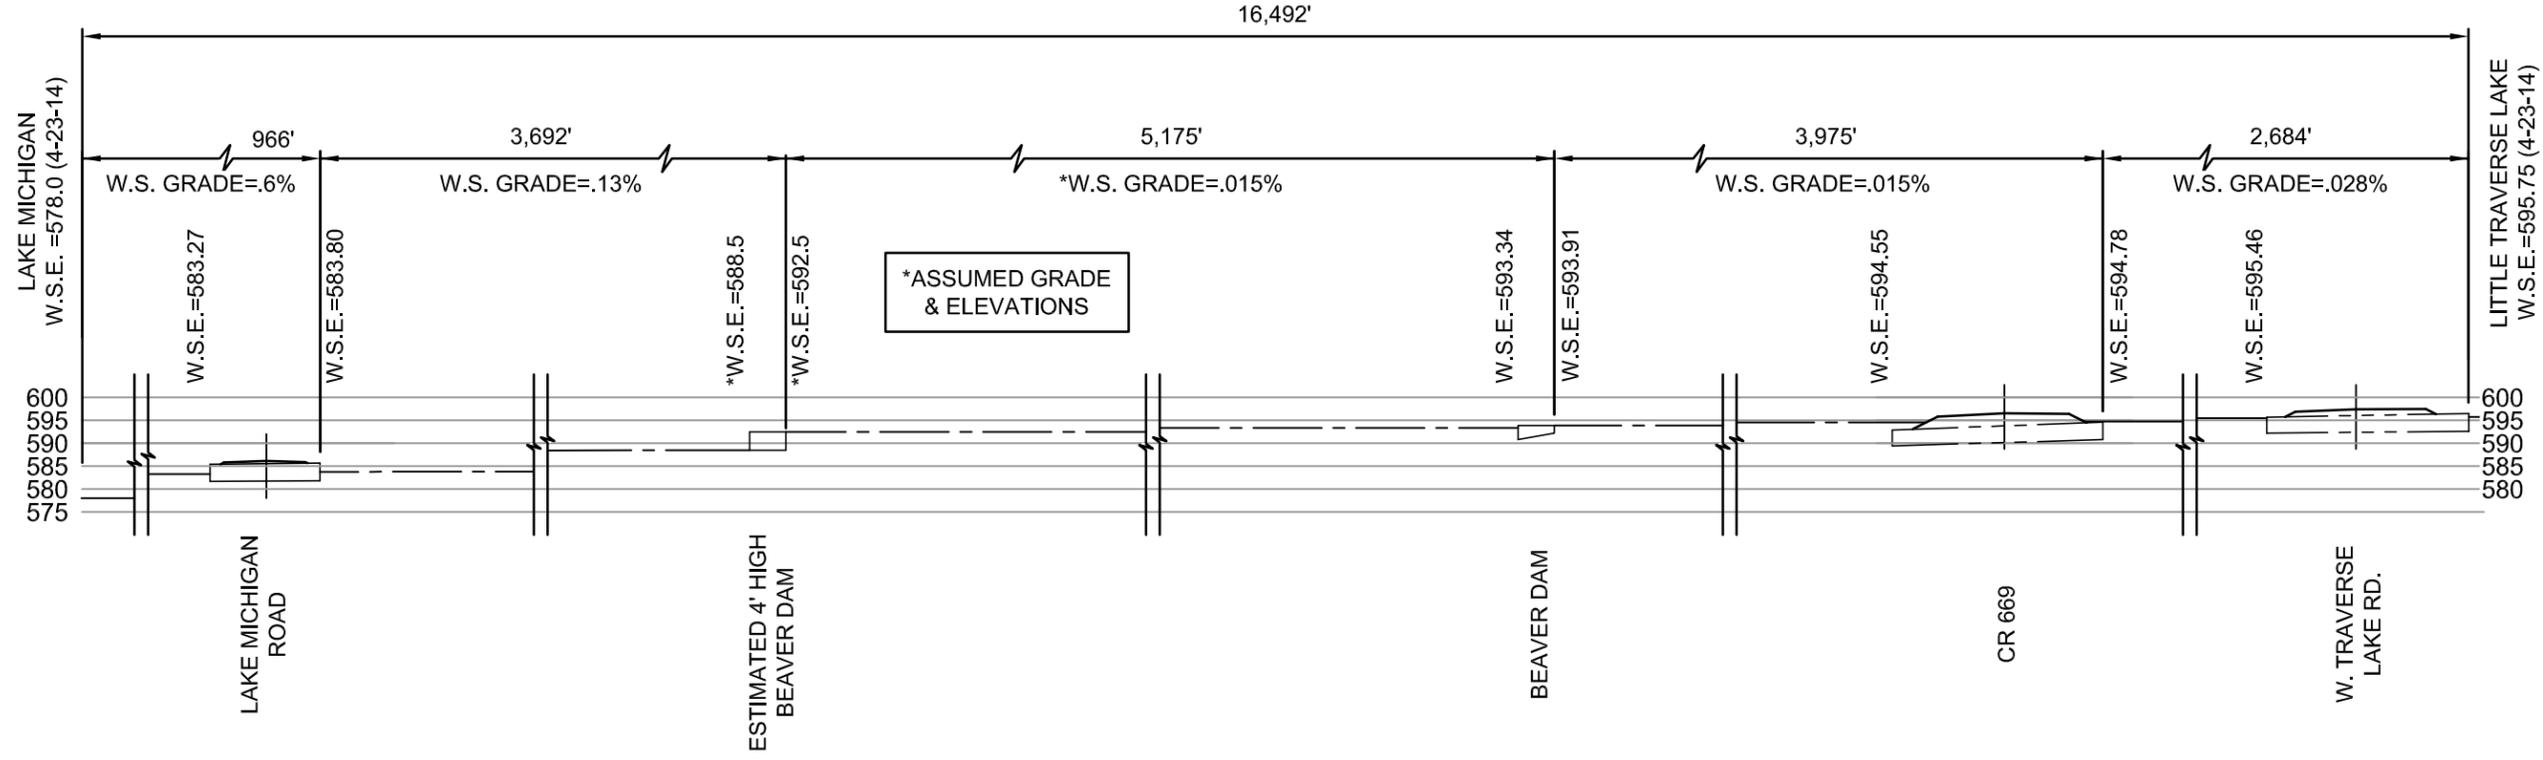
**SYSTEM PROFILE ALONG CREEK**  
N.T.S.

One aspect of the Shalda Creek system that should be noted is the widely varying water surface slope (and therefore flow capacity) at different sections of the creek. From the Lake Michigan Road culvert to the beaver dam that was located and surveyed in April, the water surface slope is at least 0.11%. However, with the subsequent discovery of the large beaver dam retaining about 4 feet of water, the slope in this section could be steeper. From the first beaver dam to CR 669 culvert, the slope is 0.015% - over 7 times less steep. From CR 669 to the LTL Rd. culvert, the slope is 0.028% - almost twice the slope of the section downstream.

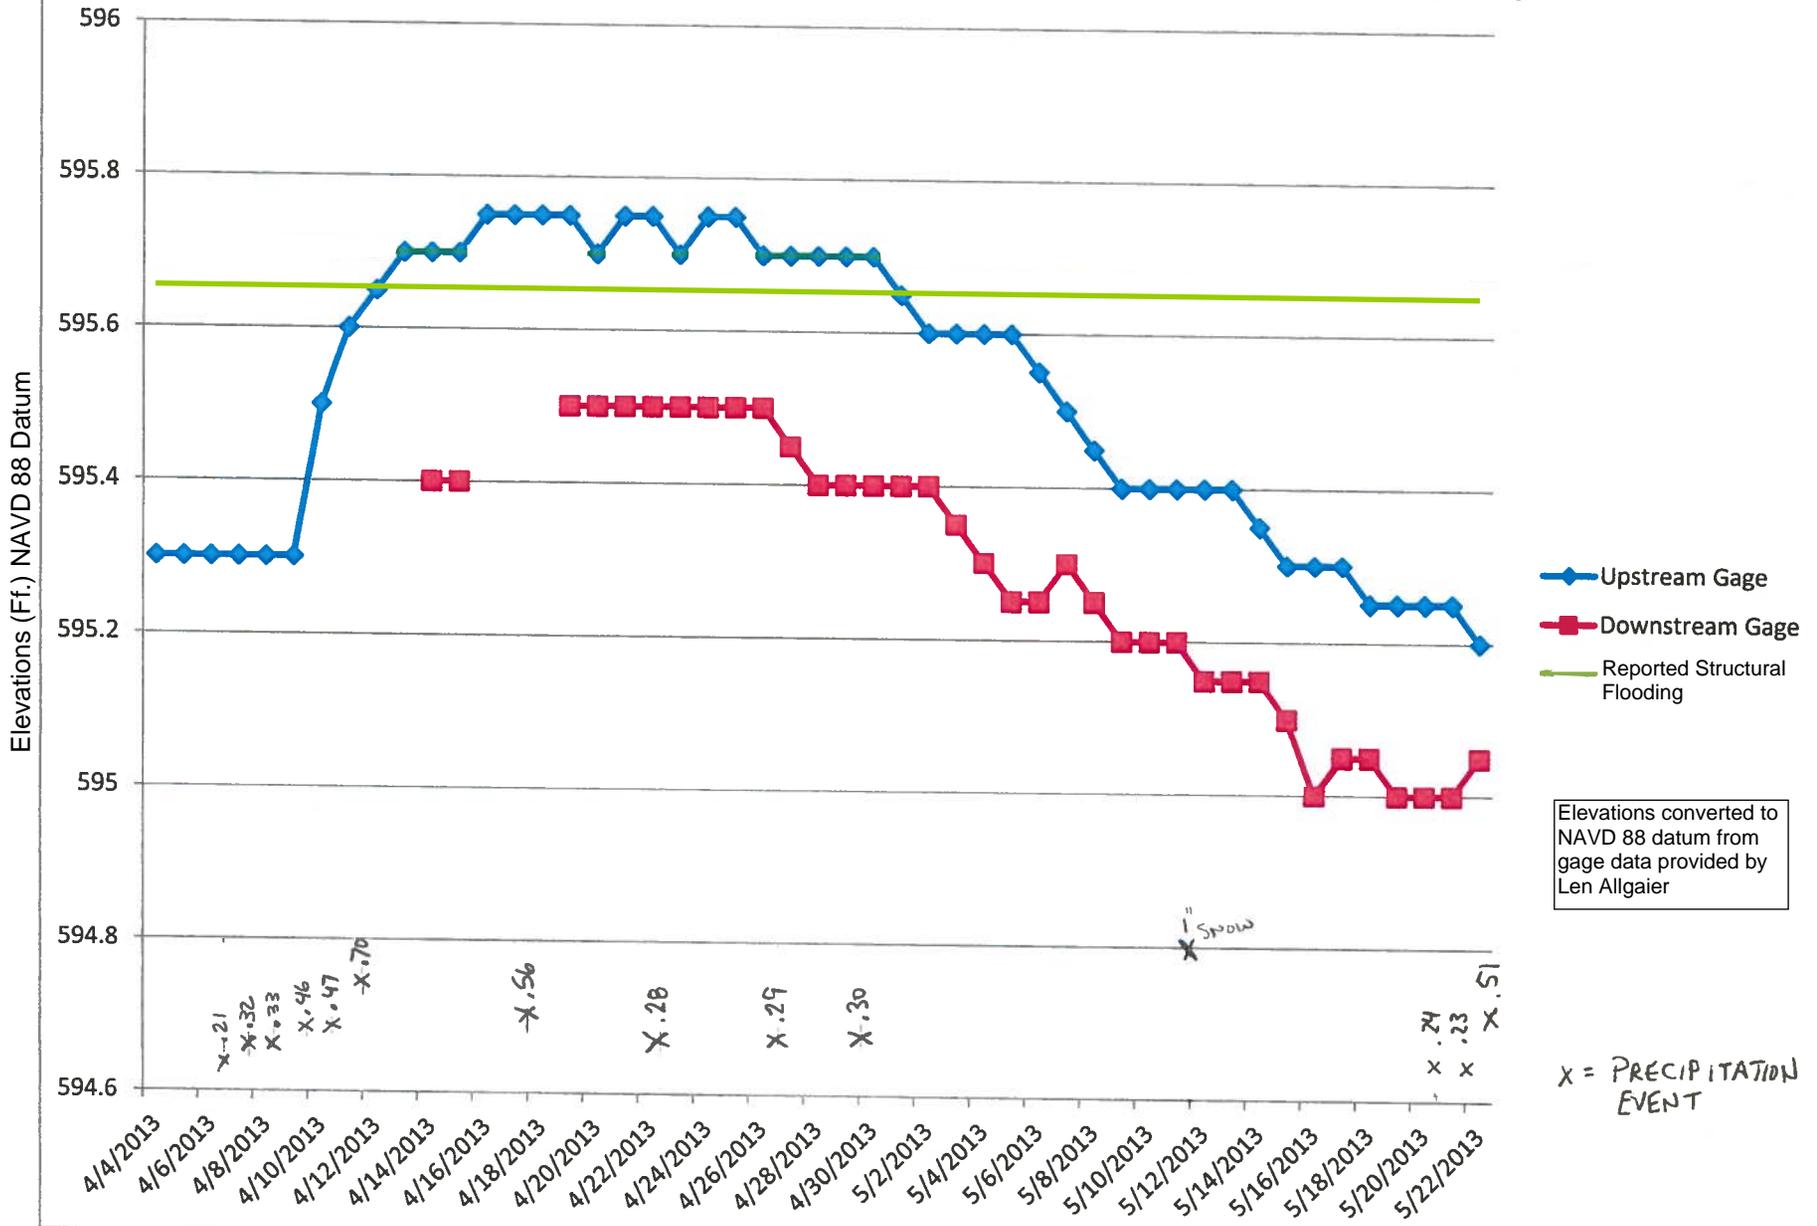
# W. Traverse Lake Road Culvert Water Surface Elevations - Spring 2013

Water level gauge readings provided by Len Allgaier were reviewed and compared to rainfall events from a NOAA weather station in Maple City. The data has been converted to NAVD datum and presented in the attached charts. The observed high water level readings reported in 2013 and 2014 closely match the conditions observed in May, 2014.

In 2013 and 2014, the lowest reported upstream water level was about 595.2. In April, 2014, a rainfall event of 1.64" raised the water level from 595.3 to 595.8. Several consecutive days of rain between .25" and .75 inches were noted during the first half of May that did not seem to significantly affect the water level. It seems the lake level is more responsive to early season rain and snow melt and there may be other variables that affect lake levels of this complex system. Len's report also indicates shoreline erosion damage occurs at 595.2 and crawl space flooding at 595.65.

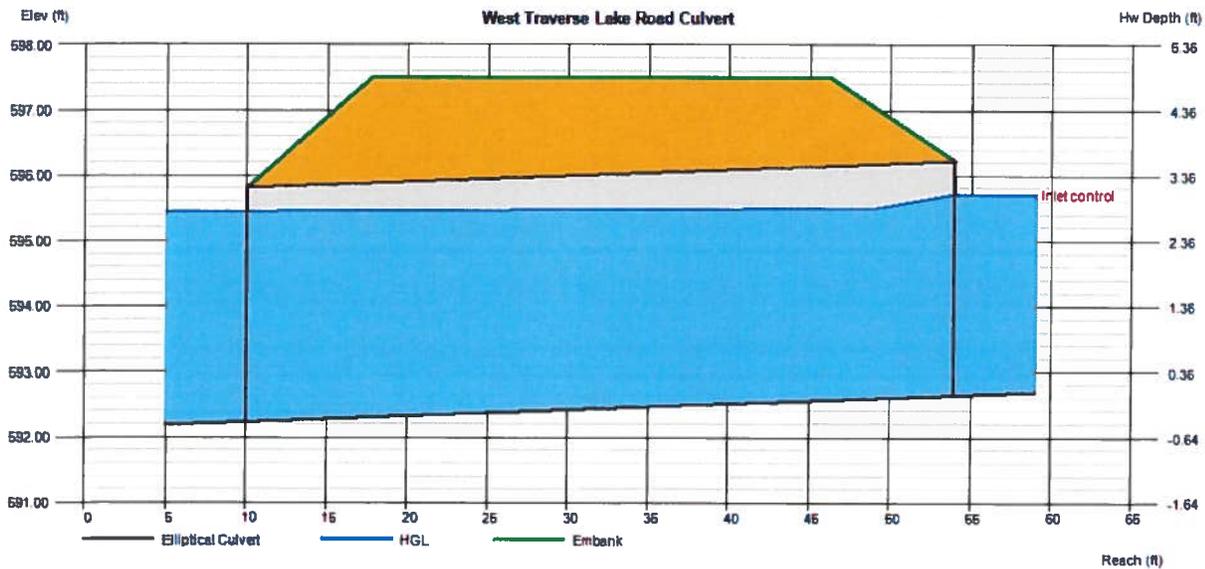
## West Traverse Lake Road Culvert

Yes. The culvert at Traverse Lake Road normally experiences a high tailwater condition that limits the capacity of the culvert. At flows lower than about 60 cfs, capacity of the culvert would be improved if the tailwater condition is lowered. However, at flows greater than 60 cfs, the culvert operates under “inlet control” conditions. This means that no matter how low the tailwater condition is, the water can’t get into the inlet fast enough, so the headwater level will be about the same, regardless of the tailwater condition. See attached analysis outputs.

<b>Highlighted</b>	
Qtotal (cfs)	= 60.00
Qpipe (cfs)	= 60.00
Qovertop (cfs)	= 0.00
Veloc Dn (ft/s)	= 4.16
Veloc Up (ft/s)	= 4.59
HGL Dn (ft)	= 595.45
HGL Up (ft)	= 595.51
Hw Elev (ft)	= 595.71
Hw/D (ft)	= 0.86
Flow Regime	= Inlet Control

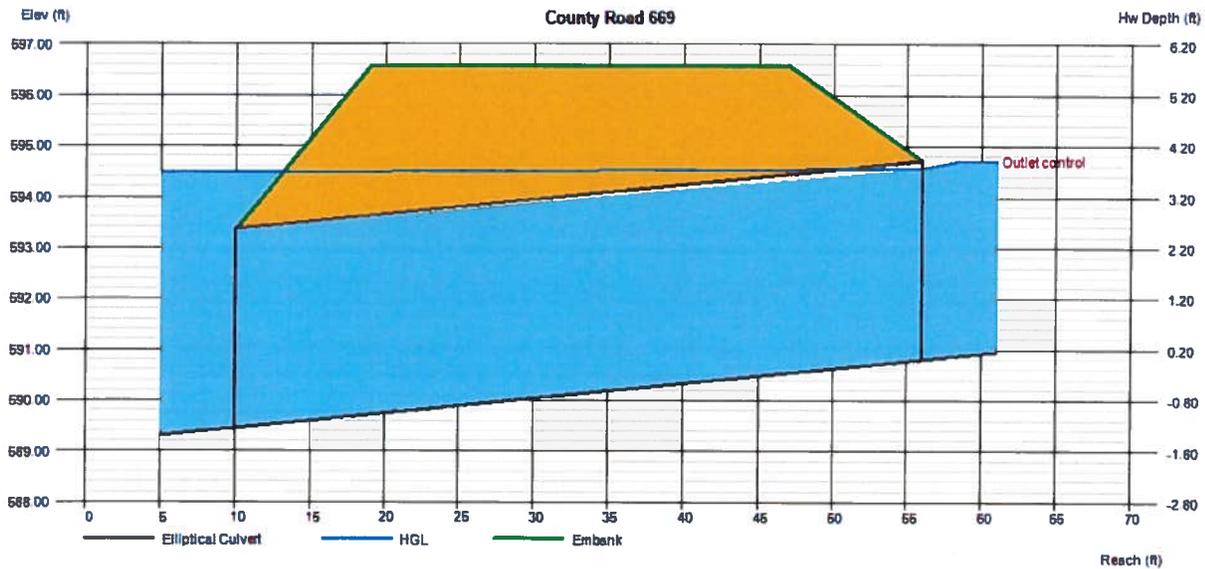
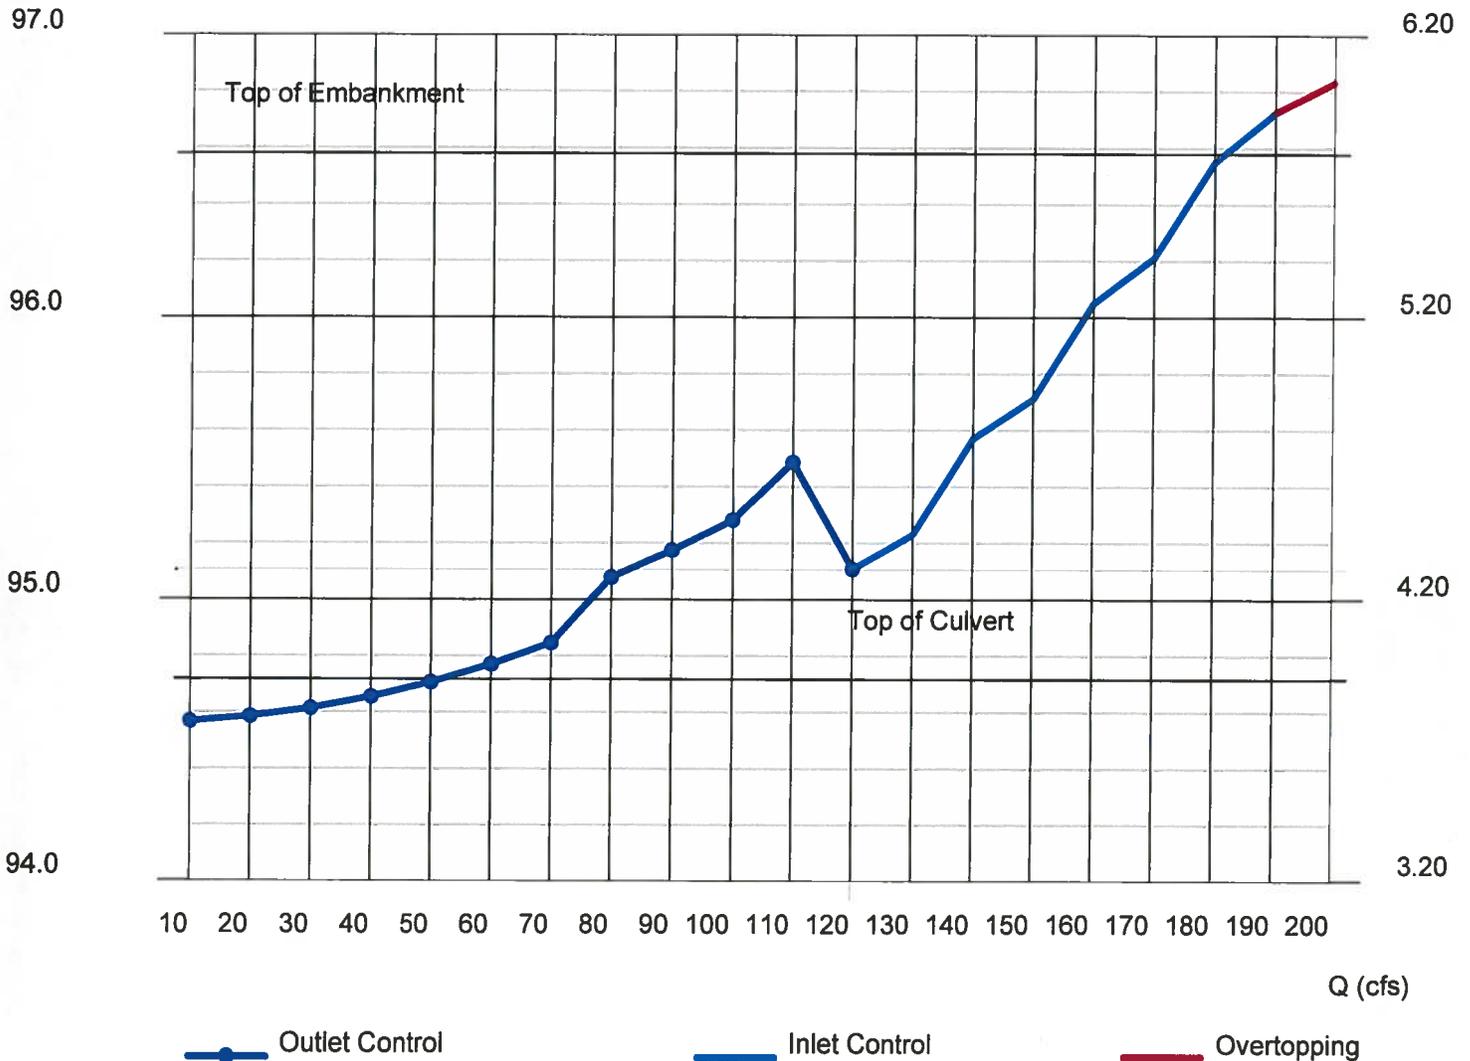
## County Road 669

Yes, but to a lesser degree than the W. Traverse Lake Road culvert. This culvert also normally experiences a high tailwater condition that limits its capacity. At flows lower than about 120 cfs, capacity of the culvert would be improved if the tailwater condition is lowered. However, at flows greater than 120 cfs, the culvert operates under “inlet control” conditions. This means that the headwater level will be about the same, regardless of the tailwater condition. See attached analysis outputs.

<b>Highlighted</b>	
Qtotal (cfs)	= 50.00
Qpipe (cfs)	= 50.00
Qovertop (cfs)	= 0.00
Veloc Dn (ft/s)	= 2.75
Veloc Up (ft/s)	= 2.79
HGL Dn (ft)	= 594.48
HGL Up (ft)	= 594.56
Hw Elev (ft)	= 594.71
Hw/D (ft)	= 1.00
Flow Regime	= Outlet Control
