# RESERVE STUDY

**The Preserve at Mayfield Ranch**  
**3451 Mayfield Ranch Blvd.**  
**Round Rock, TX**

**Date of Inspection: 12/6/2017**

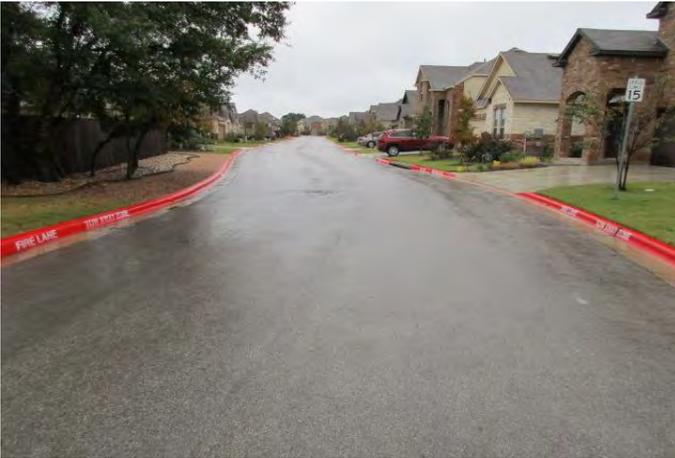
Asphalt pavement overview

Special Conditions
<p>The asphalt pavement comprising the roads and supplemental parking areas are in good condition. We assume the base course was installed at the start of construction of the community and the wear course was installed more recently, possibly even in 2016. We recommend the Association budget for crack repairs, pavement patching and seal coat applications every 5 years beginning by 2021, except for when repaving occurs.</p>

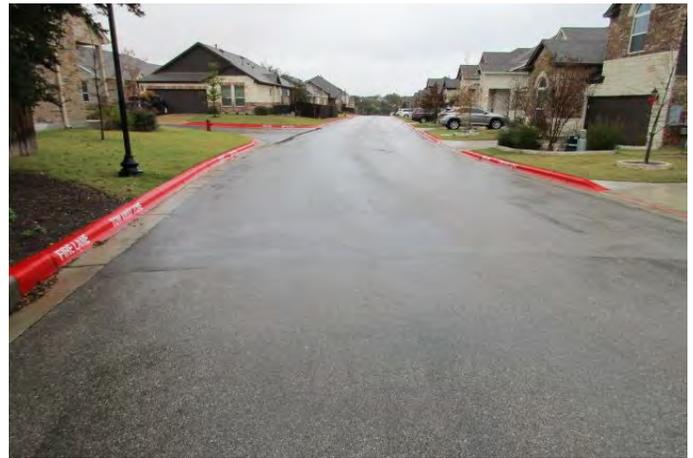
Asphalt pavement overview

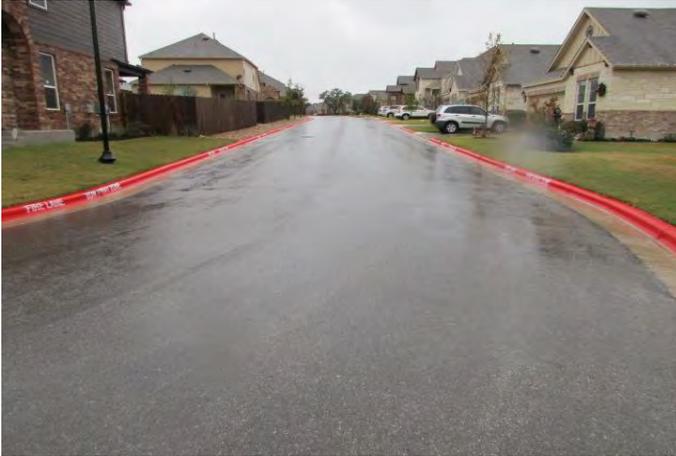
Asphalt pavement overview

Special Conditions
<p>The asphalt pavement comprising the roads and supplemental parking areas are in good condition. We assume the base course was installed at the start of construction of the community and the wear course was installed more recently, possibly even in 2016. We recommend the Association budget for milling of the top 2 inches of pavement, base and wear course repairs, and overlayment of the pavement by 2034.</p>

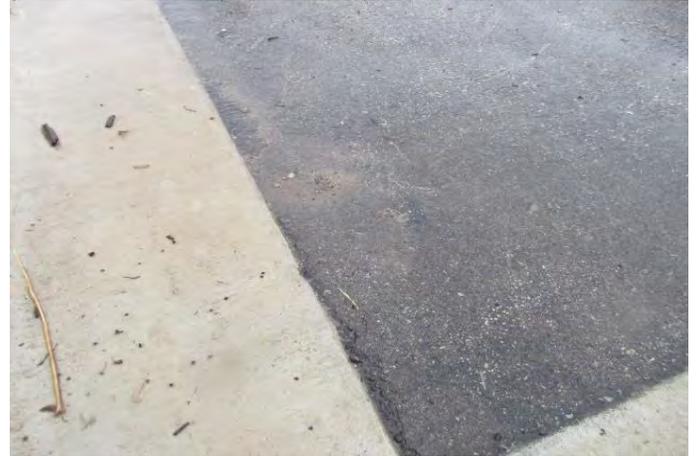
Pavement settlement

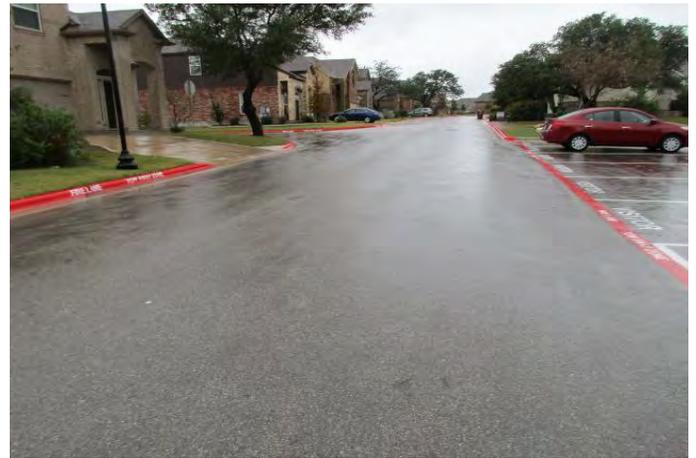
Asphalt pavement overview

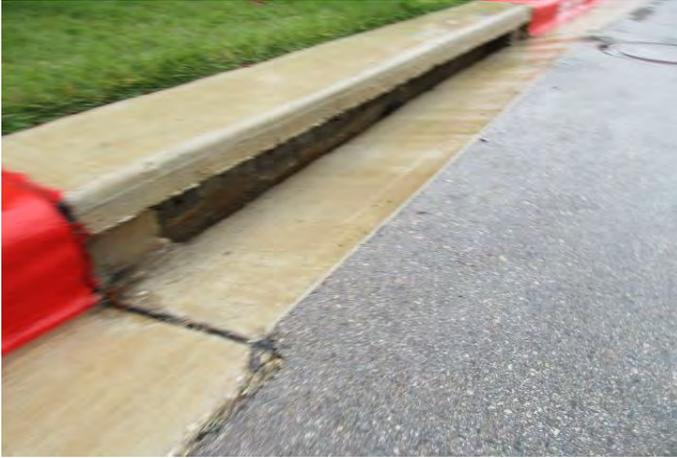
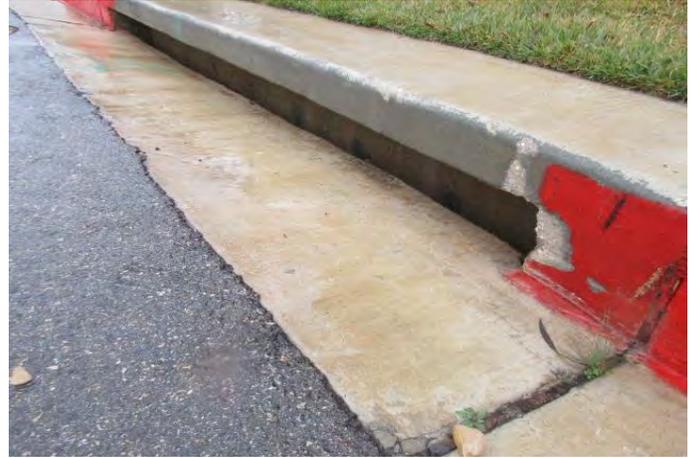
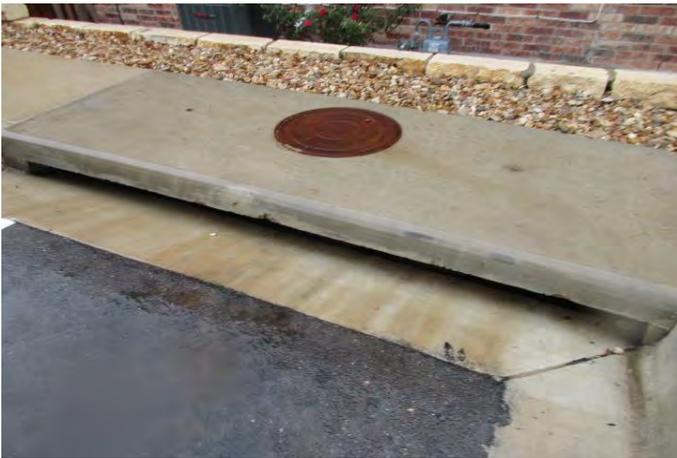
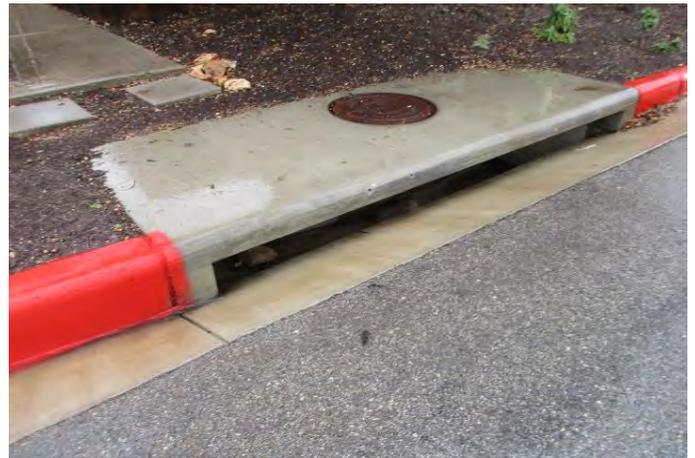
Precast concrete catch basin

Special Conditions
<p>Twenty-seven precast concrete storm water catch basins collect water from the streets and channel it through a subsurface pipe system into the community's detention basin. The catch basins appear in good condition with no evidence of settlement. We include an allowance for repairs by 2034, in coordination with street repaving.</p>

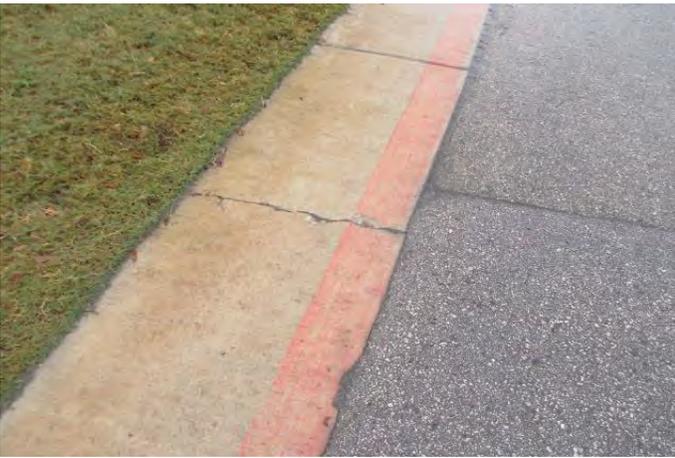
Concrete ribbon curb at Sendero

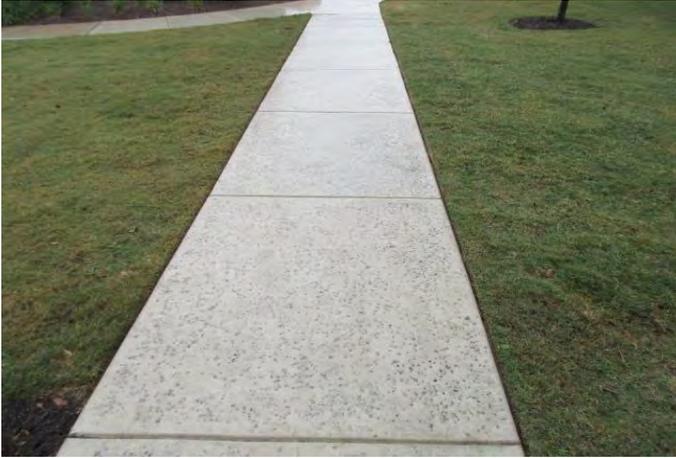
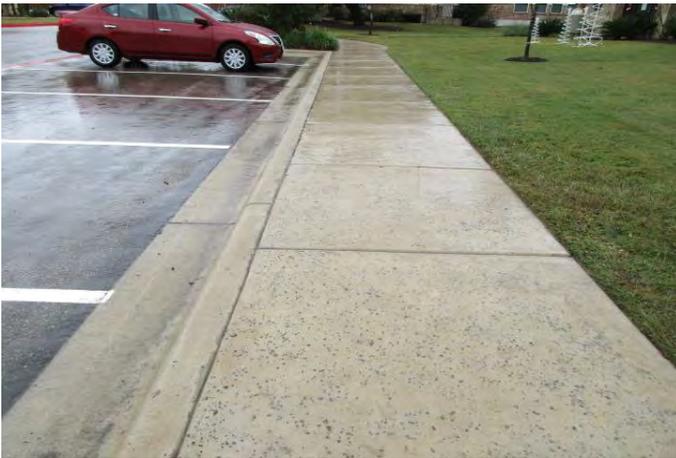
Sidewalk near pool

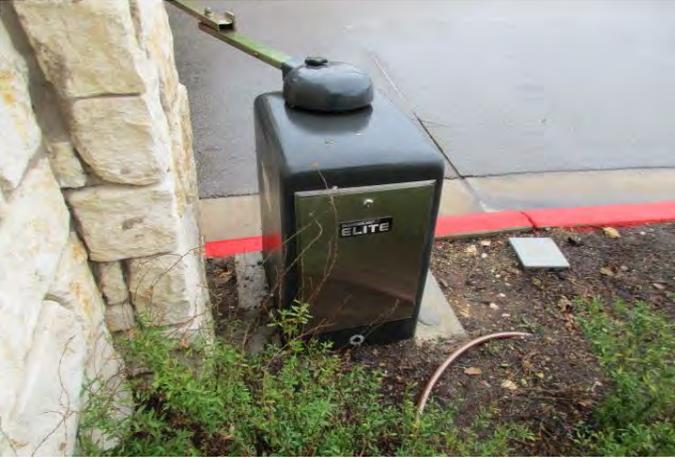
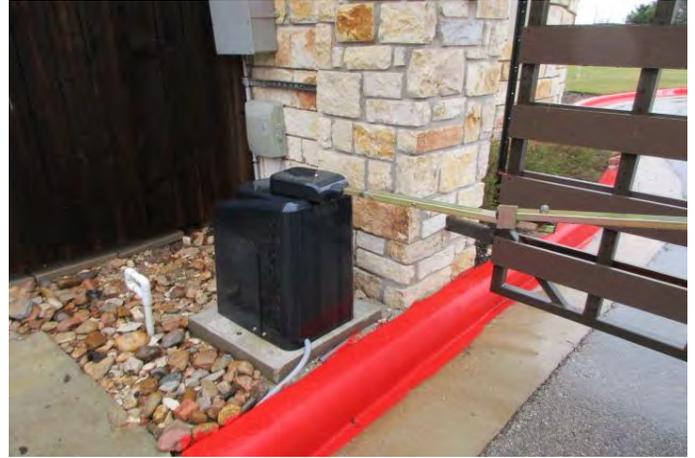
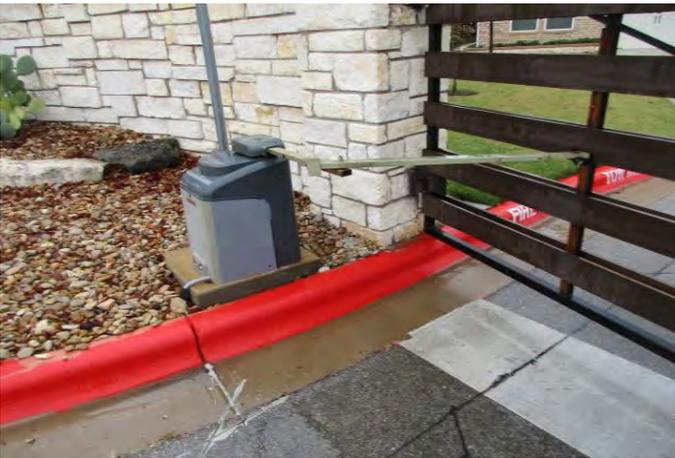
Swinging gate operator

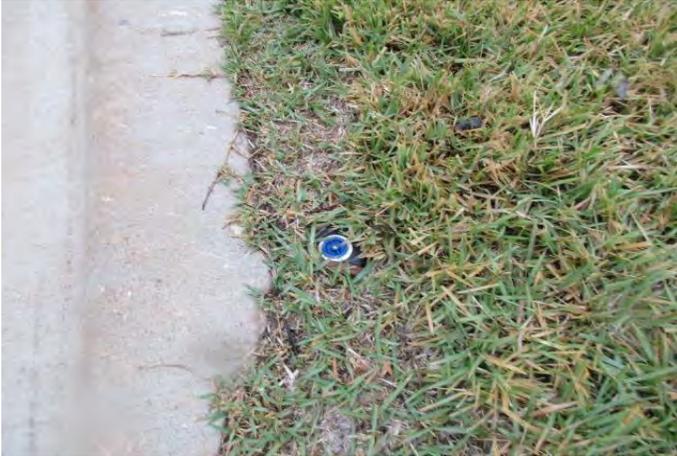
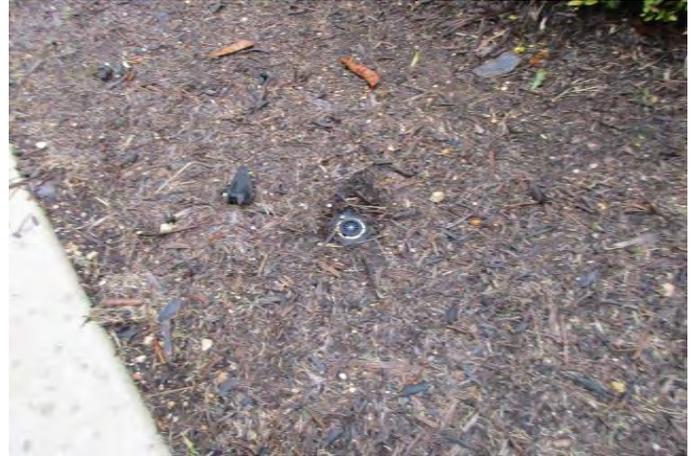
Irrigation system spray head

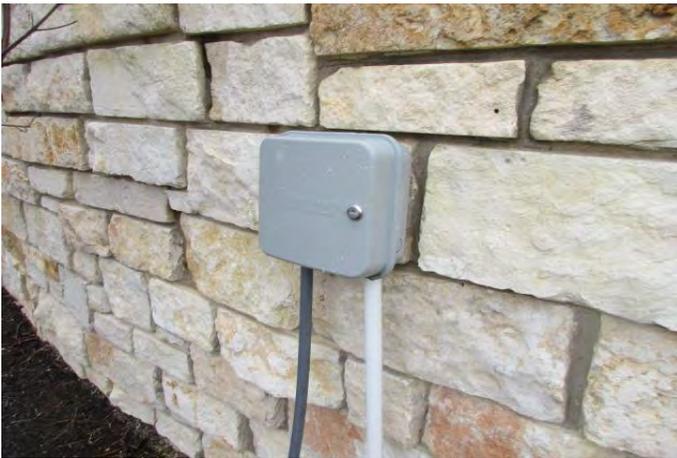
Irrigation controller

An irrigation system waters the lawn and landscaped areas throughout the community. The system is original and reported in satisfactory operational condition. Over time, erosion and plant growth will cause damage to the system. As such, we recommend the Association budget for replacement of the system by 2047. The Association should fund interim head and controller replacements through the operating budget as needed.

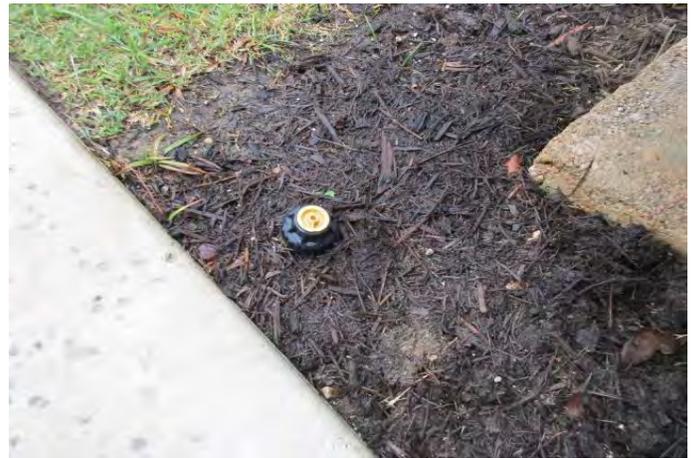
Irrigation system spray head

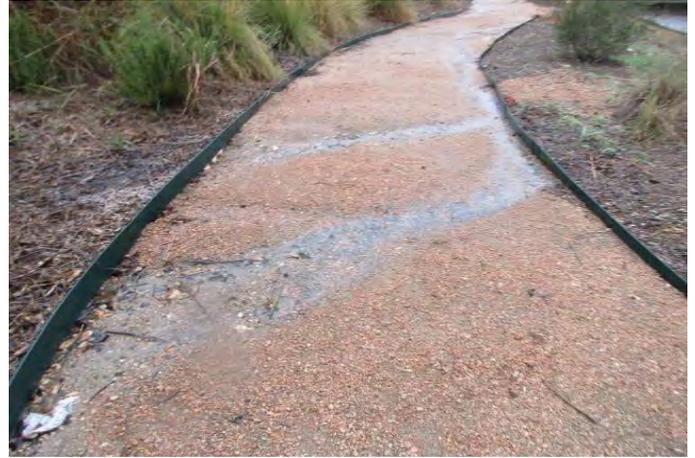
Drainage channels at path

Special Conditions
<p>Decomposed granite walking paths are located near the playground and along the east perimeter of the community. We note multiple locations of erosion or granite loss, as depicted above. The Board informs us the Association would like to extend the path near the playground to connect through to the mailbox stations. We include an allowance for erosion repairs and granite replenishment by 2019 and every 4 years after. Interim erosion control projects should be funded through the operating budget as needed.</p>

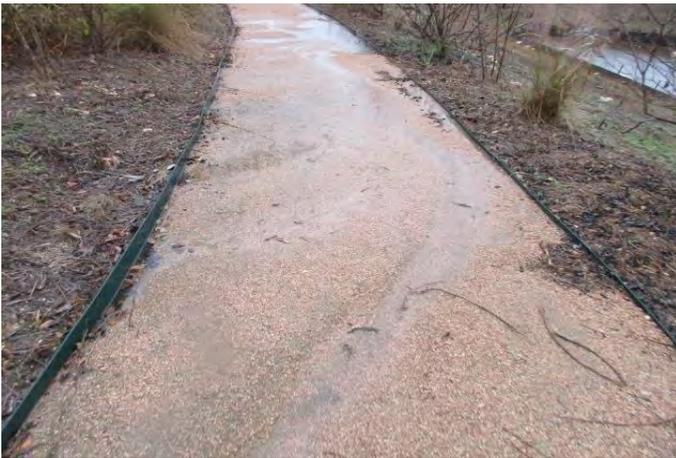
Drainage channels at path

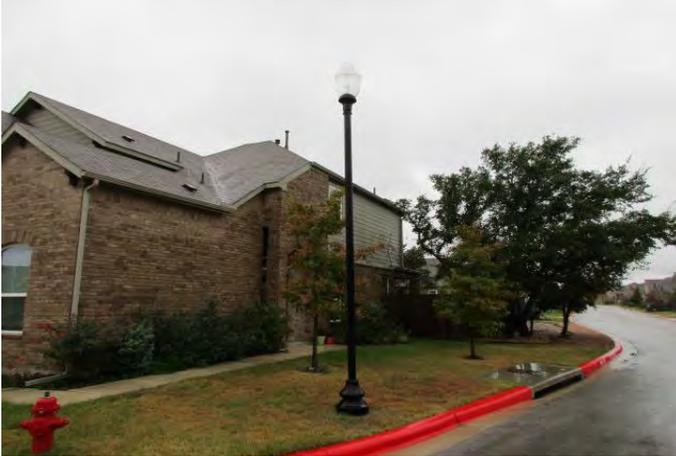
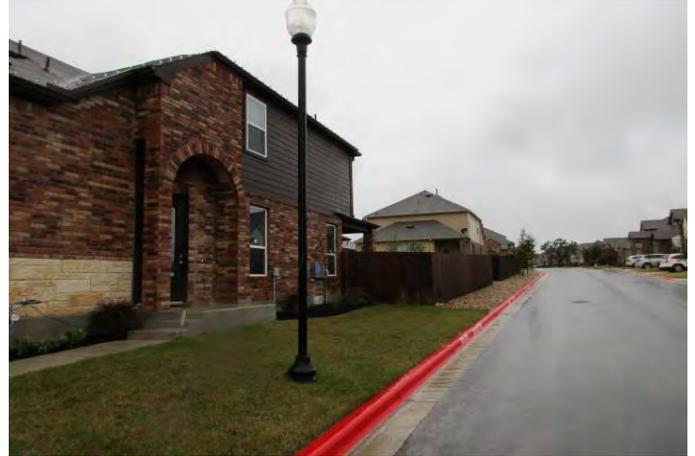
Light pole and fixture

Special Conditions
Fifteen light poles and fixture illuminate the common areas throughout the community. This quantity includes the light poles and fixtures outside the perimeter walls but that match the rest throughout the community. We include an allowance for replacement of the poles and fixtures by 2038.

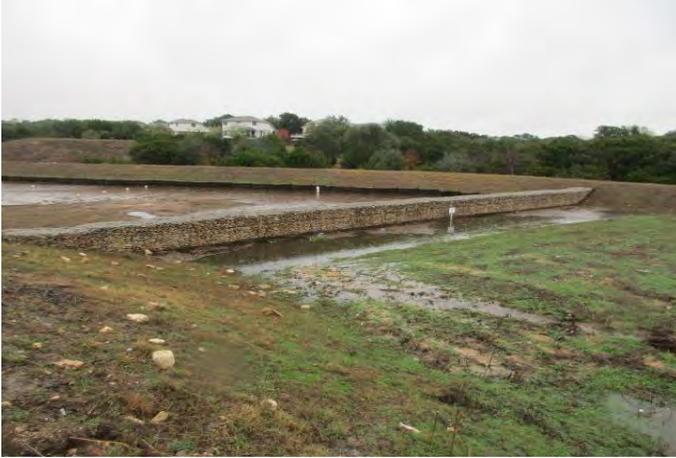
Pond area

Special Conditions
<p>A series of storm water control structures are located south and east of the community. These structures include a sedimentation area, filtration area and overflow basin. The Board and Management inform us that these structures are not performing as designed and required remediation in 2018. The costs of remediation vary between \$18,000 and \$34,000. At the direction of the Board, we include an allowance of \$18,000 in 2018 to remediate the pond area.</p>

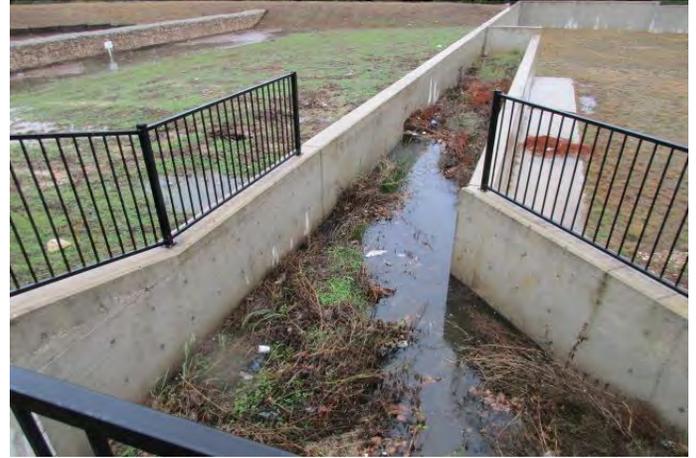
Storm water discharge channel

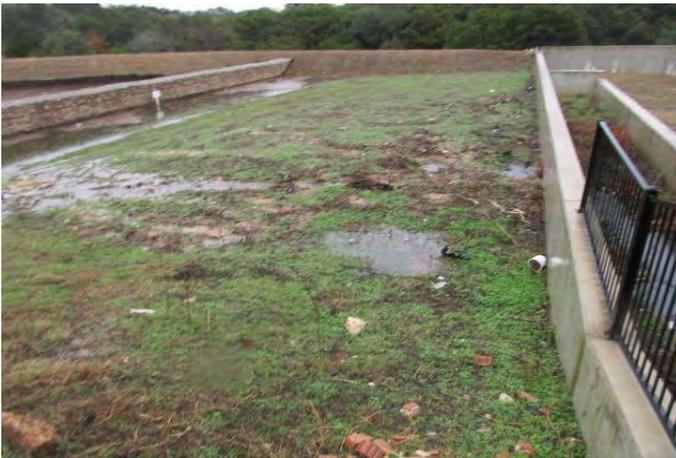
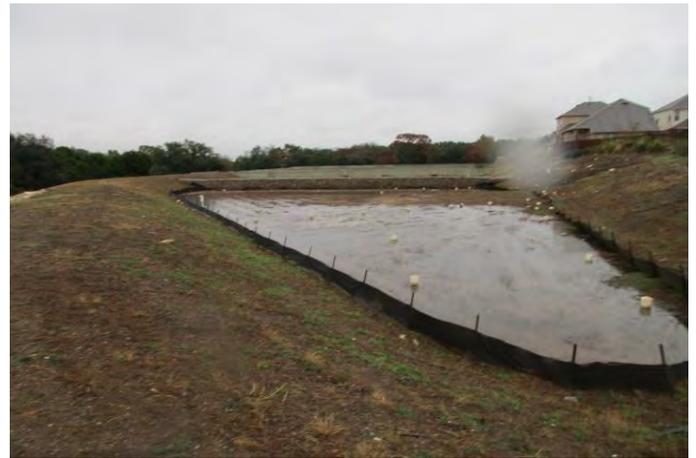
Detention area

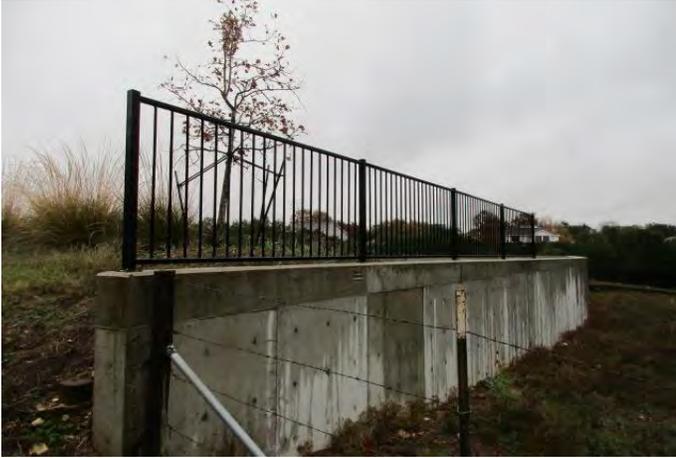
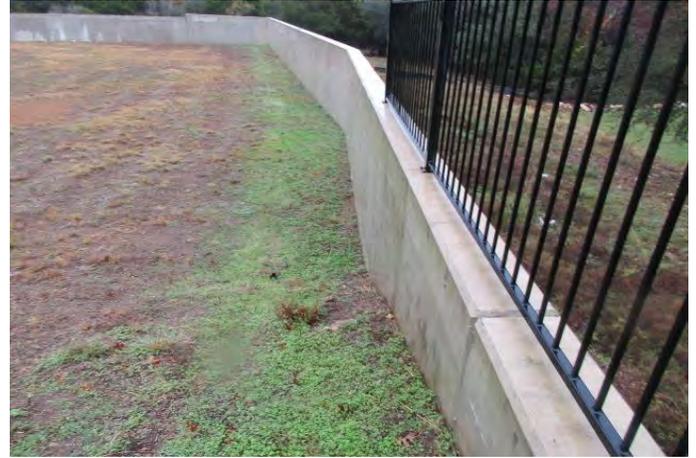
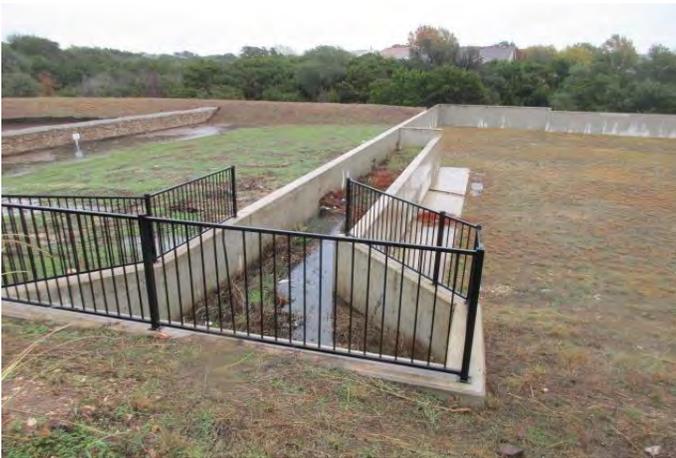
Concrete retaining wall

Special Conditions
Concrete retaining walls and storm water control structures are located at the east and south perimeters of the community. The concrete appears in good overall condition. Over time, these walls will require crack repairs and partial patching. We include an allowance for this type of work by 2025 and again by 2038.

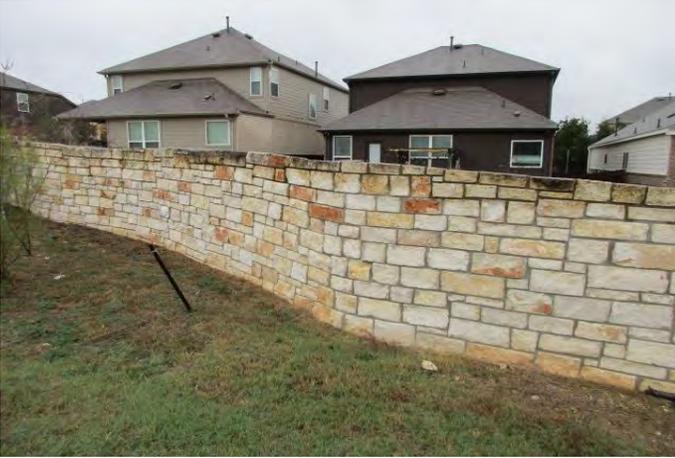
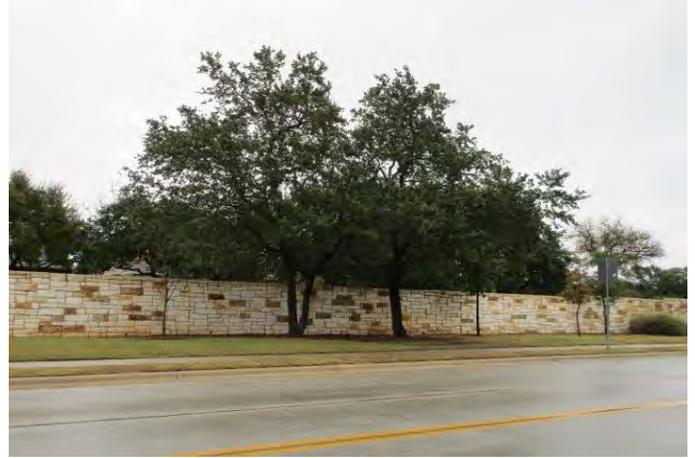
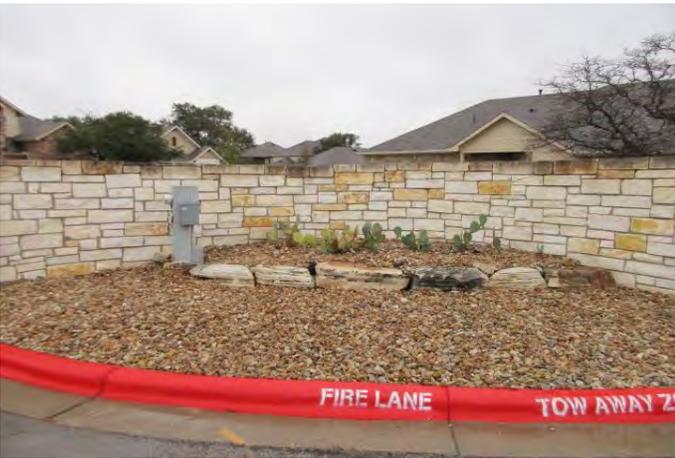
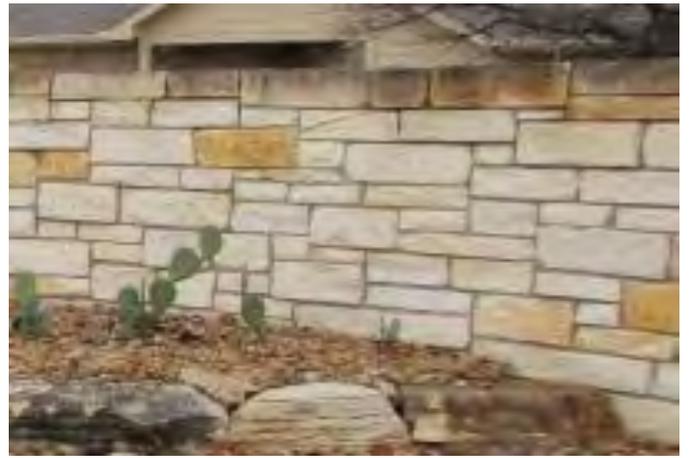
Stone perimeter wall

Special Conditions
Stone walls are located at portions of the community west and south perimeters. The stone and mortar appears in good overall condition. Over time, repointing of mortar joints and partial replacements of cracked or delaminated stone is likely. We recommend the Association budget for repairs by 2024 and every 12 years after.

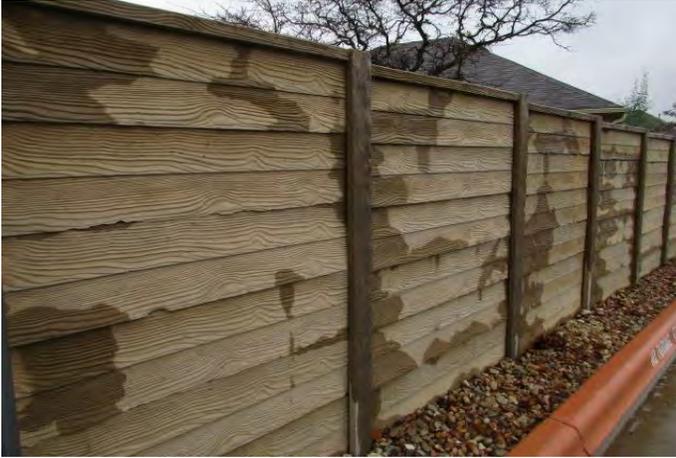
Concrete perimeter wall

Special Conditions
<p>Concrete walls are located at the perimeter of the community. The precast panels are original and in good overall condition, however, we note locations of cracks, as depicted above. Portions of the wall will continue to crack and require replacement. We include an allowance to replace portions of wall and paint both sides of the walls by 2024 and every 12 years.</p>

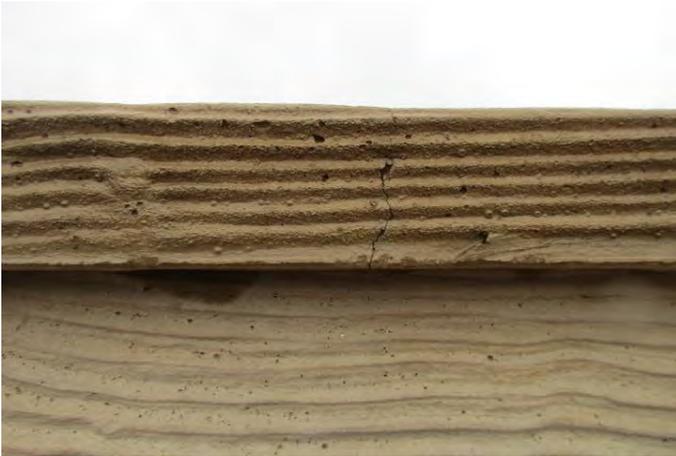
Crack at wall

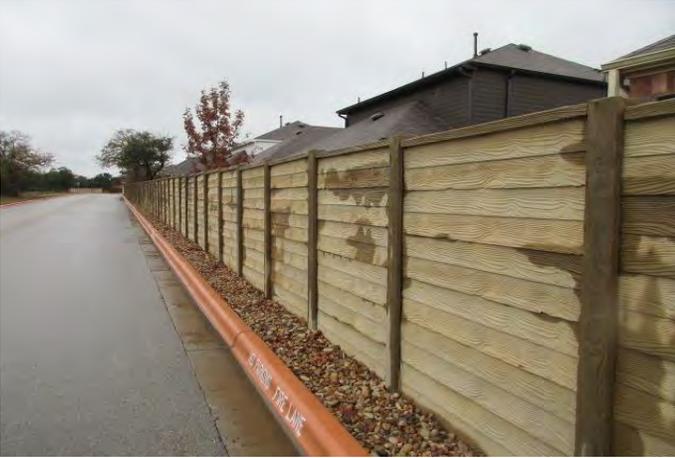
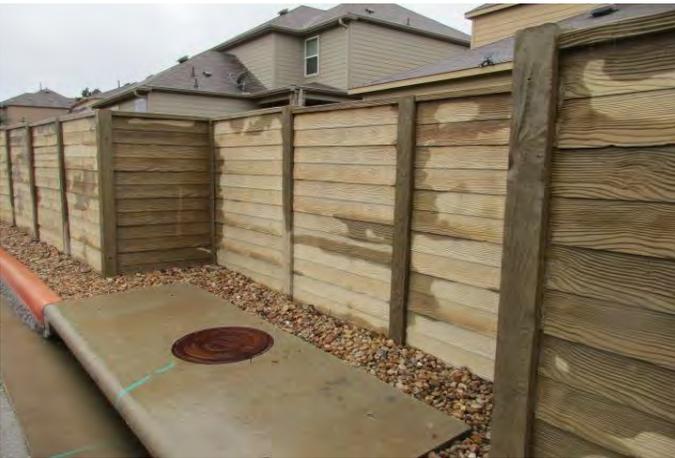
Concrete perimeter wall

Concrete walls are located at the perimeter of the community. The precast panels are original and in good overall condition, however, we note locations of cracks. The wall has a long useful life. By 2048, the end of this study, the walls will be approximately 36 years of age and will have achieved approximately 72% of their useful life. Therefore, we include an allowance to fund up to 72% replacement of the walls by 2048.

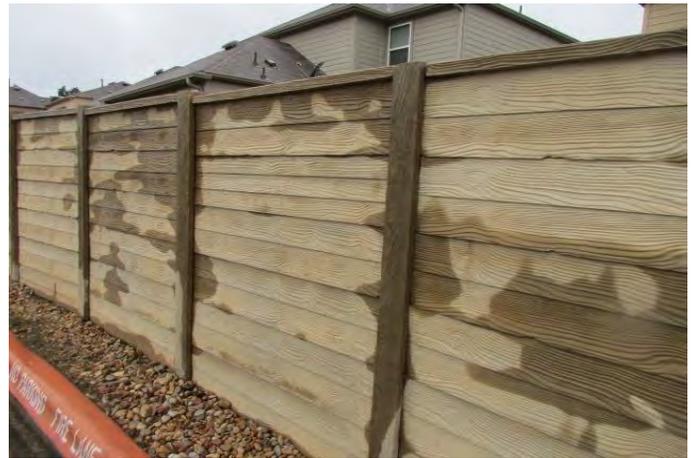
Concrete perimeter wall

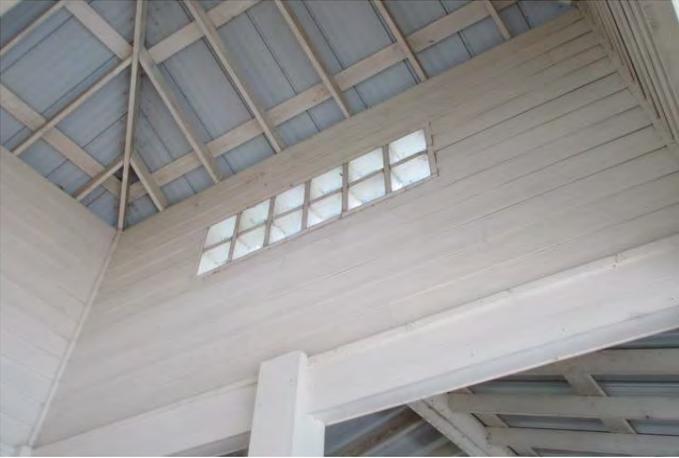
Wood siding

Special Conditions
<p>The pool house walls, beams, joists and roof use a paint finish to protect the materials. The paint finishes are in good condition. We recommend the Association budget for future paint finish applications and repairs to the pool house elements by 2023 and every 8 years after.</p>

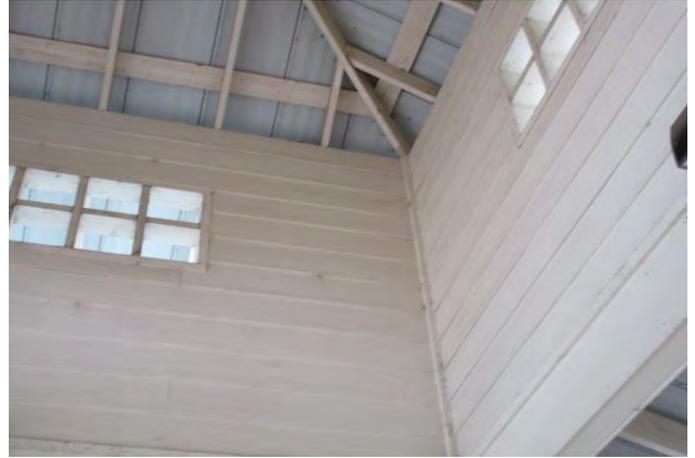
Wood siding

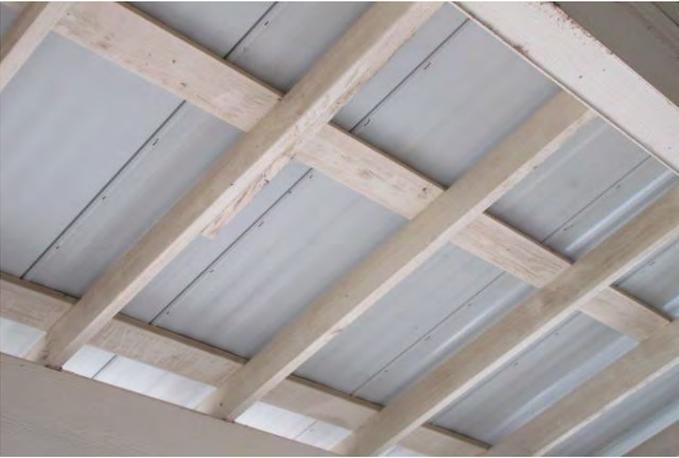
Exposed wood beams

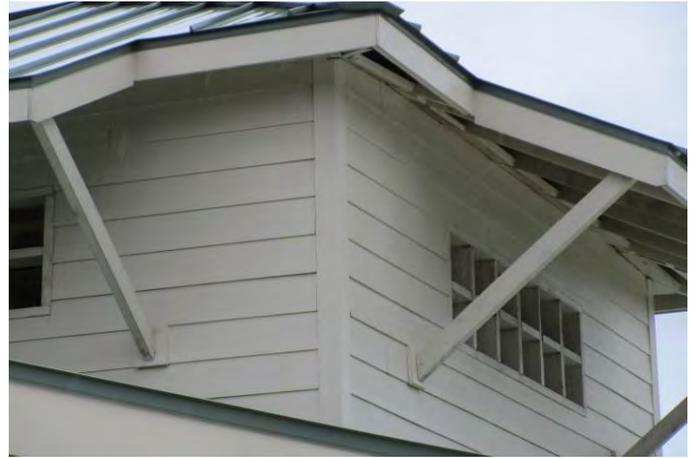
Wood siding and trim

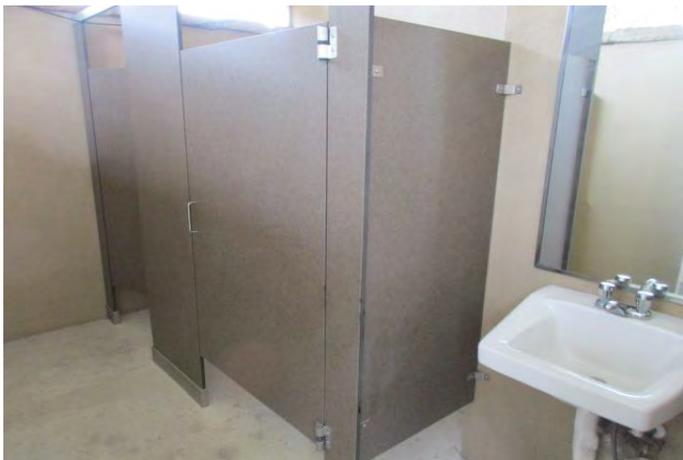
Women's rest room

Two rest rooms, a shower area and two water fountains are located at the pool house. These elements are original and in good condition. We include an allowance to renovate the rest rooms, shower area, replace the water fountains, metal doors and light fixtures by 2039.

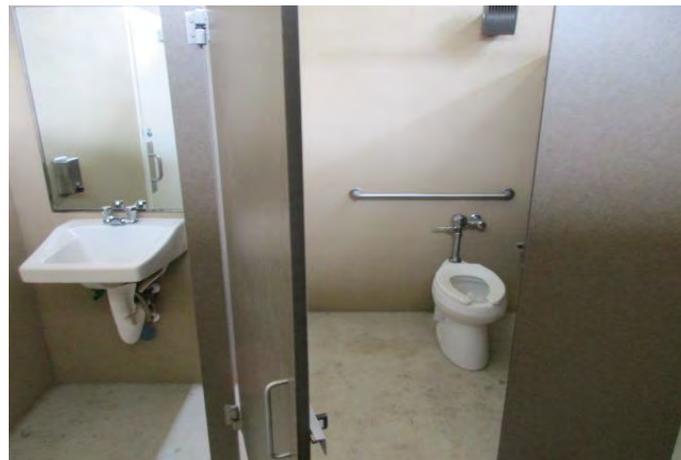
Men's rest room

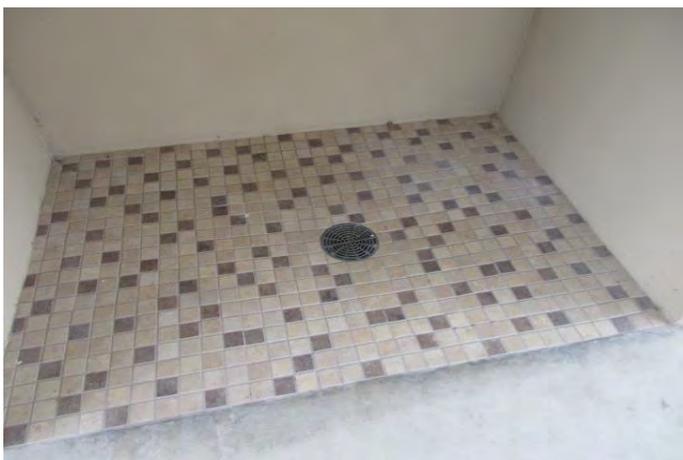
Ceramic tile floor in shower area

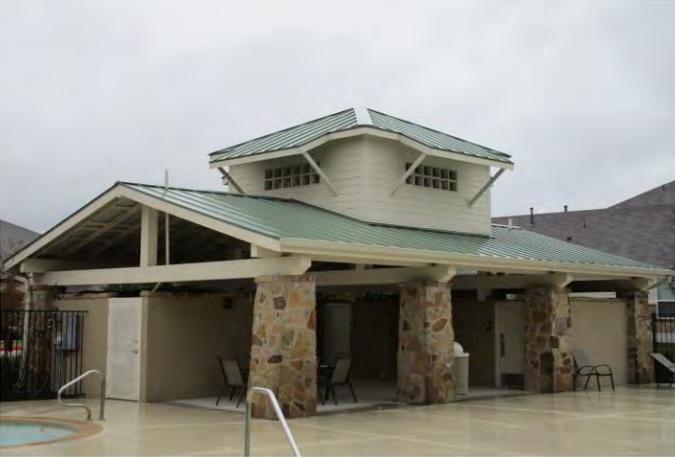
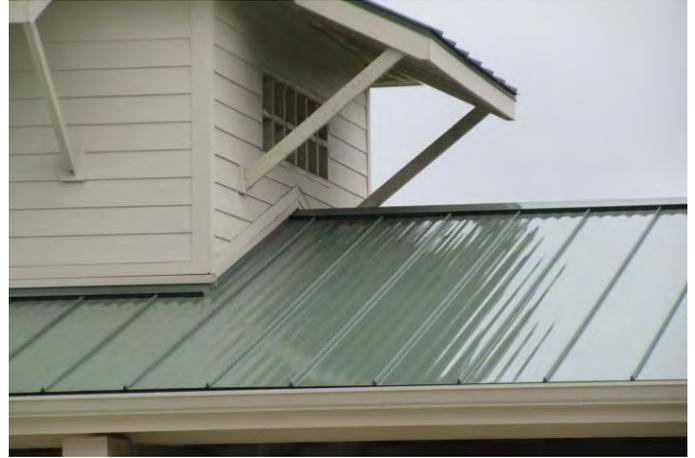
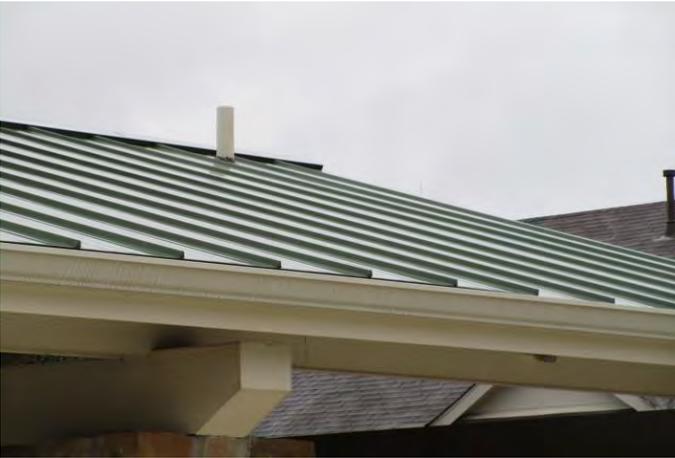
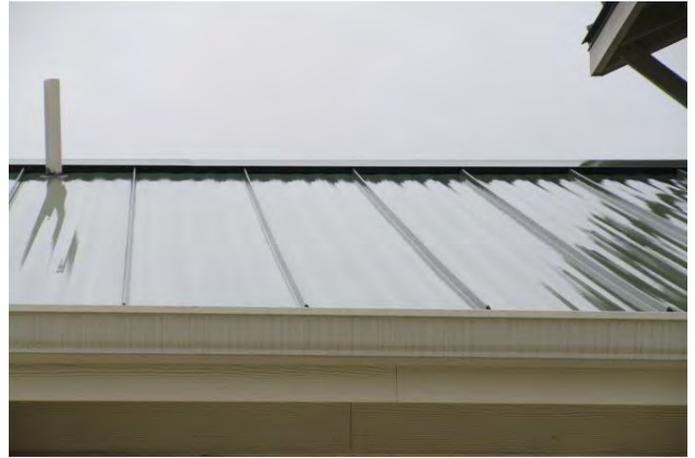
Standing seam metal roof

A standing seam metal roof is located at the pool house. Approximately 115 linear feet of gutters and downspouts drain water from the roof. We include an allowance to replace the roof, gutters and downspouts by 2039, in coordination with the renovation of the rest rooms.

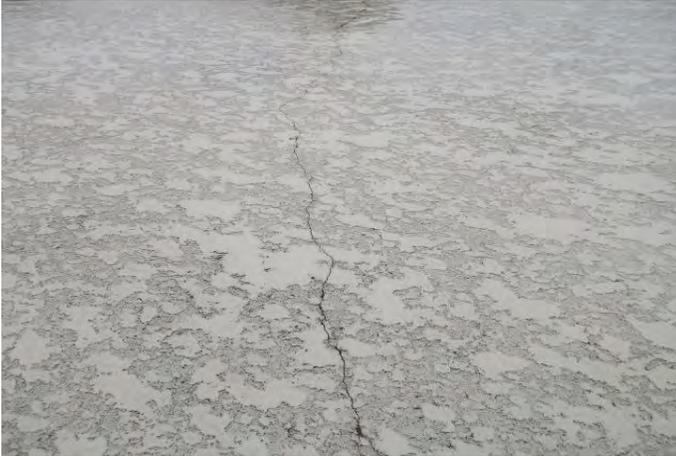
Crack at pool deck coating

Special Conditions
<p>A concrete pool deck surrounds the pool. The portions of the deck under the pool house roof does not use a coating. The portions of the deck that are not under the roof use a textured coating. The coating is original and appears in fair condition. We note cracks, as depicted above. We include an allowance to replace the coating by 2025 and again 12 years later by 2037.</p>

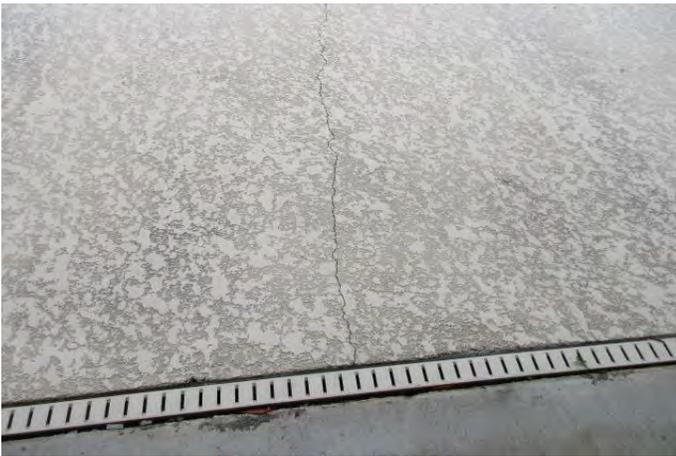
Pool deck coating crack

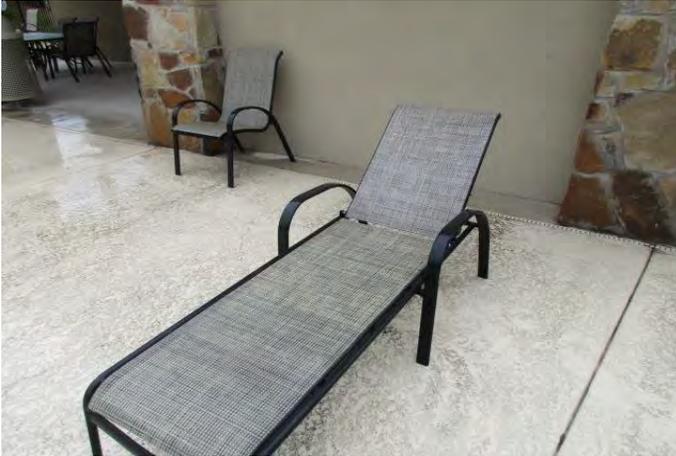
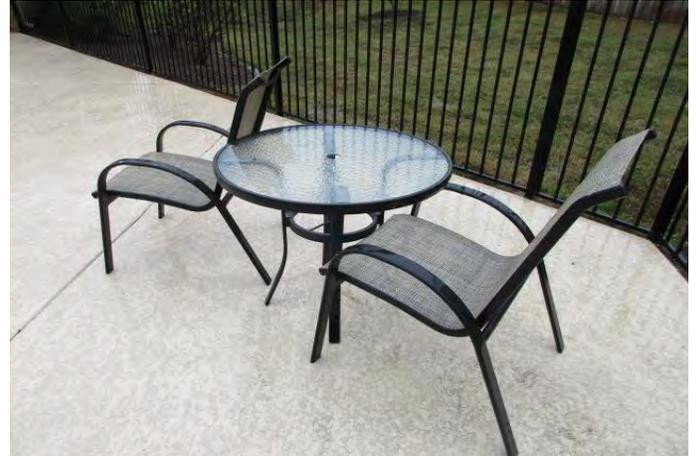
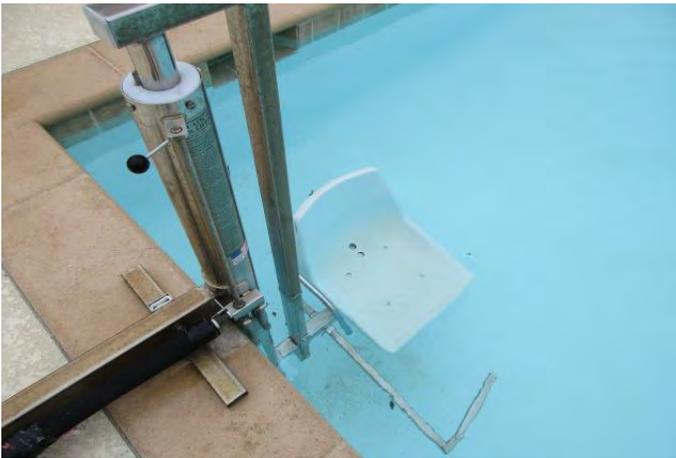
Lounge chair

Table and chairs

Lift

Chairs, lounge chairs, tables and a chair lift serve the pool area. The furniture and lift are original to pool construction. We note finish deterioration of at the furniture. We include an allowance for replacement of the furniture, including the lift, by 2021 and every 10 years after.

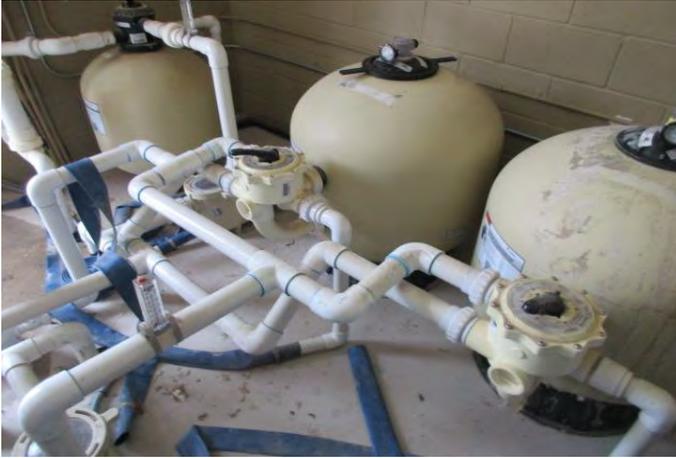
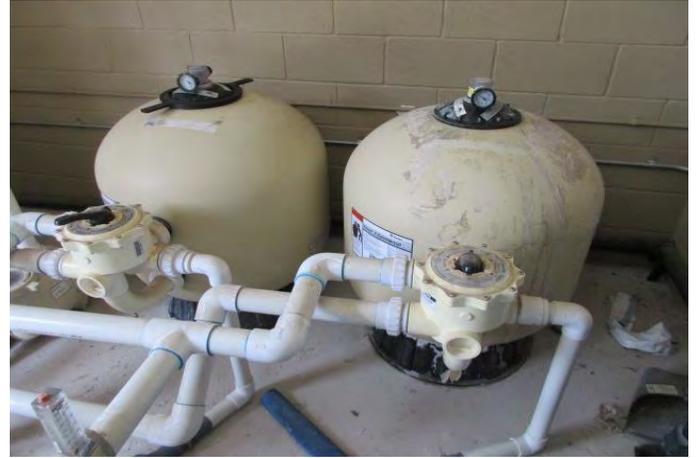
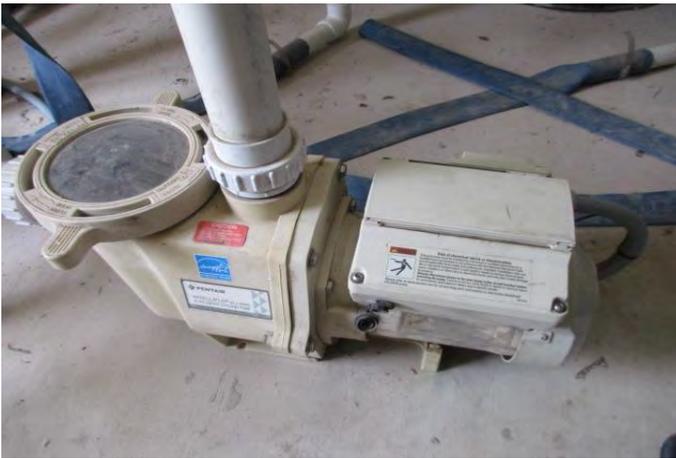
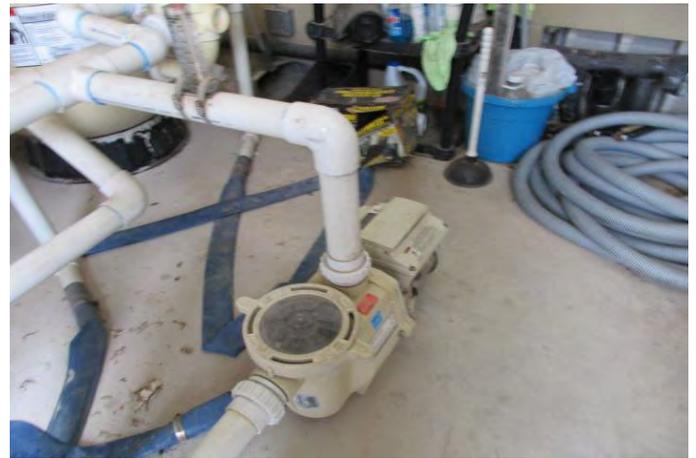
Pool mechanical equipment

Filters, valves and piping

Pool pump

Two pumps, 3 filters, 2 chlorinators, valves and pipes serve the main and wading pools. The equipment is original and reported in good operational condition. The useful life of the equipment varies from 8 to 15 years. We recommend the Association budget for replacement of up to 50% of the equipment by 2022 and every 7 years after.

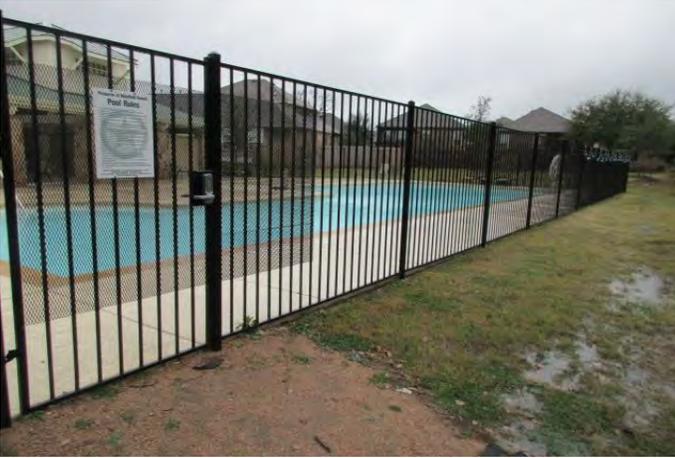
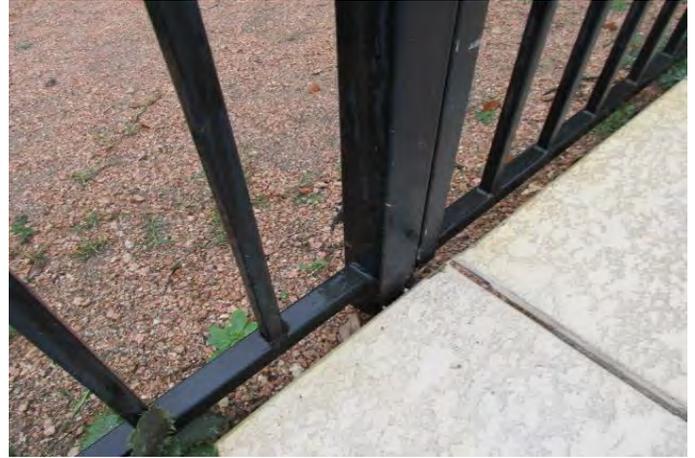
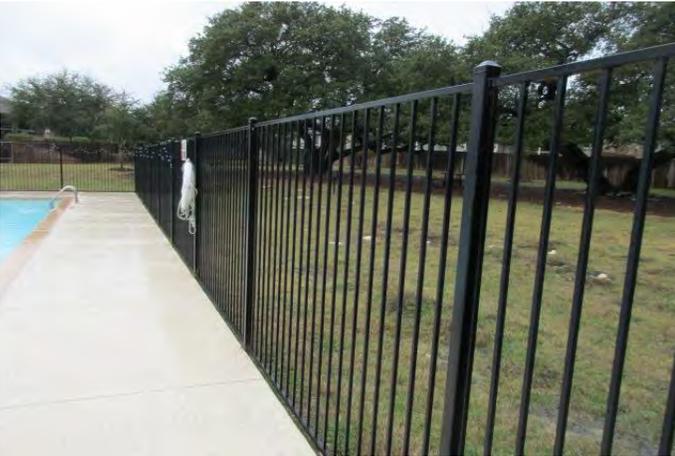
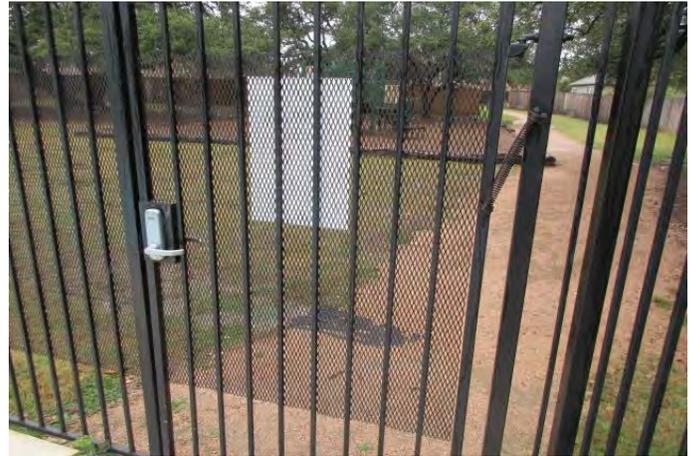
Pool rear gate and fence

Metal pickets

Pool fence

Pool rear gate

Special Conditions
A metal picket fence with 2 gates surround the pool area. The pool fence and fence finishes are in good overall condition. We recommend the Association budget for paint finish applications to the pool fence and gates by 2022 and every 7 years thereafter.

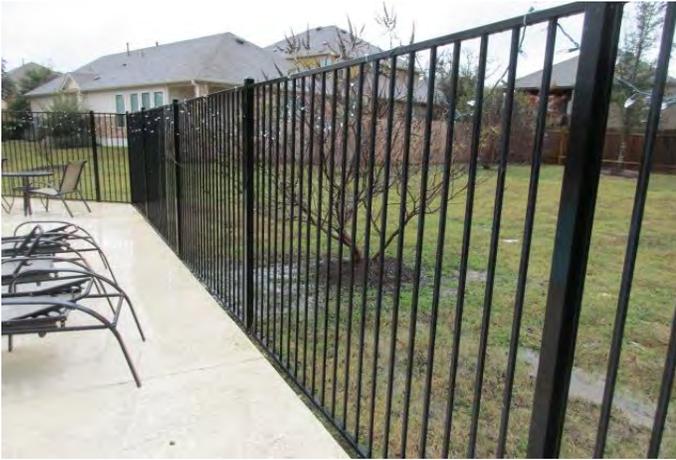
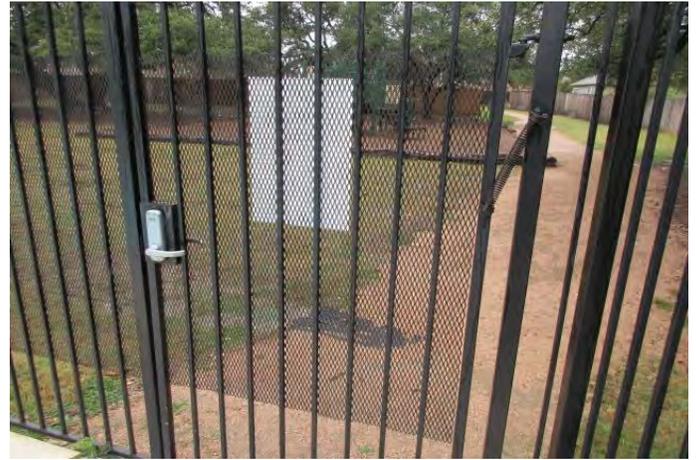
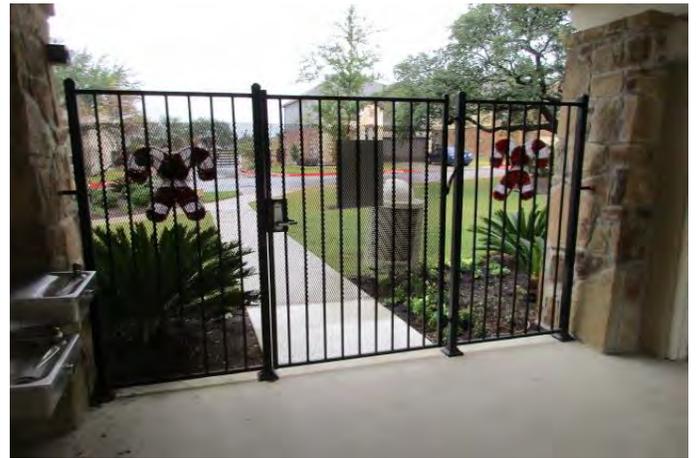
Pool fence

Pool rear gate

Pool front gate

Special Conditions
<p>A metal picket fence with 2 gates surround the pool area. The pool fence and fence finishes are in good overall condition. We recommend the Association budget for replacement of the fence and gates by 2048.</p>
