# RESERVE STUDY

**The Preserve at Mayfield Ranch**  
**3451 Mayfield Ranch Blvd.**  
**Round Rock, TX**

**Date of Inspection: 12/6/2017**

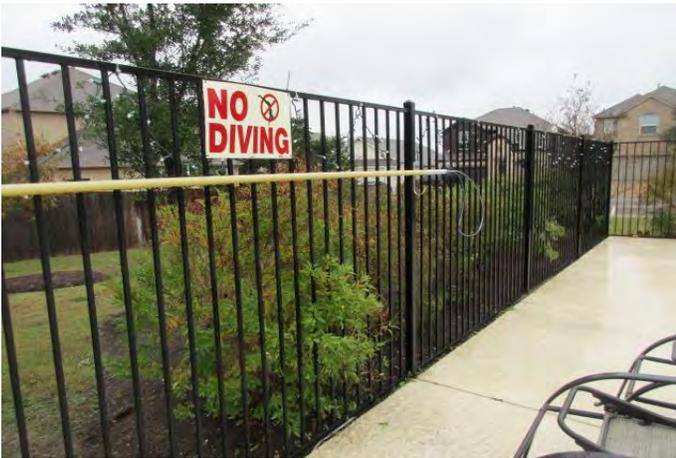
Landscape in contact with metal fence

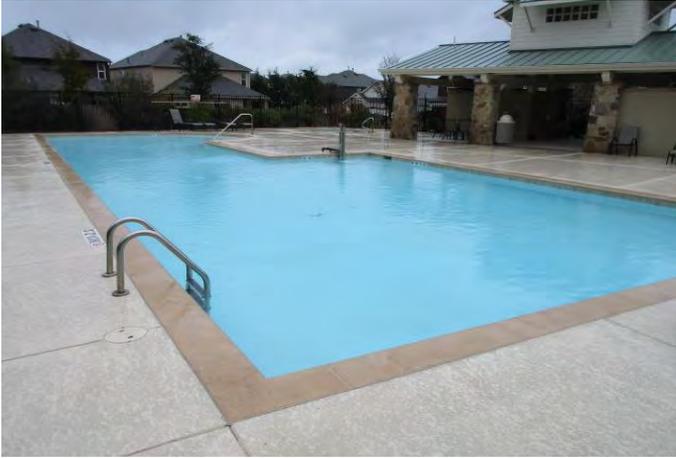
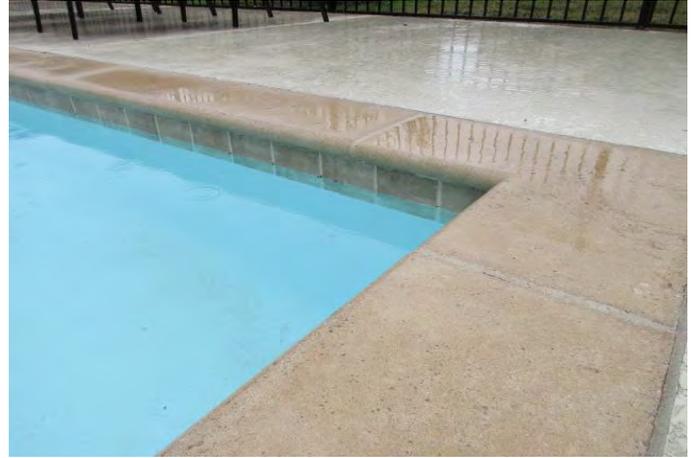
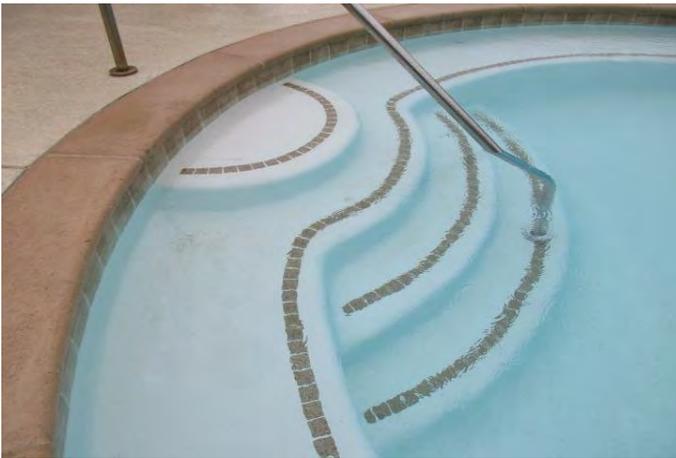
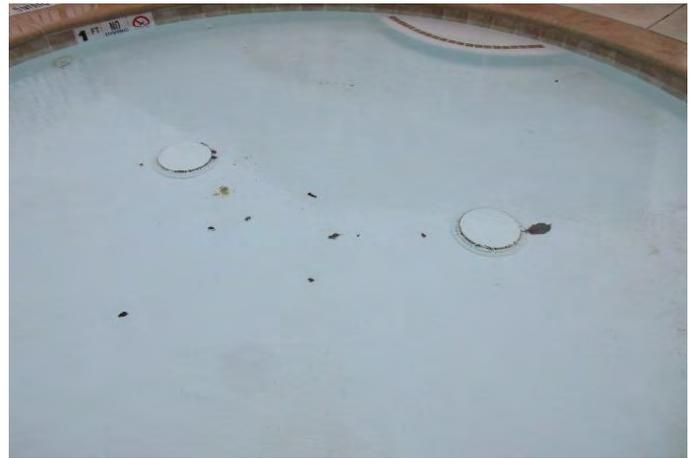
Pool overview

Tile scupper and concrete coping

Plaster finish at stairs

Wading pool finish

Special Conditions
Plaster finishes cover the wall and floor surfaces of the main and wading pools. The plaster finishes are in good overall condition. We recommend the Association budget for replacement of the plaster finishes and tile scupper, along with 50% replacement of the pool coping by 2025 and again by 2037.
