Section 11.28 Storage Tank Rule Regulation No. 11 (5 CCR 1002-11) Comprehensive Inspection Checklist

System Name & PWSID:	Florida River Estates
Inspection Date:	06/22/2017
Inspector's Name:	Charles "Bill" Donohue NACE Inspector #763
Inspector's Phone:	1-505-330-2531
Inspector's Email:	CWDIVERS@MSN.COM
SDWIS Tank Name:	Main Tank
SDWIS Facility State ID:	CO-134300
Inspection Start & Finish Time [±] :	
Tank level [±] :	
Weather conditions [±] :	
List Sanitary Defects Identified by Inspection Item # (which are in bold)*:

RE: 100K gallon Main Tank, CO-134300 ROV Inspection

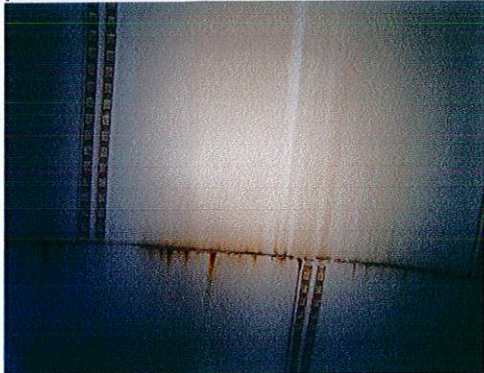
6. Interior coating: Blistering, peeling, scaling, rusting, any irregularities or other failure?	<input type="checkbox"/> Y <input checked="" type="checkbox"/> N		If conditions exist but do not constitute a sanitary defect, answer 'N' to the left and describe them here; include recommendations to prevent sanitary defects.

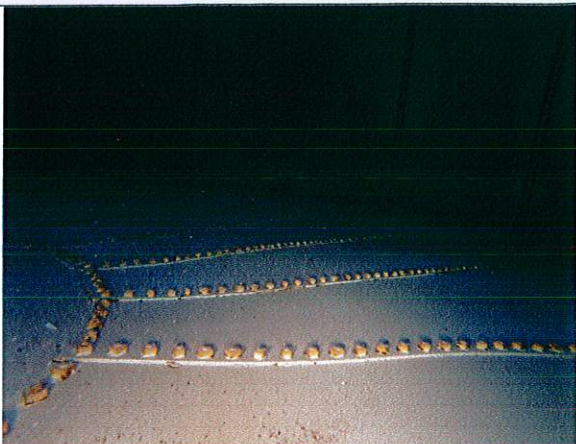
documentation, or other evidence in the written inspection plan.			
11. Tank floor: Corrosion? Sediment/Sludge? Any structural deficiencies? Any irregularities? Other failure?	<input type="checkbox"/> Y <input checked="" type="checkbox"/> N

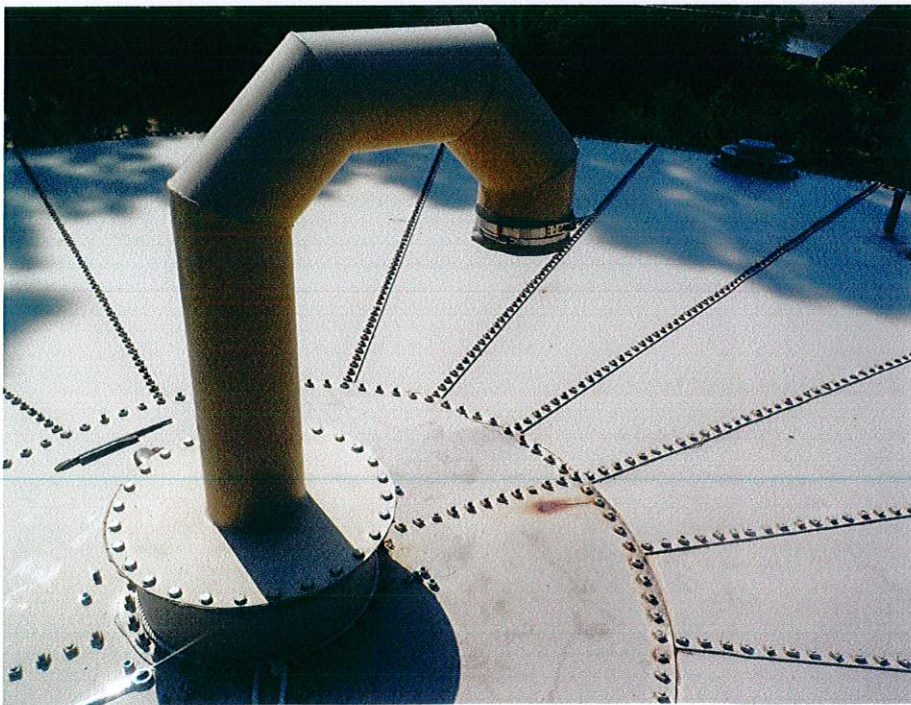
The roof is in good condition, no rust or peeling paint.

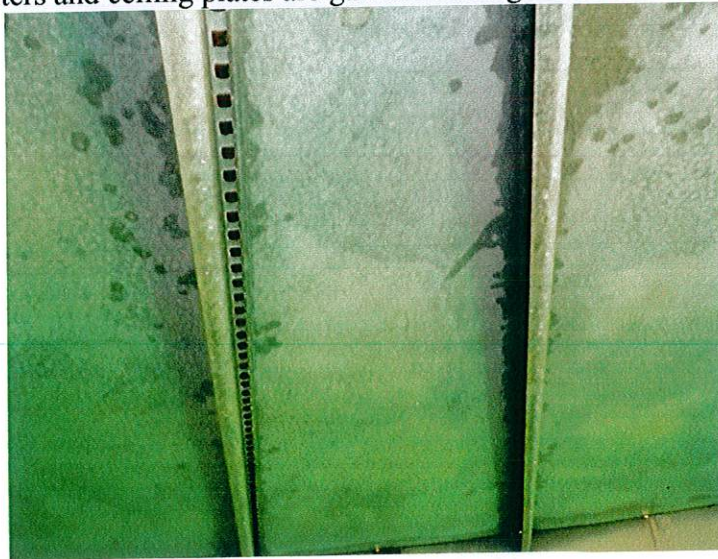
Rafters and ceiling plates are galvanized in good condition
