PERRY INSPECTION REPORT

557 Todd Loop
White Rock, NM 87547

MARCH 11, 2024

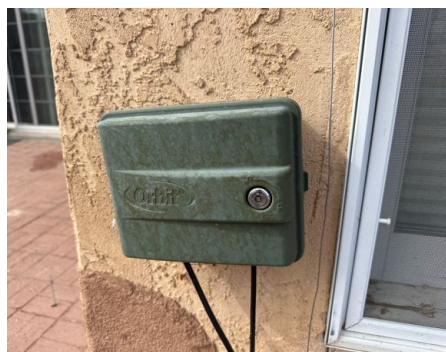
Exterior South Wall

Irrigation System: Timer Location

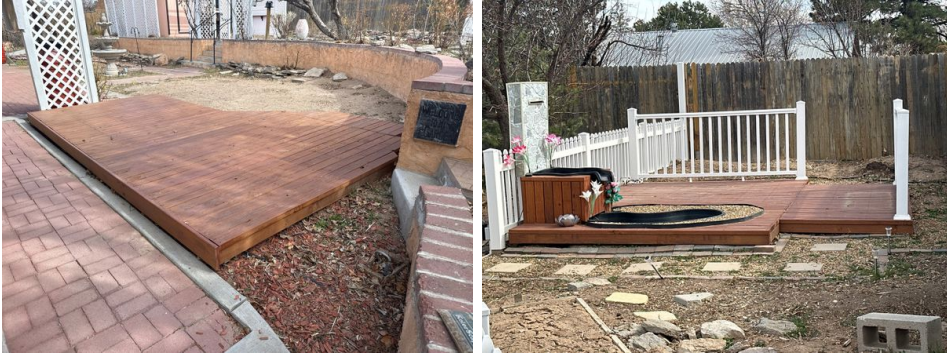
UNDERNOACCESS

There was no access to the underside of the deck and the framing structure could not be inspected.

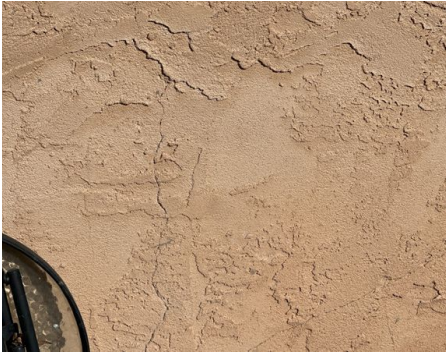
Coverings & Conditions: Typical Cracks (Monitor)

Hairline cracks were noted and are considered normal. If any crack opening become 1/8 inch or larger, it is recommended to have the crack repaired.

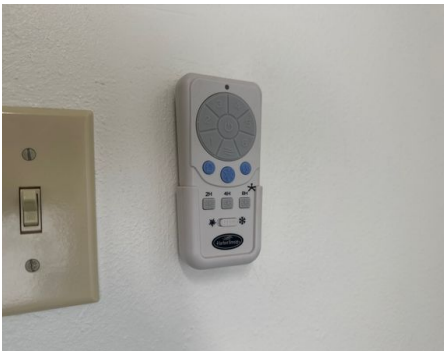
Ceiling Fans: Remote Monitor

The ceiling fan is functional. The fan uses a remote control to operate the unit. Recommend confirming the remote is in the home at the final walk-through inspection.

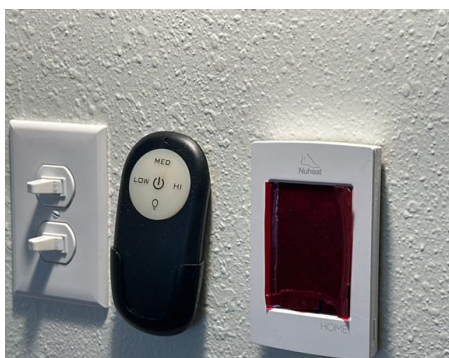
Ceiling Fans: Remote Monitor

The ceiling fan is functional. The fan uses a remote control to operate the unit. Recommend confirming the remote is in the home at the final walk-through inspection.

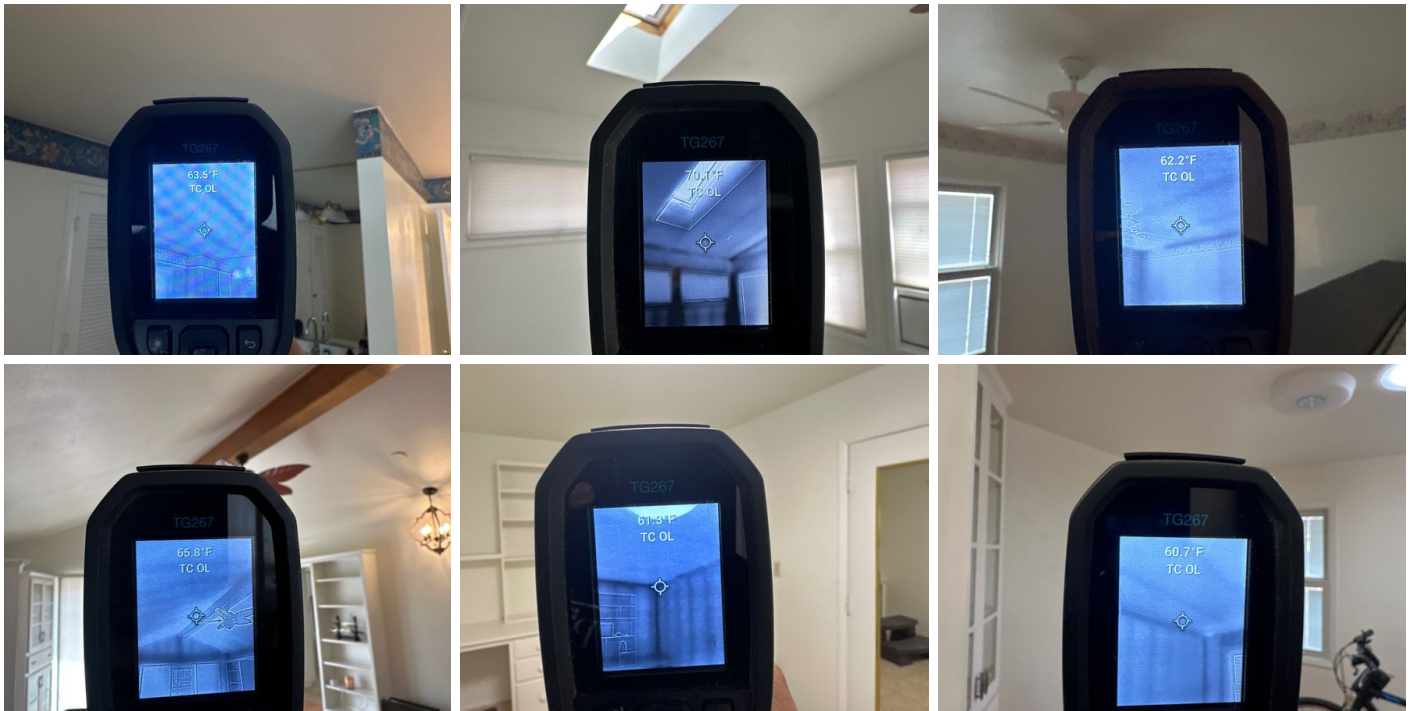
Thermography Scan: Infrared/Good

An Infrared Scan was performed at the time of the inspection. No conditions requiring repair were observed.

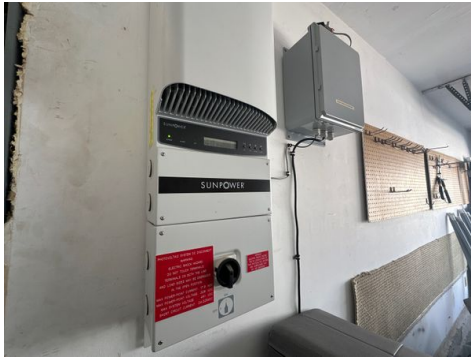
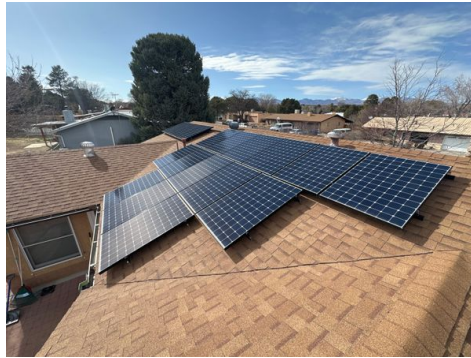
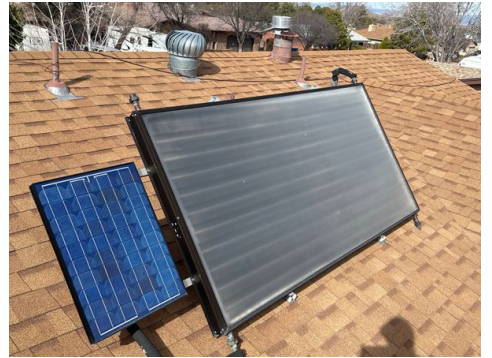
SOLAR (ROOF)

The home is equipped with a solar electrical and heating system. The system is a roof mount installation. The testing of this type of system is beyond the scope of a home inspection and was not operated.
