Upper Clark Fork Slicken Assessment Report

July 2020

Slicken Assessment Report

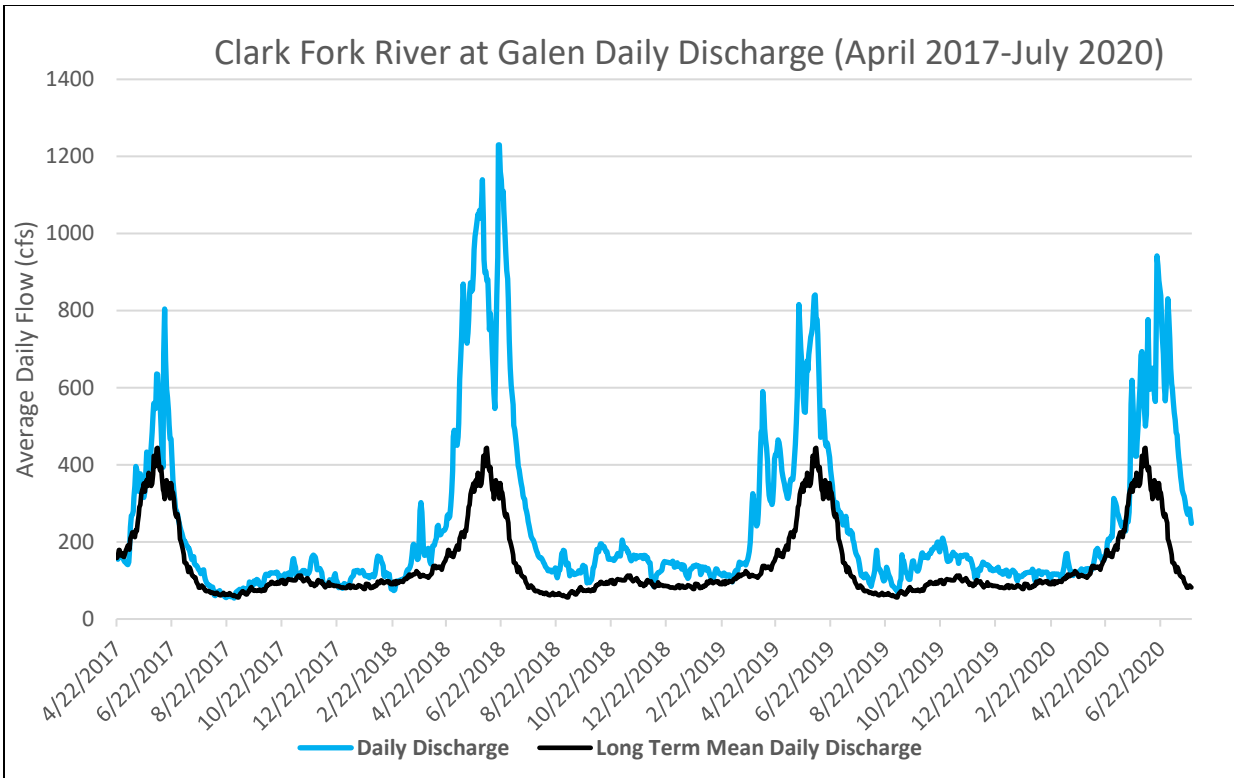
Figure 2. Median daily streamflow values for the USGS stream gage station Clark Fork River at Galen (2017-present). Note the large number of days flows exceeded the long term median daily value (i.e. the blue line is higher than the black line). Beginning in 2017, the Clark Fork River gage at Galen has seen annual peak flows well over the long term average of 460 cubic feet per second (cfs).
