# What Happened on I95?

June 19, 2023

Brian L. Bullock, Founder Road Aware Safety Systems LLC

## Tanker Fire Causes I95 Collapse

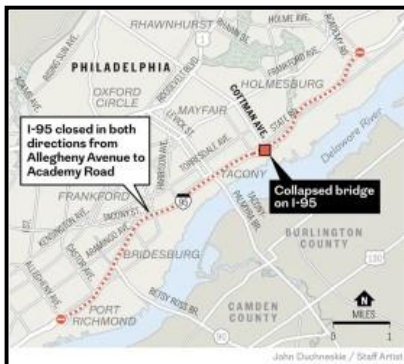
[A section of I-95 in Philadelphia has collapsed after a tanker truck fire : NPR](#)

A section of Interstate 95 in Philadelphia collapsed Sunday morning following a large tanker truck fire under the highway, city officials said.

The proximate cause was a tanker truck fire that ignited on Cottman Avenue where it passes beneath the I95 roadway. The intensity and duration of the fire weakened the steel supporting beams for the overpass to the point that they could no longer support the northbound portion of the roadway.
