STANDARD PROPERTY & TIMBER PEST REPORT

Report number: **1637784963172**
Inspection date: **25-11-2021**
Client: **Sample**
Property address: **Sample Street, Gold coast**

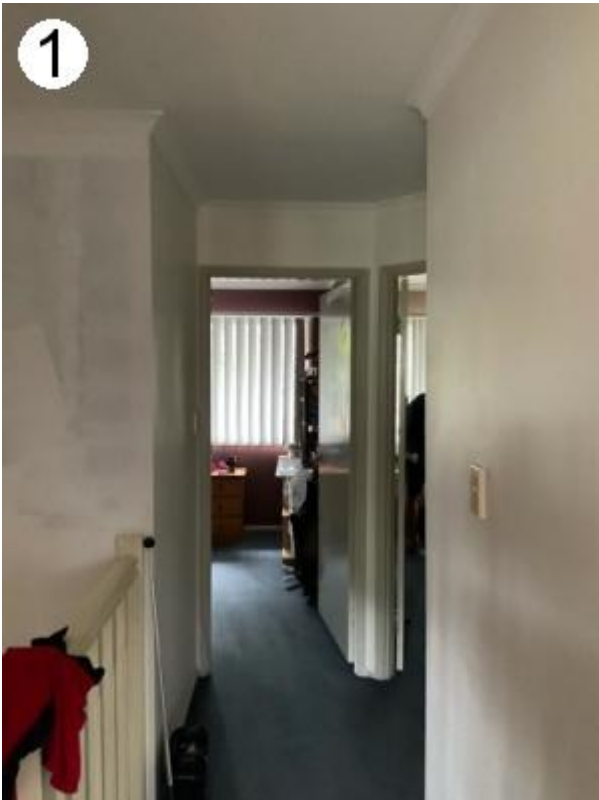
#1. Showing example of the floor, wall and ceiling coverings

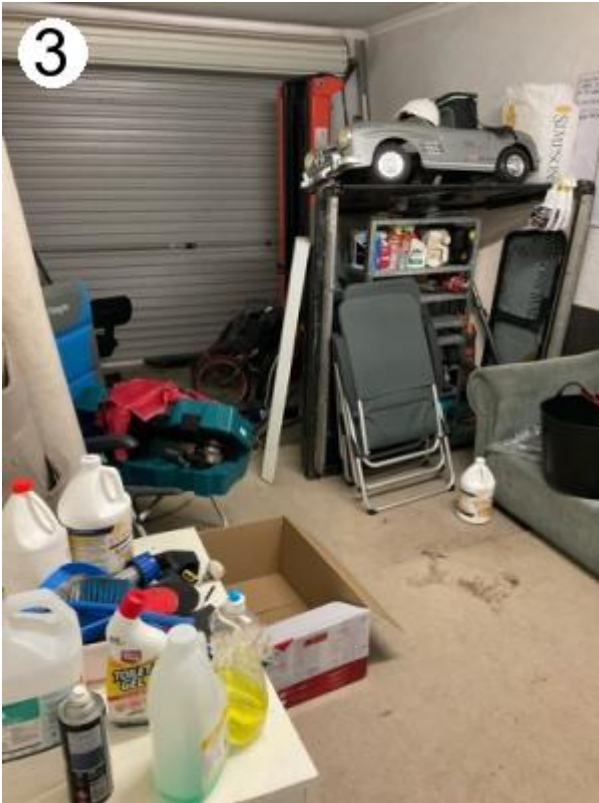
#3. Showing example of stored items

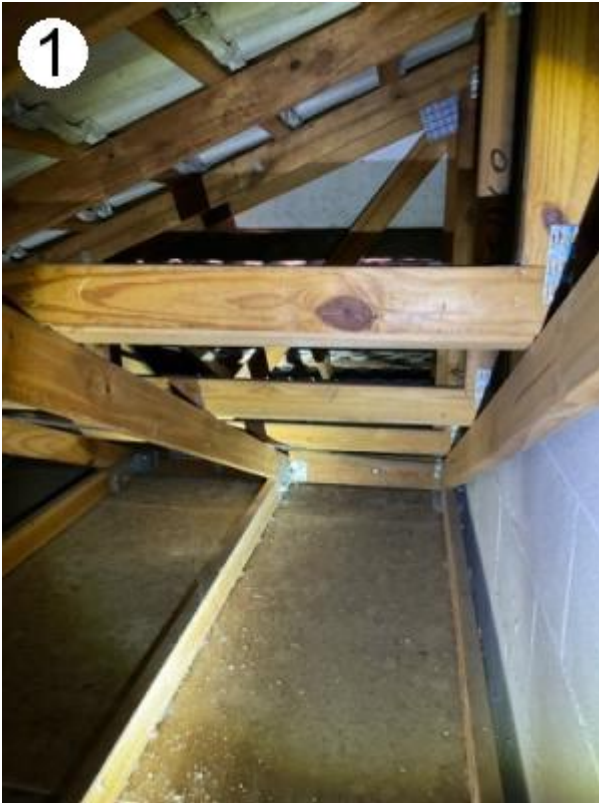
In inspecting the roof space, there was no inspection of the roof interior where the area of accessibility was less than 600 mm high x 600 mm wide

#1. Showing example of roof space height restrictions

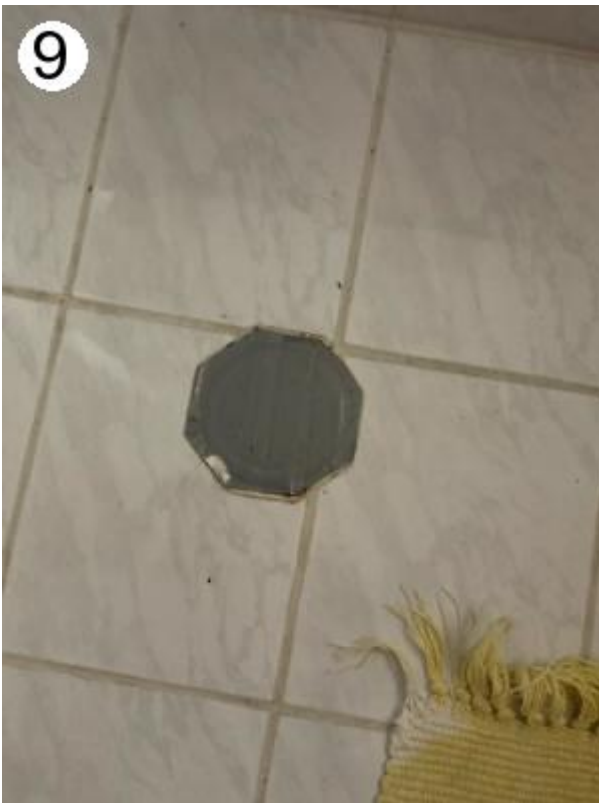
#9. Showing the floor waste
