Serenity Home Inspections LLC

Property Inspection Report

123 Your New Home Lane, Atlanta GA 30360

Date of Inspection: 1/20/2016

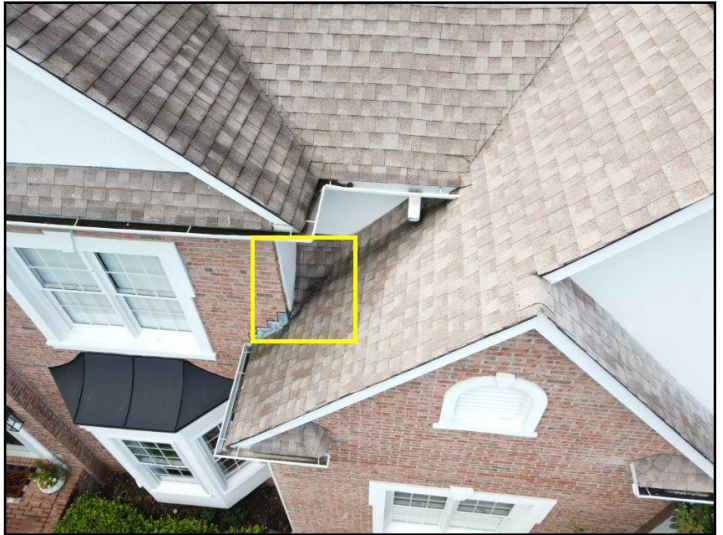
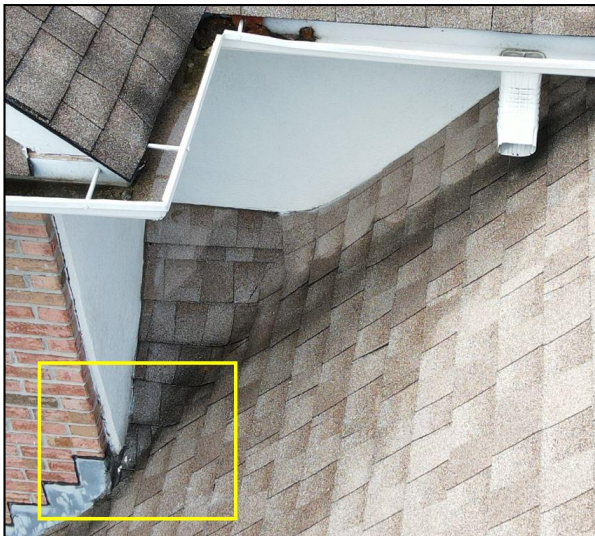
1.4. Area of roof line on right side of bay window where garage roof meets main home will have a higher potential for water intrusion due to configuration/pitch. Monitor

Area of roof line on right side of bay window where garage roof meets main home will have a higher potential for water intrusion due to configuration/pitch. Monitor

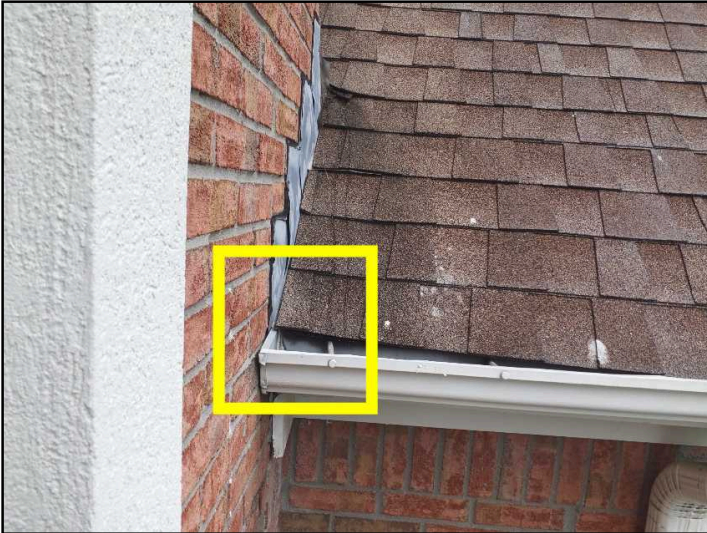
2.3. Missing kick out flashing noted at locations around the home. Kick out flashing is used to divert

Missing kick out flashing noted at locations around the home.

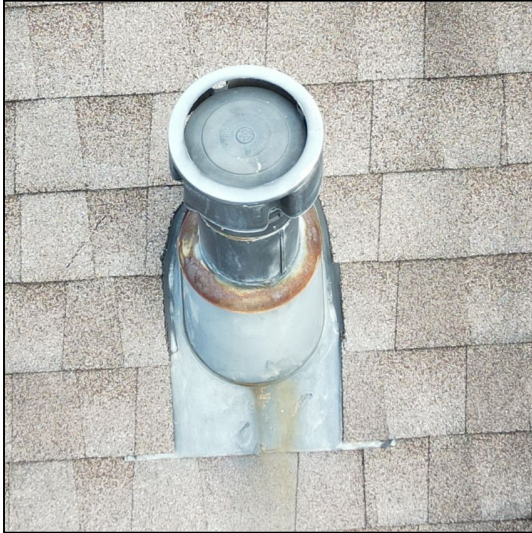
2.5. Roof exhaust vents are rusted. We recommend a review for repair or replacement as necessary by a qualified roofer.

Roof exhaust vents are rusted. We recommend a review for repair or replacement as necessary by a qualified roofer.

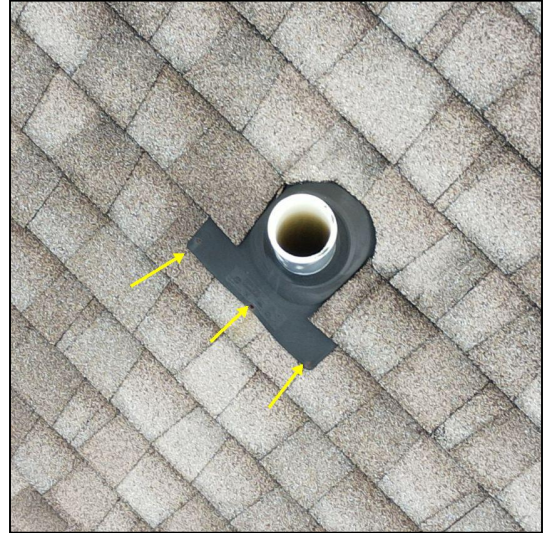
2.6. Exposed fastener heads noted at the roof penetration flashing. All fastener heads should be sealed to prevent rust/water intrusion.

Exposed fastener heads noted at the roof penetration flashing. All fastener heads should be sealed to prevent rust/water intrusion.

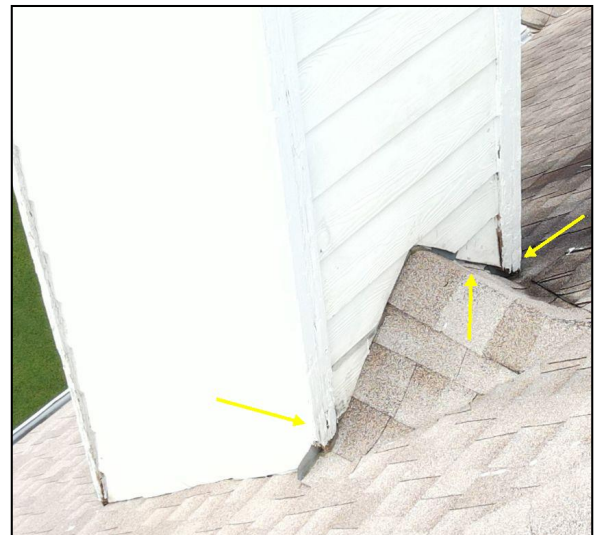
1.1. Water damage is noted on the siding and trim around the chimney. Repair or replacement needed.

Water damage is noted on the siding and trim around the chimney. Repair or replacement needed.

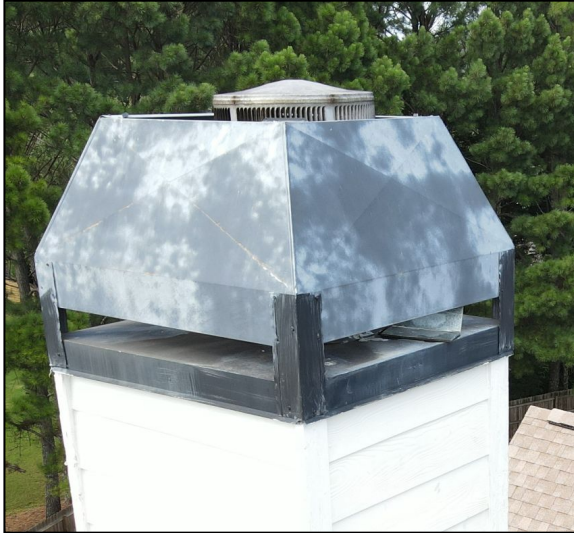
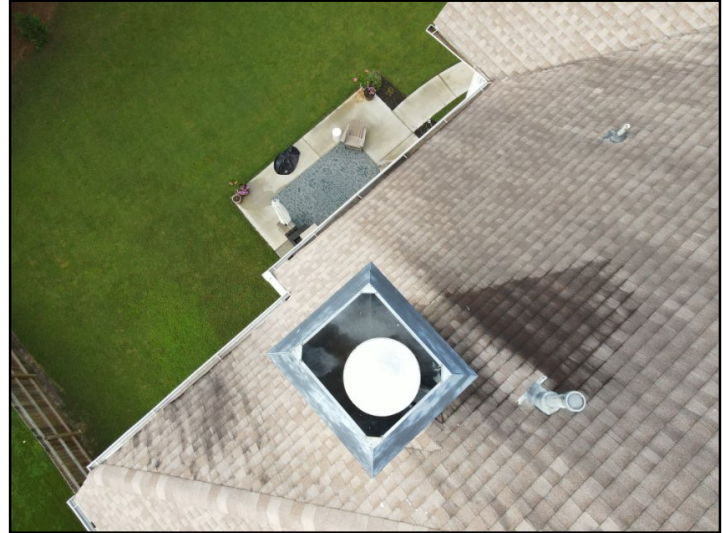
4.1. Minor rust stains are noted at the metal cap at the top of the chimney. We recommend evaluation by a qualified contractor for possible repair to extend its life expectancy and prevent rain intrusion.

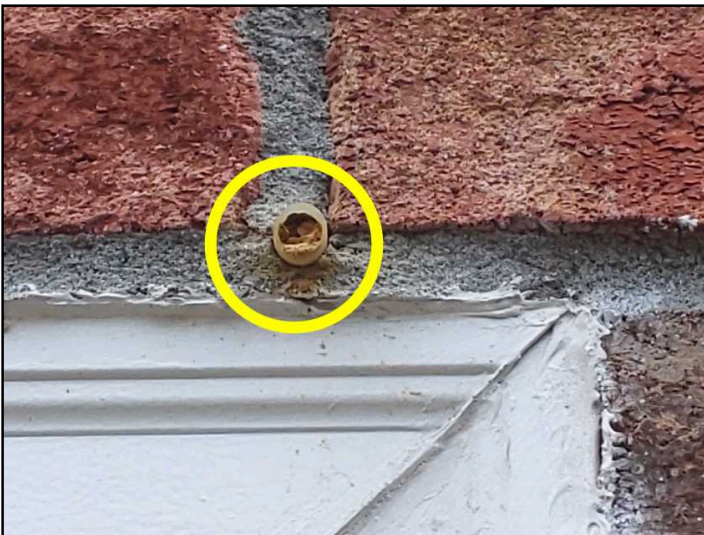
2.6. Drainage weep channels in exterior brick are clogged or missingsporadic around home. Have qualified contractor correct for proper drainage and to prevent brick from cracking.

Drainage weep channels in exterior brick are clogged or missingsporadic around home. Have qualified contractor correct for proper drainage and to prevent brick from cracking.

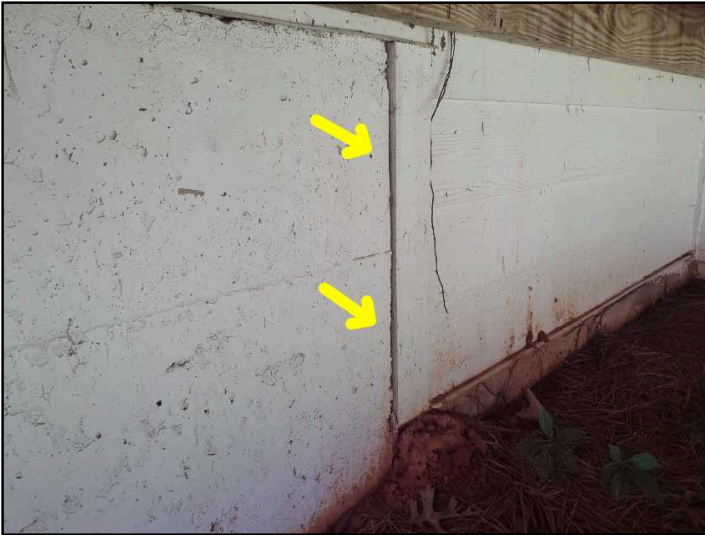
Seal vertical trim where it meets the siding and where it meets the foundation around the home to prevent water penetration or damage to the sheathing behind the siding.

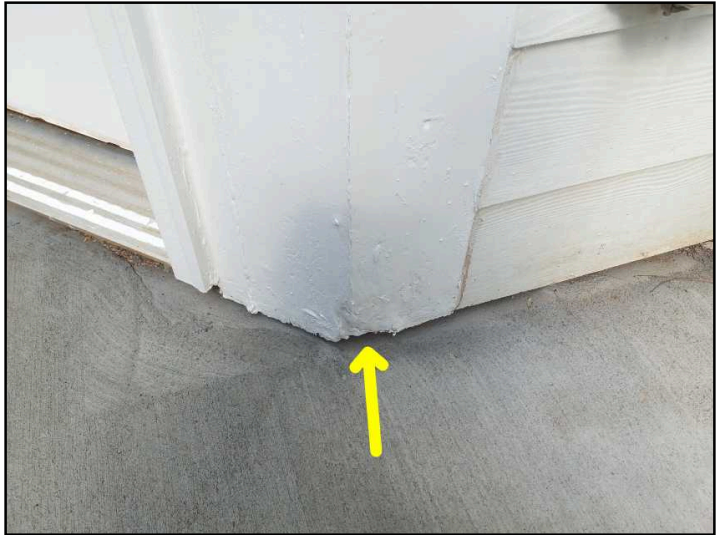
3.3. Evidence of repairs were observed to several areas of the wood trim around the home. Any patched areas of wood should be maintained with caulking and paint. We cannot verify the adequacy or integrity of repairs once they are made. We recommend investigating the history of any repairs including the need for repairs and to the extent in which repairs are needed.

Evidence of repairs were observed to several areas of the wood trim around the home. Any patched areas of wood should be maintained with caulking and paint. We cannot verify the adequacy or integrity of repairs once they are made. We recommend investigating the history of any repairs including the need for repairs and to the extent in which repairs are needed.

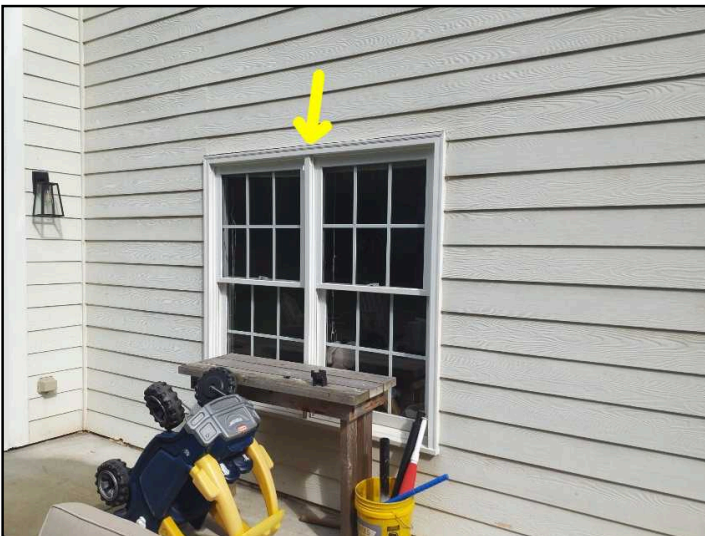
Page 18 Item: 3	Trim Conditions	3.4. Flashing issues sporadic around exterior of home where trim of all penetrations protrudes beyond edge of flashing above which may allow rain intrusion into wall cavities. further evaluation needed for correction
Page 21 Item: 5	Window/Frame Conditions	5.5. Multiple windows are stuck shut sporadic in home. Break seal and ensure operation. Stuck windows in a bedroom can prevent emergency egress in case of fire.

3.4. Flashing issues sporadic around exterior of home where trim of all penetrations protrudes beyond edge of flashing above which may allow rain intrusion into wall cavities. further evaluation needed for correction

Flashing issues sporadic around exterior of home where trim of all penetrations protrudes beyond edge of flashing above which may allow rain intrusion into wall cavities. further evaluation needed for correction

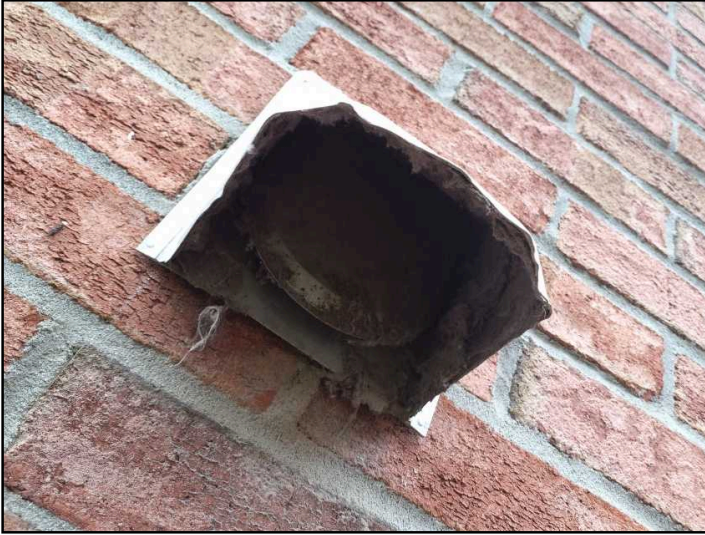
Dryer vent should be cleaned

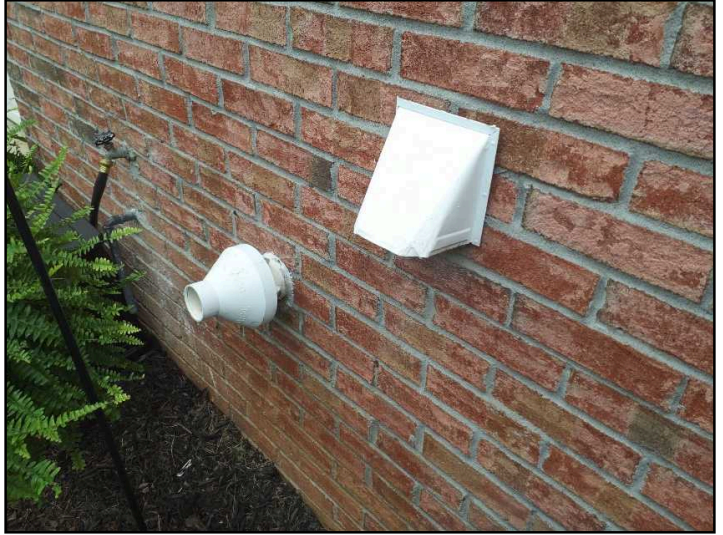
4.4. High efficiency furnace exhaust intake on right side of home should not be in close proximity to dryer exhaust vent. recommend further evaluation by qualified HVAC technician

High efficiency furnace exhaust intake on right side of home should not be in close proximity to dryer exhaust vent. recommend further evaluation by qualified HVAC technician

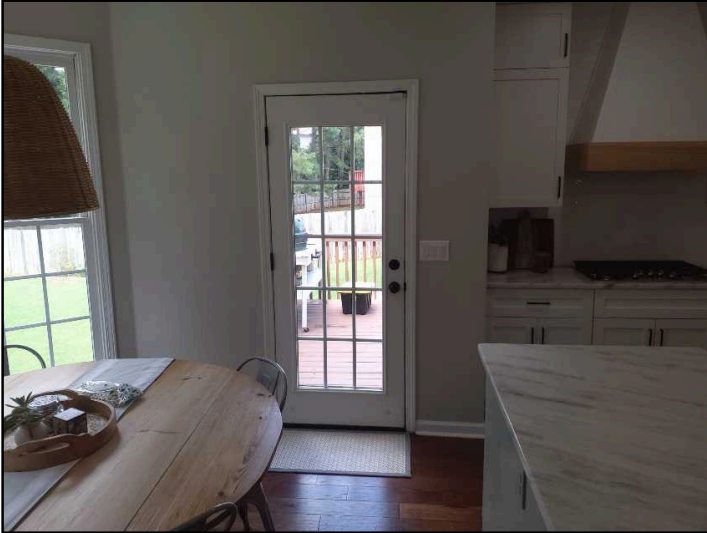
6.3. Back deck and basement exterior doors are misaligned making operation more difficult. Recommend correction

Back deck exterior door is misaligned making operation more difficult. Recommend correction

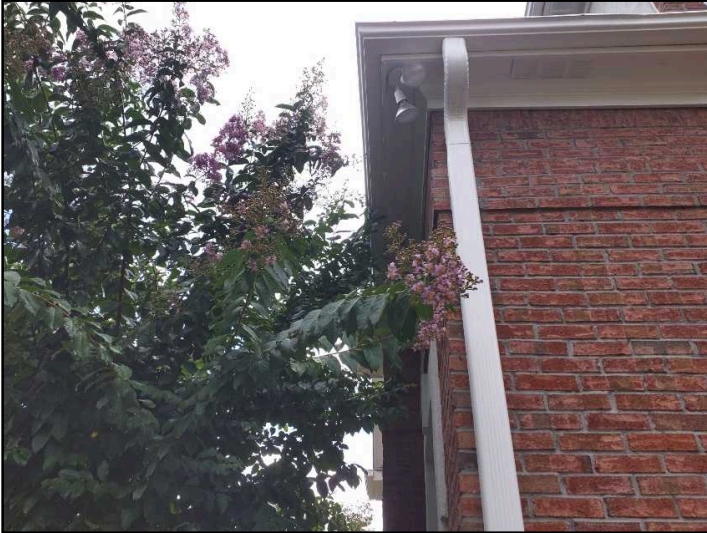
Suggest trimming back exterior vegetation from the siding and trim for proper clearance and ventilation.

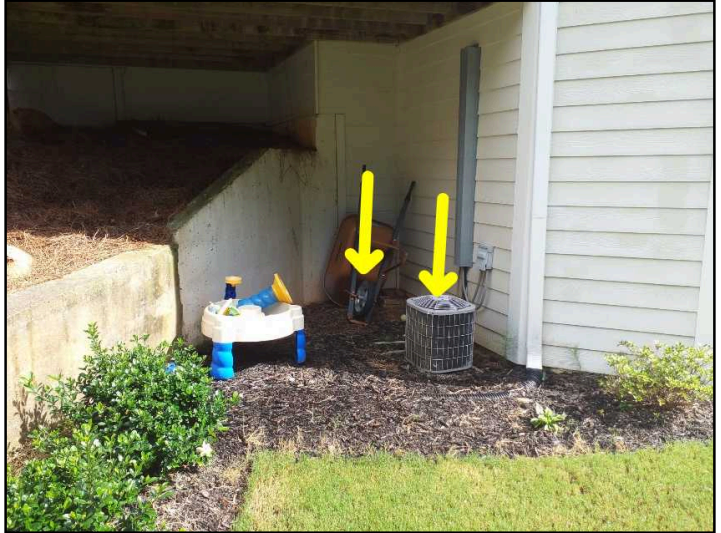
Page 22 Item: 7	Exterior Grading	7.4. The soil at the back right corner below the deck appears to be incorrectly sloped and should be repaired. It is recommended that a landscape contractor make a further evaluation and correct to prevent water from collecting against the foundation walls to prevent possible water entry.
Page 25 Item: 11	Fences/Retaining Wall Conditions	11.5. The retaining wall is leaning outward along the top below the back deck. Have a landscape contractor correct and repair as needed.

7.4. The soil at the back right corner below the deck appears to be incorrectly sloped and should be repaired. It is recommended that a landscape contractor make a further evaluation and correct to prevent water from collecting against the foundation walls to prevent possible water entry.

The soil at the back right corner below the deck appears to be incorrectly sloped and should be repaired. It is recommended that a landscape contractor make a further evaluation and correct to prevent water from collecting against the foundation walls to prevent possible water entry.

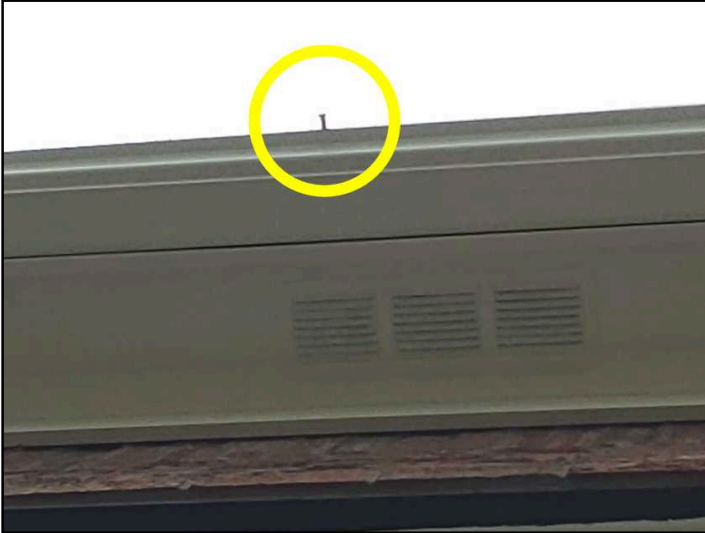
8.4. One or more areas around the home were noted where the gutters have pulled away from the fascia. The gutters should be properly secured to the home to help with proper drainage. See photographs for locations and details. Have repaired as needed.

Loose gutter pins noted sporadic around home

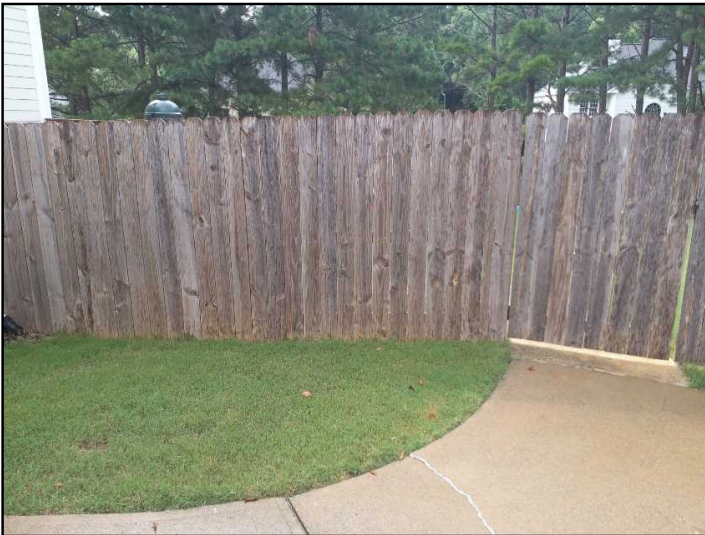
Recommend adding sealant at exterior wood fencing to extend life expectancy

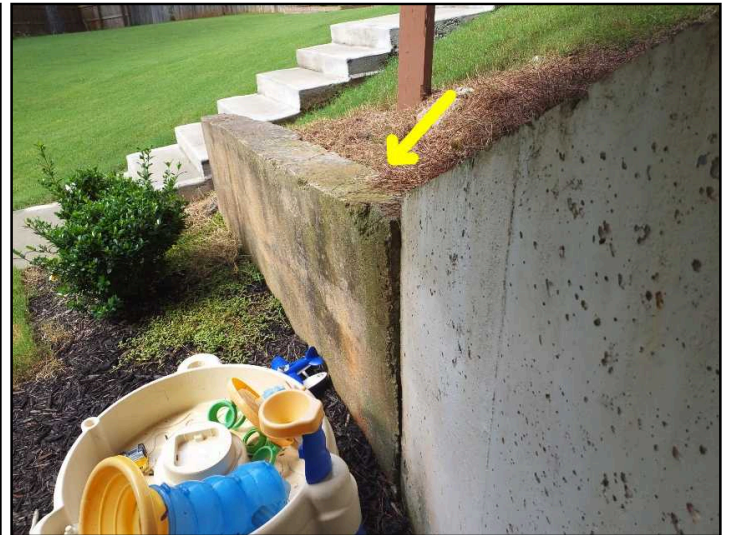
11.5. The retaining wall is leaning outward along the top below the back deck. Have a landscape contractor correct and repair as needed.

The retaining wall is leaning outward along the top below the back deck. Have a landscape contractor correct and repair as needed.

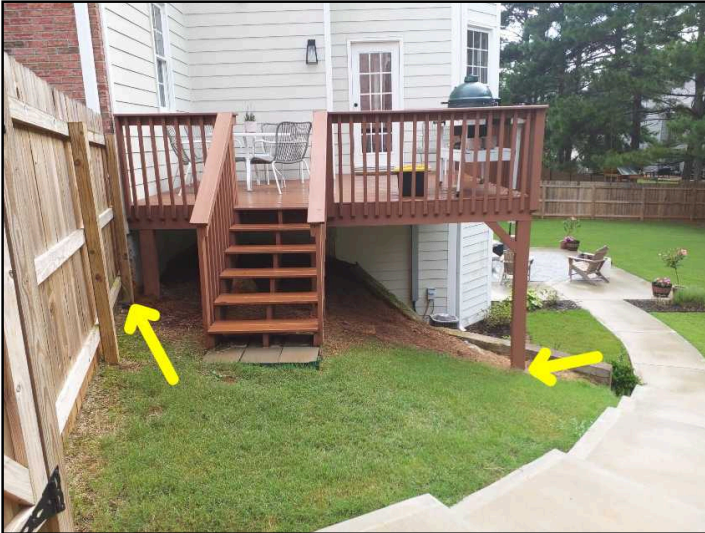
Wood deck support posts/framing should not be in direct contact with soil and will increase rate of deterioration and increase potential for movement/wood destroying organism activity

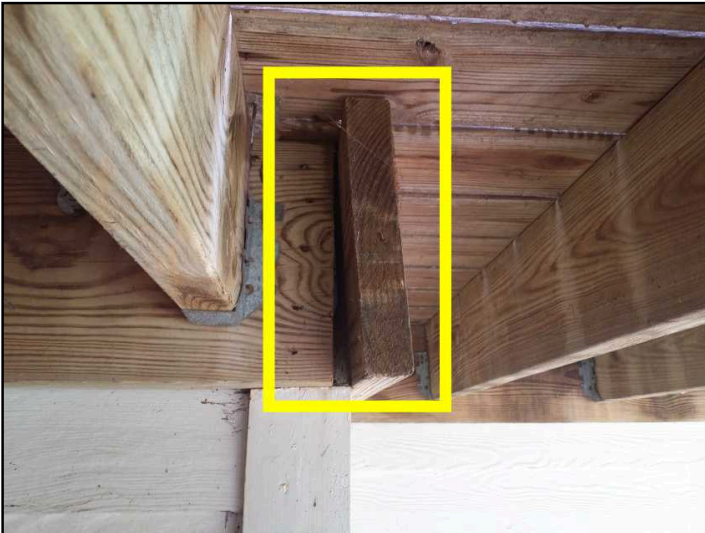
Wood deck support posts/framing should not be in direct contact with soil and will increase rate of deterioration and increase potential for movement/wood destroying organism activity

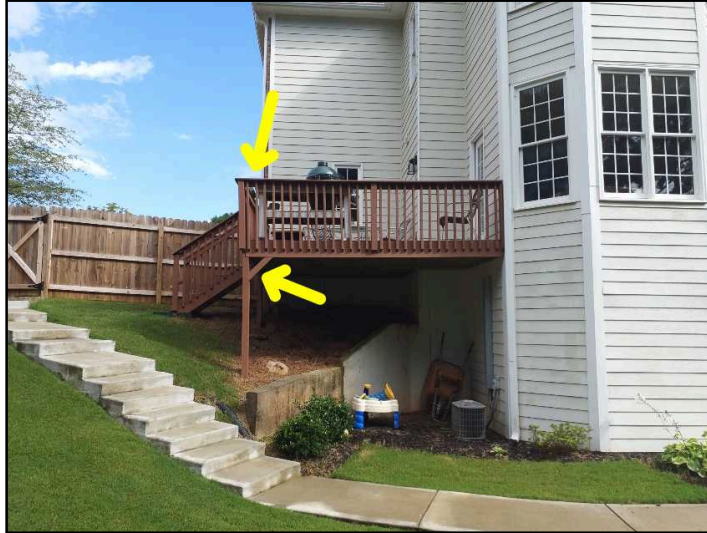
1.4. Back deck structure is visibly sagging towards outer corner with vertical posts slightly leaning below. recommend further evaluation by qualified contractor for cause and correction

It is recommended to install metal plates and fasteners to secure connections of the deck framing and the wood posts to the deck framing.

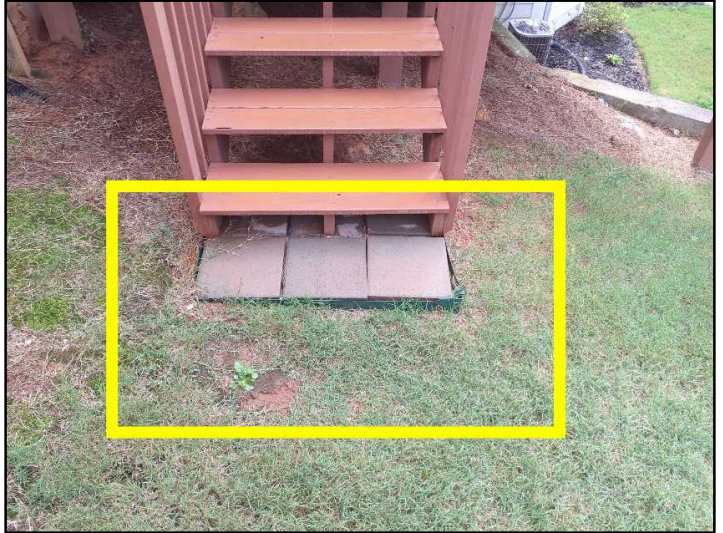
It is recommended to install a handrail at the exterior steps, whenever four or more stairs are present a handrail is usually required. See photographs for location(s).

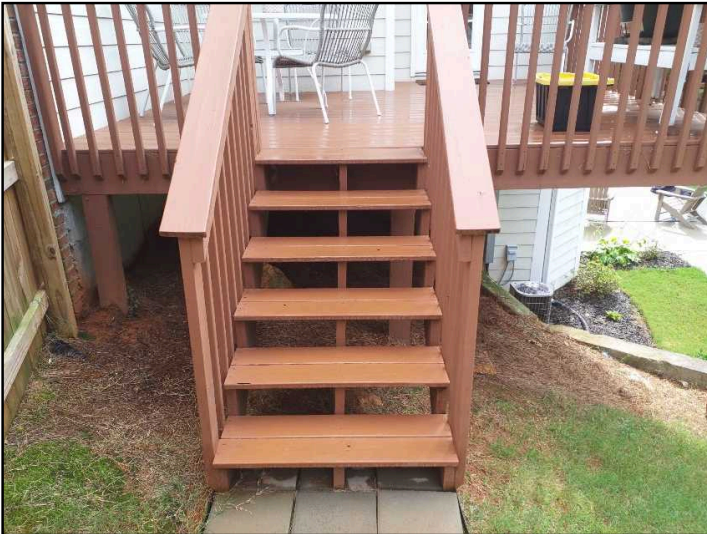
There needs to be a landing installed at the base of the rear deck steps. The landing should be at least 3' feet in the direction of travel and at least the width of the stairs.

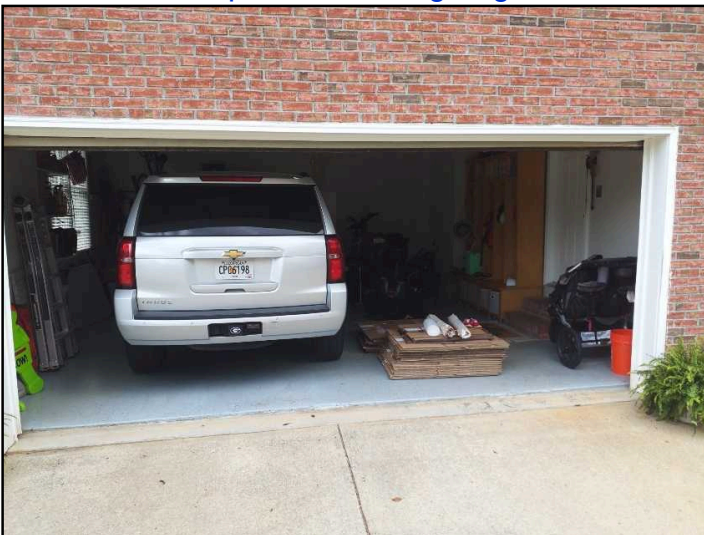
4.2. Limited inspection of the garage due to cars parked.

Vehicles noted in garage

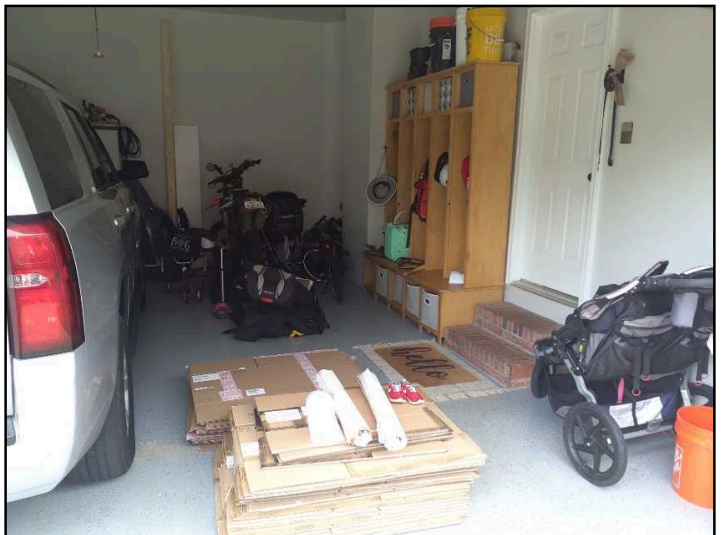
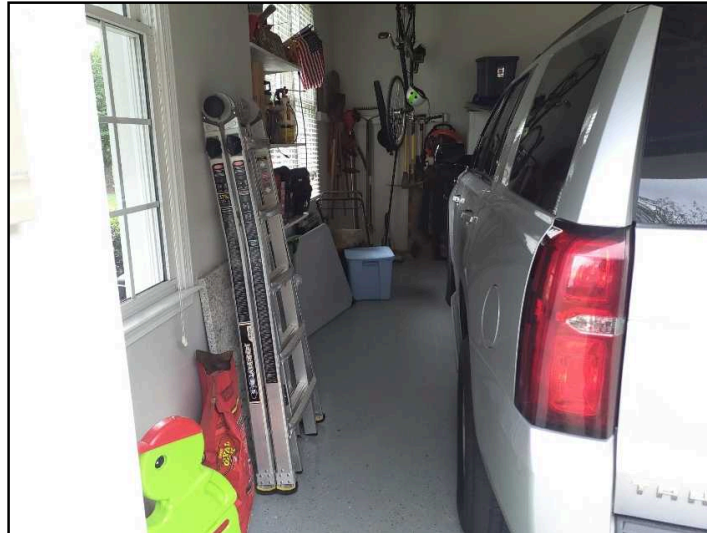
4.1. Limited inspection due to storage of personal property.

Personal storage in the garage

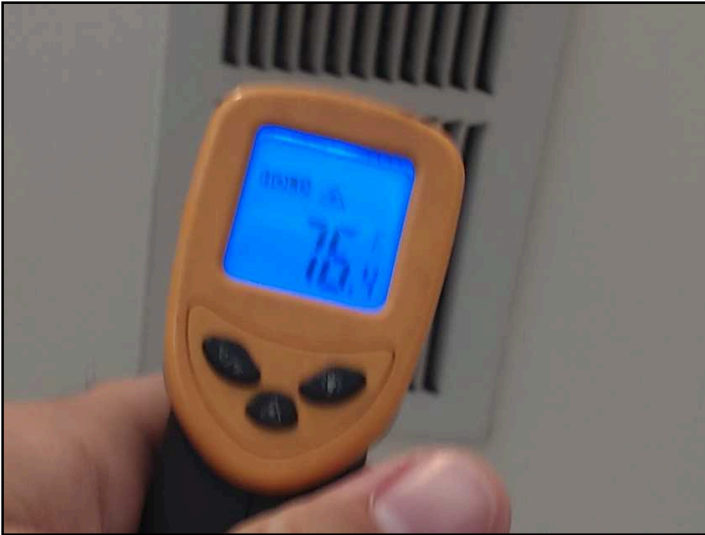
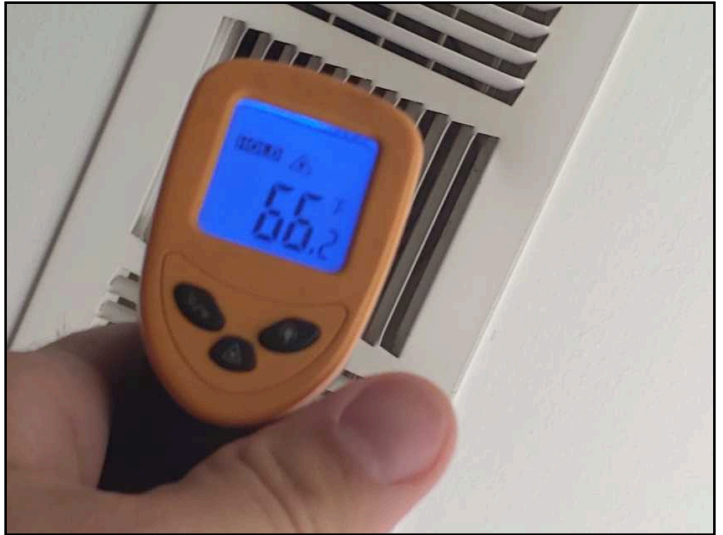
1.4. The second floor AC unit did not appear to adequately cool when tested. Less than a 12 degree temperature difference was noted, between the supply and return, with 14-22 degrees being the expected operating range. It is suggested to have the unit reviewed and serviced as needed by a licensed HVAC contractor to ensure proper operation.

The second floor AC unit did not appear to adequately cool when tested.

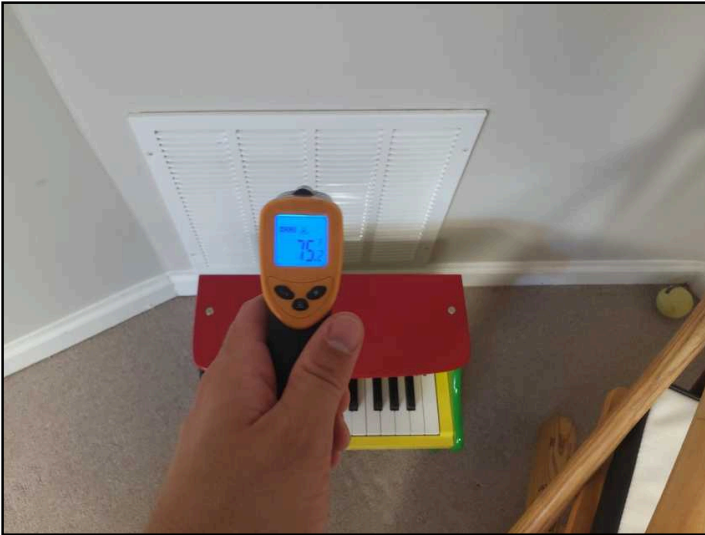
1.5. The basement level AC unit did not appear to adequately cool when tested. Less than a 12 degree temperature difference was noted, between the supply and return, with 14-22 degrees being the expected operating range. It is suggested to have the unit reviewed and serviced as needed by a licensed HVAC contractor to ensure proper operation.

The basement level AC unit did not appear to adequately cool when tested. Less than a 12 degree temperature difference was noted, between the supply and return, with 14-22 degrees being the expected operating range. It is suggested to have the unit reviewed and serviced as needed by a licensed HVAC contractor to ensure proper operation.

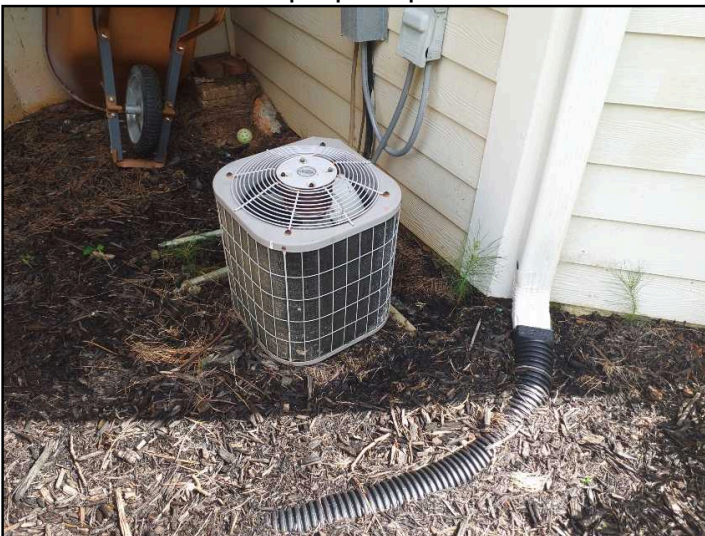
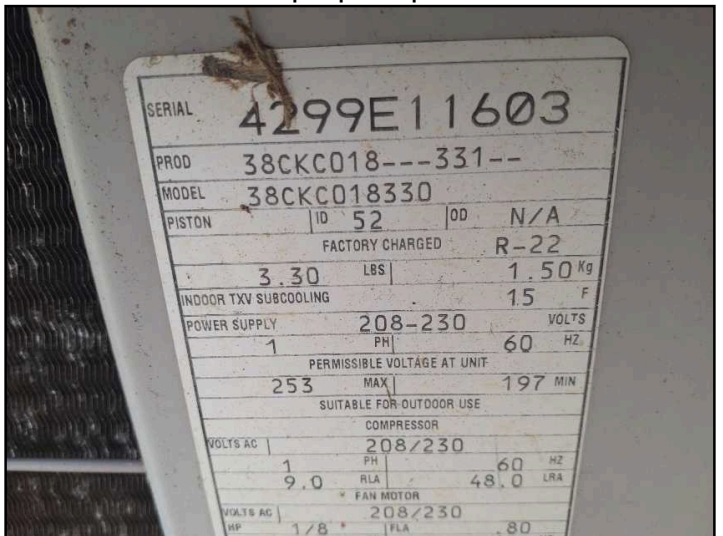
1.3. One or more components of the air-conditioning system are nearing their normal life expectancy, a service review by a licensed HVAC contractor is advised to ensure proper function of all components of the system. No guarantees can be made as to how long the unit will last.

Back right exterior AC unit carrier 1999 unit is well beyond its normal life expectancy

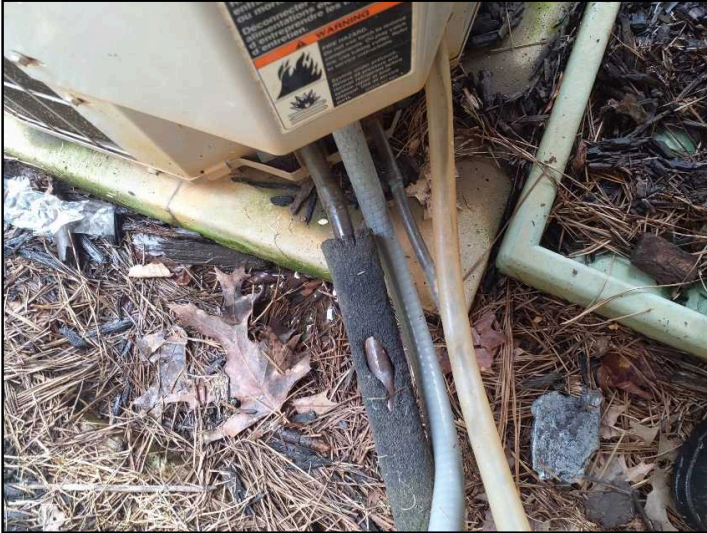
1.1. Refrigerant line insulation is damaged/missing at the outdoor ac-unit. Recommend repairs for improved performance.

Refrigerant line insulation is damaged/missing at the outdoor ac-unit. Recommend repairs for improved performance.

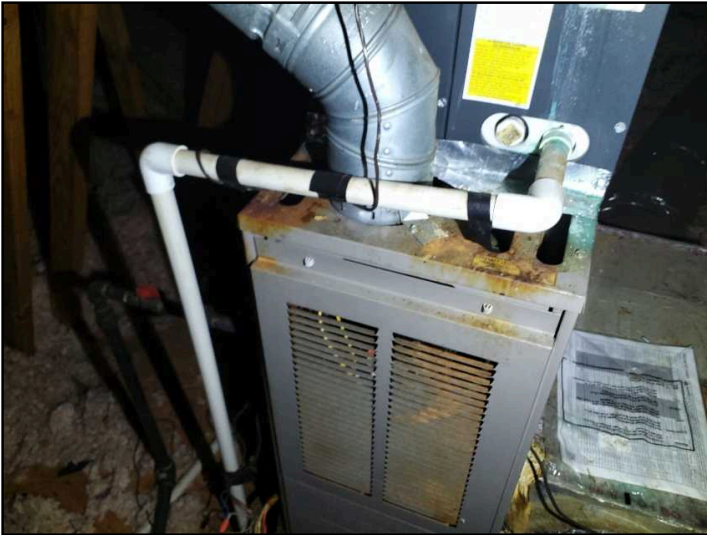
2.2. Condensation drain exiting evaporator coil is missing an access tee with a removable cap.

Condensation drain exiting evaporator coil is missing an access tee with a removable cap.

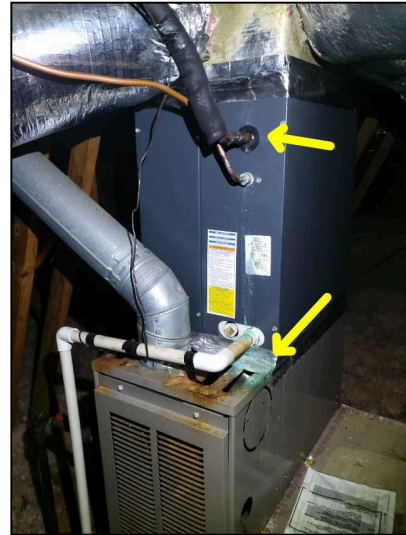
2.4. Condensation is dripping from the evaporator coil penetrations when air conditioning was tested. Recommend correction by a qualified HVAC technician.

Condensation is dripping from the evaporator coil penetrations when air conditioning was tested. Recommend correction by a qualified HVAC technician.

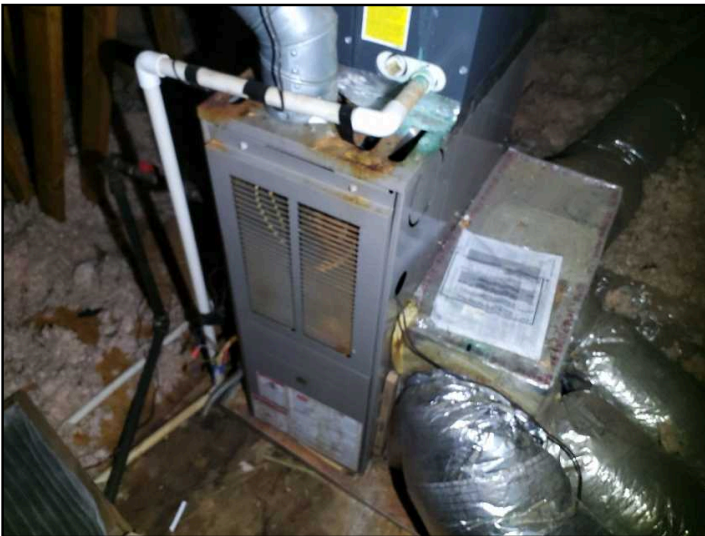
6.1. The heating system(s) is approaching its designed life expectancy. We make no warranty, guarantee or estimation as to the remaining useful life of this unit. However, proper function was noted at the time of inspection. It is suggested to have the entire HVAC system serviced to ensure proper function and prolong the service life.

Gas furnace portion of HVAC system in attic space. unit is beyond its normal life expectancy

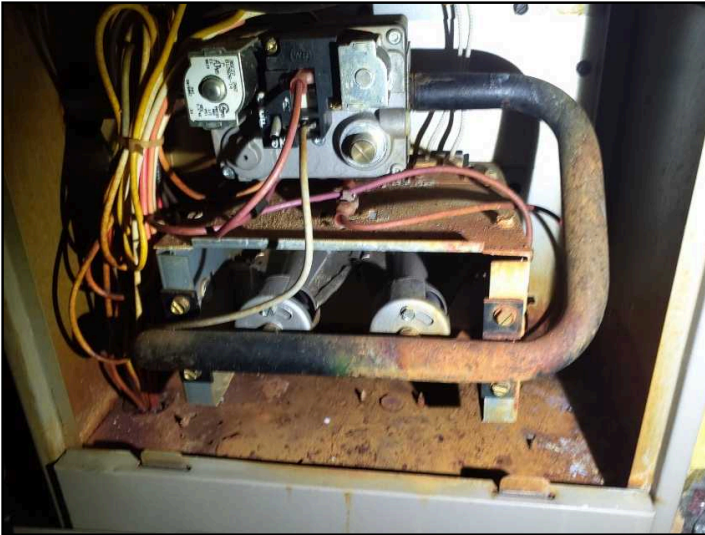
6.2. Due to presence of rust, scale, and some debris in this appliance, a service review by a licensed HVAC contractor is advised to ensure proper and safe operation of this unit. Inspection for holes and/or cracks in heat exchangers is not within the scope of this inspection and should be performed prior to closing to ensure the proper and safe operation of the system.

Rust noted on burners in furnace

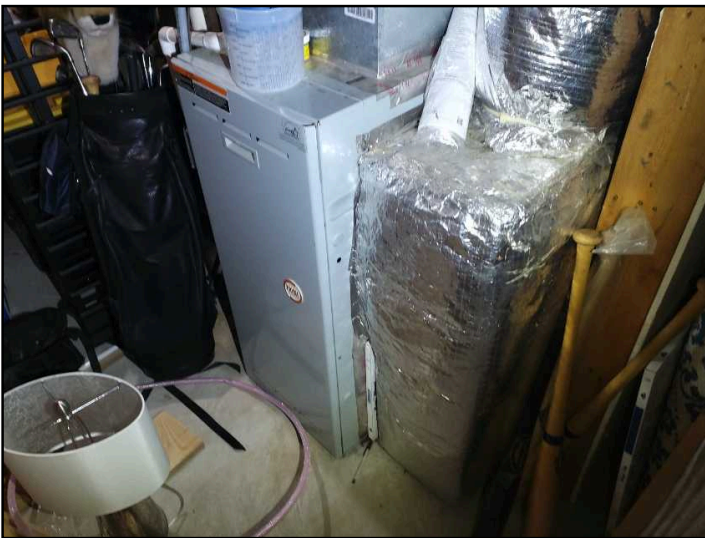
Gas furnace portion of basement HVAC system
 pain 1999 unit has reached its normal life
 expectancy

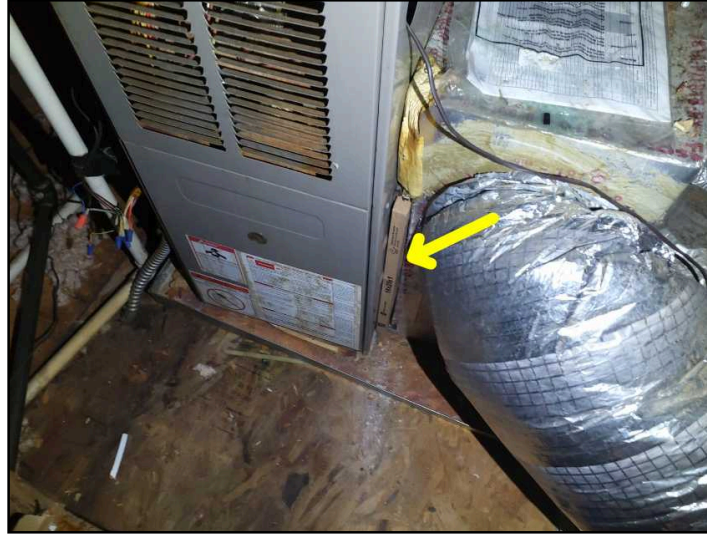
8.1. The filter cover is missing at the side of the furnace in the attic/basement. Have the cover installed to prevent from drawing unfiltered air through the furnace.

The filter cover is missing at the side of the furnace in the attic/basement. Have the cover installed to prevent from drawing unfiltered air through the furnace.

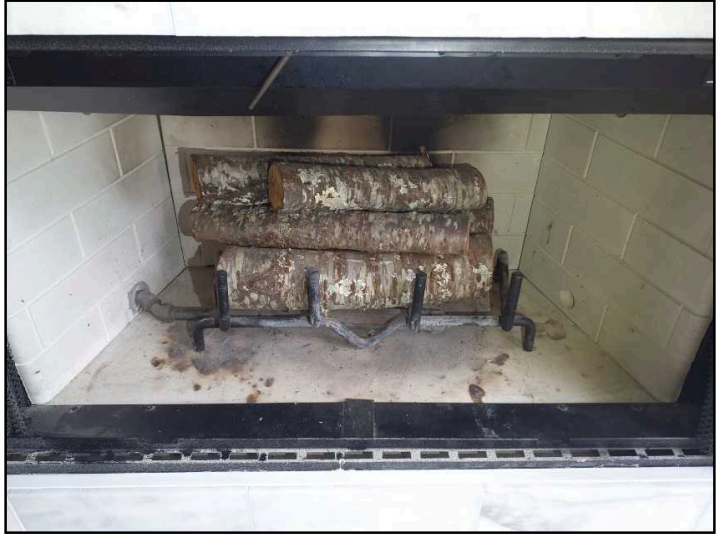
10.3. The gas appeared to be turned off at the fireplace(s) inside the home. The units are visually inspected, but not tested. It is suggested to have the gas turned on at the units and proper operation verified.

The gas line valve/pilot was shut off at the time of inspection.

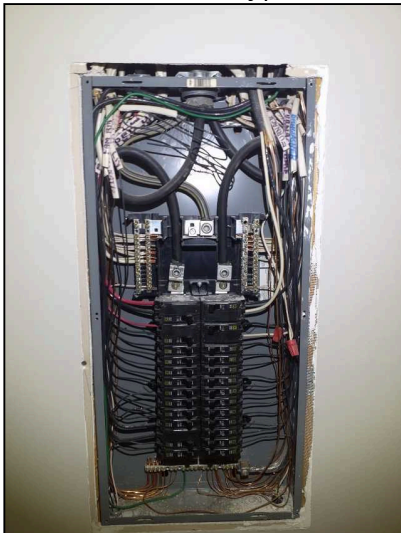
Interior of main panel

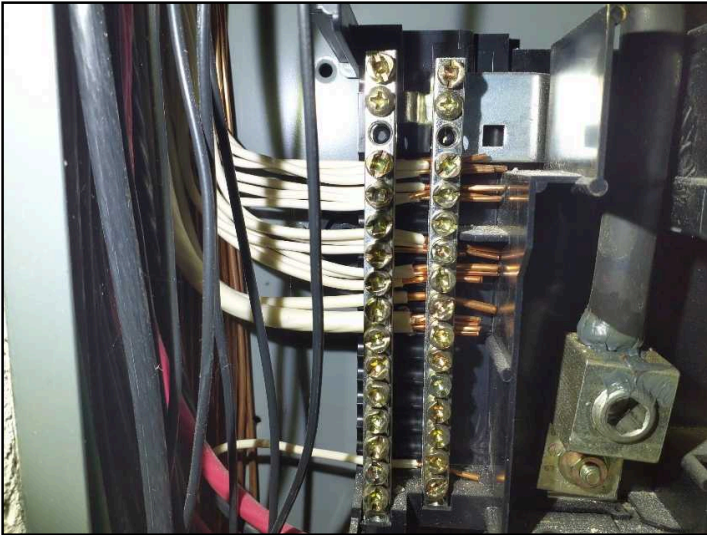
240 live white wires noted at main panel

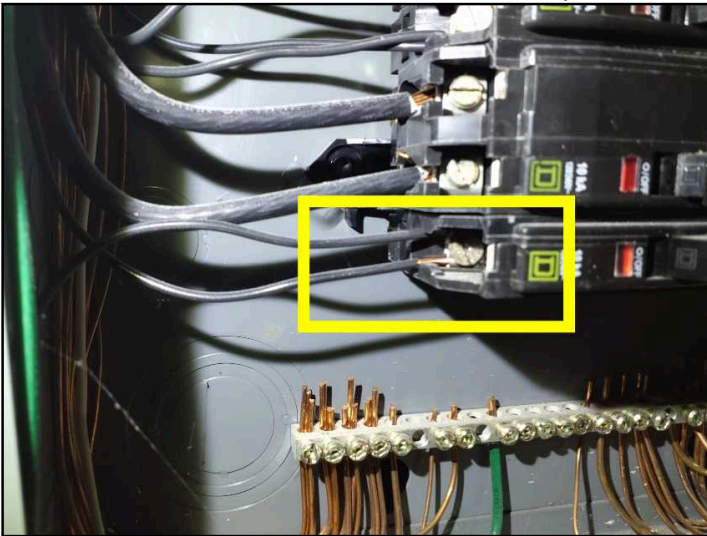
3.5. Double tapping observed at the breakers at the left side of the main panel box. This is where more than one wire is installed at a breaker point meant only for one wire. Have an electrician examine and repair.

Double tapped breakers

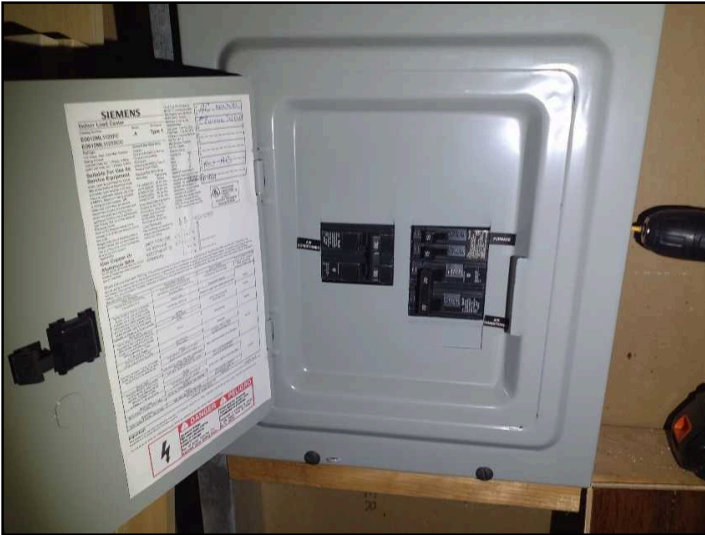
There is a sub panel located at the basement.

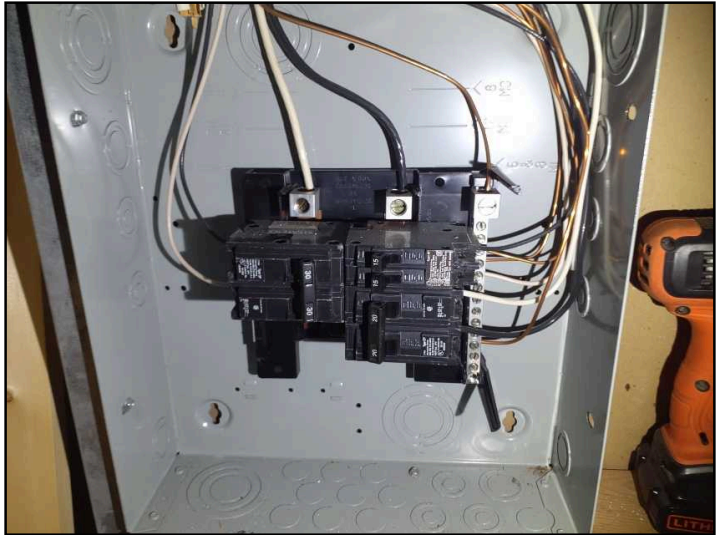
- 4.1. There is a sub panel located at the basement.
- 4.2. Labeling present on electric circuits locations in the sub panel. (These are not checked for accuracy)
- 4.3. Ground and neutral wiring in sub electrical panel should be isolated on a separate buss.
- 4.4. Multiple deficiencies uncovered at sub-electric panel in basement with improper wire gauges, improper wire installation and other deficiencies. recommend a full evaluation by qualified electrical contractor for extend of correction needed

Interior wiring at the sub panel

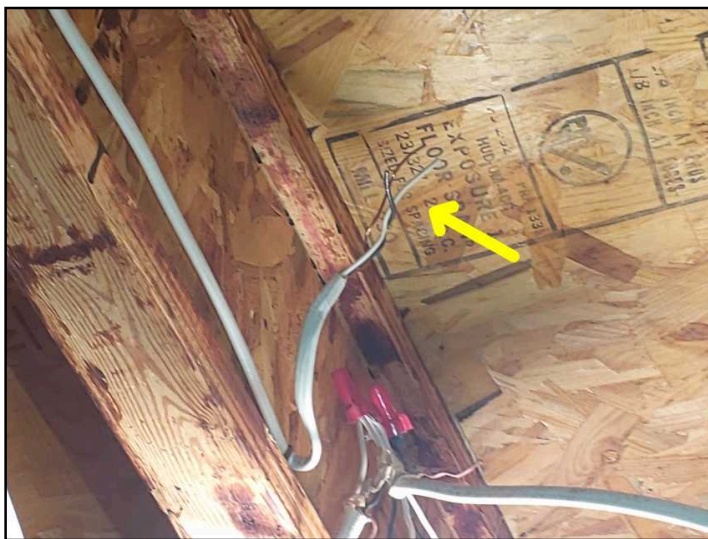
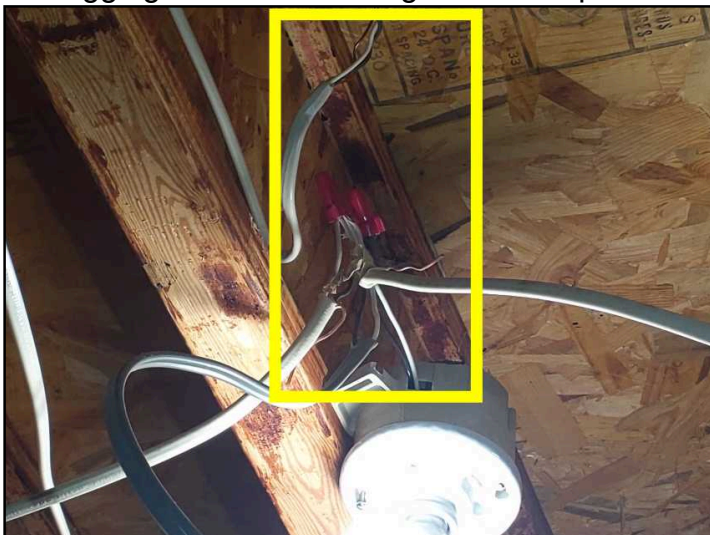
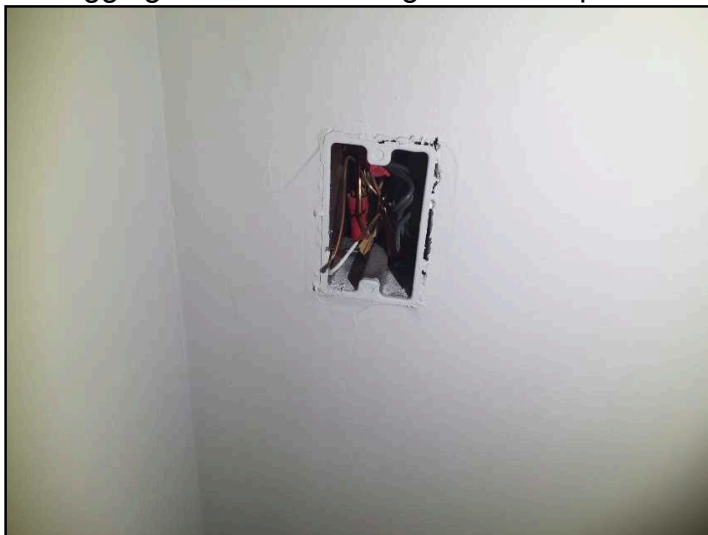
Much of the wiring appears to not be a professional installation in the basement with sagging wires and floating electrical splices.

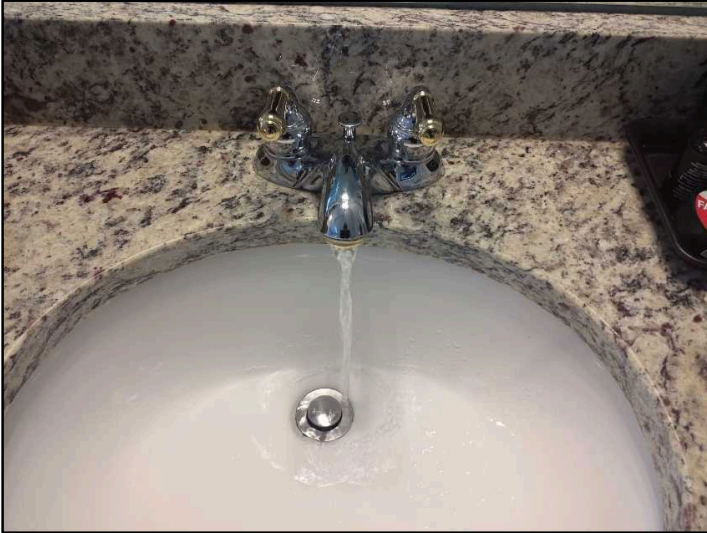
The water pressure dramatically decreases when multiple plumbing fixtures are operated simultaneously. Rec commend further evaluation by a qualified plumber for cause and correction.

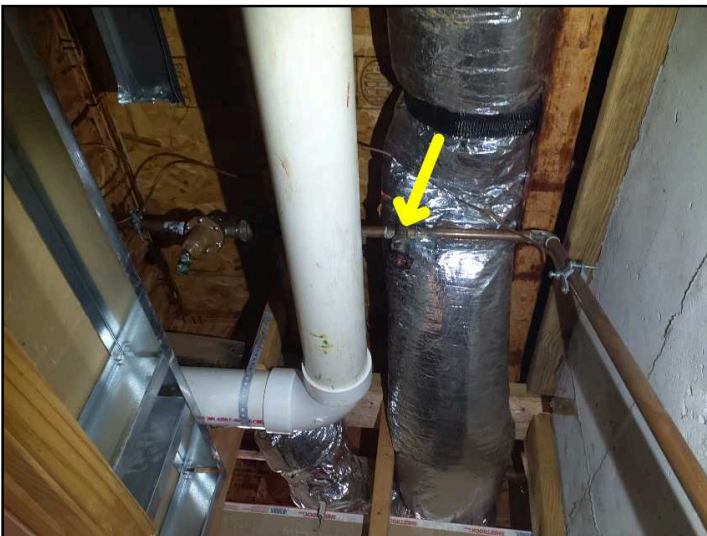
Main water shut off noted at the front basement wall

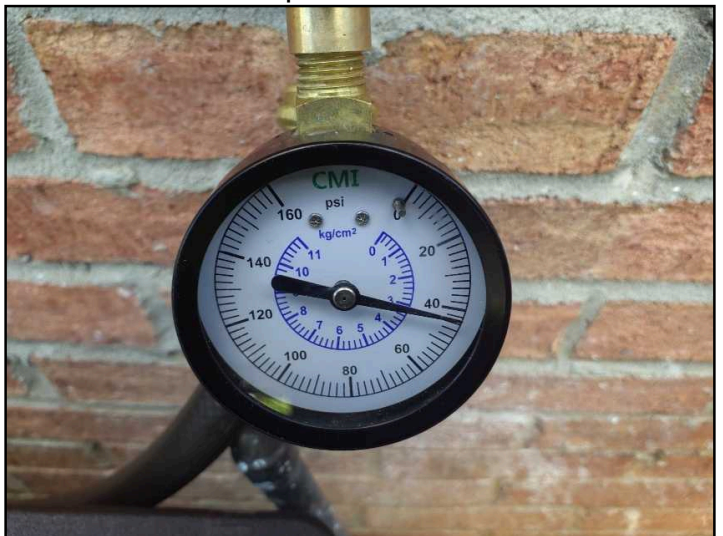
Water pressure measured 40-45 pounds per square inch (psi) at the time of the inspection. Acceptable water pressure is between 40 and 80 psi.

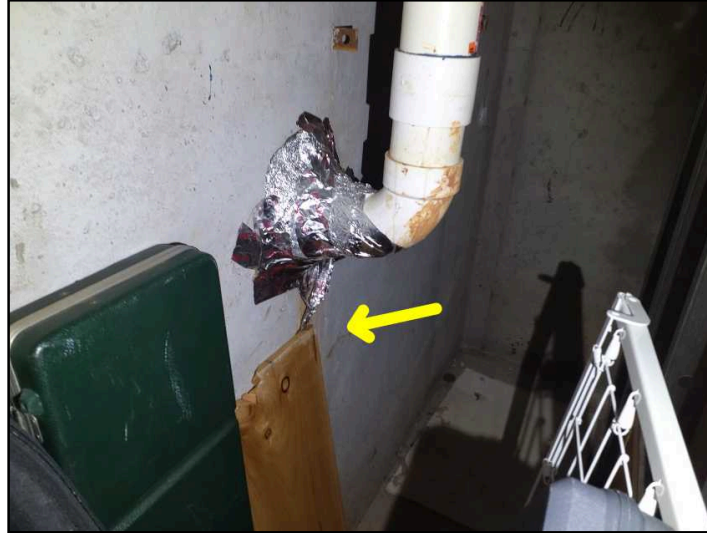
Evidence of past water intrusion noted at the wall below the main waste line penetration. The area appears to have been patched/sealed, and no moisture was noted at the time of inspection. Suggested to monitor and if further issues arise, have repaired as needed.
