Serenity Home Inspections LLC

Property Inspection Report

123 Your New Home Lane, Atlanta GA 30360

Date of Inspection: 1/20/2016

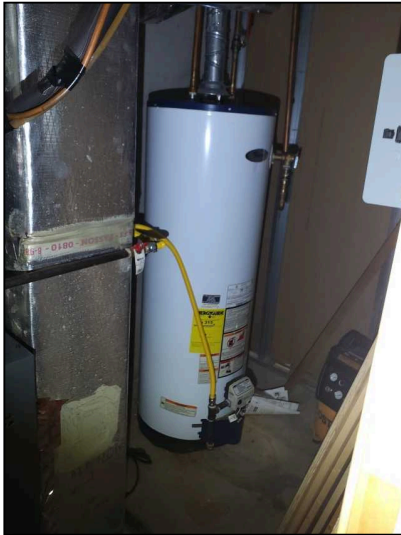
3.1. The water heater is near the end of the expected service life, and will likely need to be replaced in the future. However, it is functioning at the time of the inspection. We offer no warranty as to the expected remaining service life of the unit. Suggested having the water heater reviewed and serviced as needed to prolong the remaining life of the unit.

3.2. No overflow pan or drain line is noted under the water heater. It is recommended to install an overflow pan and drain line to prevent damage to the flooring under and around the water heater if leaks occur.

Water heater located in the basement gas
Whirlpool 50 gallon 2013

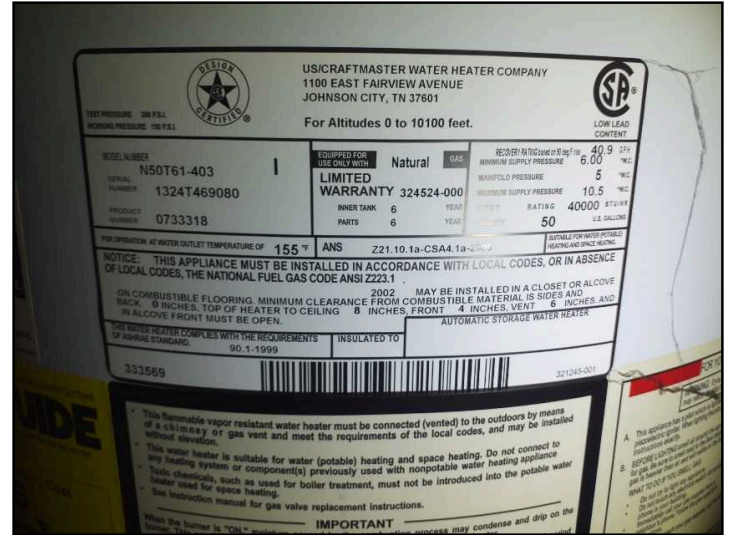
Water heater data tag

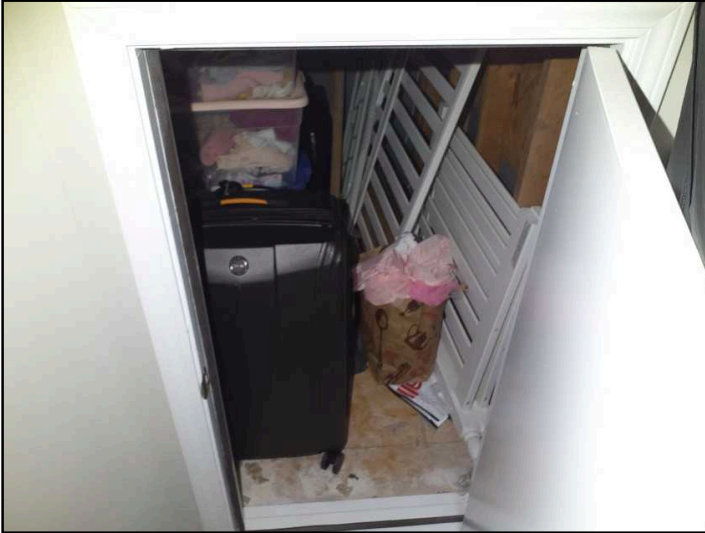
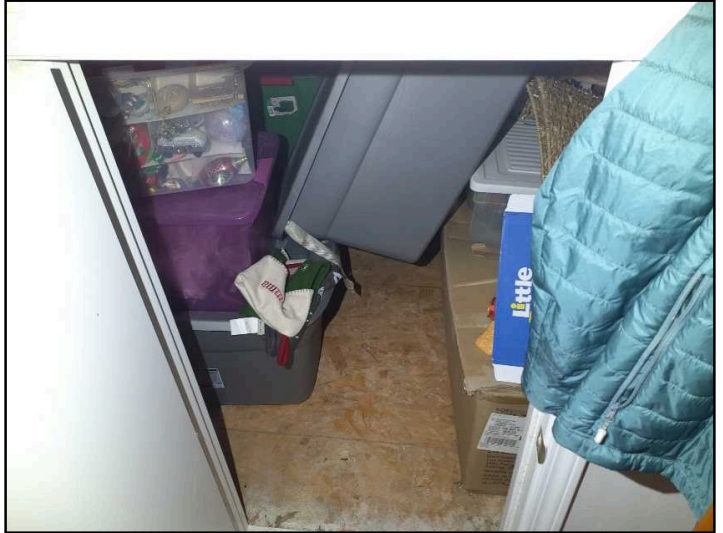
Could not fully view all areas of the attic due to storage. Areas blocked by storage are excluded from this report. Any areas of concern should be checked once the storage has been removed.

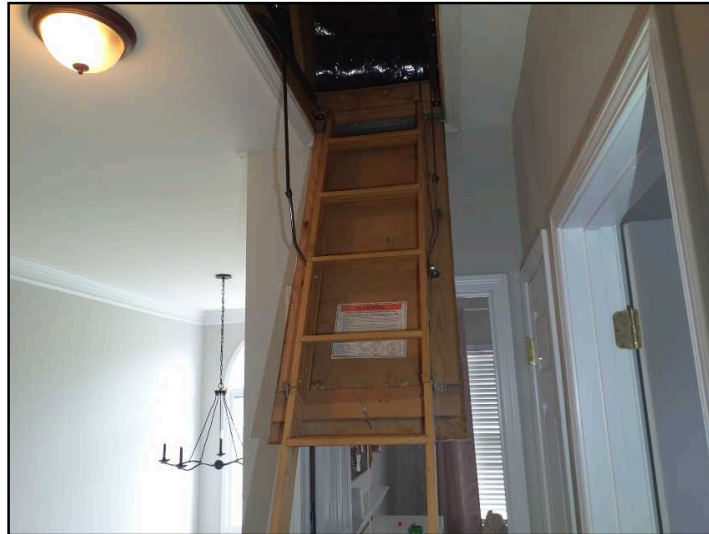
1.2. All attic access openings should be insulated and weather stripped. It is recommended to properly seal and insulate any access between conditioned spaces and the attic

Weather strip and insulate all attic access at living spaces

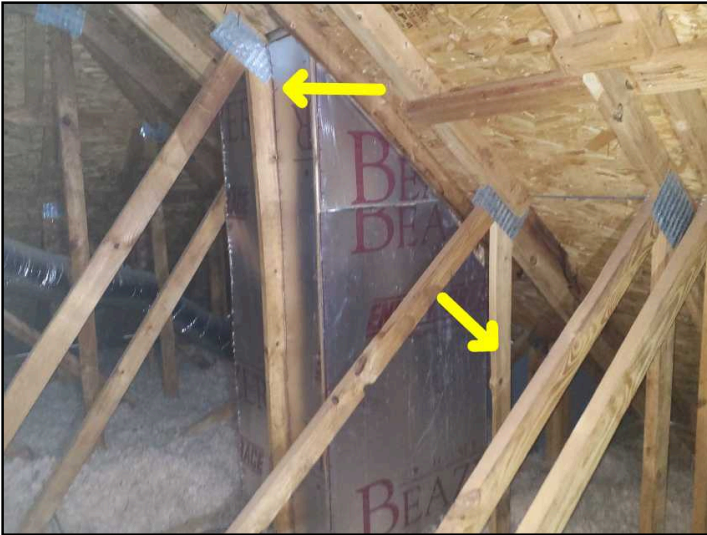
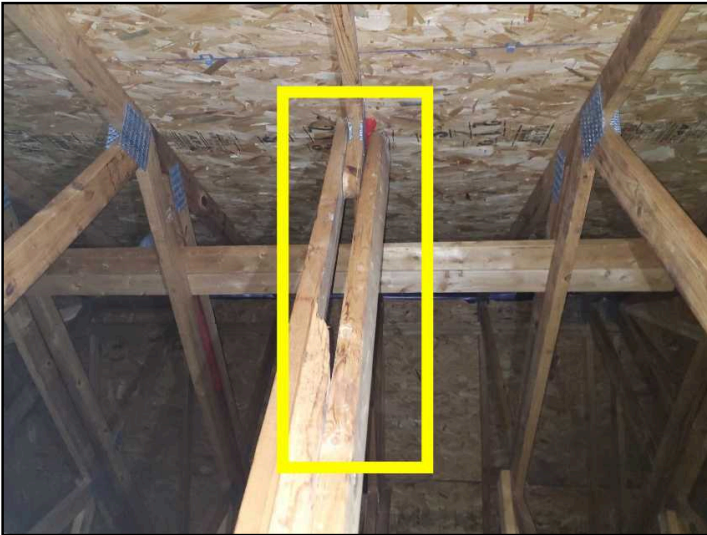
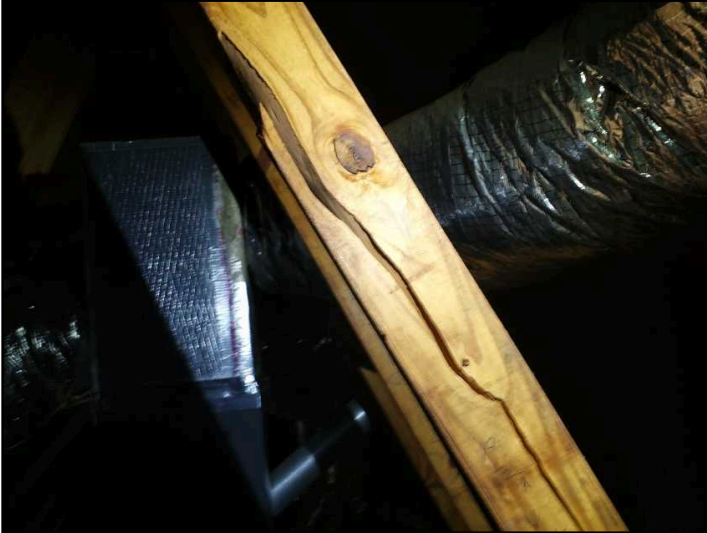
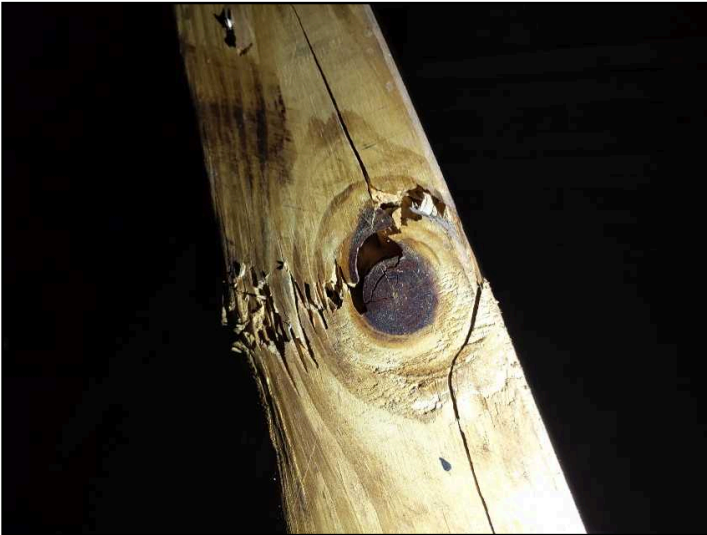
2.1. A portion of the roof truss framing system appears to have been cut or altered running through the chimney and multiple surrounding truss framing members have cracked and separated with some previous repairs beginning to separate. recommend further evaluation for cause and correction by qualified contractor or engineer

A portion of the roof truss framing system appears to have been cut or altered running through the chimney and multiple surrounding truss framing members have cracked and separated with some previous repairs beginning to separate. recommend further evaluation for cause and correction by qualified contractor or engineer

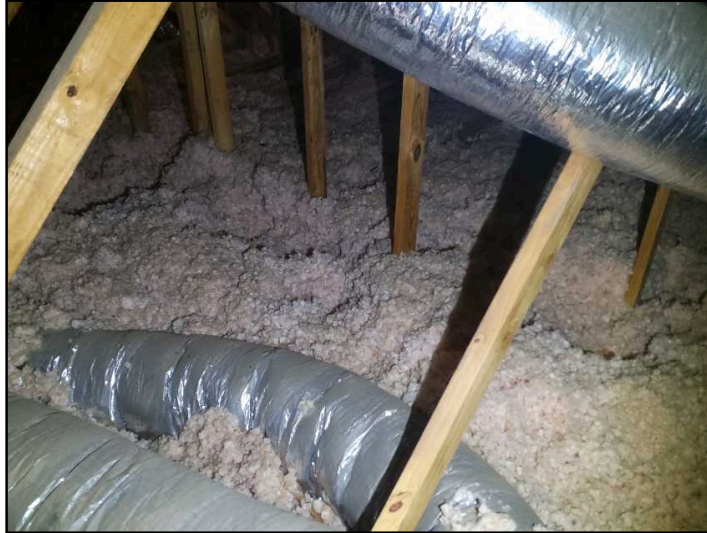
Average insulation depth was approximately 9 inches in the attic space.

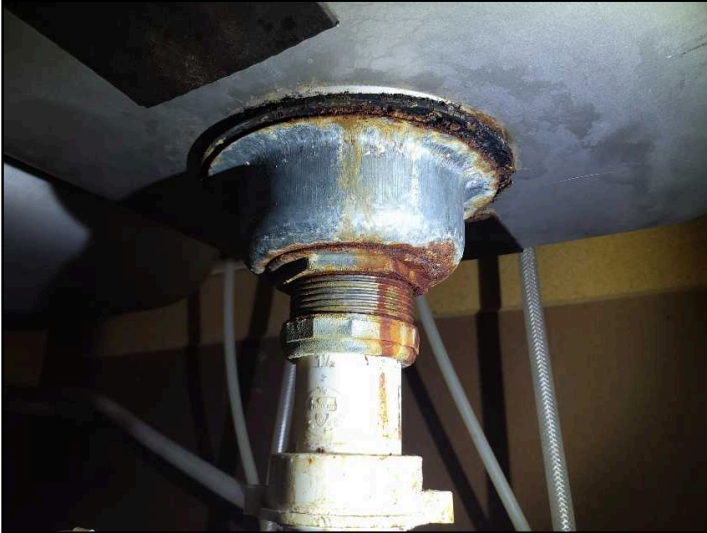
Repair the minor leak at the drain line connection under the basement kitchen sink. Have a plumber examined and repair.

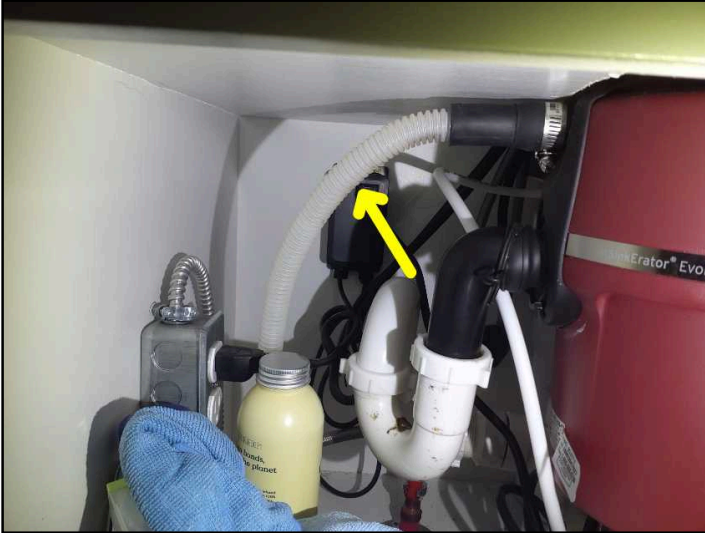
The dishwasher drain line should be looped below the cabinet elevated above the sink drain to prevent potential backflow into the dishwasher in case the sink drain becomes clogged.

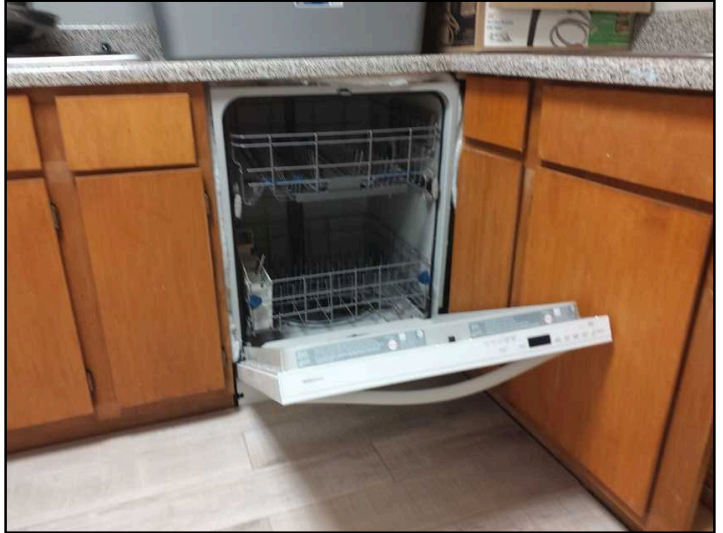
The dishwasher is not secured in the opening of the base cabinet, Dishwashers should be anchored to the countertop in the basement

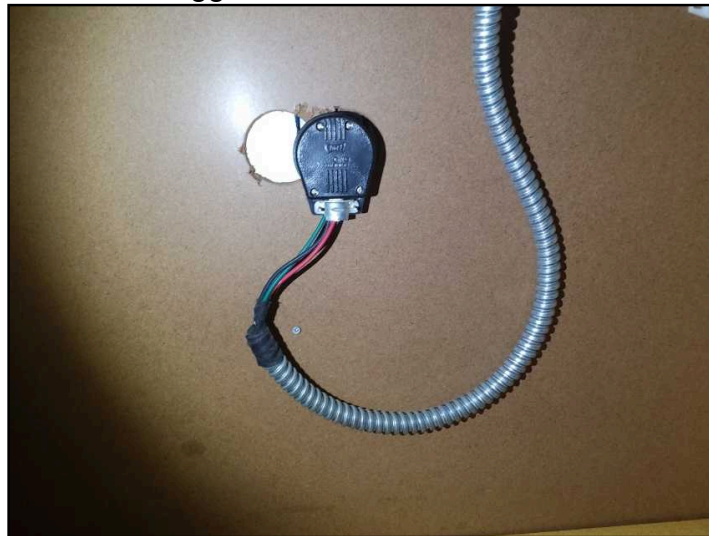
Electrical wiring was not properly installed below basement kitchen range cooktop at connection to receptacle

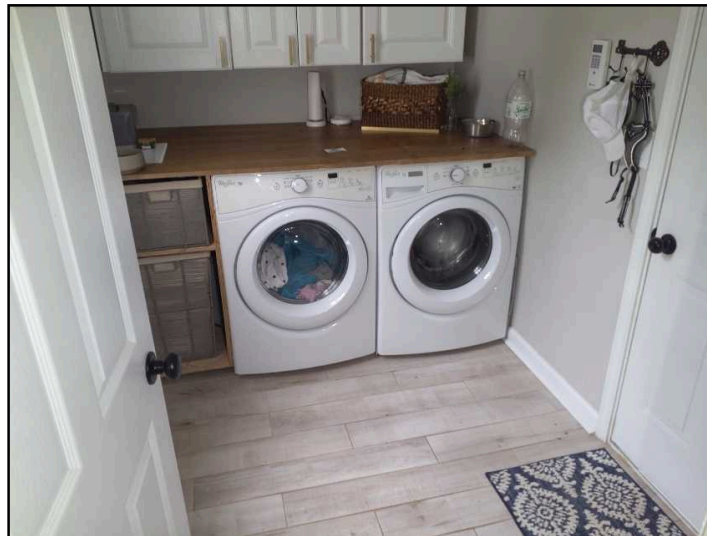
There should be a drain pan and drain line installed under the clothes washing machine. This is recommended when the laundry area is located over finished space OR to protect the flooring in and around the laundry room.

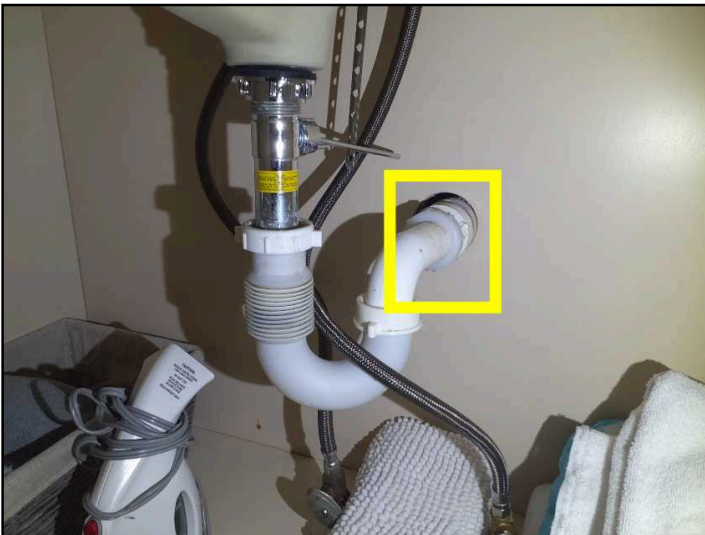
3.5. Leaking noted at the drain lines beneath one or more bathroom sinks. Suggested to have the drain lines reviewed and repaired by a licensed plumber as needed. See photographs for locations.

Active Plumbing Leak at sink drain on right side in master bathroom

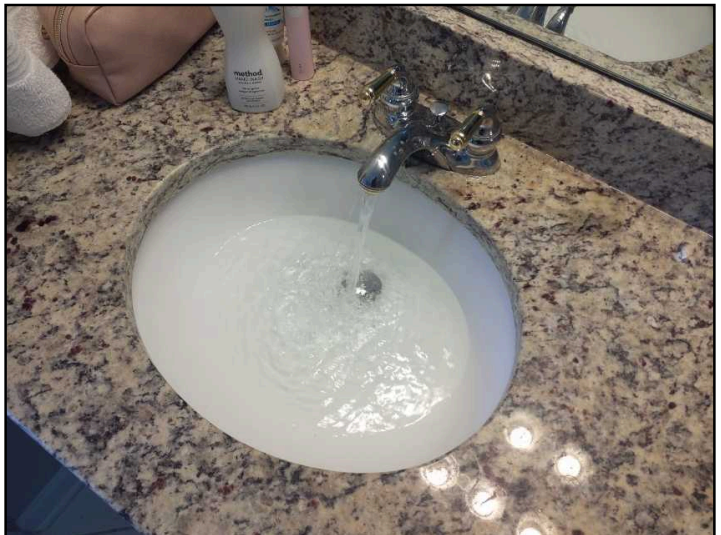
3.2. Slow drain(s) noted in the home. This is most likely due to a clogged P-Trap. Suggested to clean/snake the trap. If proper flow is not restored, it is suggested to consult a licensed plumber to respond and repair. See photographs for exact locations and details.

Slow drainage at left sink in master bathroom

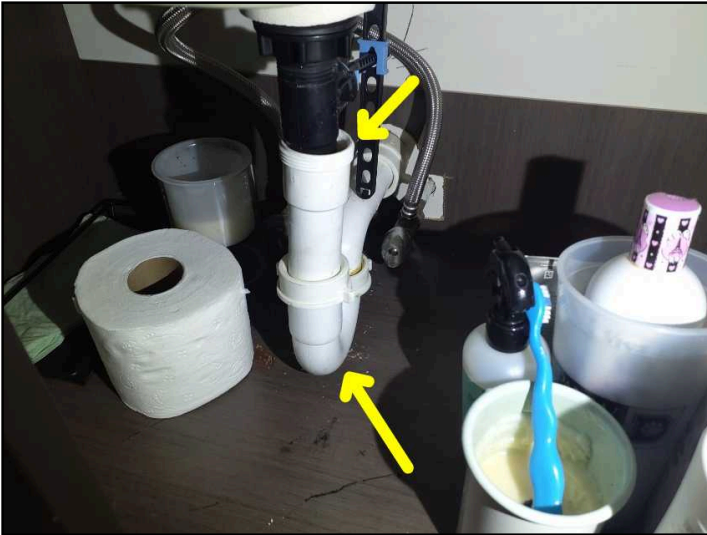
Drain below main level hall bathroom sink is not properly secured and configuration prevents removal of p-trap

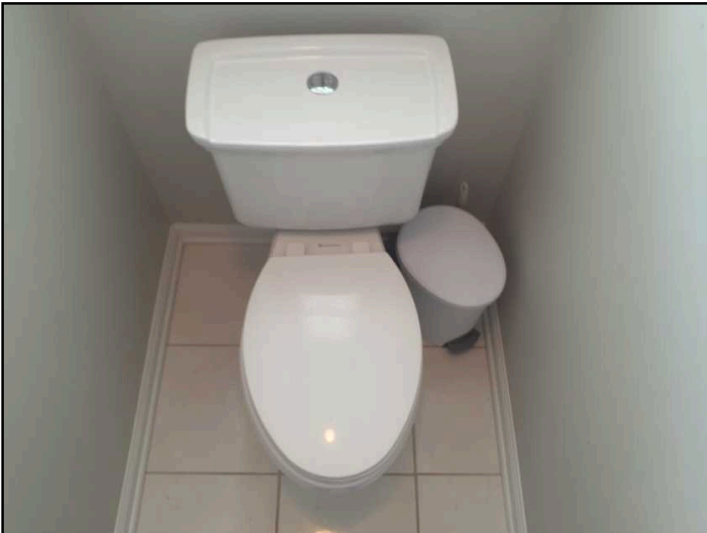
4.1. Loose toilet(s) noted in the home. All toilets should be properly secured to the floor to prevent leakage and ensure proper function. It is suggested to have all plumbing work performed by a licensed plumber. See photograph(s) for locations and details.

Loose toilet at master bath

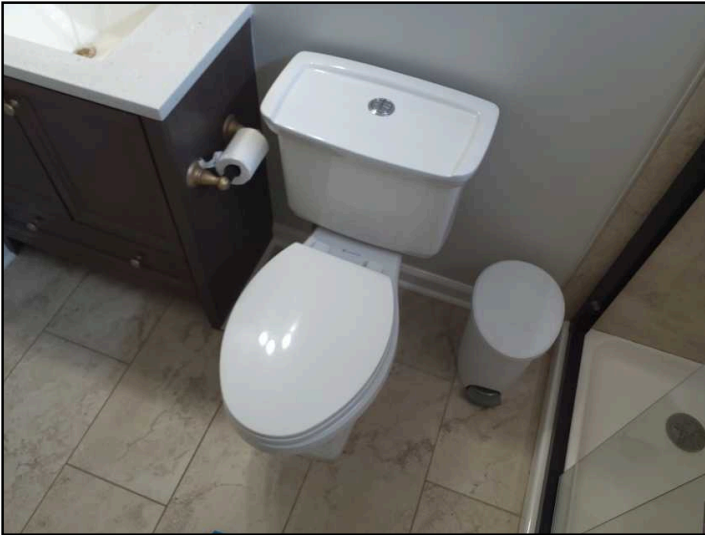
Loose toilet at main floor guest bath

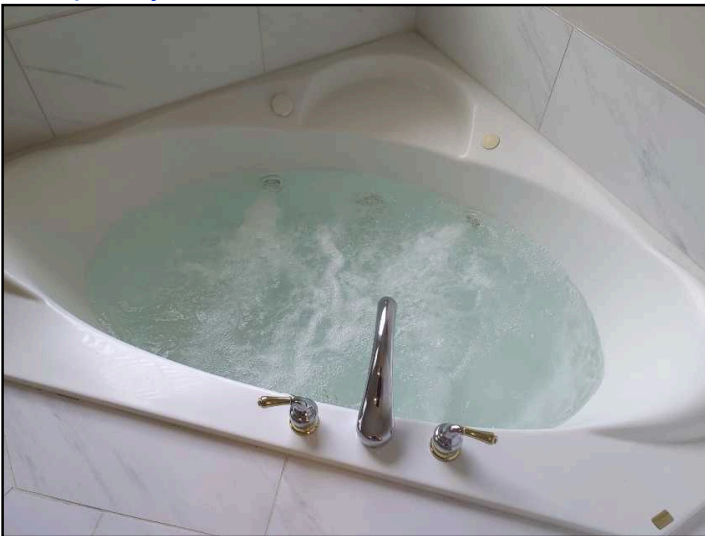
5.2. Jetted tub observed. Tub was filled to a level above the jets and operated to check intake and jets. The tub was then drained to check for leaks and/or damage. Pump and supply lines were not completely visible or accessible. The items tested appeared to be in serviceable condition.

Jetted tub filled and briefly tested

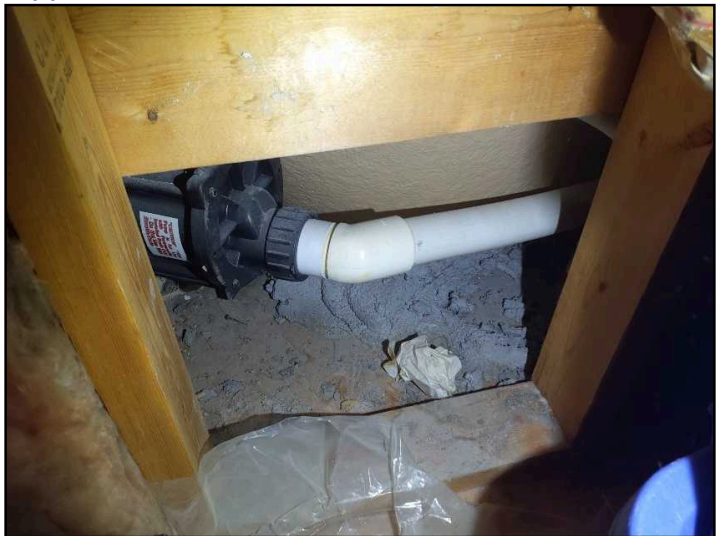
Jetted tub motor

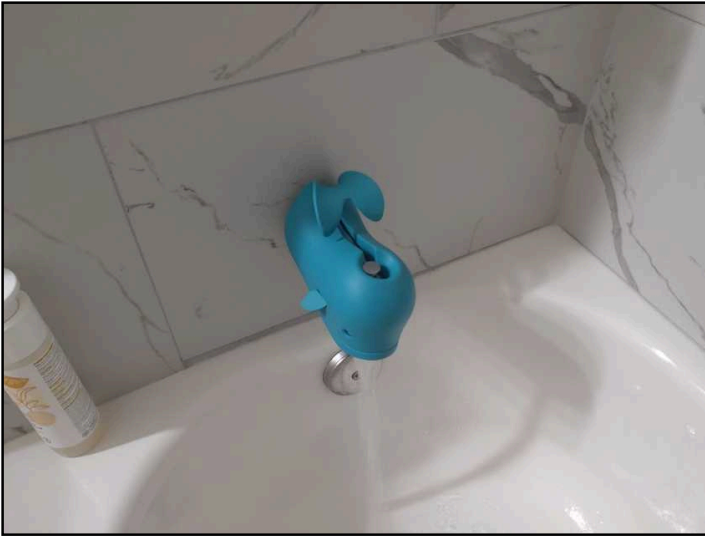
6.2. Tub faucet spout is loose at the upper guest bath room tub. Have secured as needed.

Tub faucet spout is loose at the upper guest bath room tub. Have secured as needed.

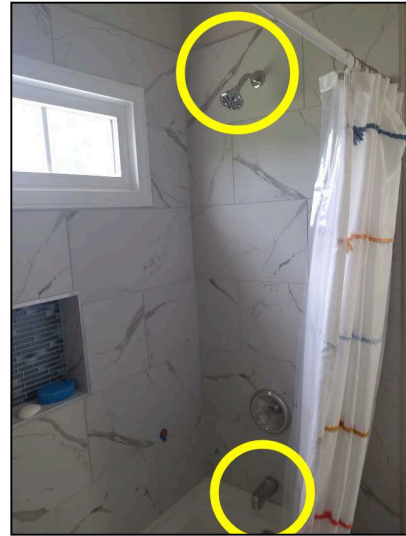
6.3. The plumbing components at the upper hall bathroom shower stall are not properly secured or sealed which may allow damage to piping or water intrusion into wall cavity

The plumbing components at the upper hall bathroom shower stall are not properly secured or sealed which may allow damage to piping or water intrusion into wall cavity

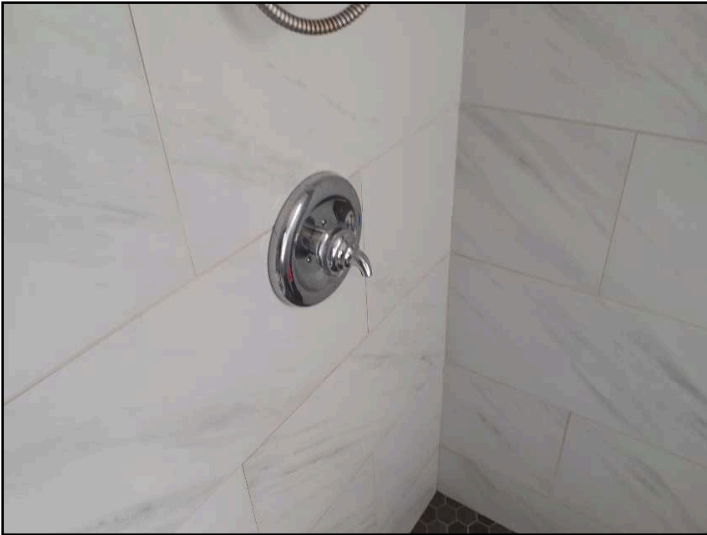
8.3. Missing handle noted at one or more shower faucets in the home. See photographs for locations and details. Have repaired/replaced as needed.

Missing or broken control handle at master shower stall

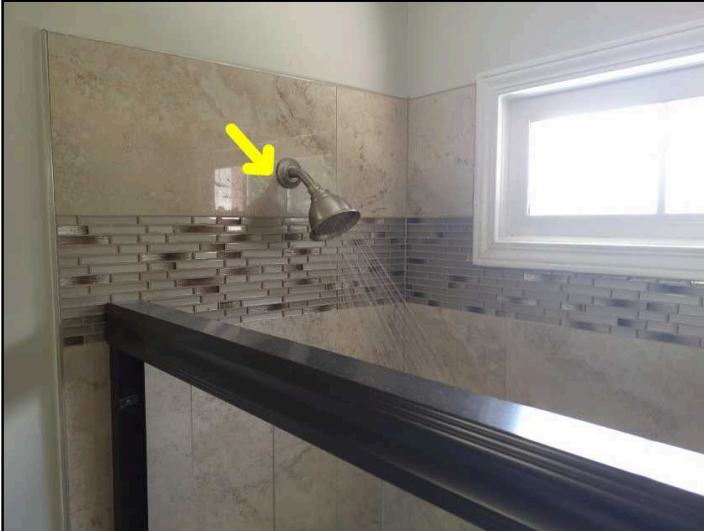
8.5. Plumbing components for main level shower head were not properly secured inside wall cavity and are extremely loose

Plumbing components for main level shower head were not properly secured inside wall cavity and are extremely loose

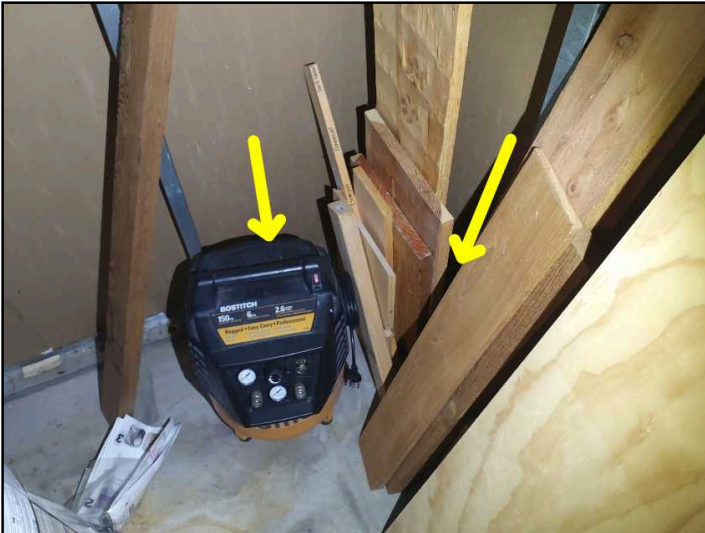
Possible mold growth and pace of drywall across from water heater in basement. recommend further testing to determine type and correction needed

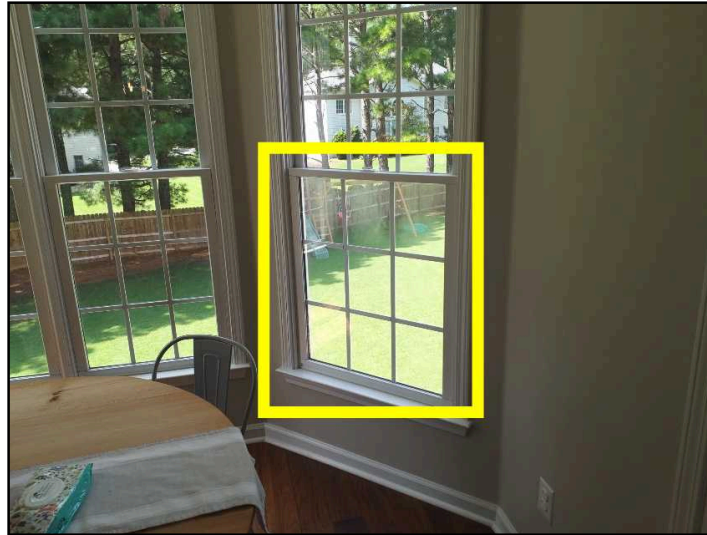
5.1. Thermal seal failure with fogging or condensations noted at one or more interior thermal pane windows around the home. This is indicative of a broken seal which will reduce visibility and the insulating capability of this window. To restore visibility and regain the insulating capability, replacement of this window pane is required. See photographs for locations and details.

Thermal seal failure at window in the kitchen

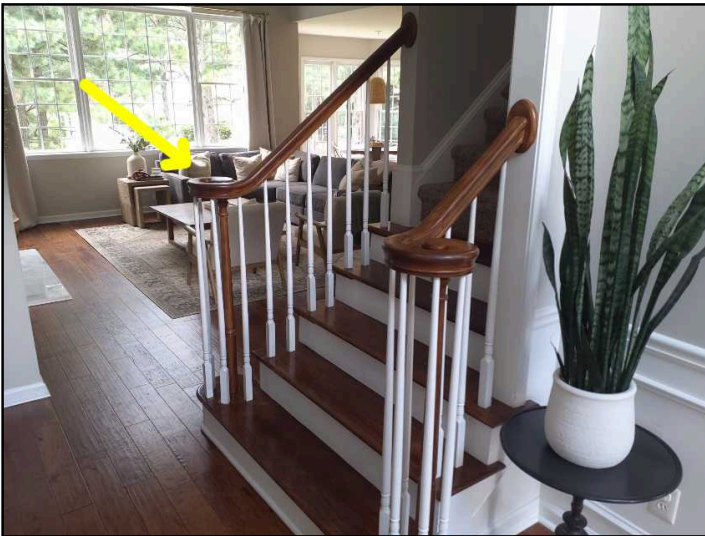
Secure the loose hand rail at the base of the second floor staircase.

6.1. Secure the loose hand rail at the second floor staircase.

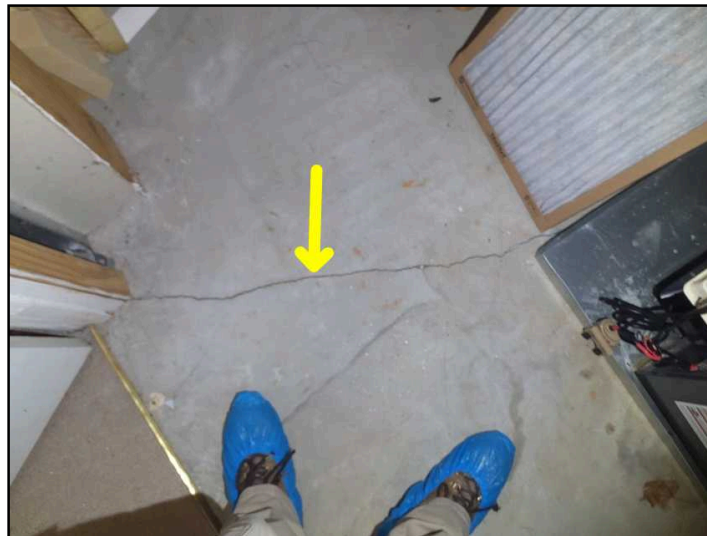
2.2. Common cracks noted. Recommend consultation with qualified contractor should condition worsen or water intrusion occurs.

Common cracks noted. Recommend consultation with qualified contractor should condition worsen or water intrusion occurs.

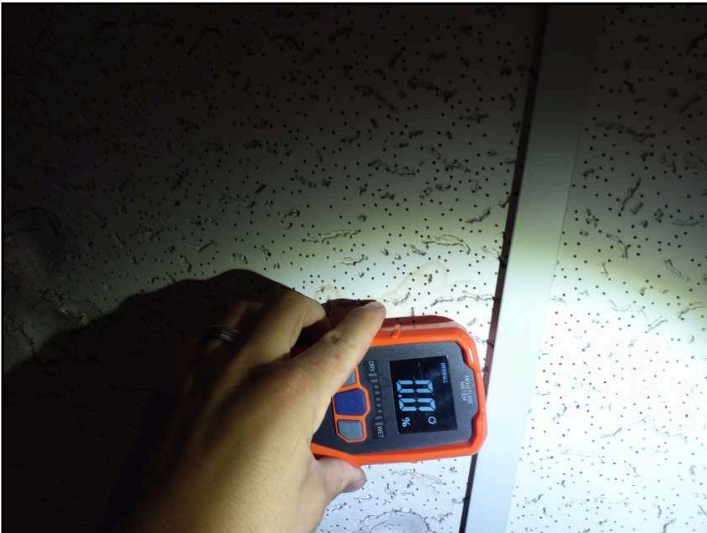
5.1. Water staining on ceiling tiles sporadic throughout basement. No current saturation was detected during inspection. replaced tiles and monitor

Water staining on ceiling tiles sporadic throughout basement. No current saturation was detected during inspection. replaced tiles and monitor

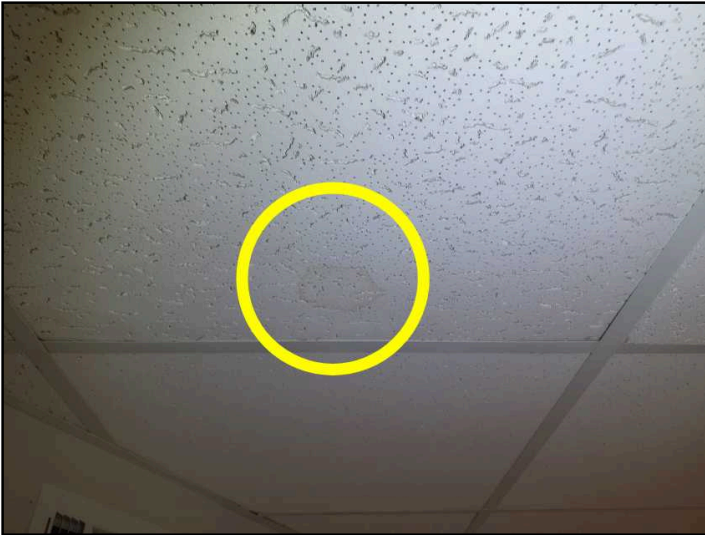
Water staining on ceiling tiles sporadic throughout basement. No current saturation was detected during inspection. replaced tiles and monitor

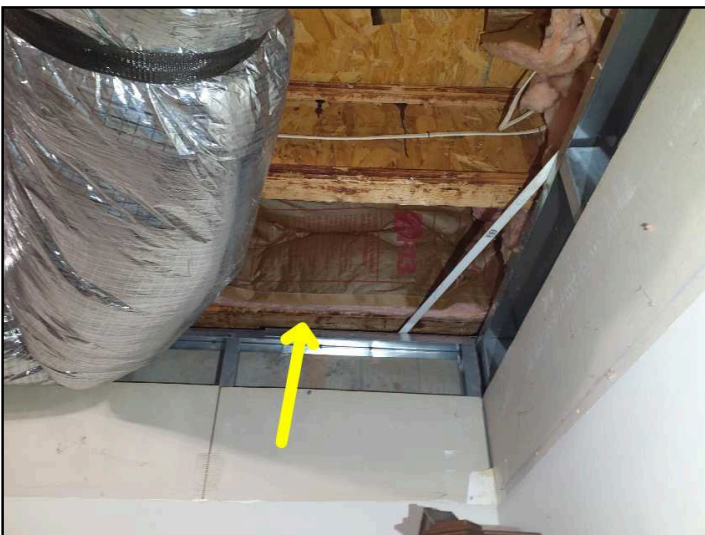
6.3. The insulation at the ceiling or walls of the basement has been installed backwards. The paper facing should be installed towards the conditioned side of the home. The paper portion is flammable and should not be left exposed.

The insulation at the ceiling or walls of the basement has been installed backwards. The paper facing should be installed towards the conditioned side of the home. The paper portion is flammable and should not be left exposed.

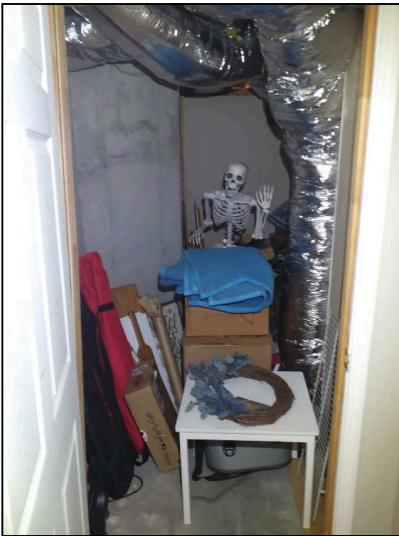
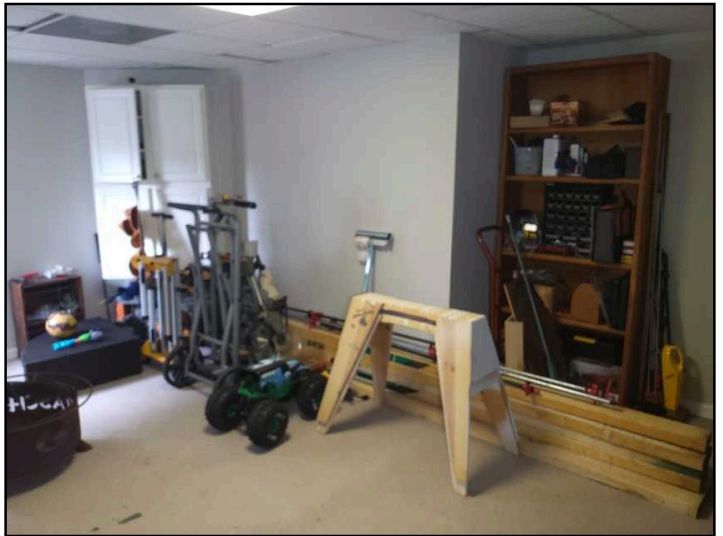
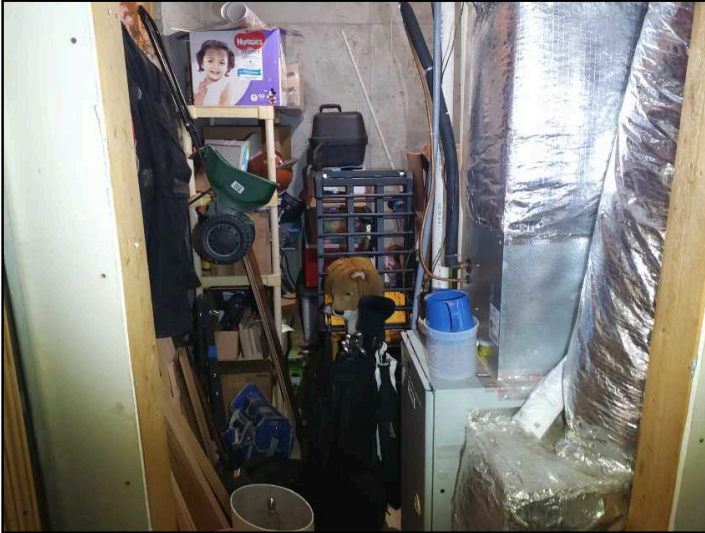
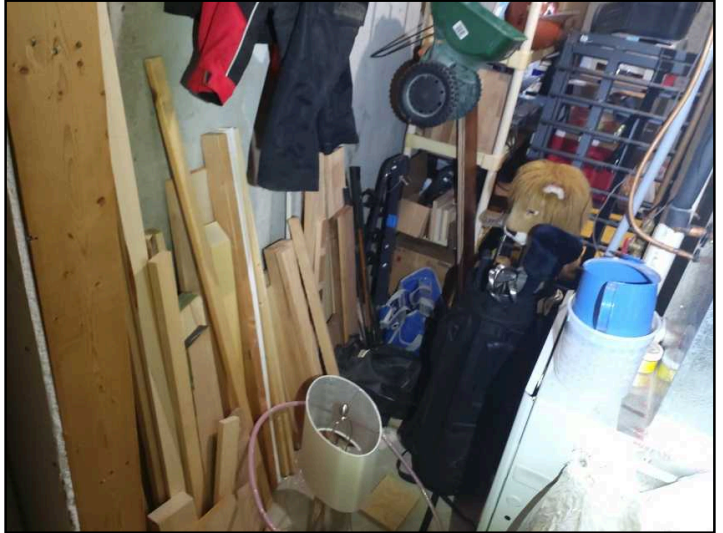
Limited view in basement due to storage

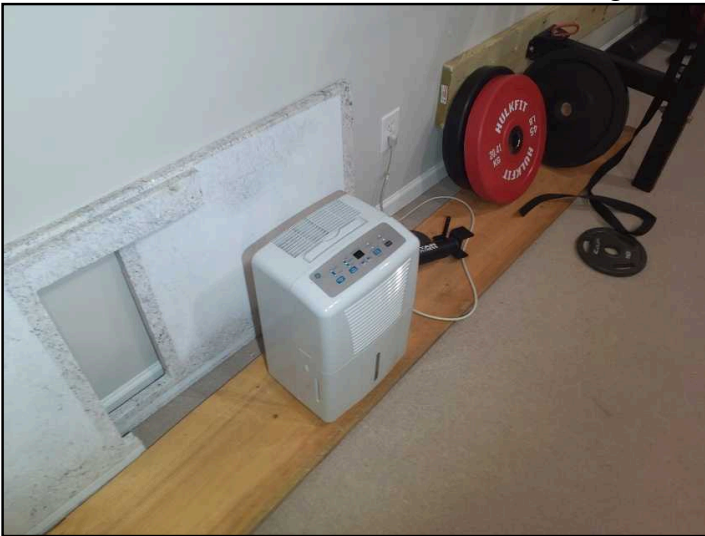
7.2. There is a dehumidifier running in the basement at the time of the inspection. This is a common way to reduce moisture in the air if the basement is not conditioned or if the AC does not run often enough.

There is a dehumidifier running in the basement at the time of the inspection. This is a common way to reduce moisture in the air if the basement is not conditioned or if the AC does not run often enough.

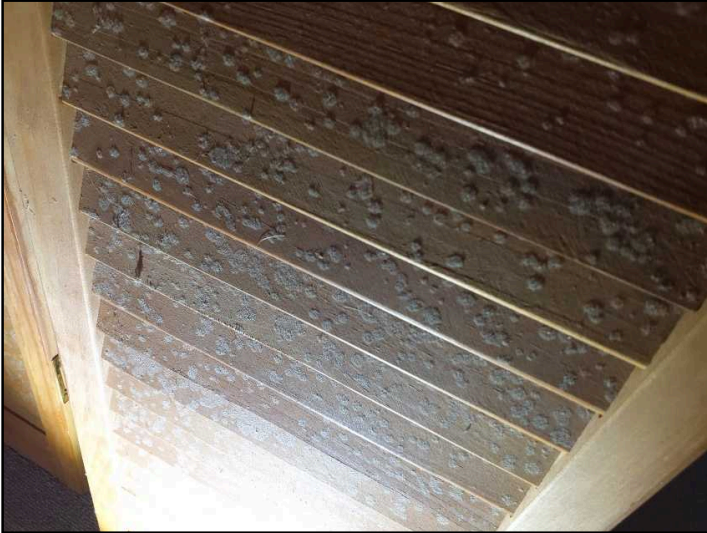
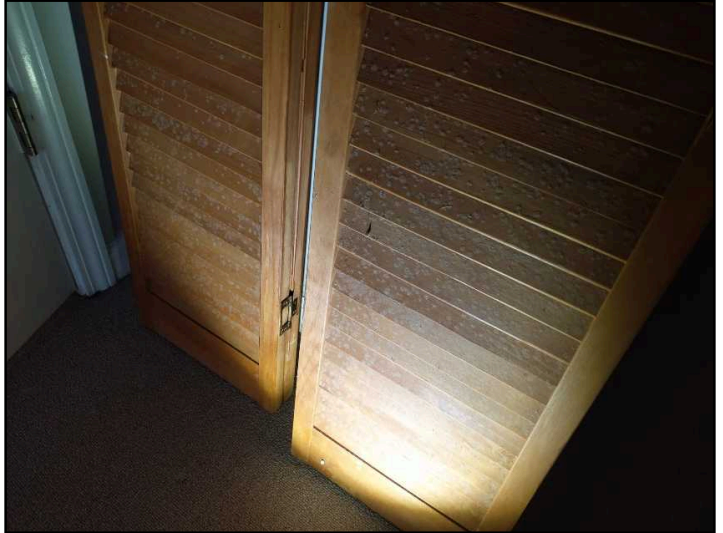
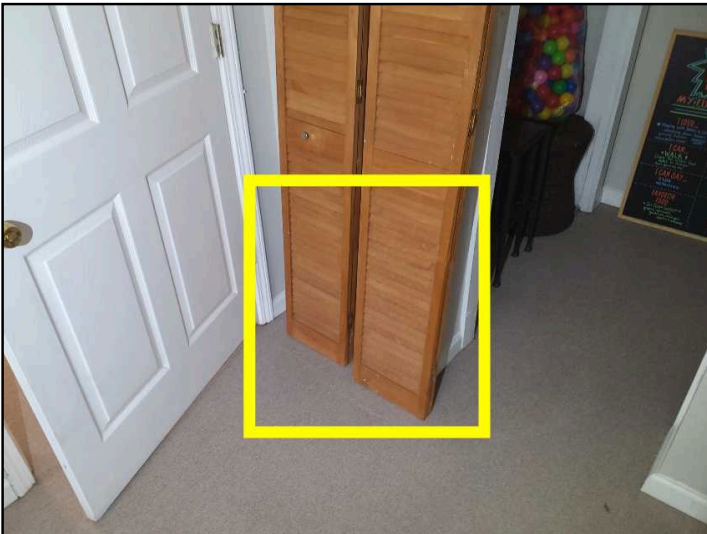
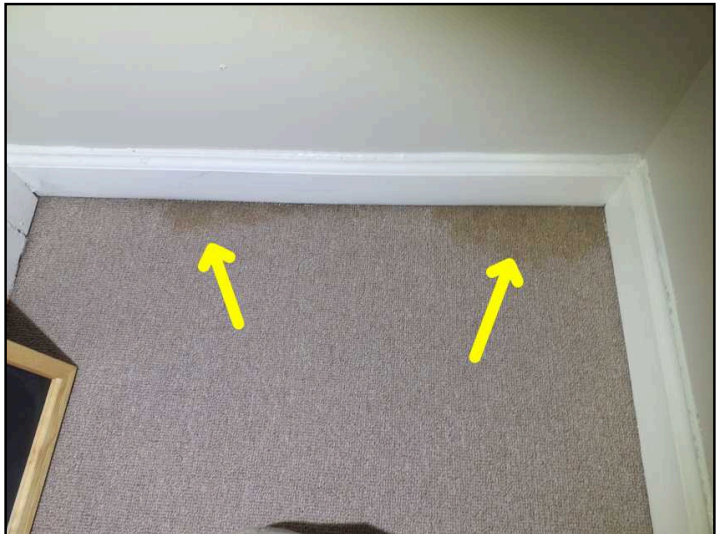
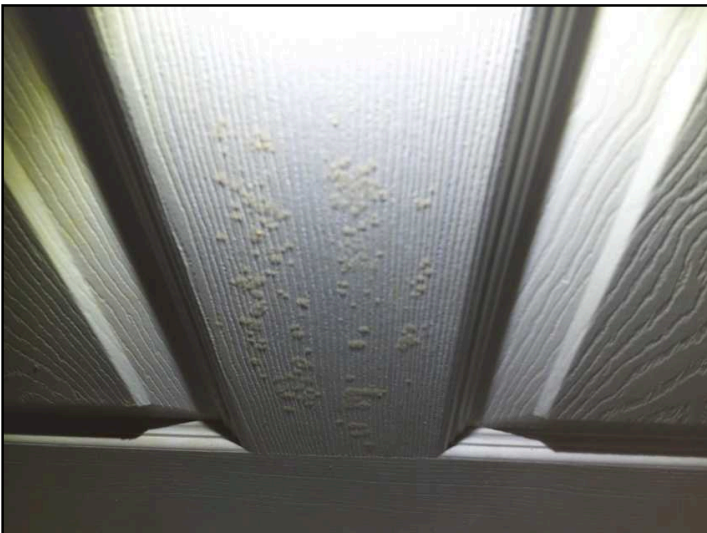
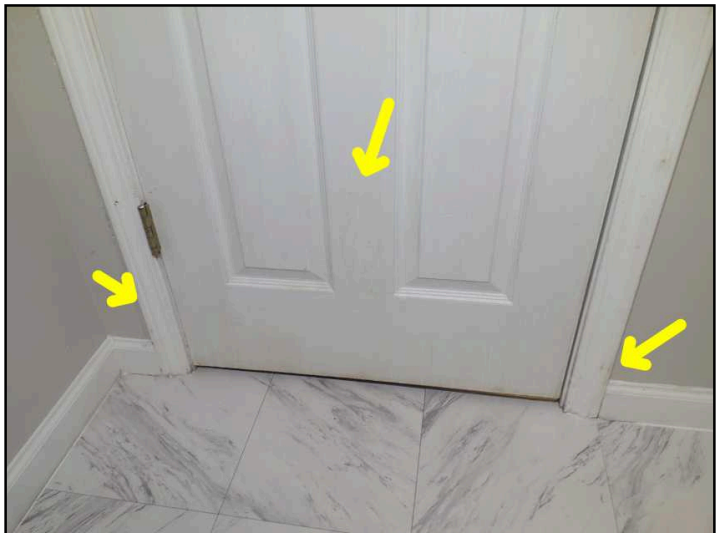
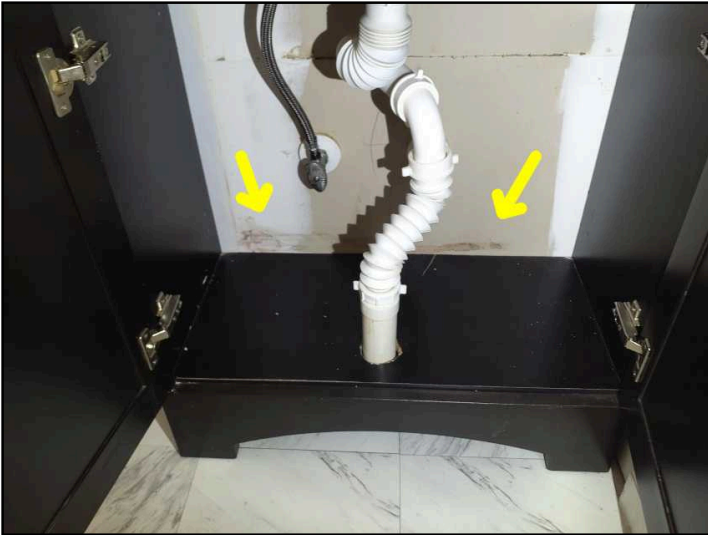
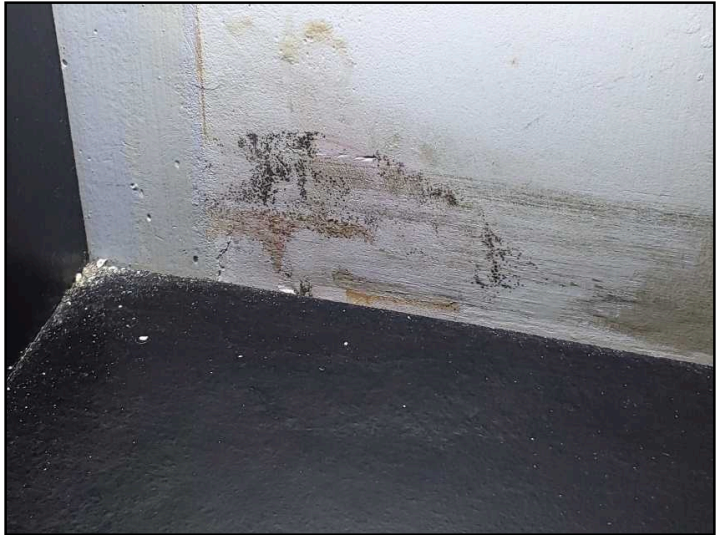
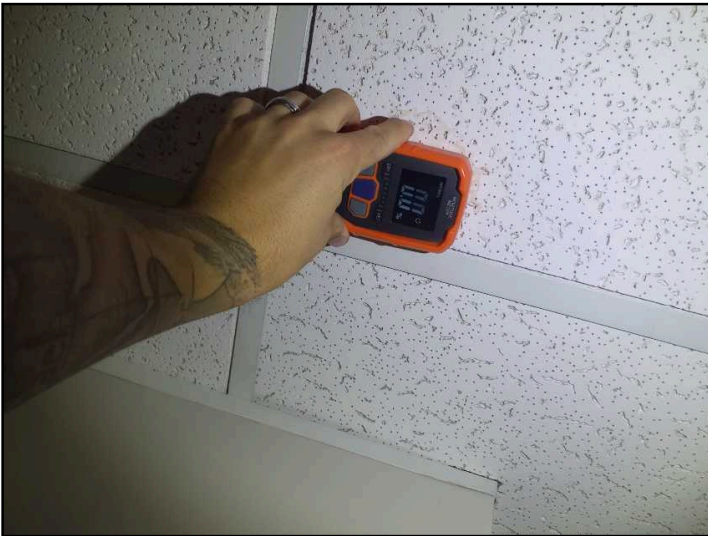
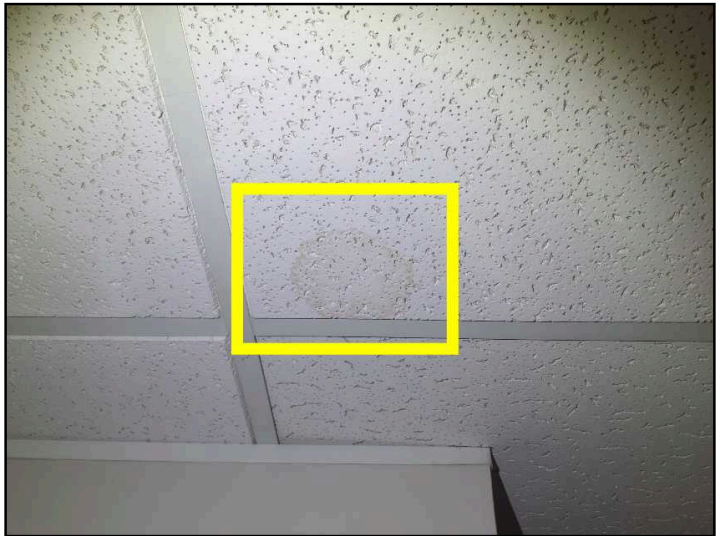
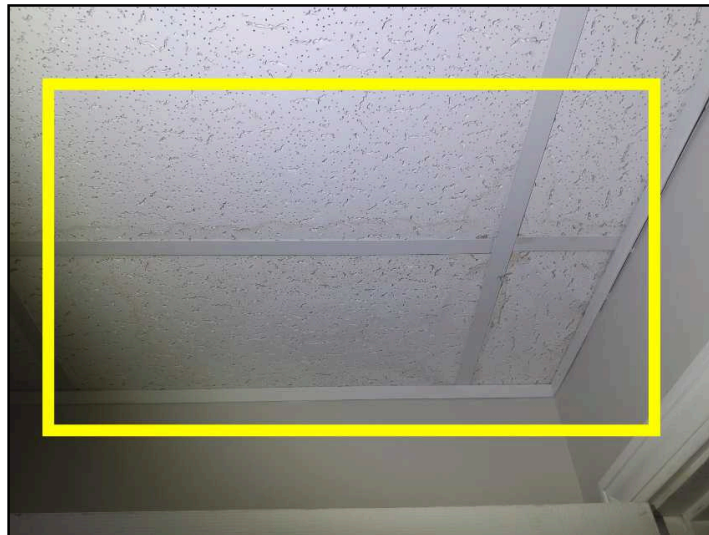
7.5. Evidence of past water event in basement around bedroom closet and bathroom. staining and discoloration is visible on multiple ceiling tiles although no current saturation was detected during inspection. organic like growth was uncovered at multiple locations in this area. further testing will be needed to determine type of growth and correction or treatment needed. recommend further evaluation for cause and correction by qualified contractor

Evidence of past water event in basement around bedroom closet and bathroom.
