Motor Boat Rinker 360 Survey Report

MOTOR BOAT	Rinker 360
HIN	[REDACTED]
DATE	[REDACTED]
REPORT NO.	[REDACTED]

Report completed by	Hatem Salama	Date	██████
Signature	xxxxxxxxxxxxxxxxxxxx	ID Number	AVI 00325 SAMS SA
Company on whose behalf inspection carried out	Buyer : Mr. ██████		
Report summary seen by	Buyer : Mr. ██████	Date	██████
Place of survey	██████████, ██████ On.		
Type of survey	Condition and valuation survey

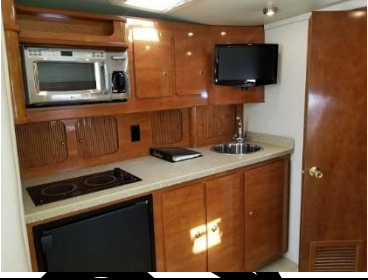
4.1	Galley	Yes ✓	No	NA	NS
Galley space located at port side in accommodation space, drawers, cabinets and accessories found in good condition.

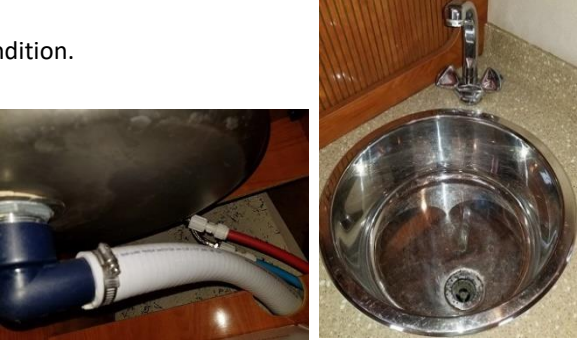
4.4	Coffee Maker	Yes ✓	No	NA	NS
Coffee maker attached to microwave oven, not tested.					
4.5	Galley Sink	Yes ✓	No	NA	NS
Stainless steel sink and faucet. Water and drain lines checked found in good condition.

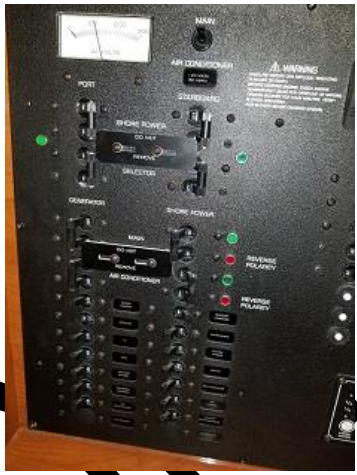
120 V, 60 HZ AC power system, source from shore power connection, and AC generator.
 Original AC power panel with main breaker.
 Power source switch double pole breakers between generator and shore power connections.
 All Ac equipment are properly connected to AC breaker with switches.
 AC volt meter gauge and polarity indicator apply on panel.

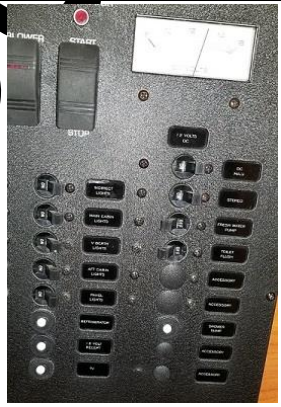
12 V DC power system, source from battery bank.
 Original DC power panel with main DC single breaker.
 DC equipment connected to DC panel with proper switches.
 DC voltmeter gauge applies on panel.
 DC equipment fuse box on battery switch panel at cockpit deck.

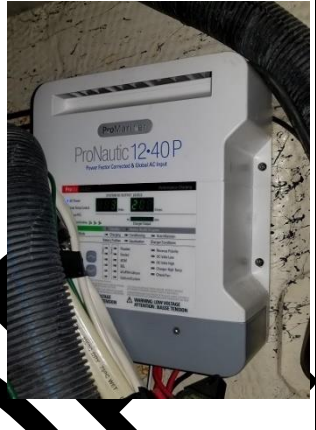
ProMariner 40 AMPS marine battery charger in engine compartment with digital light indicator.
 Battery charger properly connected to AC panel with AC switch.
 Battery charger connected to batteries through proper DC over current protection 80 AMPS breakers for each battery bank.

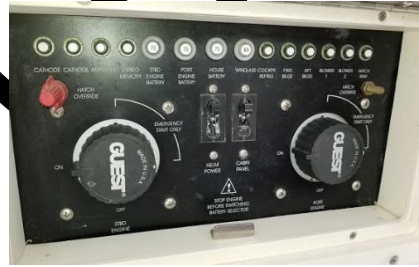
2 Guest battery switches one for each battery bank located on cockpit deck starboard side in enclosed compartment.

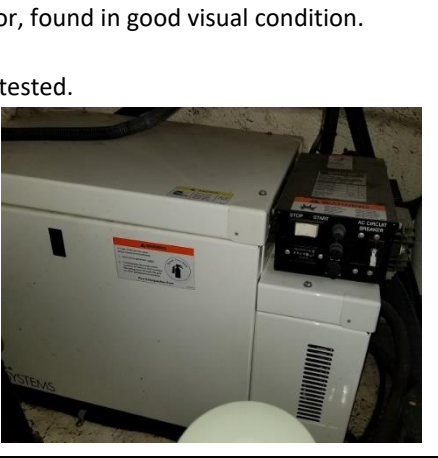
Kohler model 5E, 5 KW, gasoline marine water cooled generator, found in good visual condition.
AC circuit breaker properly supplied on generator, and starter.
Generators lines and parts found in good visual condition, not tested.
