Azimut 62 Survey Report

POWER BOAT	Azimut 62
HIN	[REDACTED]
DATE	[REDACTED]
REPORT NO.	984.73.MBSR.28.24

ID Number	AVI 00325 IIMS : S1283
Person on whose behalf inspection carried out	Buyer : Mr. [REDACTED]		
Report summary seen by	Buyer : Mr. [REDACTED]	Date	11.06.24
Place of survey	[REDACTED]		
Type of survey	Condition and valuation survey

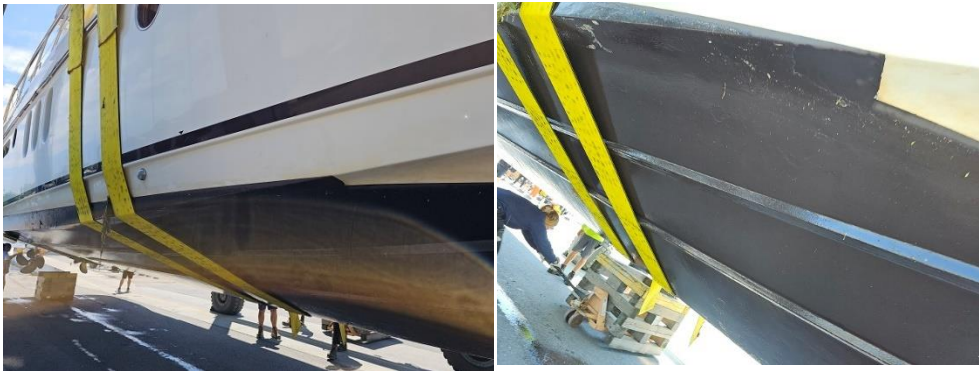
1.1	General Hull Condition
<p>Mould construction fiberglass mono hull. white gelcoat above water line found to be smooth and fair in good condition with low moisture levels were obtained from above water line area, minor cosmetic scrapes observed in multiple spots in gelcoat.</p> <p>Black antifouling coat below water line in new condition, however signs of antifouling peeling and flaking present in multiple spots.</p> <p>Recommendation : Sanding the hull and application of new coat is advised.</p> <p>Hammer test carried out along the hull while found to be structurally sound, no indication of soft spots or delamination evident, moderate to high moisture readings were obtained from below water line where antifouling is applied, lower reading from paint flaked spots and inner hull.</p> <div data-bbox="290 646 1263 1014">

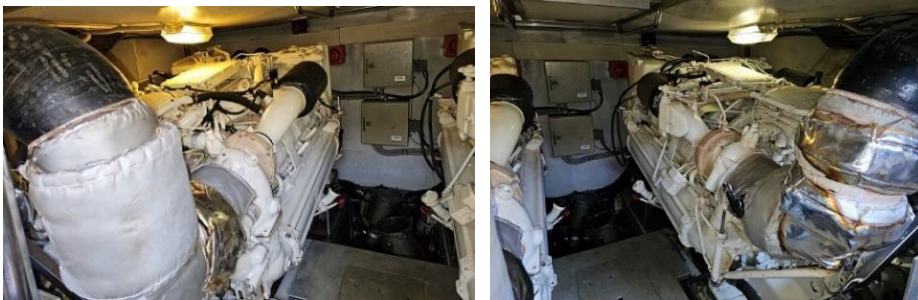
2.1	General Engine Condition
	<p>Twin MTU M90, 8 cylinders, turbo charged marine diesel engines. Engines were not started or loaded at the time of survey. Recommendation: Engines and attached parts to be inspected by qualified marine mechanic to determine the comprehensive condition of the engines.</p> <div style="display: flex; justify-content: space-around;">
