Catalina 42 Survey Report

| SAIL BOAT | Catalina 42 |

| Type Of Survey | Condition And Valuation Marine Survey. | | |

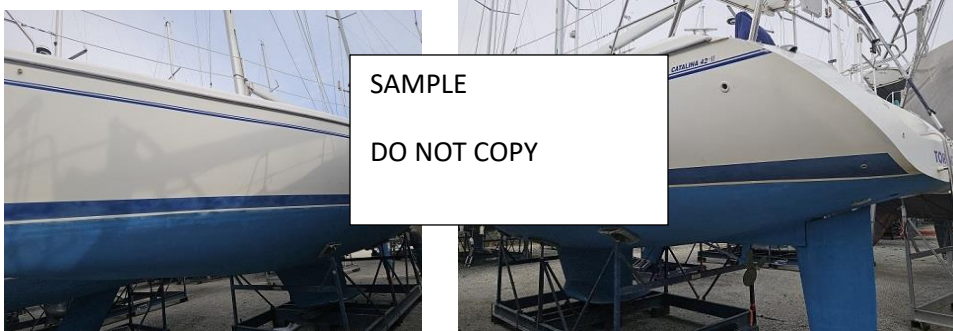
| 1.1 | General Hull Condition | <p>Fiberglass mould construction mono hull, white gelcoat above water line with blue accent stripes. Hull above water line found to be smooth and fair in very good condition. Low moisture levels were obtained from above water line area.</p> <p>Blue antifouling coat below water line in good and serviceable condition, no indication of coat flaking or fading observed.</p> <p>Hammer test carried out along the hull, found to be structurally sound, no proof of soft spots or damage evident with low moisture levels were mostly obtained from below water line where antifouling is applied.</p> <div data-bbox="287 602 1234 930"></div> <div data-bbox="404 942 1047 1035"><p>PRIVATE INFO</p></div> |

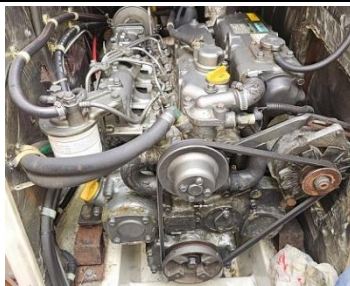
| 2.1 | General Engine Condition |

| | <p>Yanmar 4JH2E, 4 cylinder in line water cooled marine diesel engine.</p> <p>Engine was not started or loaded at time of survey.</p> <p>Recommendation: Engine to be inspected by qualified marine mechanic to determine the comprehensive condition of the engine.</p> |

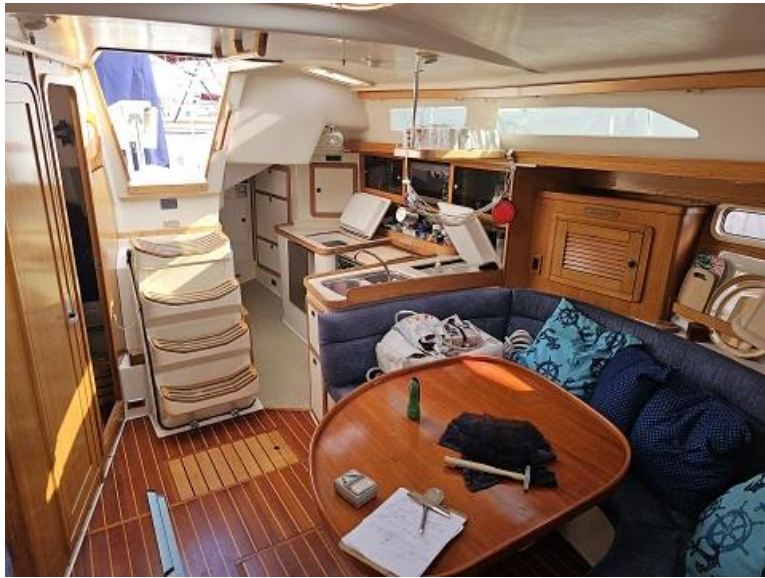
3.1 Interior

Modern wooden finish interior and bulkheads inside accommodation space.
V berth closed cabin and forward toilet.
Galley located at port side of accommodation space, and aft toilet at starboard side.
Aft cabin with access from starboard quarter.
Furniture, wooden flooring, drawers, cabinets, and upholstery are in good and clean condition.
