Inspection Report

Property Address:
101 Sample Road
Summerville SC 29483

Cardinal Home Inspections, LLC

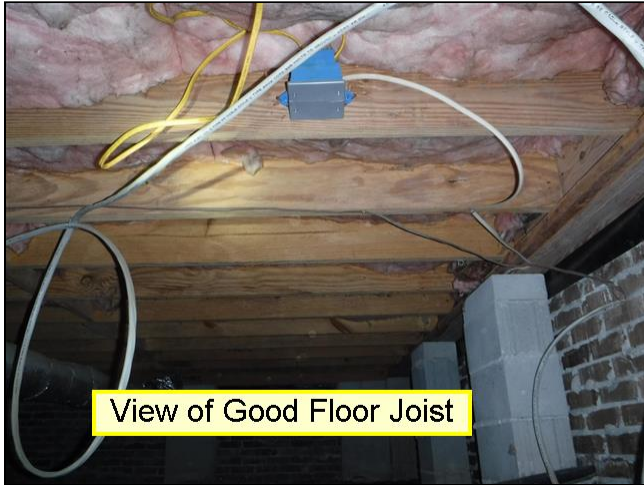
1.1 Item 5(Picture)

(1) The floor joist and structure are in poor condition below the sunken family room and kitchen areas. The air handler is located in the crawlspace and is pouring harmful condensation onto the ground under the home. There is also evidence that rain water runoff is entering the home along the rear. The floor structure needs replaced in areas and repaired in other areas under the sunken family room and kitchen. Recommend relocating the air handler to the attic or garage and recommend installing gutters on the home. These repairs combined are significant in cost and should be considered prior to purchase. Recommend contacting a general contractor for cost estimates.

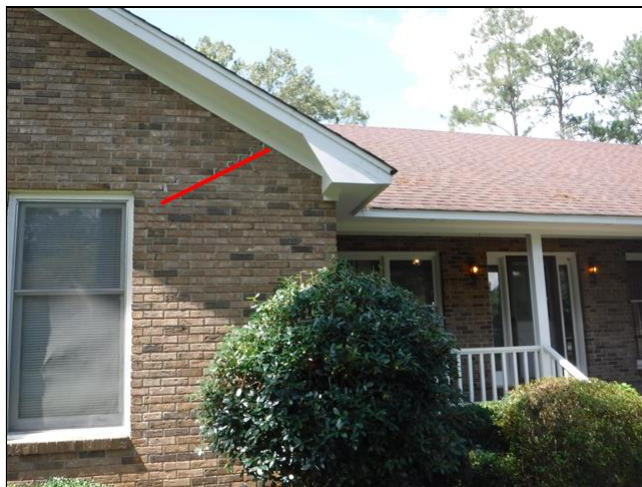
2.0 Item 2(Picture)

Brick veneer reveals a settlement crack at the front of the home above the right bedroom window. Recommend further investigation for repair.

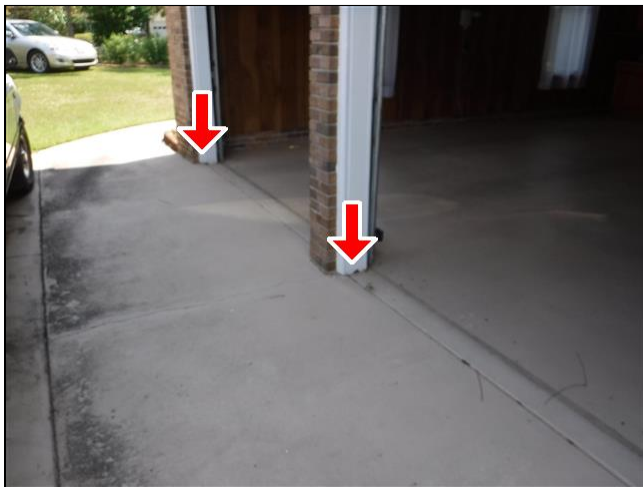
2.3 Item 3(Picture)

Wood casing at the garage doors reveals water damage where in contact with the ground and needs repair or replace.

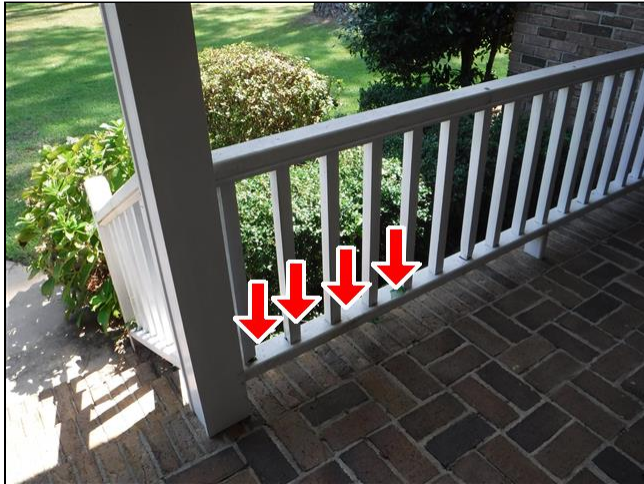
2.4 Item 3(Picture)

(1) Several pickets located at the front porch reveal water damage and need replaced.

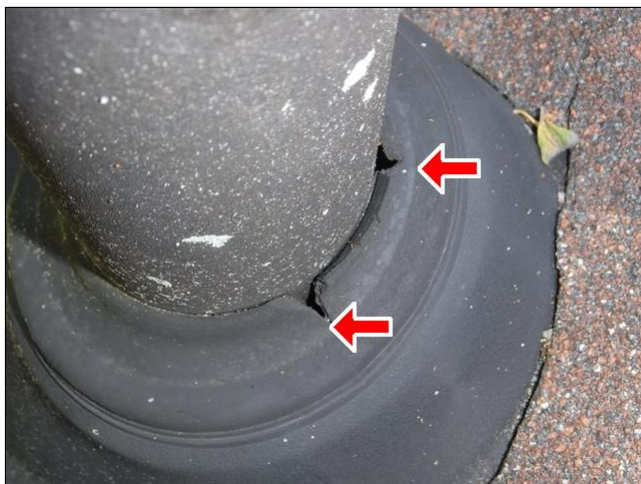
3.2 Item 2(Picture)

Plumbing vent pipes need caulking around perimeter of pipe and boot where boot flange has failed. These areas can leak if not corrected.

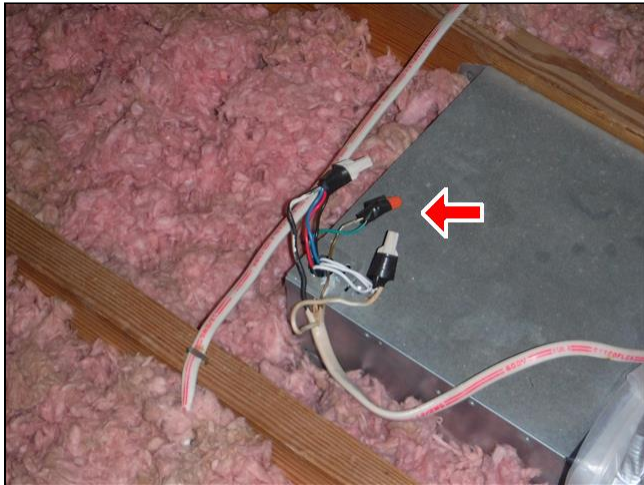
5.3 Item 1(Picture)

(1) Bathroom exhaust fans have exposed wire splices located in the attic. Wire splices should be inside an enclosure with a coverplate to prevent electrical fire.

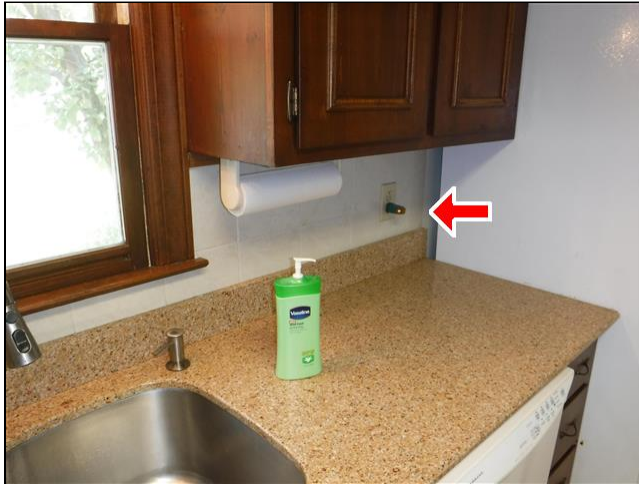
5.6 Item 3(Picture)

Recommend updating outlets located over all kitchen countertops to "GFCI" protected outlets.

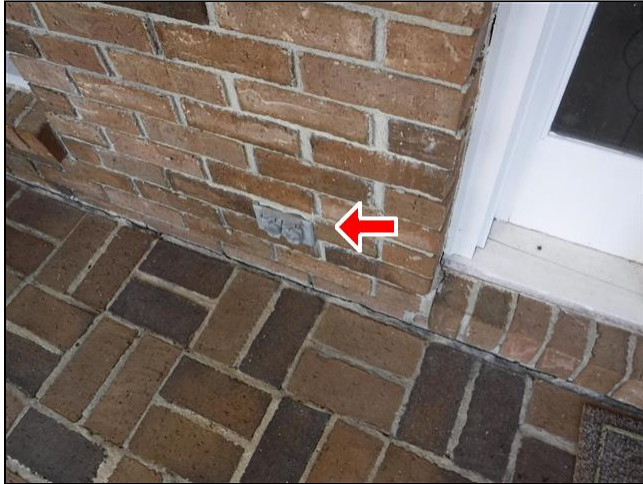
5.7 Item 1(Picture)

All exterior outlets need to be updated to GFCI protected outlets with weather covers.

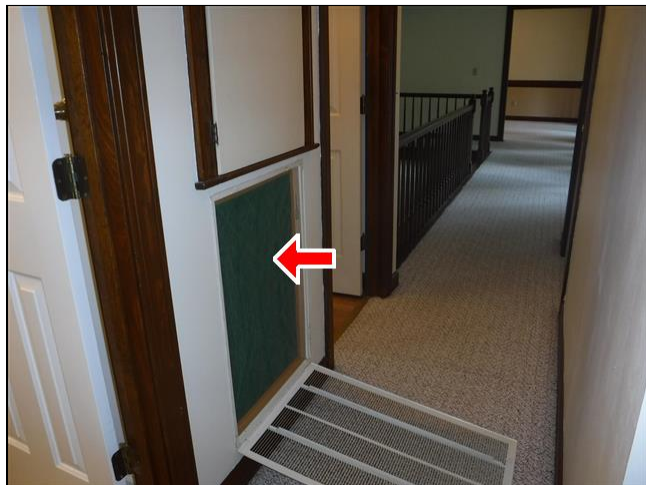
6.4 Item 1(Picture)

Filter location (see photo)

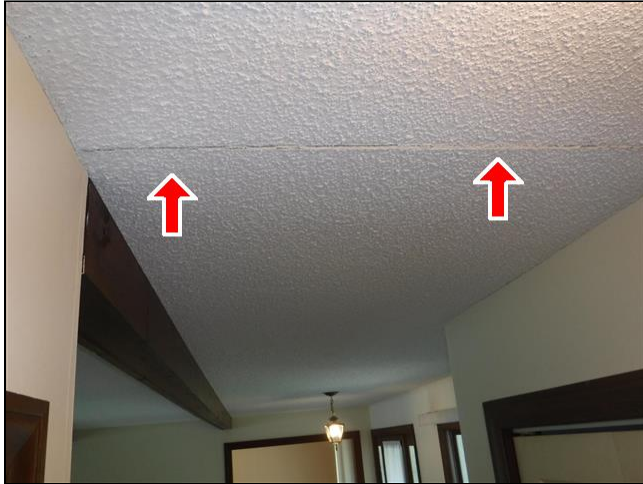
8.0 Item 4(Picture)

(3) Sheetrock reveals seam/joint at the front hallway location.

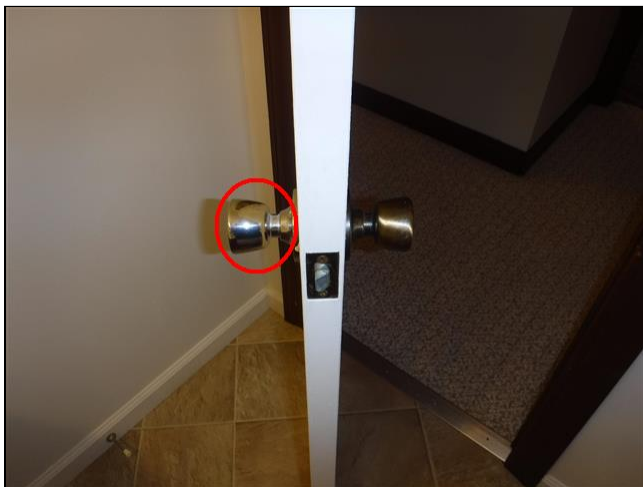
8.4 Item 1(Picture)

(1) The door lock does not work at hall bathroom door.

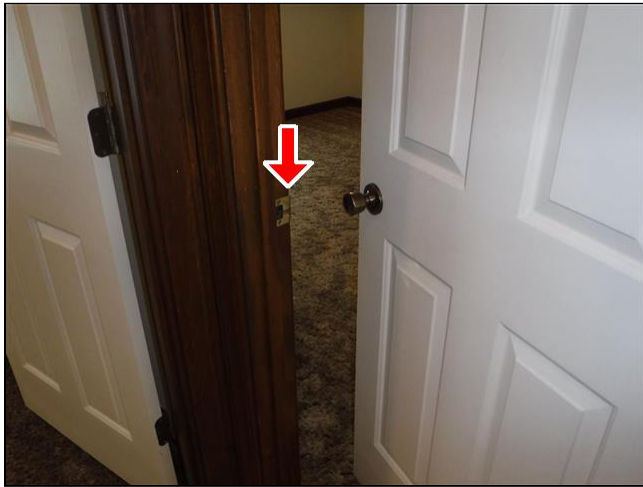
8.4 Item 3(Picture)

(2) The left side bedroom located at the end of the hallway needs strikeplate adjustment for the door to latch properly when closed.
