Inspection Report

Sample Report

Property Address:
Sample Drive
Summerville SC 29486

Date: 5/19/2021	Time: 10:00:00 AM	Report ID: 202105102
Property: Sample Drive Summerville SC 29486	Customer: Sample Report	Real Estate Professional:

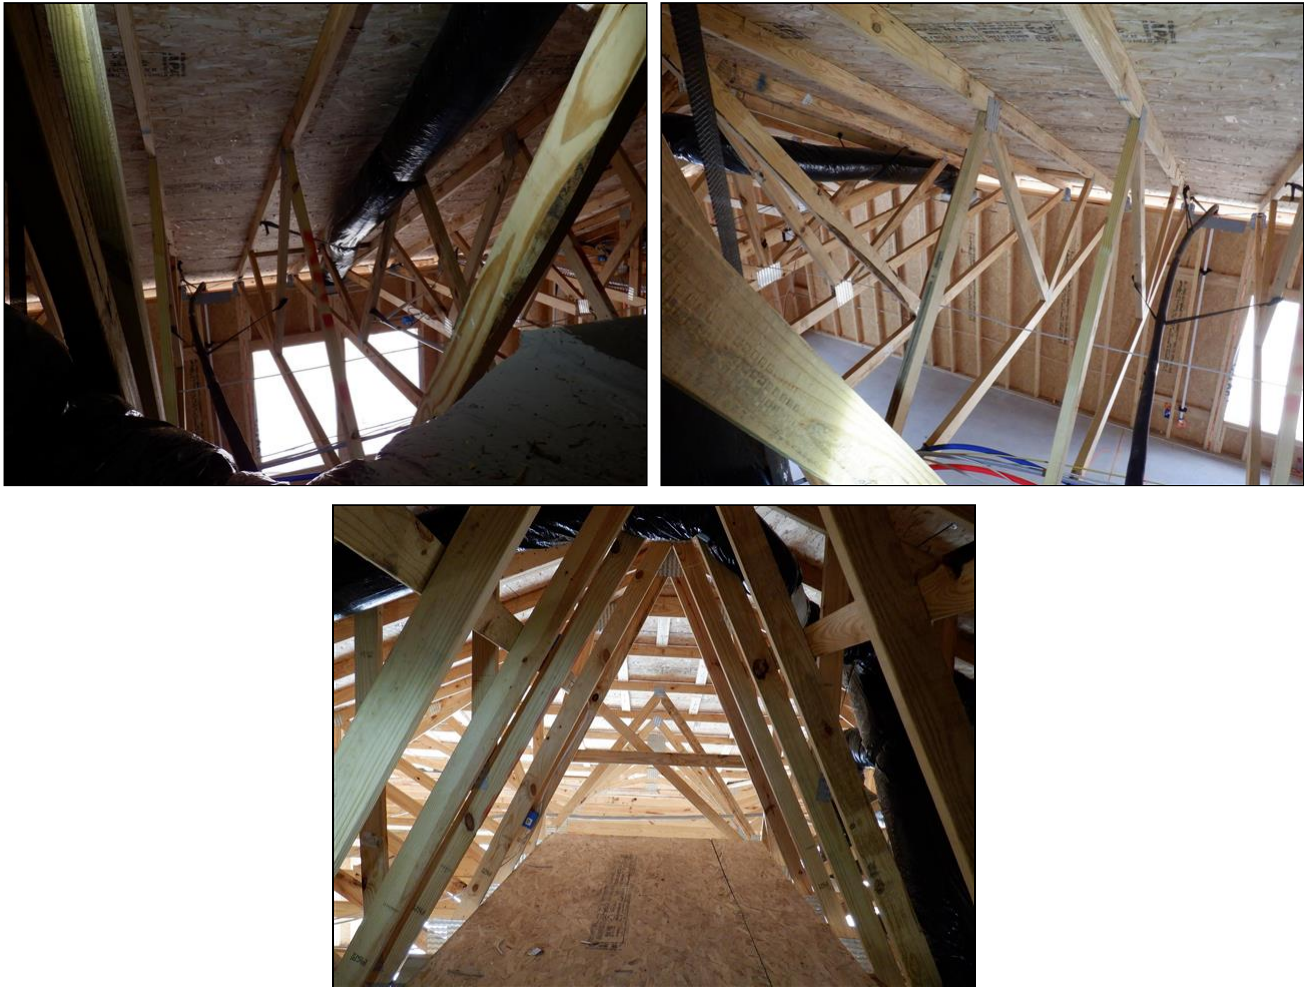
Foundation: Poured concrete	Method used to observe Crawlspaces: No crawlspace	Floor Structure: Slab
Wall Structure: 2 X 4 Wood	Ceiling Structure: Engineered Truss	Roof Structure: Engineered wood trusses
Roof-Type: Hip	Method used to observe attic: Walked

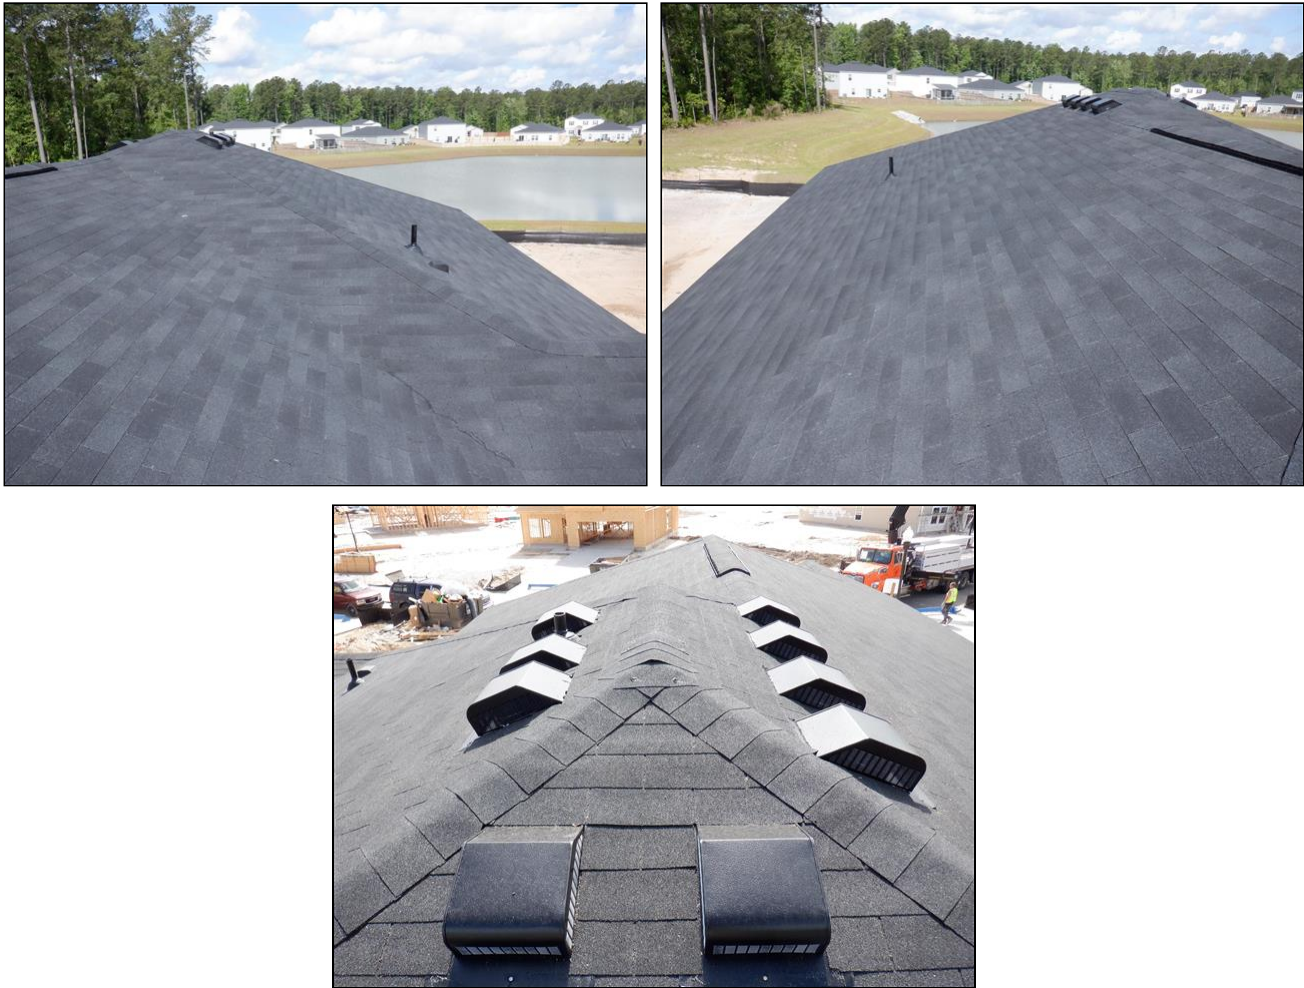
Roof Covering:	Viewed roof covering from:	Sky Light(s):
3-Tab fiberglass	Walked roof	None
Chimney (exterior):		
N/A
