13-IAGT-XXX (REFERENCE PROGRAM)

AIRFOIL THICKNESS AS A LIFE LIMITING FACTOR OF GAS TURBINE BLADES

Kevin Wiens, P.Eng.*†

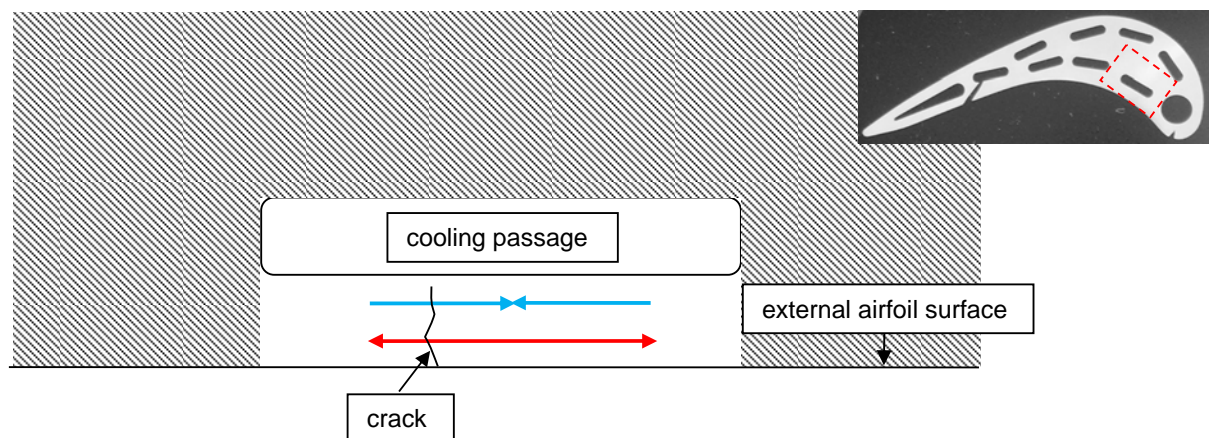
A mechanism for the observed cracking is depicted in **Figure 6**. On heating, the thin wall between the external surface and the cooling passage expands. The relatively bulky regions near the thin wall take longer to heat, constraining the thin wall leading to a compressive stress. Following shut down of the engine, the thin wall cools more rapidly than the surrounding metal, which generates a tensile stress perpendicular to the observed crack.

Figure 6: Schematic showing the mechanism for thin wall cracking during transient thermal loading. The thin wall expands (red arrow) and contracts (blue arrow) faster than the surrounding metal (hatched area) which generates stress cycles perpendicular to the observed crack.
