11-IAGT-304

OPERATOR EXPERIENCE WITH NON-GAS PATH POWER TURBINE DISC CORROSION AS AN EMERGENT EQUIPMENT INTEGRITY THREAT

**TransCanada Corporation ([†]barry_ruggiero@transcanada.com)*

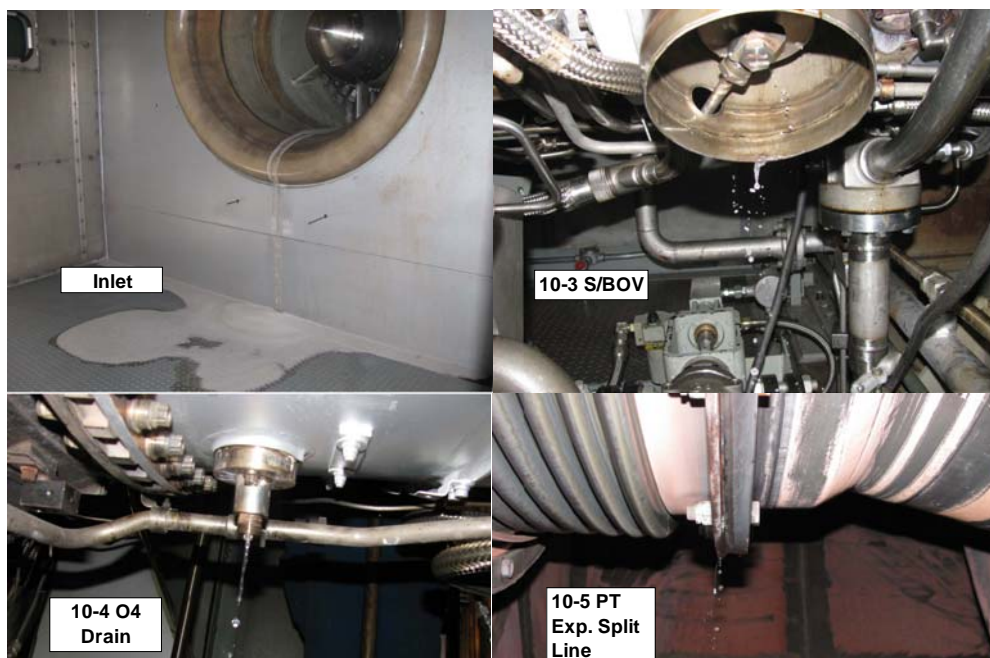
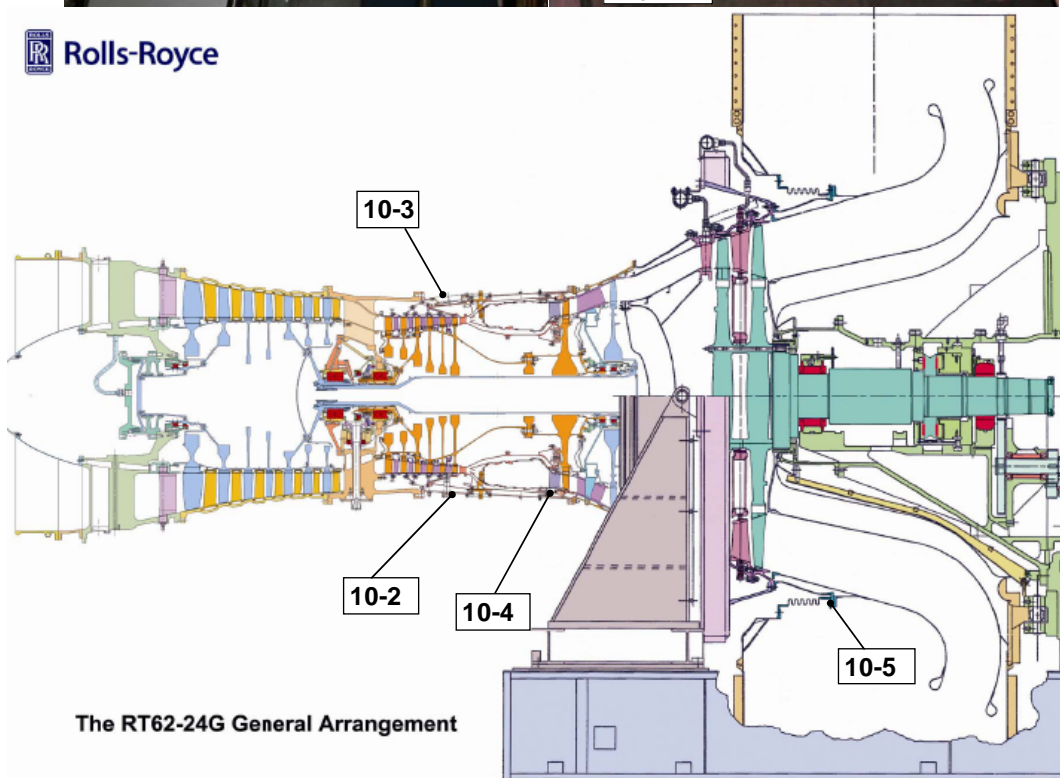
Sample	Sodium (ppm)	Chloride (ppm)	Sulphate (ppm)	Potassium (ppm)
#10-1 A2 Wash Water	-	0.19	0.53	-
#10-2 HP3 BOV Rinse	4.6	0.77	104	4.05
#10-3 SBOV Rinse	5.9	0.73	141	6.80
#10-4 O4 Drain	16.7	20.4	359	25.1
#10-5 PT Exhaust Expansion Joint Split	21.7	1.4	411	28.8

Figure 21: ICP-OES Analysis results from [50]. Image courtesy of Rolls-Royce.
