# LAND SHARK

# REPORT OF MARINE SURVEY

### LAND SHARK

CONDUCTED BY  
MICHAEL CUNNINGHAM

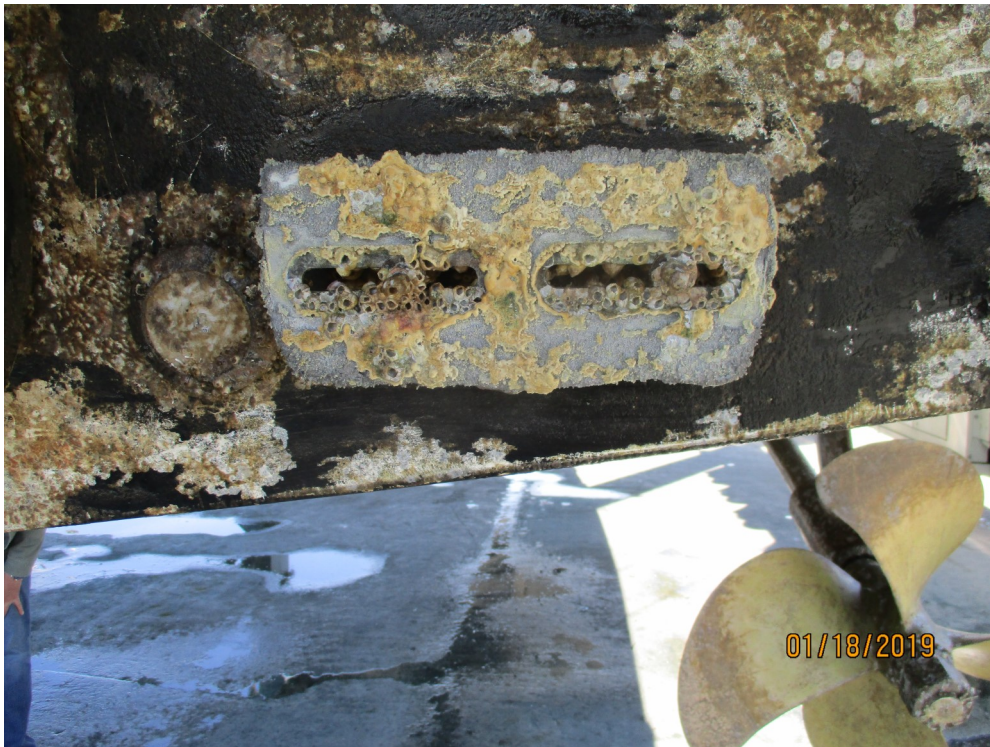
Below waterline Machinery:	The wetted surface was percussion tested at 6" -8" intervals with a phenolic hammer and is found to be free from delamination (At the time of survey). All underwater appendages showed no excessive signs of deterioration do to galvanic or electrolytic corrosion. There were no major scars or gouges.
Propeller:	4 Bladed Bronze. 33" measured, no abrasion or dings sighted. Had no blade tip erosion and rang true when tapped by a mallet
Propeller shaft:	Stainless steel 3" measured. Turns freely.
Shaft Cutlass Bearing:	Cutlass bearing showed no signs of sloppiness or end play.
Rudder::	The rudders moved smoothly from side to side, without binding, flutter or chatter. The bronze tiller arms on the rudder post and the steering mechanisms' appeared in good working order with no abnormal side , vertical nor rotational play was noted on the rudder post mechanisms.
Rudder material:	The rudder is bronze
