Your Home Inspection Report

2330 Bayview Pl, Everett, WA 98023

Z-Home Inspections

Residential Home Inspection

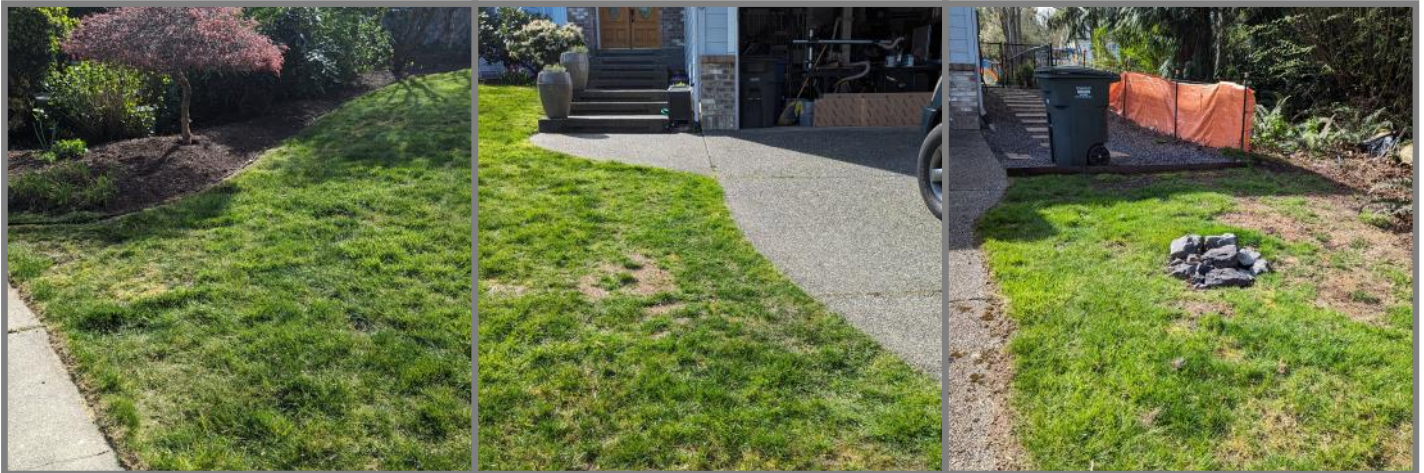
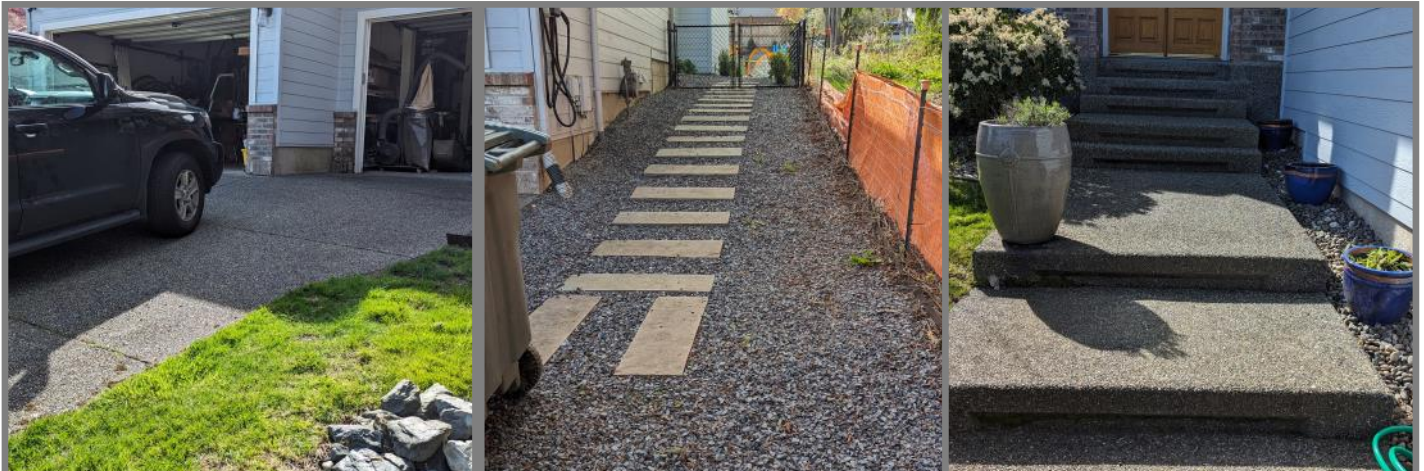
1. **Site**— The yard, concrete sidewalk, and concrete driveway were in good condition and appeared they should for a home 26 years old. The home's lot appeared to do a good job with shedding water away from the home as most of the lot is sloped downward and away from the foundation.

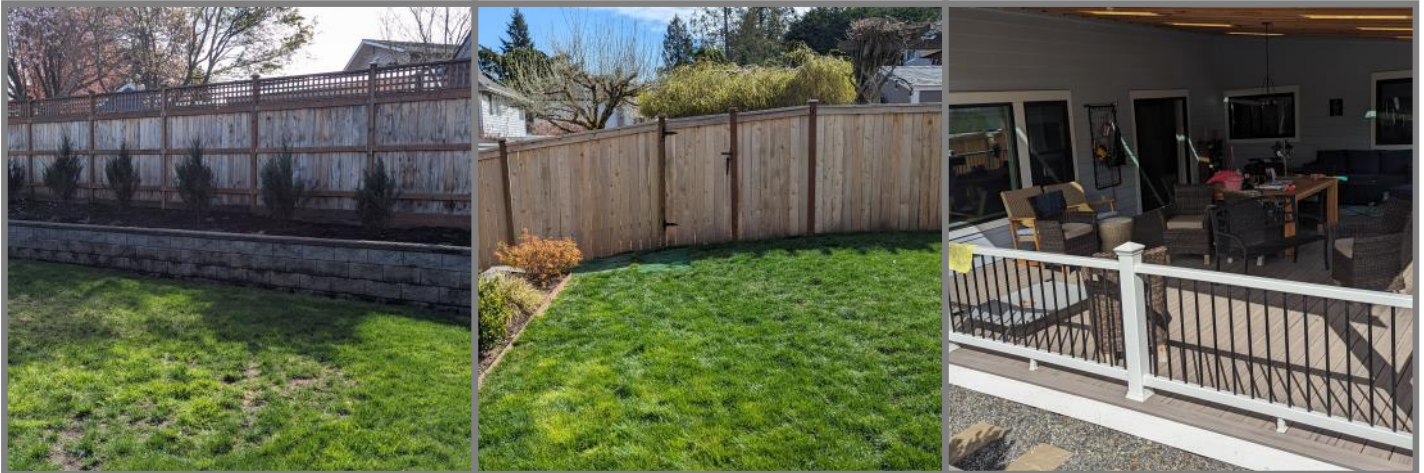
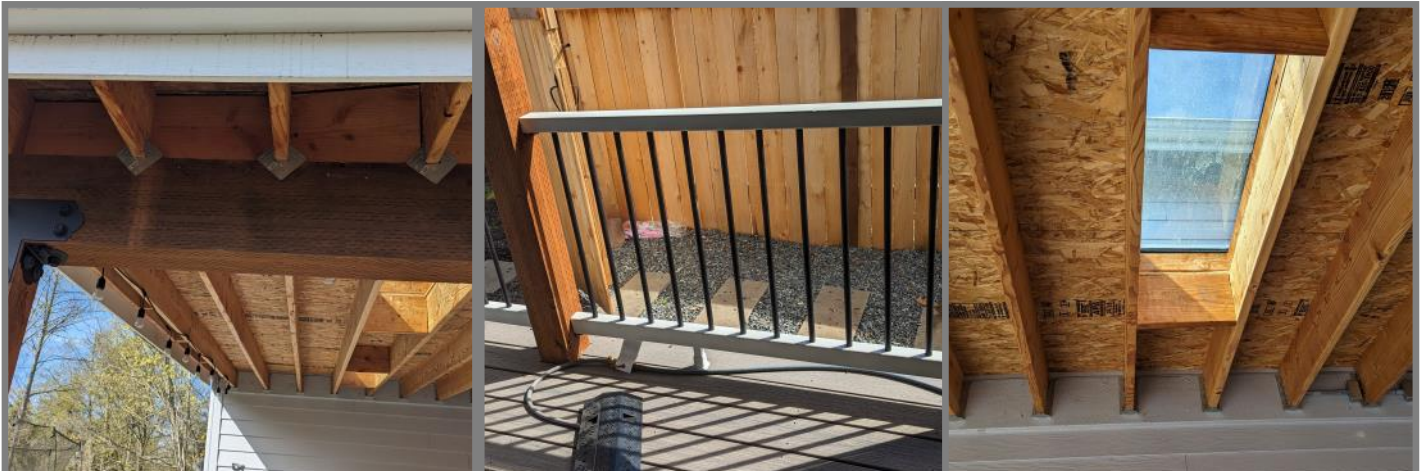
2. **Site**— The wood fence and concrete block retaining walls appeared to be in good condition during the inspection.

The wood/composite deck appeared to be in good condition and properly attached to the home with a ledger board and anchor bolts. All handrails were in good condition.

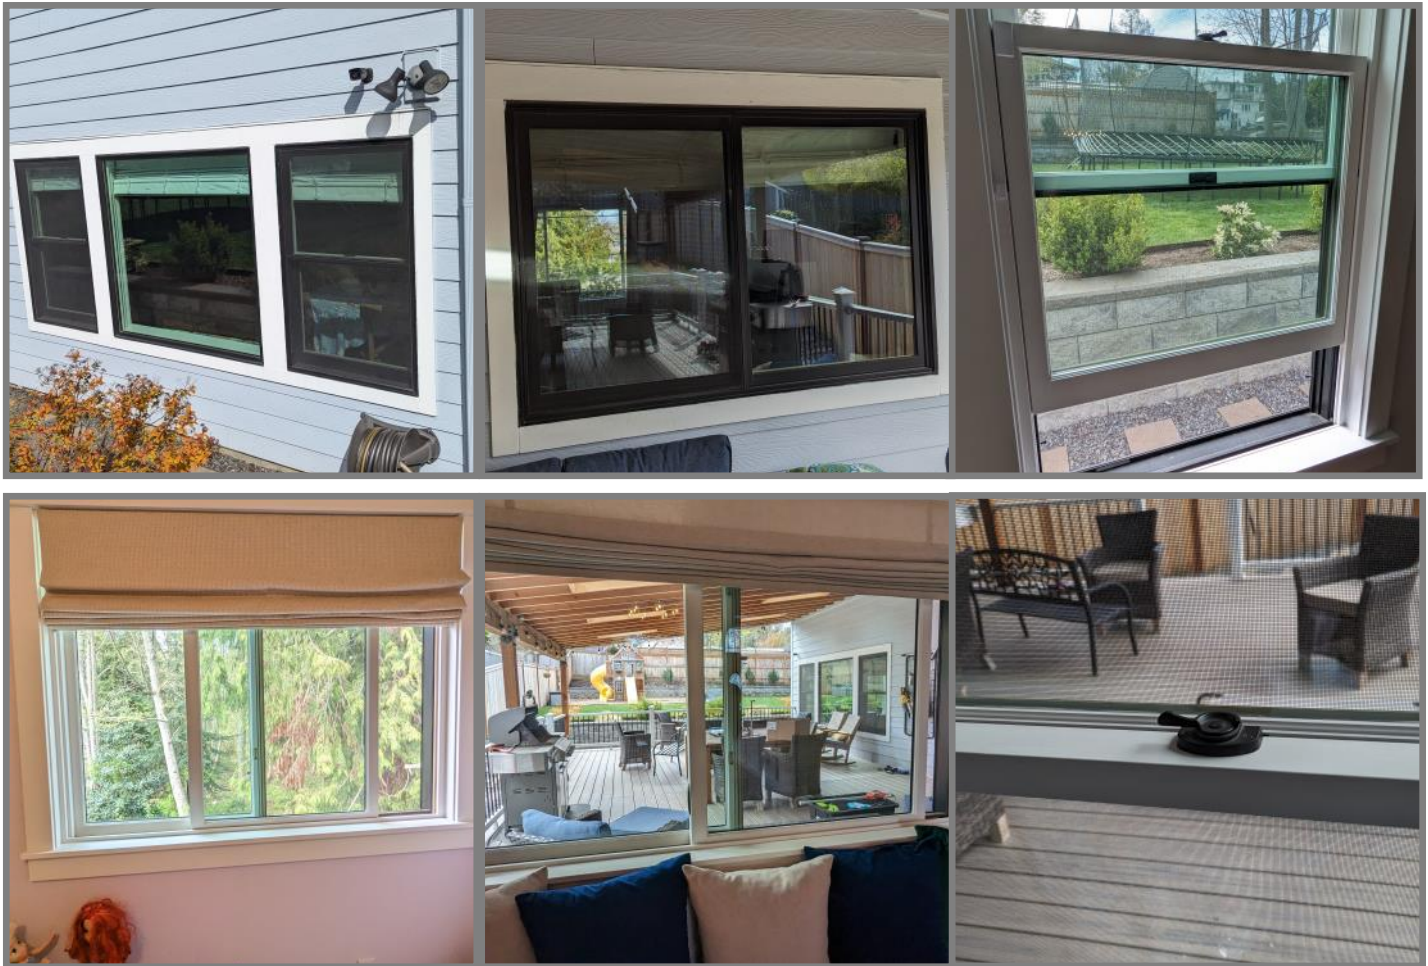
The home appears to have the original double pane vinyl framed windows on the original portion of the home. All original windows tested did operate as they should.

The home appears to have updated aluminum double pane windows on the addition portion of the home. All the updated windows did operate properly during the time of the inspection.

No jamming or loose window panels were detected at the time of the inspection.

There were no signs of failed window seals or broken glazing or glass.

All operable windows tested did lock properly at the time of the inspection.

Most screens appeared to be in place and in good condition.

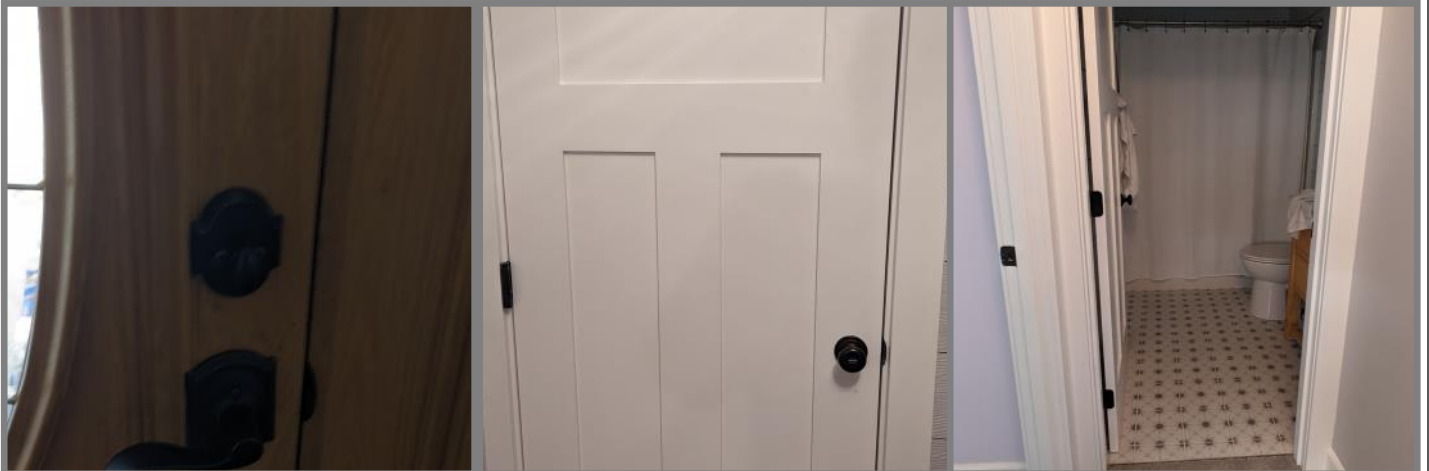
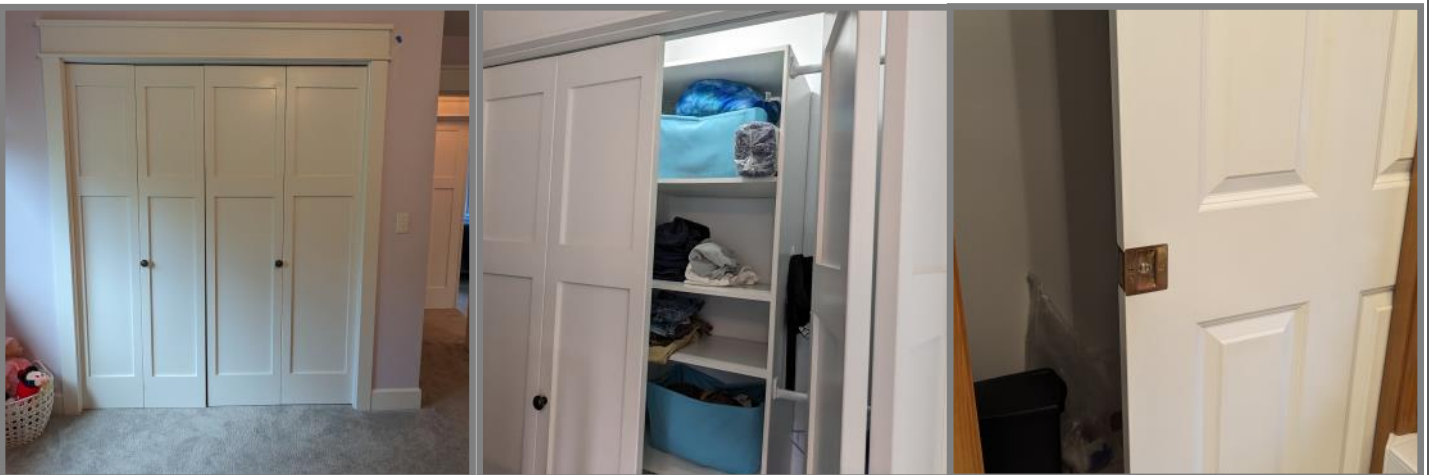
The home appears to have the original and updated exterior and interior doors throughout the home. All doors tested did operate as they should.

No jamming or loose fitting door jams were detected at the time of the inspection.

There were no signs of failed or missing door hardware.

All operable doors and door deadbolts tested and did operate properly at the time of the inspection.

All closet doors operated properly appeared to be in good condition.

The man-door to the attached garage was self-closing and self-latching as is required per fire codes.

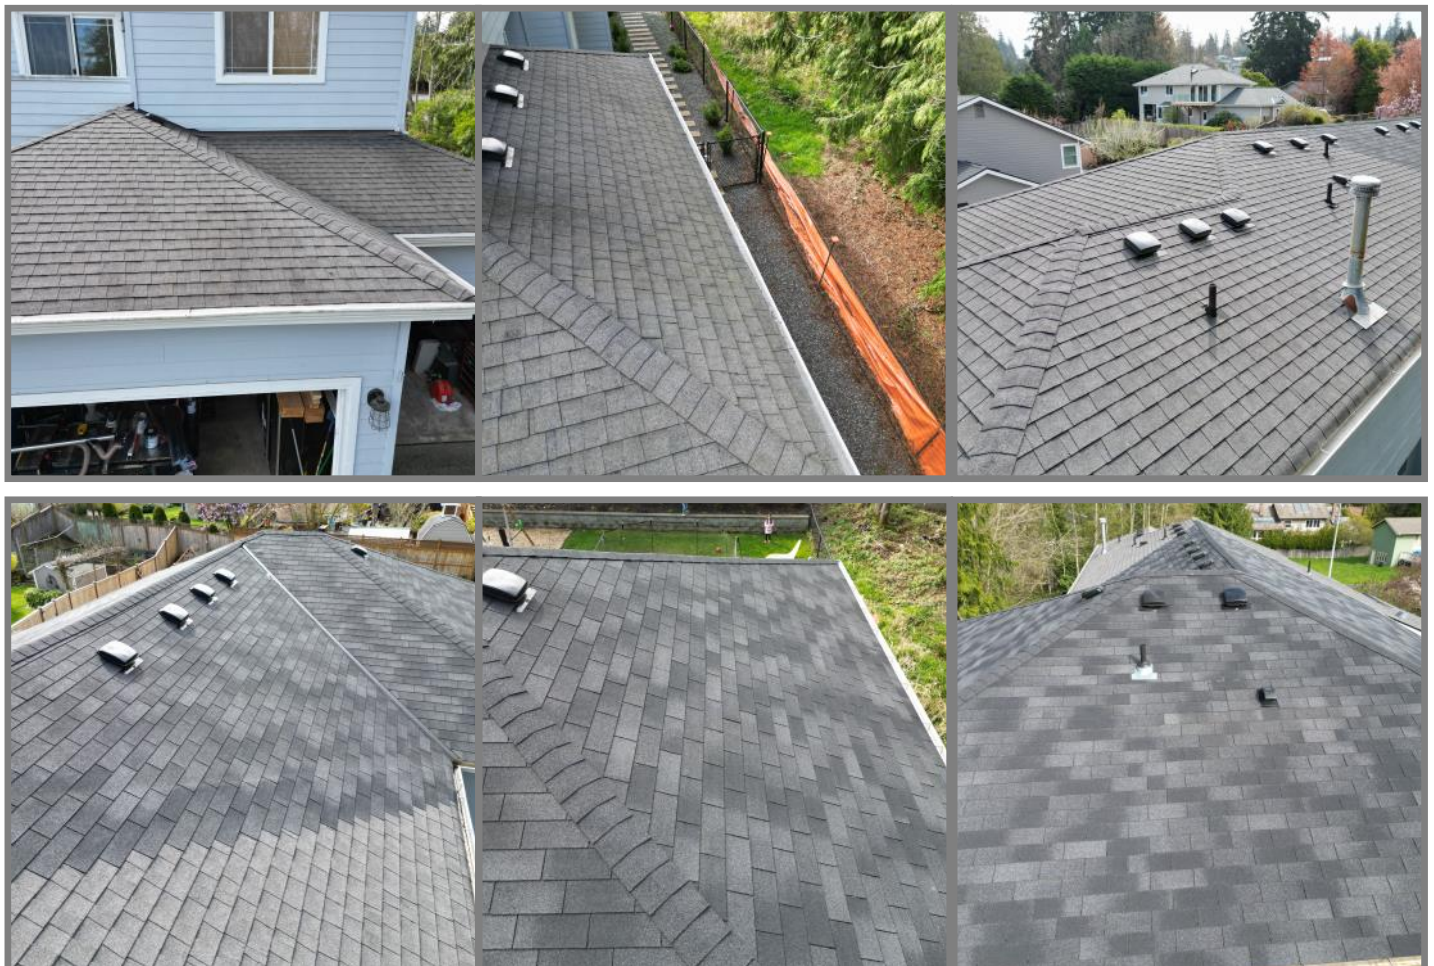
There was the original architectural composite asphalt and the updated three-tab composite asphalt type roofing materials. The original roof cover is located on the front portion of the home and the newer roof cover is located on the addition to the home.

All materials looked to be intact and in good condition during the time of the inspection. There were no signs of significant granule loss, curling and/or damaged materials. There were no signs of excessive moss build-up.

This roof covering should protect the home for at least 8+ more years under normal weather conditions and regular maintenance.

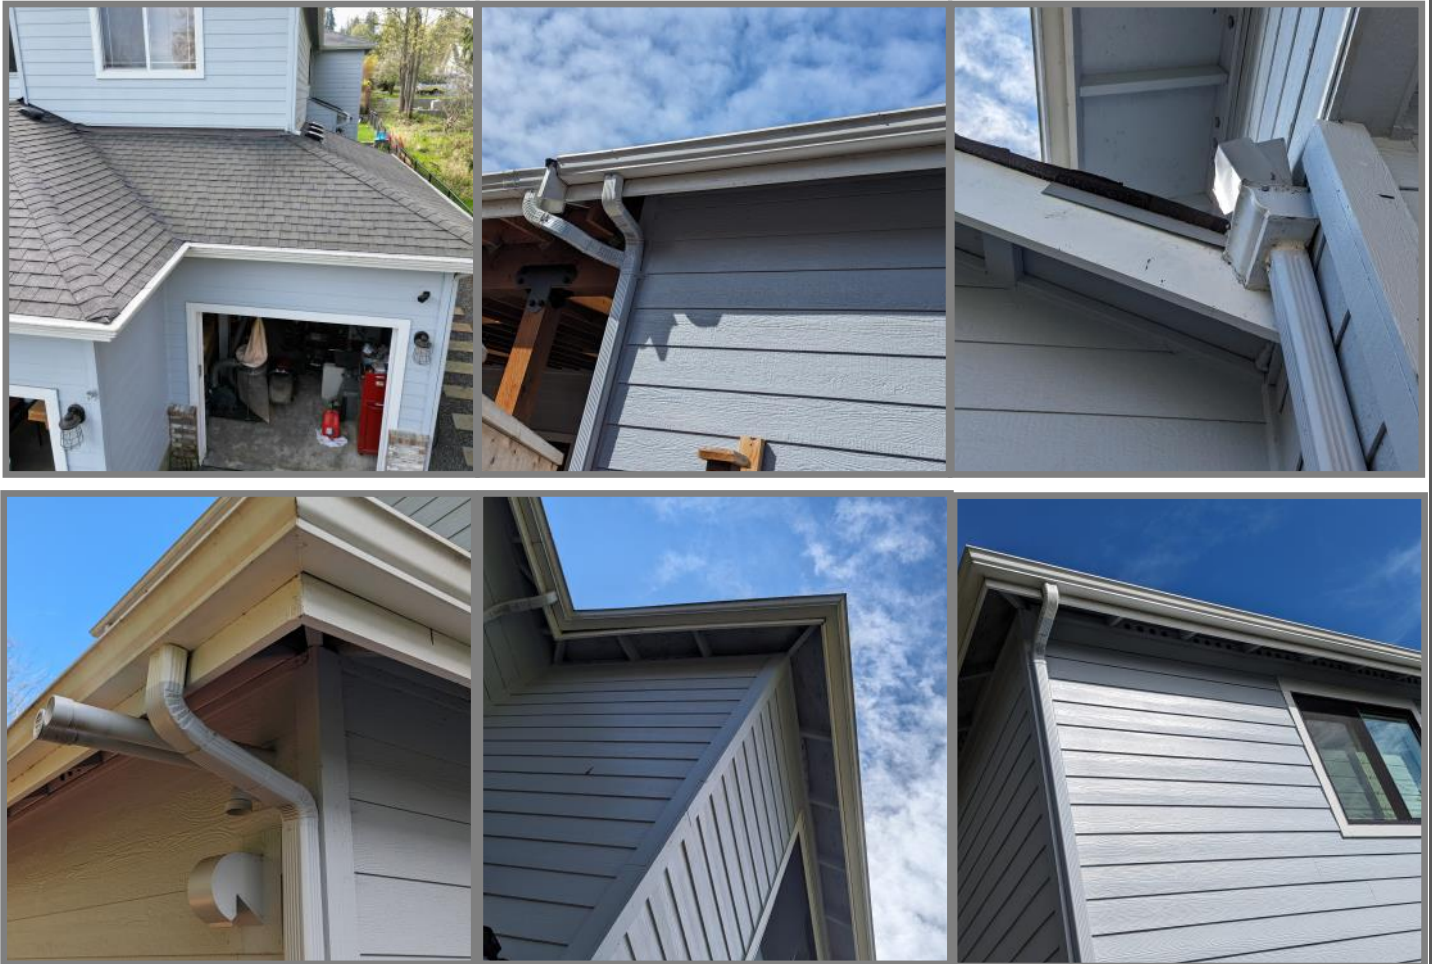
The gutters appear to be in good condition and well attached to the home.

Note: Recommend establishing a regular maintenance schedule for having the gutter system cleaned and maintained to ensure the gutters are effectively protecting the home.

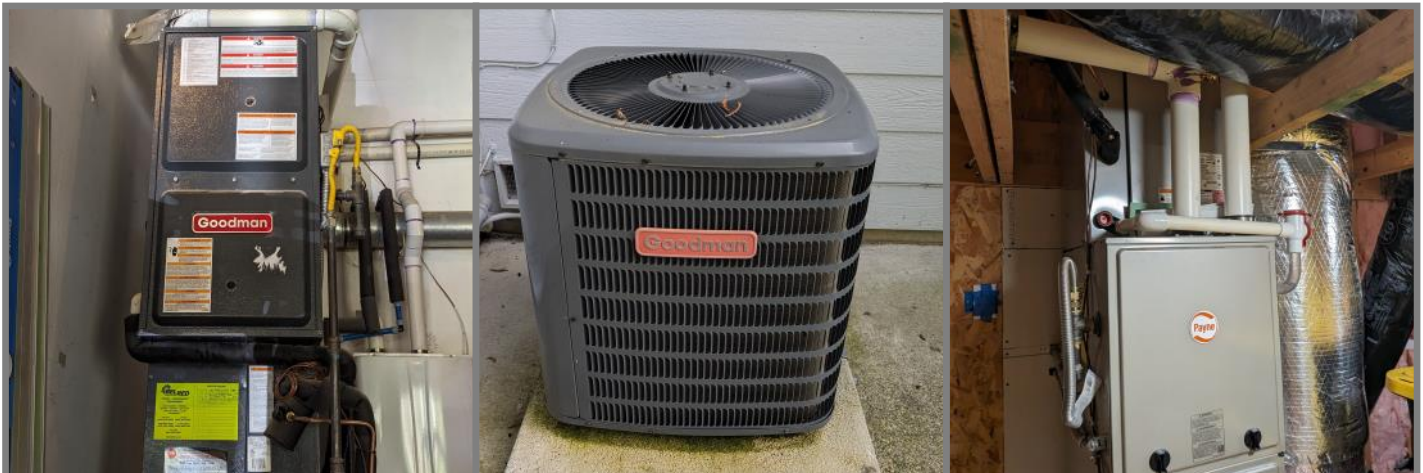
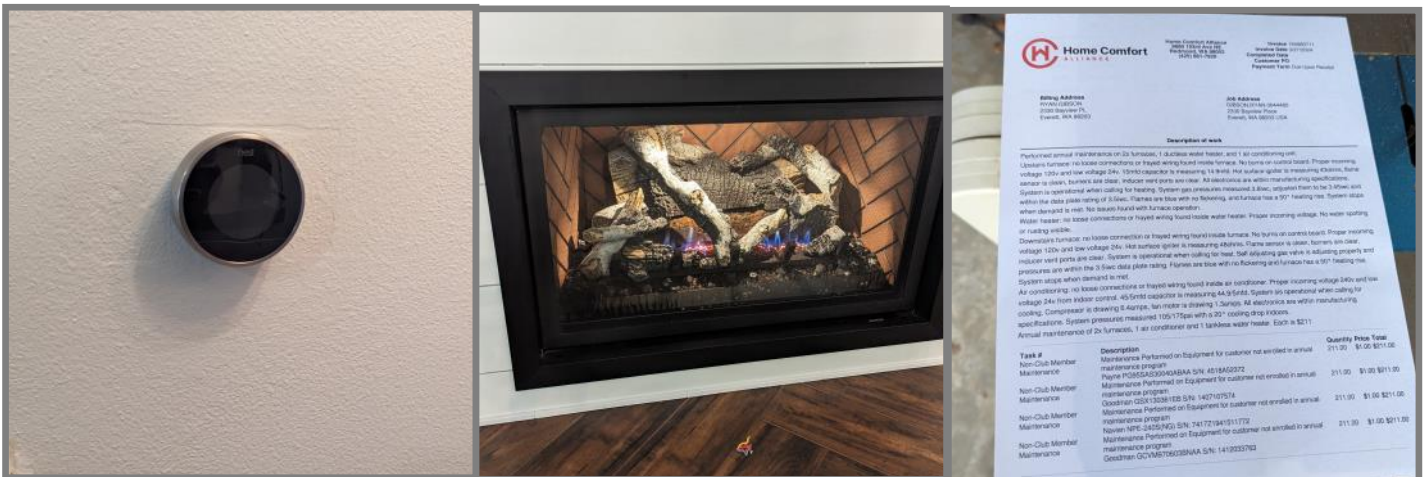
Both of the gas furnaces have been recently professionally serviced.

The gas fireplace located in the living/dinning room of the home did activate during the time of the inspection.

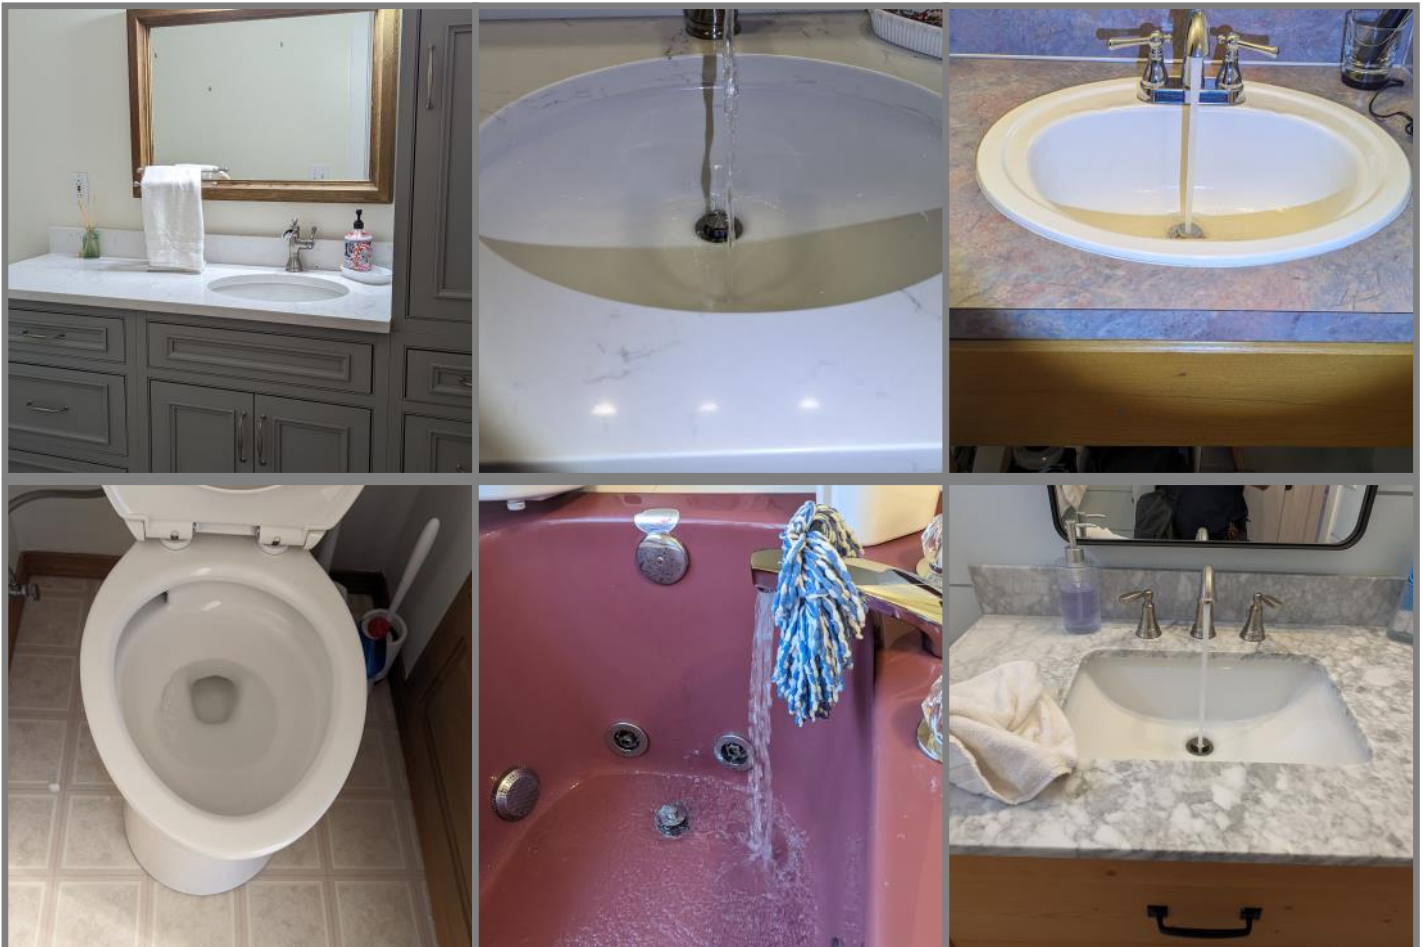
Master Bathroom:

All faucets, toilets, showers and exhaust fans were tested and operated as they should.
All bathroom built-in cabinets doors and drawers were tested and operated as designed.
The jacuzzi portion of the bathtub was not activated during the inspection.
No leaks were detected.

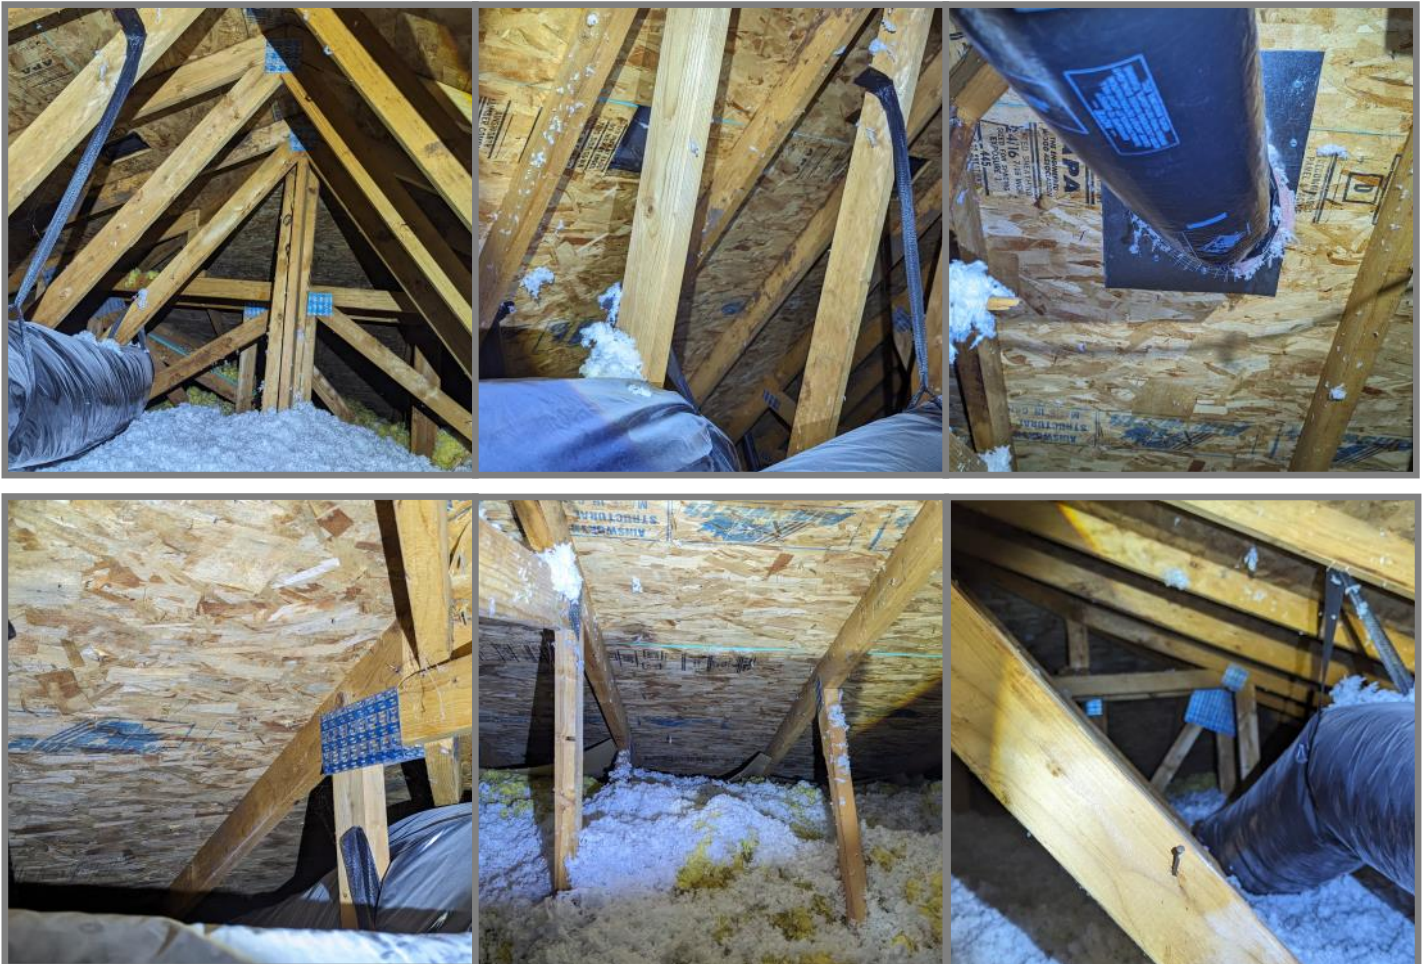
All wood rafters/ wood roof trusses, wood sheathing, other materials appeared to be in good condition, properly constructed.

All materials showed no signs of any water intrusion/ damage during the time of the inspection.

The attic space did appear to have the appropriate amount of ventilation.
