Your Home Inspection Report

6751 Waterton Cir. Mukilteo, WA 98275

4/13/2023 3:00pm – 5:00pm

Residential Home Inspection

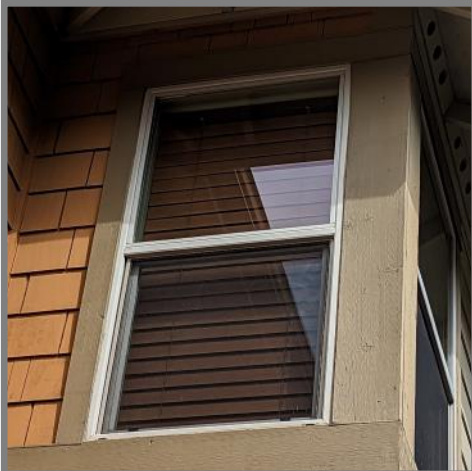
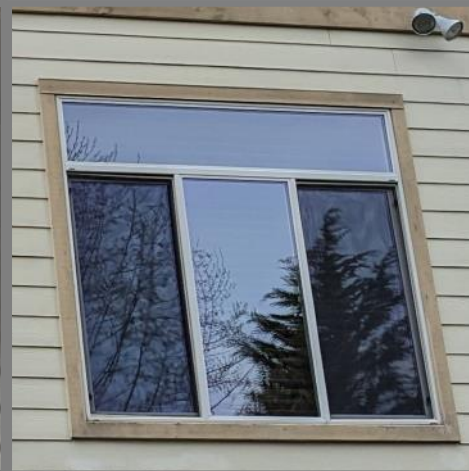
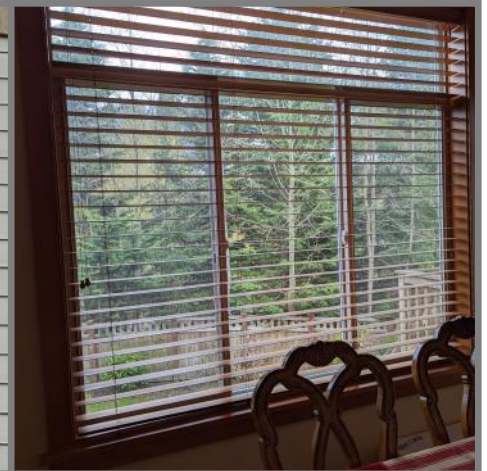
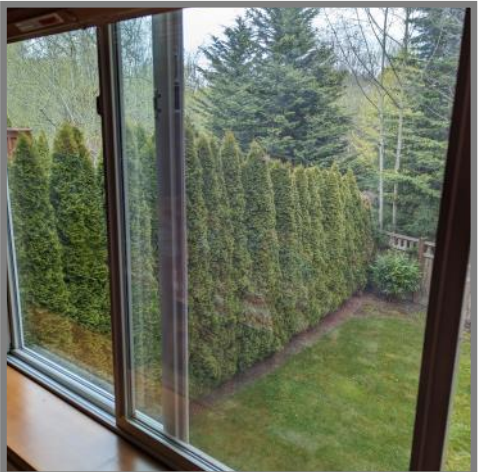
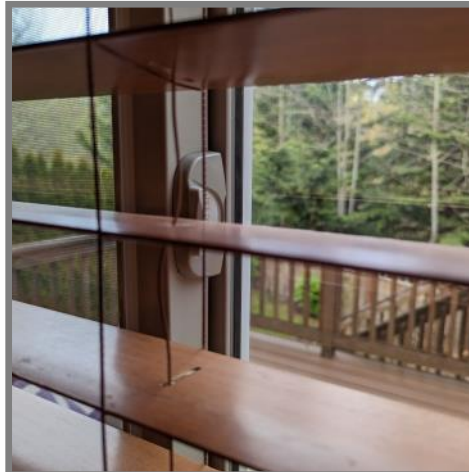
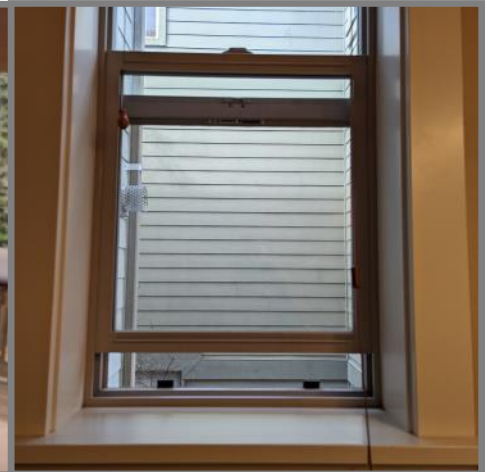
3. Windows:

The home appears to have the original double pane vinyl framed windows. All windows tested did operate as they should.

No jamming or loose window panels were detected at the time of the inspection.

There were no signs of failed window seals or broken glazing or glass.

All operable windows tested, did lock properly at the time of the inspection.

All screens appeared to be in place and in good condition.

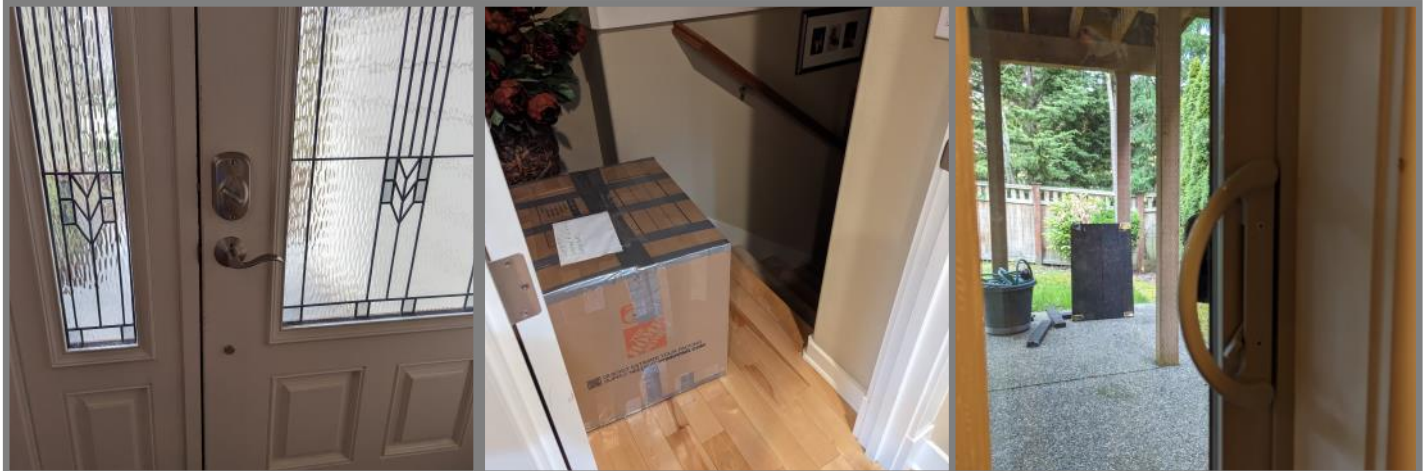
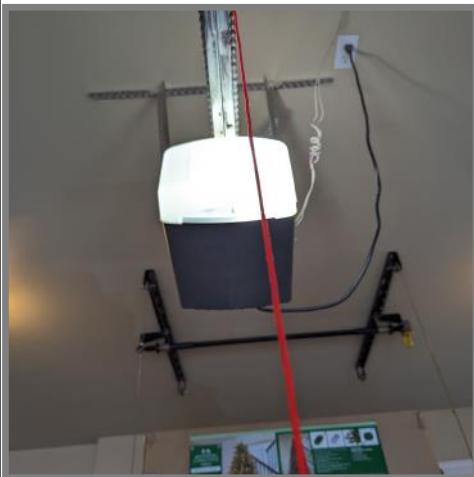
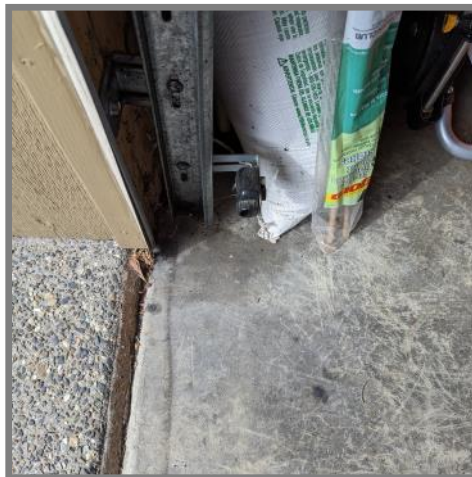
4. Doors:

The home appears to have the original exterior and interior doors throughout the home. All doors tested did operate as they should.

No jamming or loose fitting door jams were detected at the time of the inspection.

There were no signs of failed or missing door hardware.

All operable doors and door deadbolts tested and did operate properly at the time of the inspection.

All closet doors operated properly appeared to be in good condition.

The two car garage door did activate properly during the time of the inspection. The safety photo eyes to the garage door were tested and did activate properly.

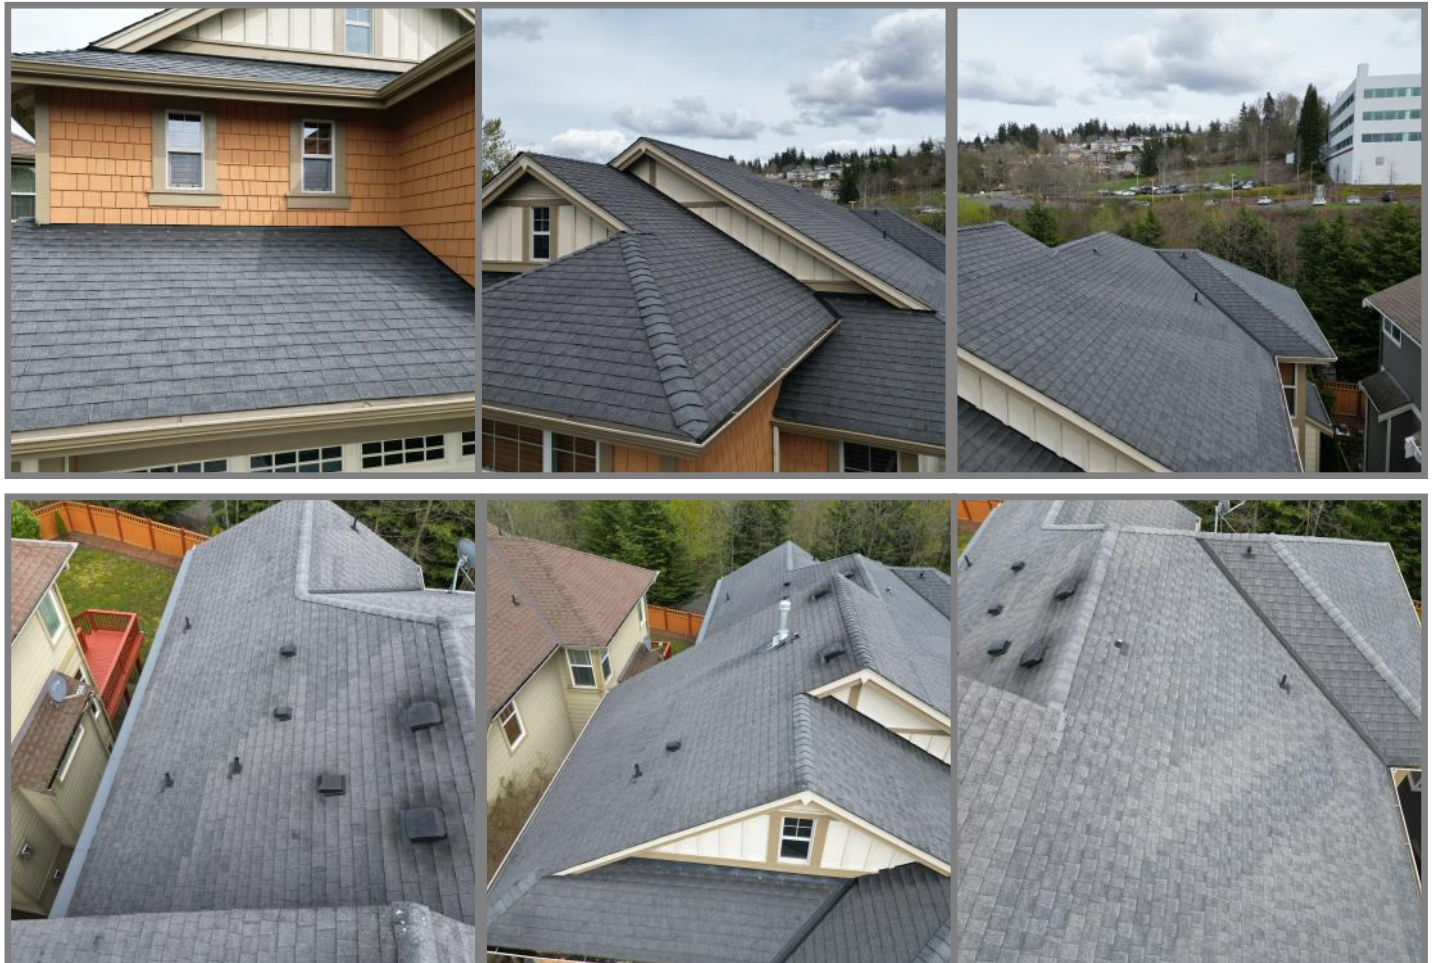
4. Roof

There was the architectural composite asphalt type roofing material.

All materials looked to be intact and in good condition during the time of the inspection. There were no signs of significant granule loss, curling and/or damaged materials. There were no signs of excessive moss build-up.

This roof covering should protect the home for at least 12+ more years under normal weather conditions and regular maintenance.

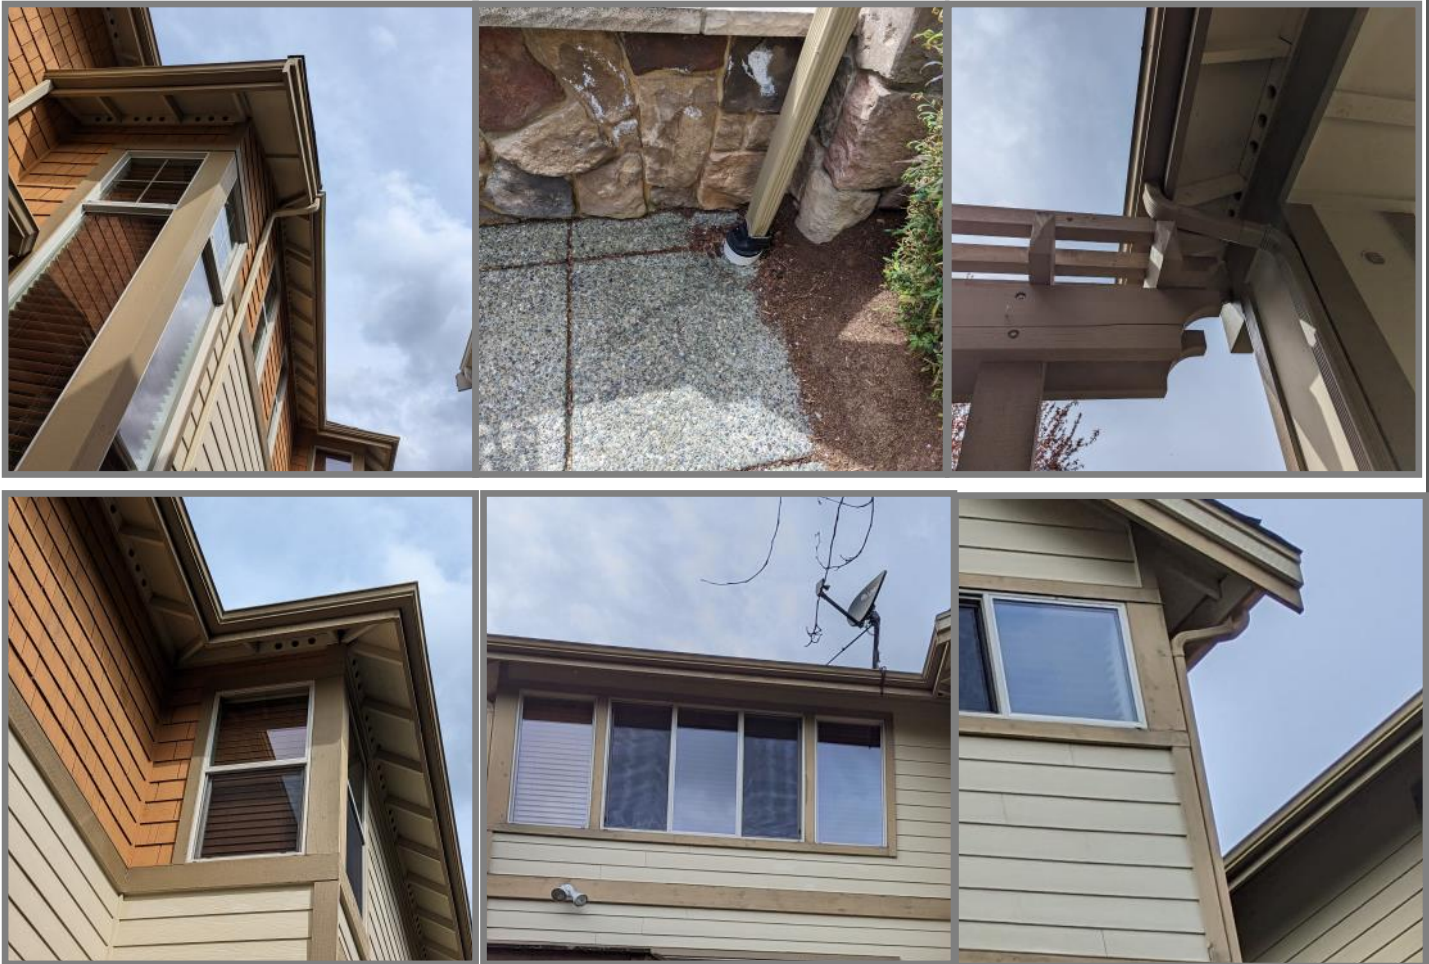
5. Gutters and Downspouts

The gutters appear to be in good condition and well attached to the home.

The gutters appear to have an adequate number of downspouts to help keep rainwater flowing away from the home on all sides.

Note: Recommend establishing a regular maintenance schedule for having the gutter system cleaned and maintained to ensure the gutters are effectively protecting the home.

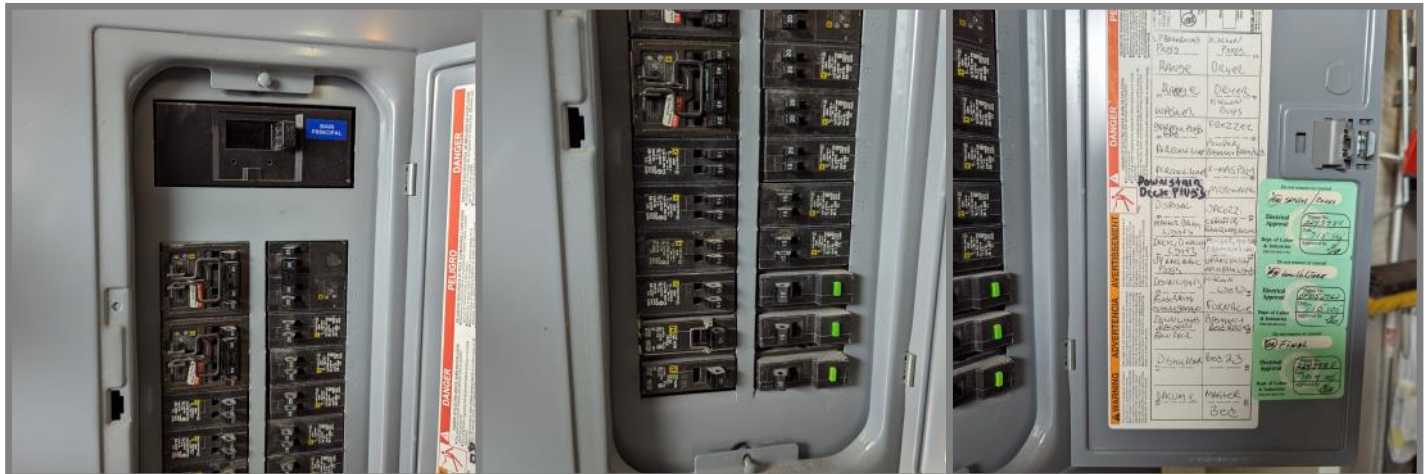
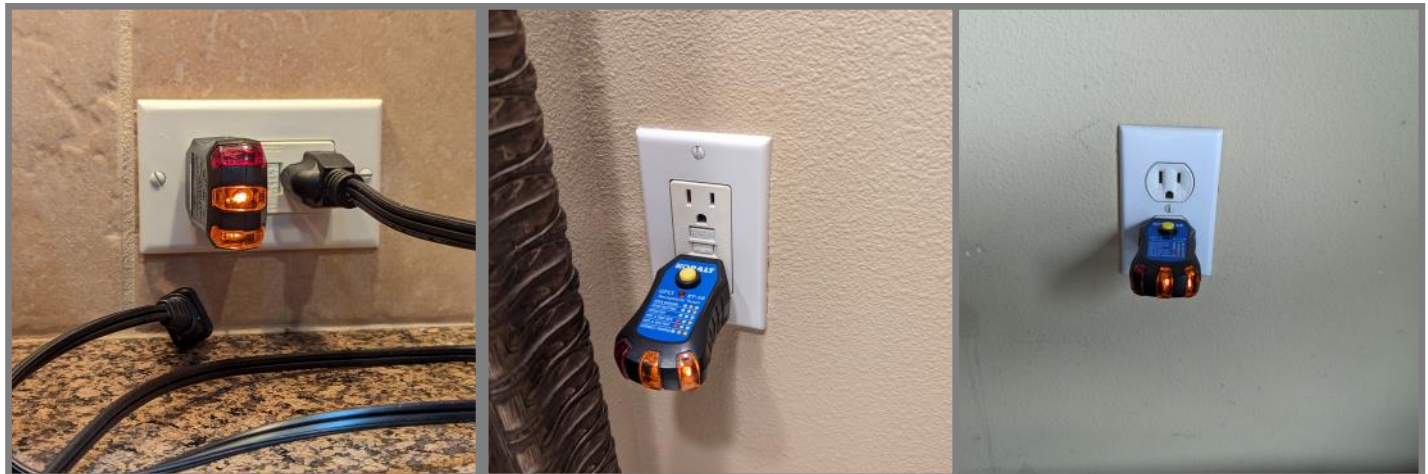
6. Electrical

The panel appeared to be the original panel and in good condition.

All GFCI's were tested and worked properly.

All electrical outlets were tested and did test as properly wired and properly grounded.

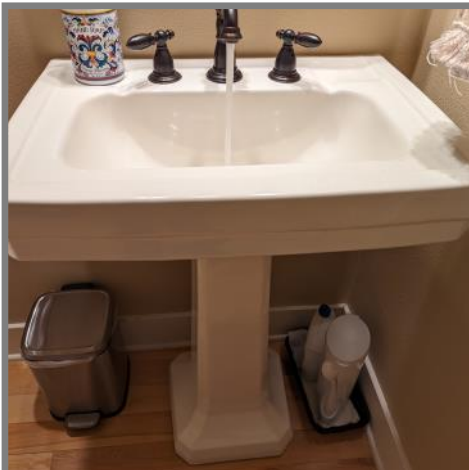
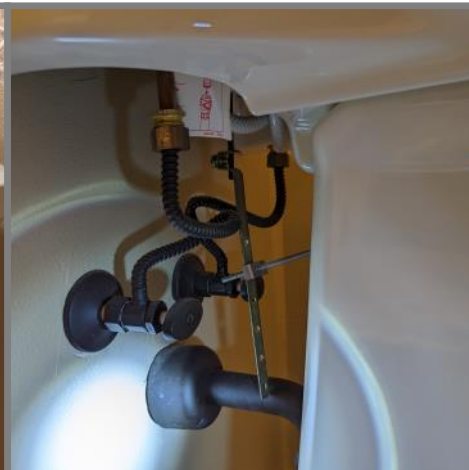
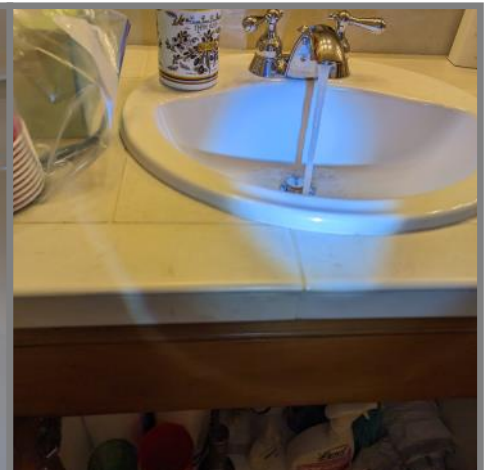
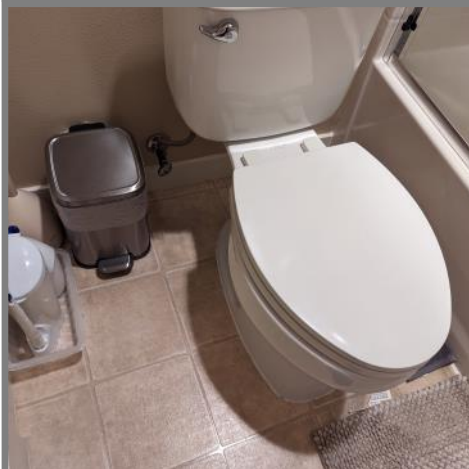
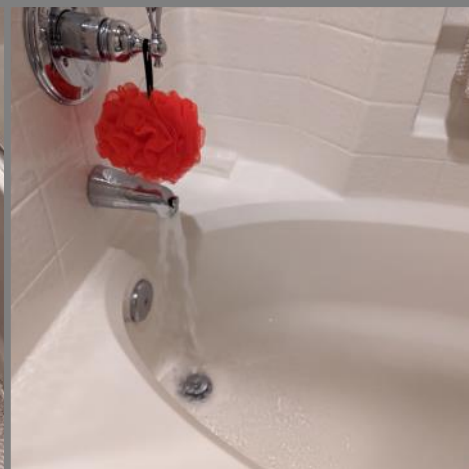
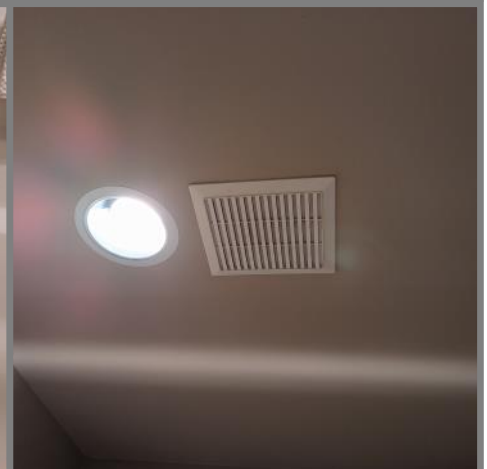
10. Bathroom

All faucets, toilets, showers and exhaust fans were tested and operated as they should.

All bathroom built-in cabinets doors and drawers were tested and operated as designed.

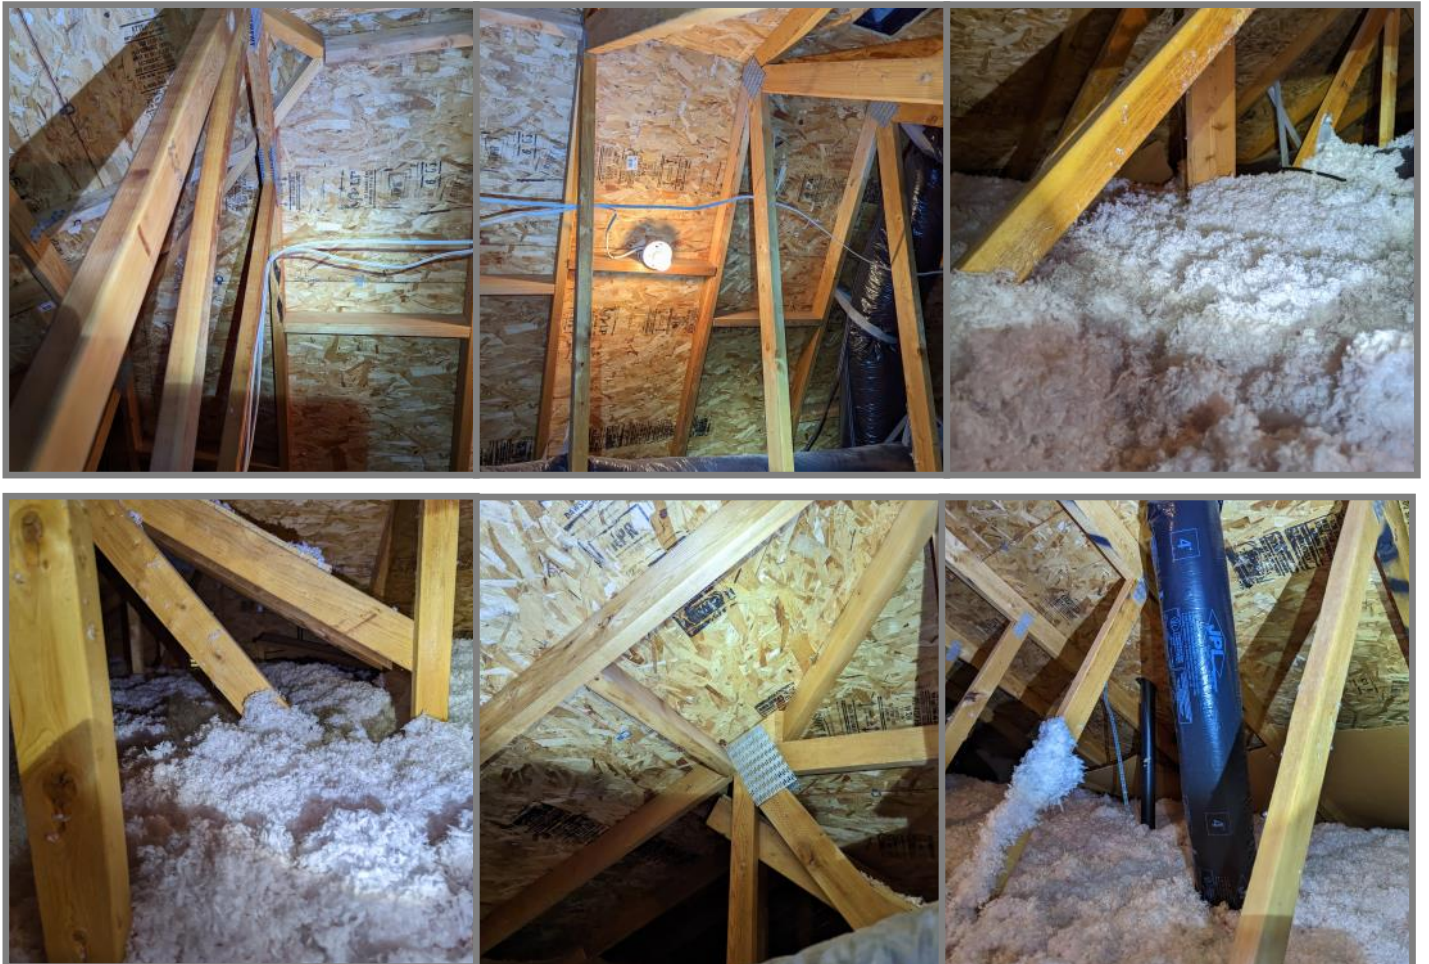
All wood rafters/ wood roof trusses, wood sheathing, other materials appeared to be in good condition, properly constructed.

All materials showed no signs of any water intrusion/ damage during the time of the inspection.

The attic space did appear to have the appropriate amount of ventilation.

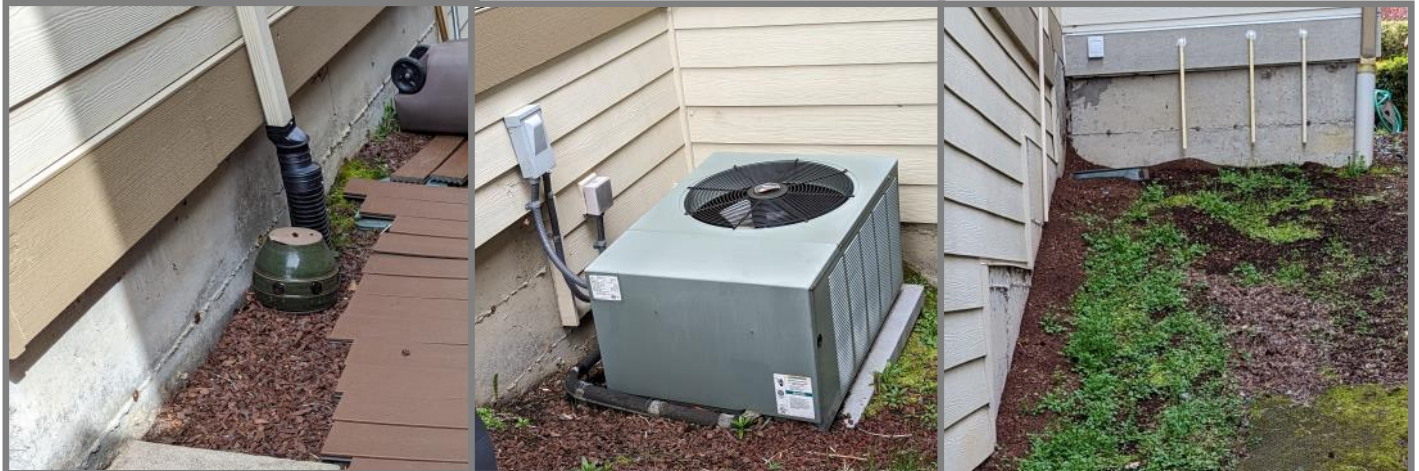
13. Foundation—Slab/Basement:

The poured concrete slab foundation appeared to be in good condition.

There were no signs of major cracks or movement in the concrete foundation during the time of the inspection.

There were **no** signs of typical foundation issues such as, uneven floors, cracks in the interior ceiling and walls and/or jamming windows and doors.
