Your Home Inspection Report

5518 148th PL SW, Edmonds, WA 98026

Residential Home Inspection

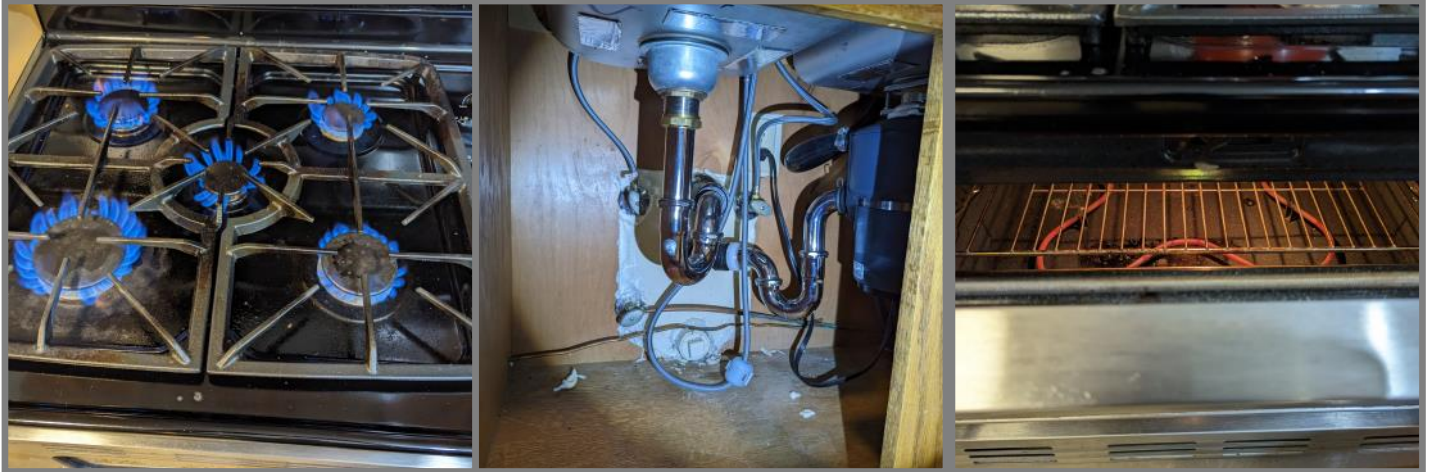
The both ovens, gas stove top, built-in microwave, garbage disposal, exhaust fan and dishwasher were operational during the time of the inspection.

All kitchen built-in cabinets doors and drawers were tested and operated as designed.

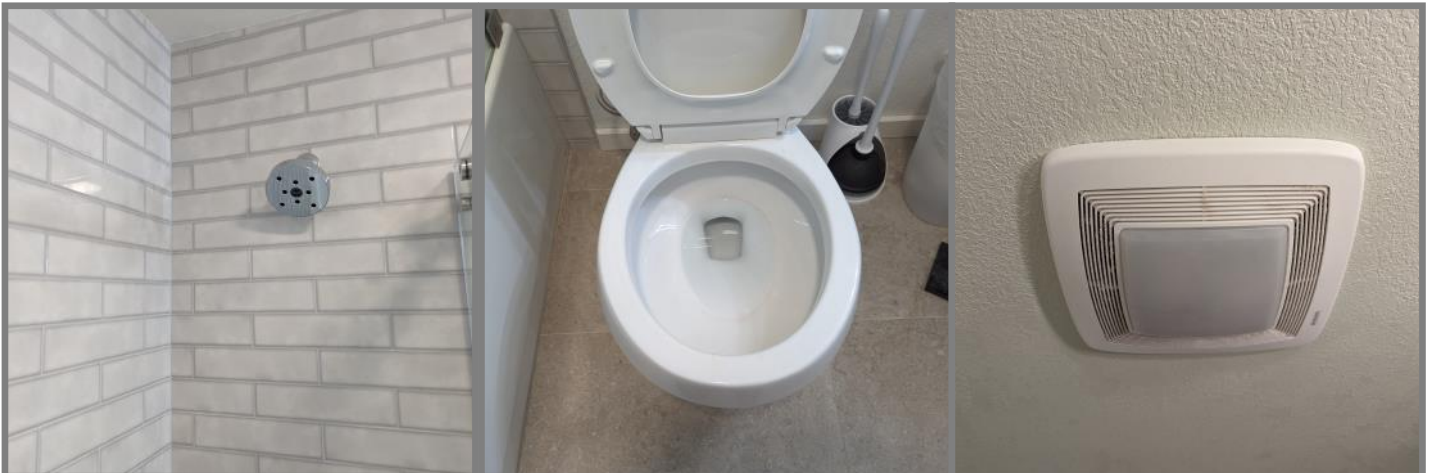
10. Bathroom

All faucets, toilets, showers and exhaust fans were tested and operated as they should.

All bathroom built-in cabinets doors and drawers were tested and operated as designed.

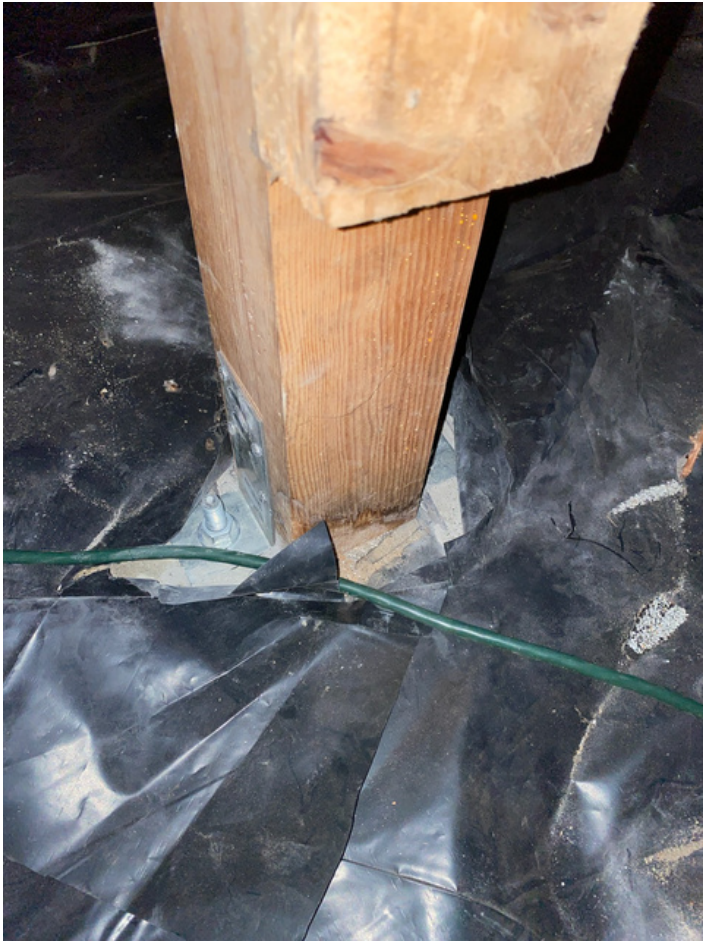
3 posts secured by contractor. No sag or compromise to floor joists was noted.
