FULL RESERVE STUDY

Victorian Condominium Association

Cleveland Heights, Ohio
August 23, 2018

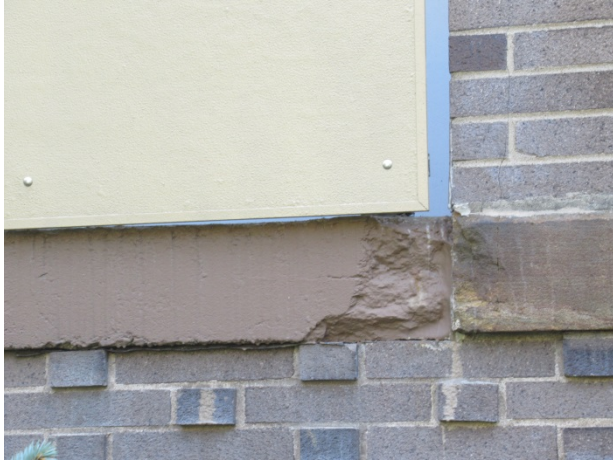
Condition: Good to fair with areas of spalled concrete and minor efflorescence present

Spalled balcony concrete

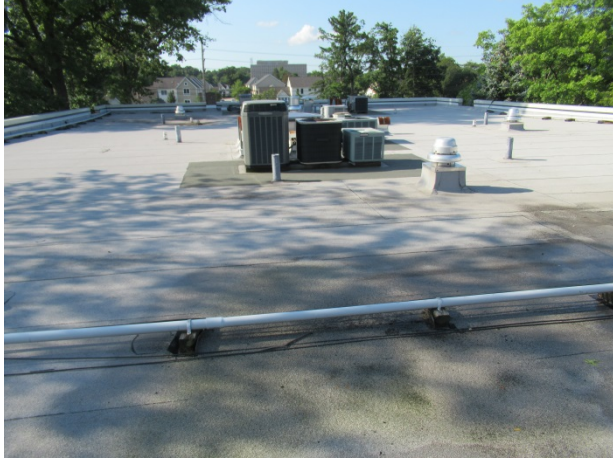
Modified bitumen overview

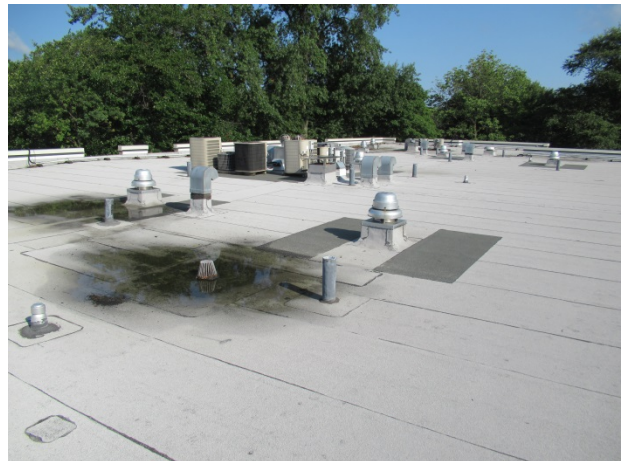
Condition: The main roofs are in good overall with isolated loose membrane and ponding water evident. We note debris build-up at the drains. Drains should be inspected regularly and keep clear to avoid severe water ponding, which may result in leaks. The deck roofs are in fair to poor condition, with weathering, loose membrane and ponding. The Board does not report history of leaks.

Roof overview, note ponding water and build-up at drain

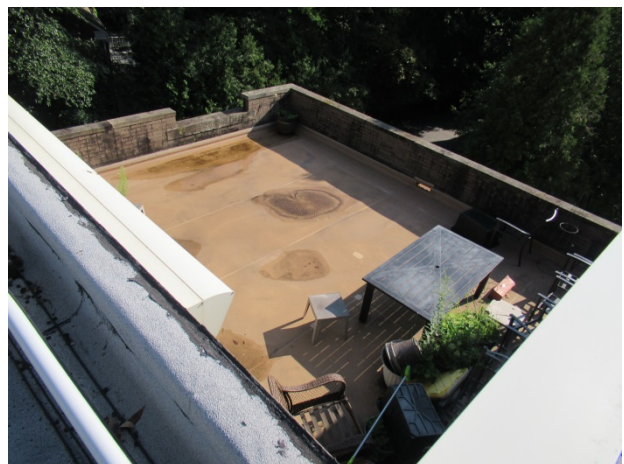
Membrane at balcony

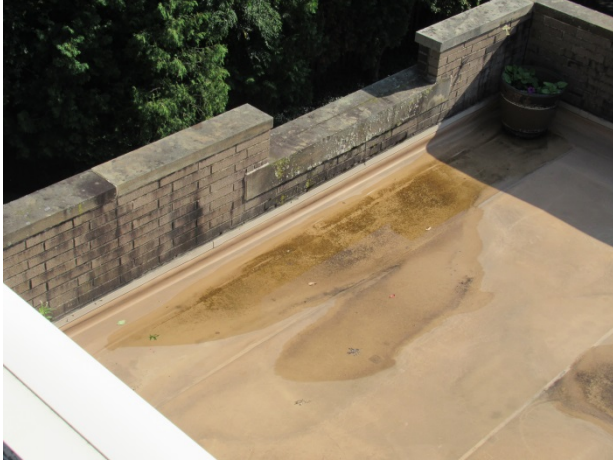
Loose membrane and ponding water at balcony

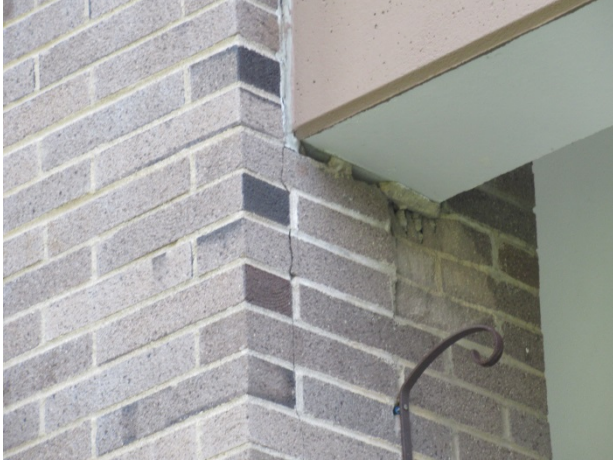
- Previous repairs evident
- Lintels exhibit rust
- Masonry exhibits cracks, particularly adjacent to balconies and at the base of the walls
- Masonry exhibits spalls at stone near balconies
- Mortar loss is evident at lintels and below sills
- Stains are present
- Mortar joints are tooled
- Weeps and flashing at lintels are not visible
- Sealant failure is typical

Cracked and spalled masonry below balcony

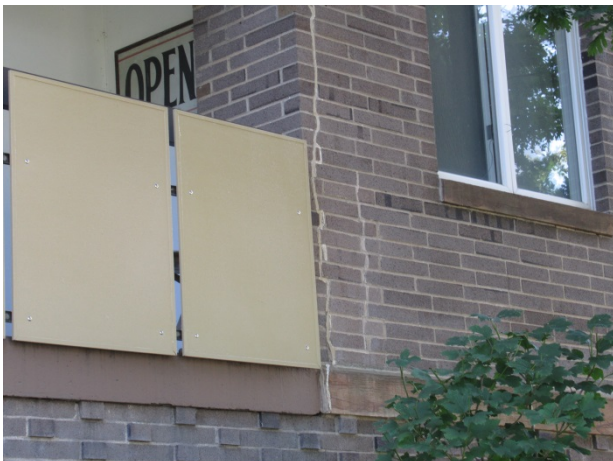
Previous masonry repairs

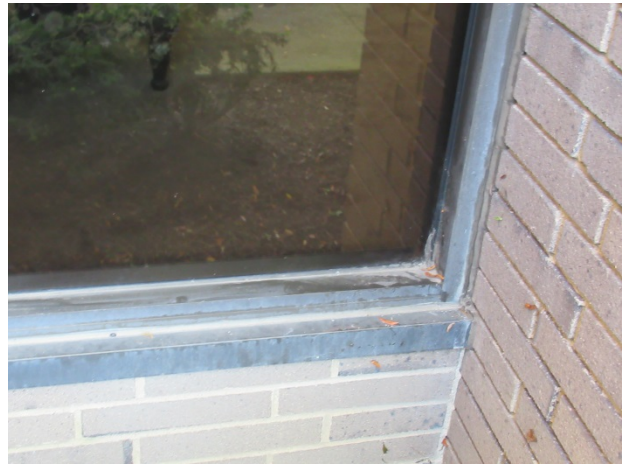
Condition: Fair overall, with frame discoloration at the lobby aluminum frames

Lobby window frame, note discoloration

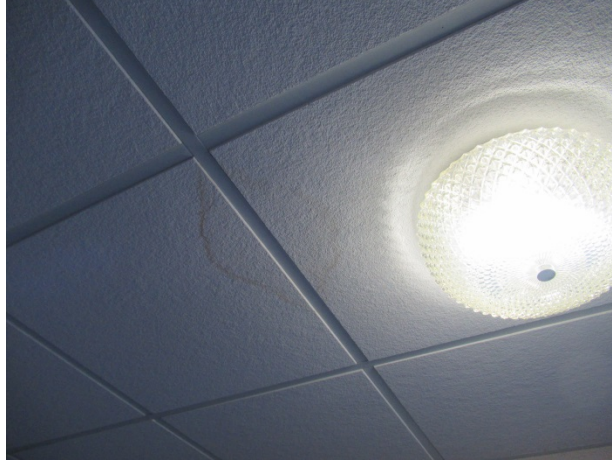
Ceiling tile stain at hallway

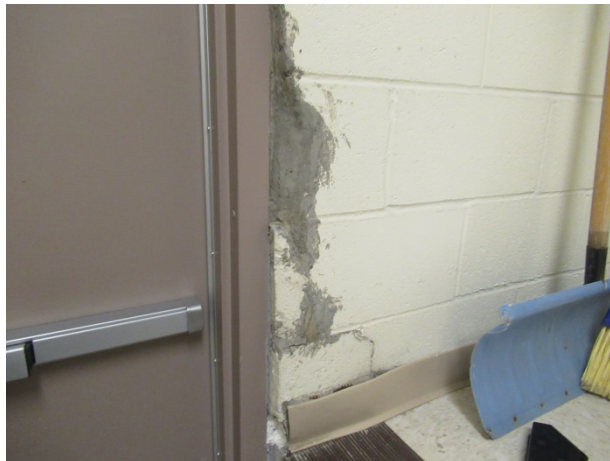
Conditions: Good to fair with isolated wall cracks and repairs evident

Stairwell wall repairs

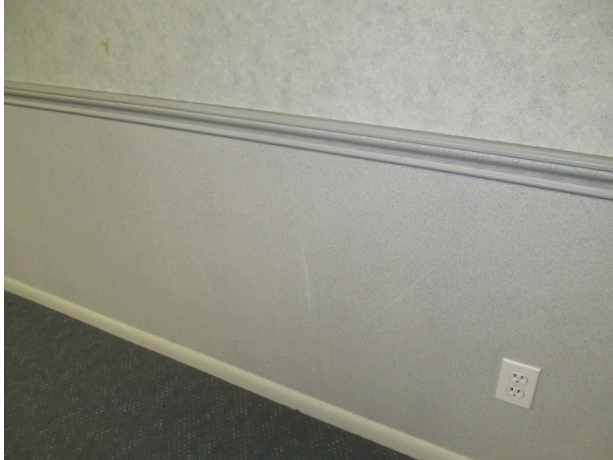
Condition: Good to fair with limited peeling and loose wallpaper, and minor scuffs

Scuffed wall coverings at billiards room

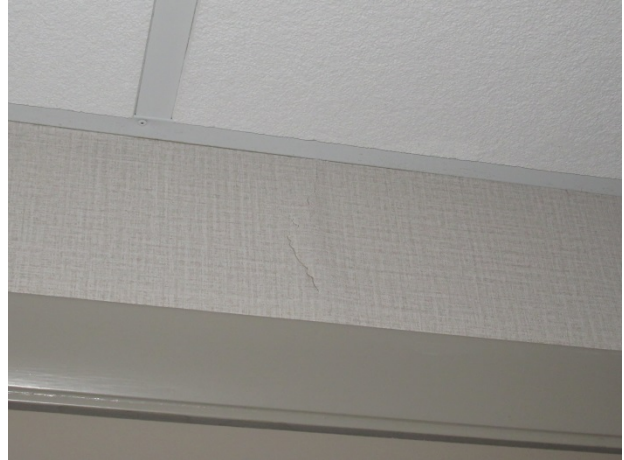
Torn wall coverings at second floor

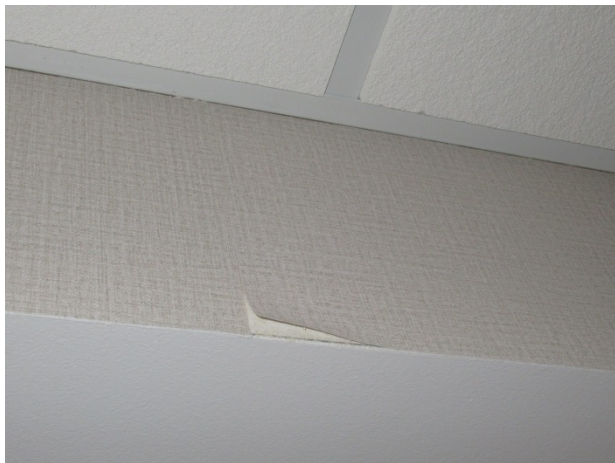
Lifted wall coverings

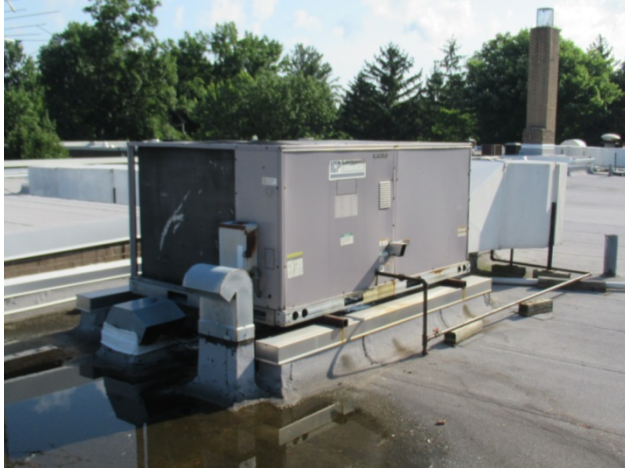
Condition: Reported satisfactory without operational deficiencies

West hall rooftop unit

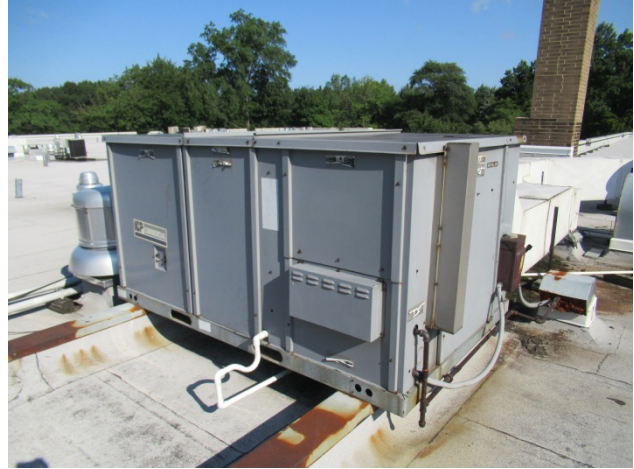
East hall rooftop unit

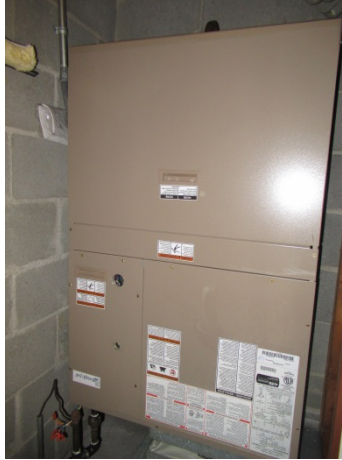
Condition: Reported satisfactory without operational deficiencies

Split system furnace

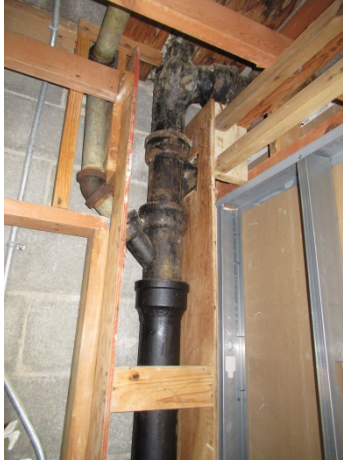
Location of pipe repair at part room 'build-out'

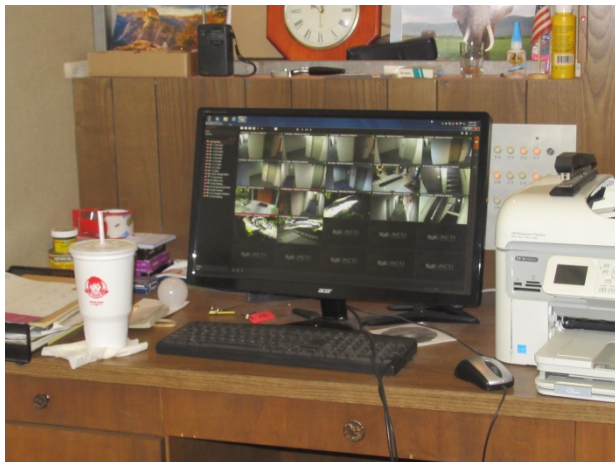
Condition: Reported satisfactory

Security system display

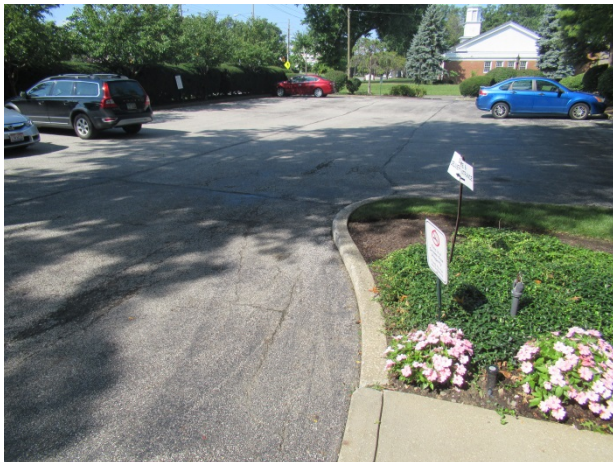
Condition: Fair to poor with cracks, pavement deterioration and potholes evident

Front parking area pavement

History: Last repaved in 1992. The Association plans to mill and overlay the rear pavement in 2019, and crack fill and repair the front pavement.

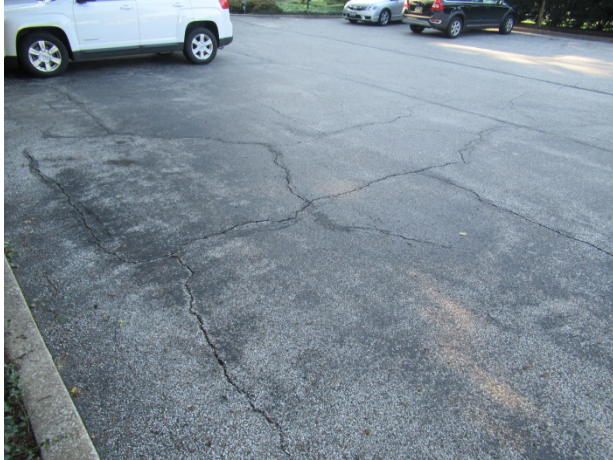
Front pavement cracks

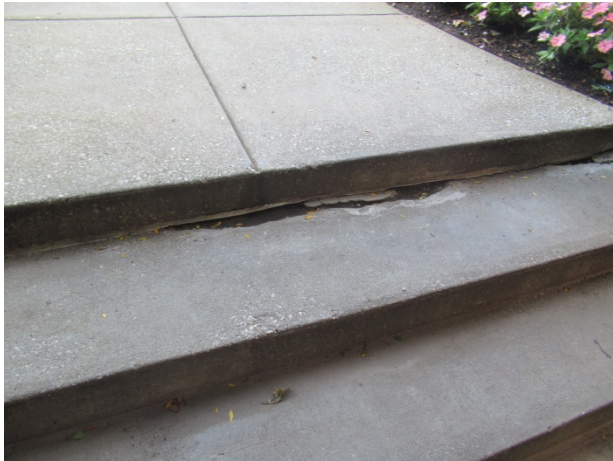
Condition: Good to fair, with spalls, cracks and areas of settlement present.

Entrance concrete step deterioration

History: The Association plans to spend approximately \$6,500 in 2019 to replace the concrete flatwork at the garage threshold, the front driveway apron and partial replacements to the rear apron.

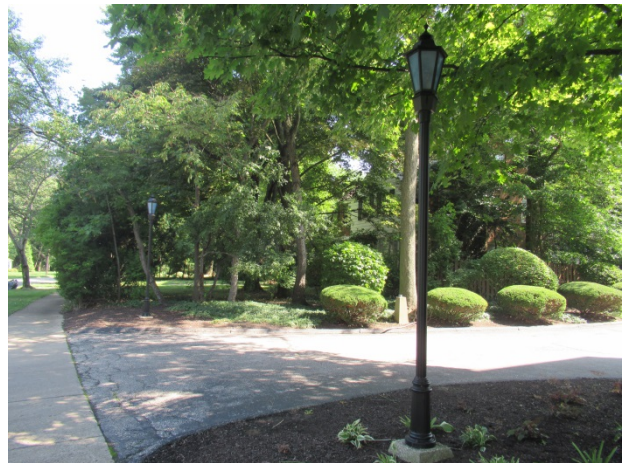
Newer light pole and fixture

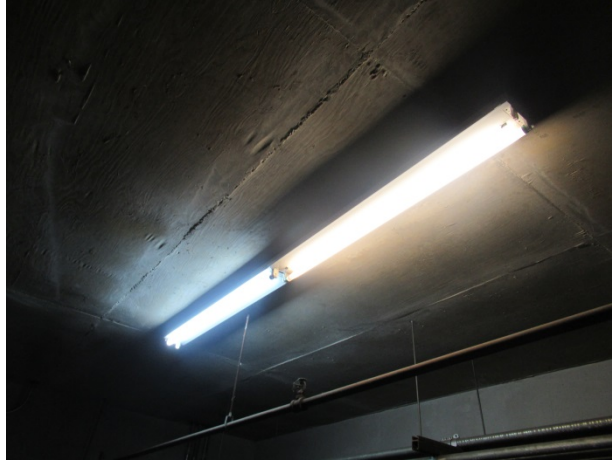
Condition: Reported satisfactory

Garage light fixture
