Inspection Report

123 Main St
Anytown CT 06000

Date of Inspection: 11/23/21

Welcome Home Inspections LLC

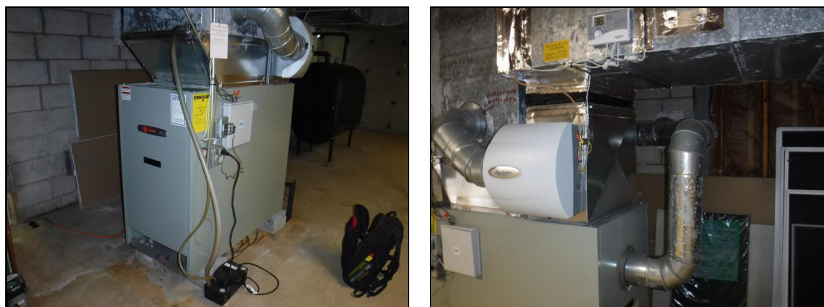
Fire-o-matic Installed: Yes

Recommendation: I do recommend you have the unit cleaned and serviced if it has not been in the last year.

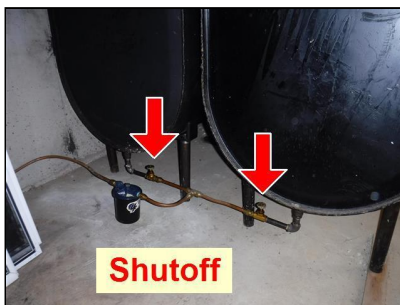
6.3 MAIN FUEL SHUT OFF (Describe Location)

Observation: The main fuel shut off is located in the basement at the fuel oil tank.

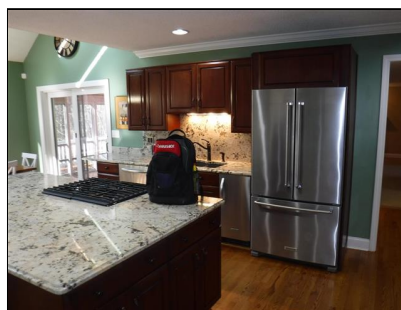
9.2 REPRESENTATIVE NUMBER OF CABINETS

Observation: I opened and closed the majority of the cabinets and they appeared to operate adequately. Material: Wood

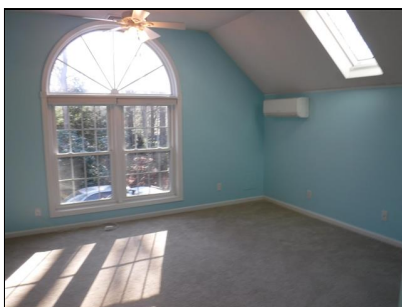
10.6 Ceilings / Walls

Observation: At the time of the inspection, there were no major cracks on the ceilings or walls and I did not note any significant staining.

Note: Some minor cracking may have gone unnoticed. Recommend if you see any minor cracking to have it repaired.
