Windstone Colony CAI

Katy, TX

Report #: 37292-5

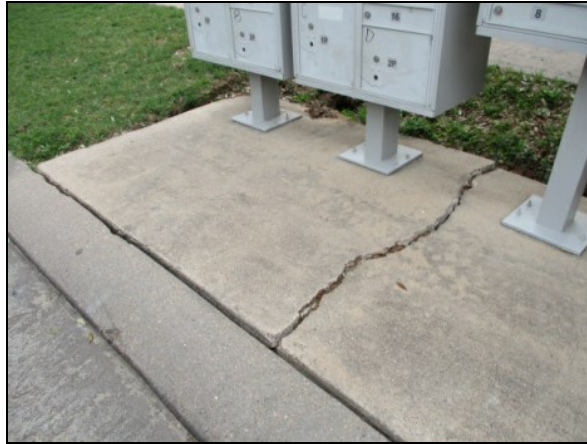
Useful Life:
10 years

Remaining Life:
3 years

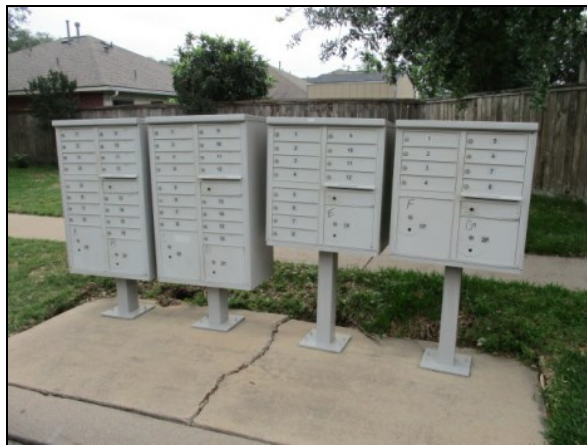
Useful Life:
30 years

Remaining Life:
8 years

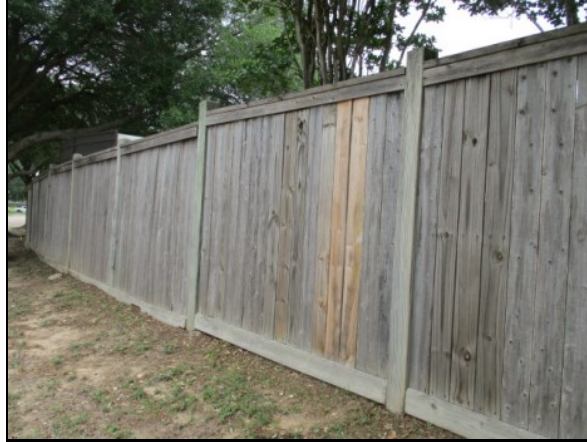
Useful Life:
15 years

Remaining Life:
3 years

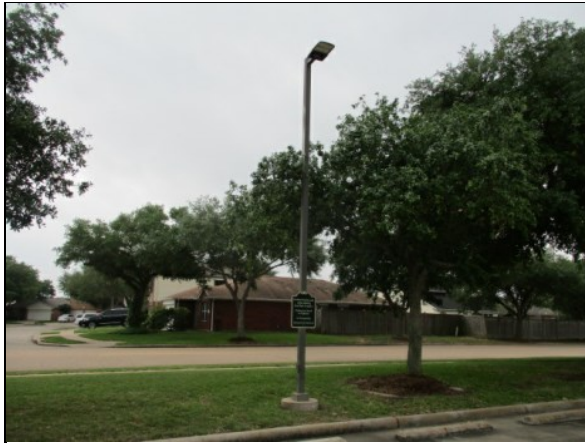
Useful Life:
40 years

Remaining Life:
16 years

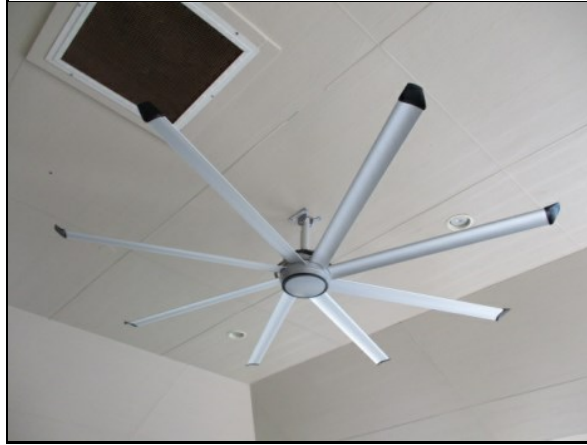
Useful Life:
15 years

Remaining Life:
13 years

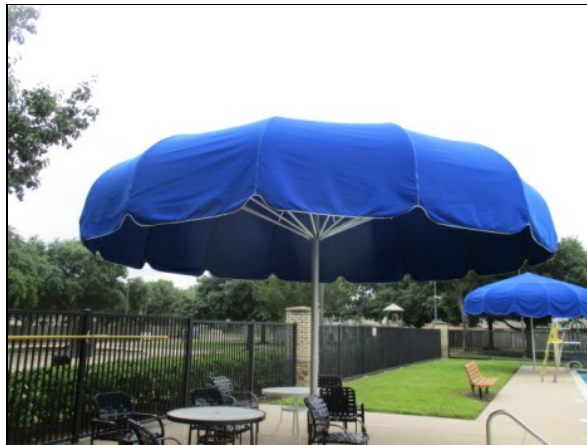
Useful Life:
10 years

Remaining Life:
9 years

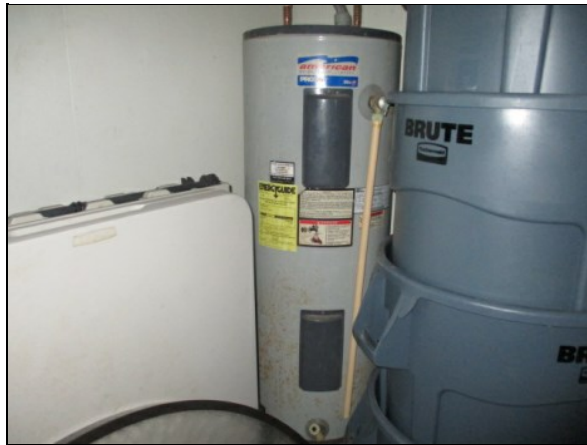
Useful Life:
18 years

Remaining Life:
0 years

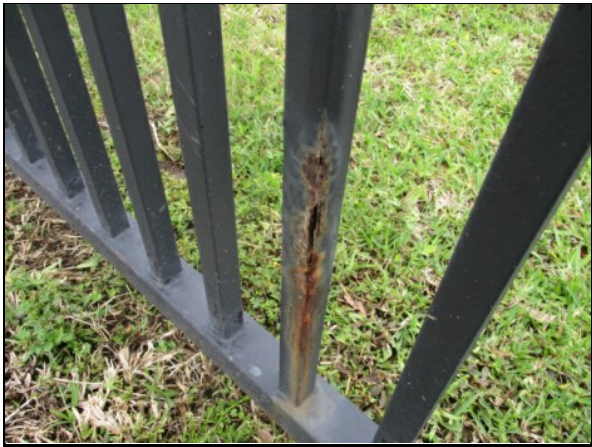
Useful Life:
5 years

Remaining Life:
0 years

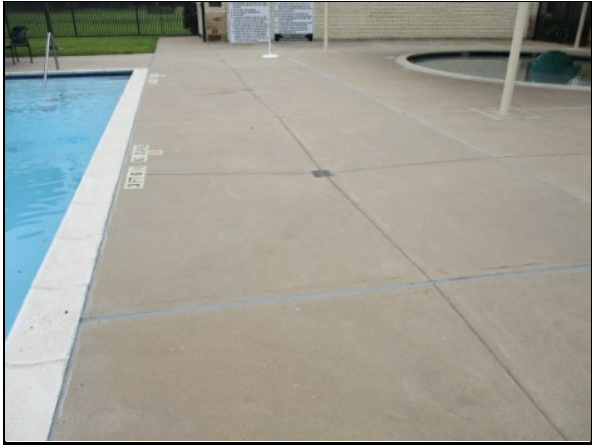
Useful Life:
25 years

Remaining Life:
3 years

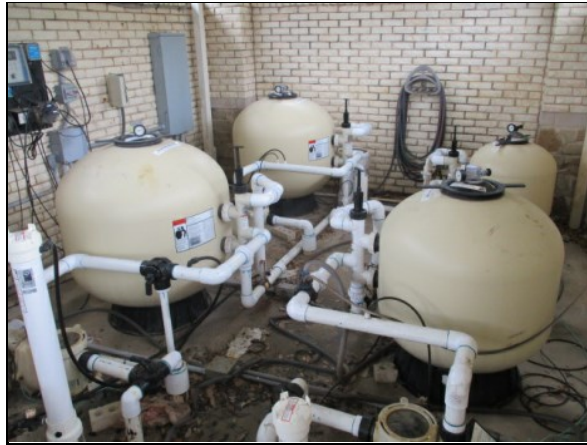
Comp #: 1207 Pool Filters - Replace**Quantity: (4) Sand Filters**

Filters are in good condition at this time. No reported issues. Pool vendor should inspect regularly for optimal performance and address any repairs or preventive maintenance as needed. Minimal or no subjective/aesthetic value for pool and spa equipment and useful life is based primarily on normal expectations for service/performance life in this location. Life expectancy can vary depending on location, as well as level of use and preventive maintenance. Unless otherwise noted, remaining useful life expectancy is based primarily on original installation or last replacement/purchase date, our experience with similar systems/components, and assuming normal amount of usage and good preventive maintenance. Cost estimates shown below assume replacement with similar filter types/sizes as existing.

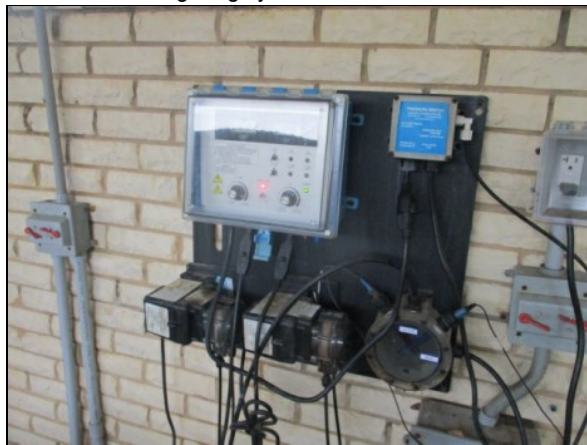
Comp #: 1209 Chemical Controller - Replace**Quantity: (1) Controller**

Comments: Chemical controller is assumed to be functional and good condition. The chemical controller was not tested during inspection, but are assumed to be functional. No reported issues at this time. Funding has been provided for the periodic replacement of control panels and motors following roughly the schedule below.

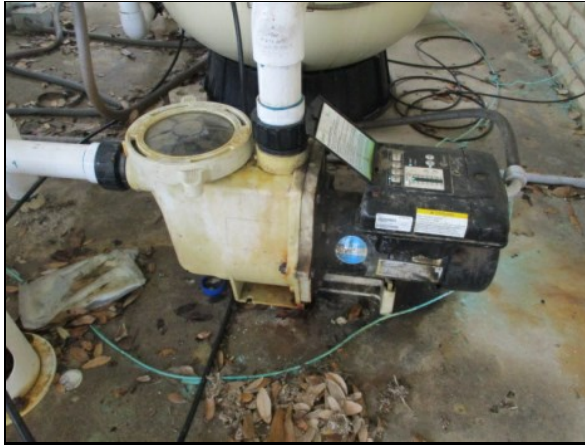
Comp #: 1210 Pool Pumps - Replace**Quantity: (4) Pumps**

Comments: The pumps are 3 HP and (2) motor replacements have occurred since their replacement in 2021. We will continue to fund for replacement.

Pumps should be inspected regularly for leaks and other mechanical problems. Minimal or no subjective/aesthetic value for pool and spa equipment. Useful life is based primarily on normal expectations for service/performance life in this location. Unless otherwise noted, remaining useful life expectancy is based primarily on original installation or last replacement/purchase date, our experience with similar systems/components, and assuming normal amount of usage and good preventive maintenance. Cost shown is based on replacement with the same types/sizes, and may include a small allowance for new piping, valve replacements, and other repairs to be conducted as needed.

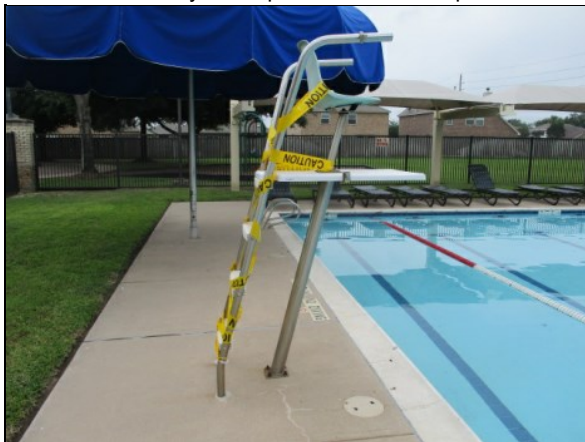
Comp #: 1211 Lifeguard Stands - Replace**Quantity: (2) Stands**

Comments: The lifeguard stands are intact and in fair condition at this time. No areas of damage or premature deterioration. Inspect on a regular basis in order to ensure stability. Anticipate the need to replace following roughly the schedule below.

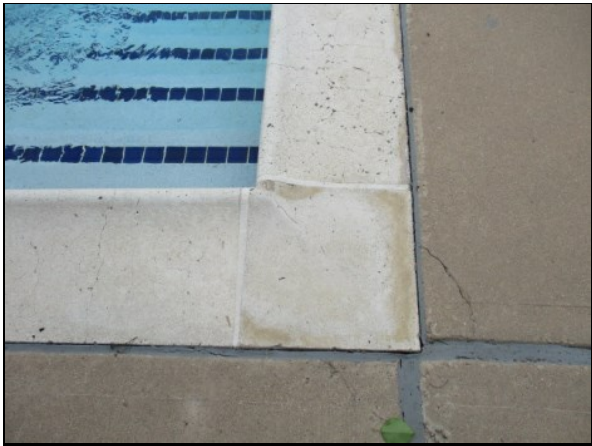
Comp #: 1215 Pool Coping - Replace

Comments: The pool coping is in fair condition at this time. Local areas of deterioration evident. Minimal cracking. Pool coping is generally a long life component that will require minimal maintenance over the years. Pool coping materials and costs can vary, but it is appropriate to fund for eventual replacement of the coping surfaces. Coping areas can develop cracks, which can lift and cause trip hazards. The typical concrete composed materials can often get stained and discolored over time so funding for periodic replacements ensure that aesthetics are met at the pool area. Timing for completion of this project should occur in coordination with every other pool replastering project unless specified here.

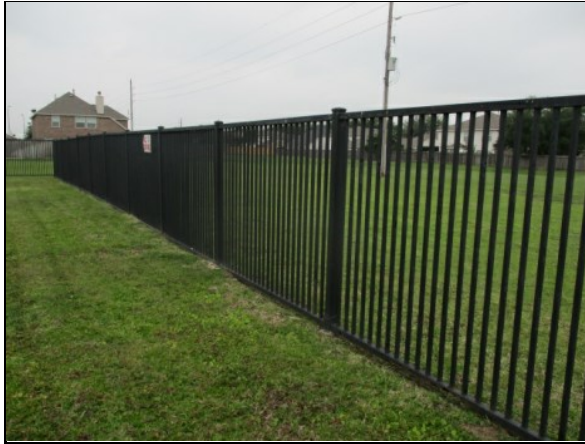
Comp #: 1225 Pool Perimeter Fence - Replace

Comments: Fair condition: Pool fencing determined to be in fair condition typically exhibits some minor to moderate amounts of surface wear and other signs of age, which may include corrosion, loose or unstable pieces/sections or hardware, and/or overgrowth by surrounding vegetation. Overall, appears to be in serviceable but declining condition.

We recommend that the Client periodically clean fencing with an appropriate cleaner and touch up paint as needed in between regular paint cycles. Gates and locks should be inspected to make sure they close and lock properly as a faulty perimeter around a pool area can expose a Client to significant liability risk. As a routine maintenance item, fence should be inspected regularly and repaired as needed through the Operating budget to ensure safety. When evaluating replacements, be sure to comply with any applicable building codes. When possible, replacement should be coordinated with other projects, such as pool deck projects, other fencing/railing work, etc. Based on evident conditions, aesthetic standard considerations, and/or Client history provided during this engagement, we recommend replacement at the approximate interval shown below. Unless otherwise noted, cost estimates below assume replacement with a similar material/height as currently in place.

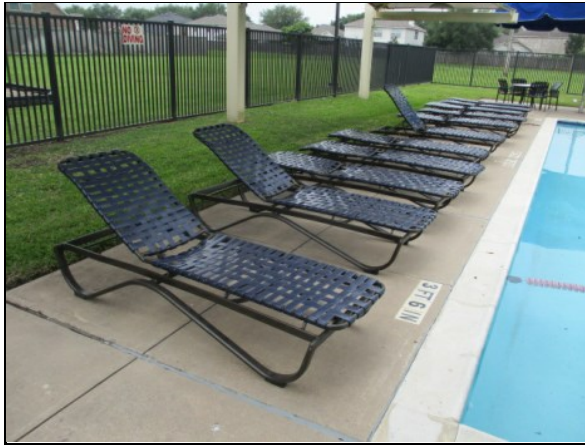
Comp #: 1230 Pool Furniture - Replace**Quantity: (65) Assorted Pieces**

Pool furniture is determined to be in good condition. Normal wear and aging noted at this time. No signs of rips or tears in fabric/straps. Best to replace all of the pieces at the same time in order to maintain a uniform appearance.

We recommend regular inspections and repair or replacement of any damaged pieces promptly to ensure safety. Protected storage of furniture when not in use can help to extend useful life. Best practice is to replace all pieces together in order to maintain consistent style and quality in the pool/recreation area. Individual pieces can be replaced as needed each year as an Operating expense. Costs can vary greatly based on quantity and type of pieces selected for replacement. Funding recommendation shown here is based on replacement with comparable number and quality of pieces as existing.

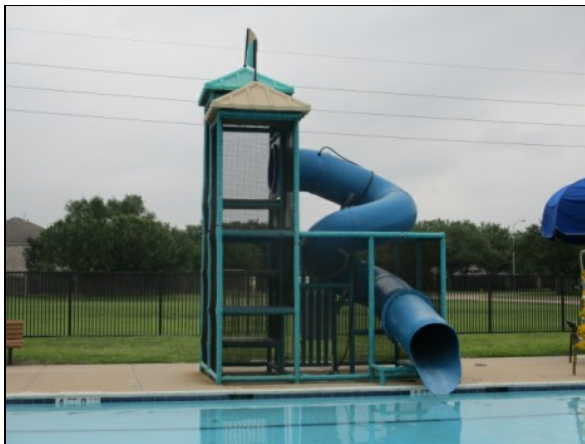
Comp #: 1236 Water Slide - Replace**Quantity: (1) Slide**

Comments: The slide will be replaced in 2024. Conditions at the time of the inspection were declining. Corrosion and deterioration evident.

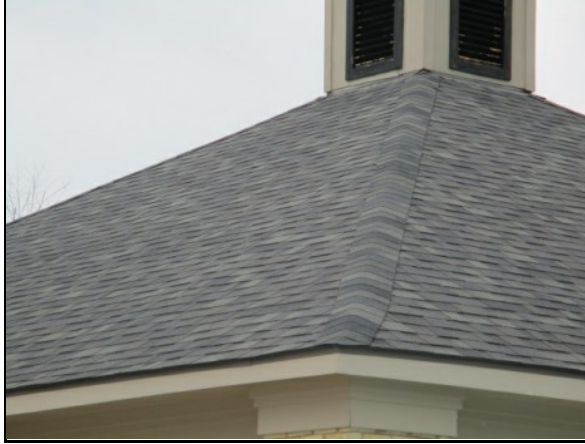
Comp #: 1303 Asphalt Shingle Roof - Replace**Quantity: ~ 2,030 GSF**

Comments: Good condition: Asphalt shingle roofs determined to be in good condition typically exhibit few or no signs of curling/cupping of shingles, and granule cover appears to be thick and consistent. Little to no organic growth or staining patterns evident, and no unusual or significant leaks reported. Shingles and flashing appear to provide good coverage to all areas, especially at intersection points and around any penetrations.

As routine maintenance, many manufacturers recommend inspections at least twice annually and after large storm events. Promptly replace any damaged/missing sections or conduct any other repair needed to ensure waterproof integrity of roof. Keep roof surface, gutters and downspouts clear and free of moss or debris. Moss growth can decrease the life of the roofing shingles and should be removed promptly. We recommend having roof inspected in greater detail (including conditions of sub-surface materials) by an independent roofing consultant prior to replacement. There is a wealth of information available through organizations such as the Roof Consultant Institute <http://www.rci-online.org/> and the National Roofing Contractors Assn. (NRCA) <http://www.nrca.net/>. If the roof has a warranty, be sure to review terms and conduct proper inspections/repairs as needed to keep warranty in force. Dimensional shingles typically have longer useful lives and are generally considered to be more valuable from an aesthetic standpoint. We recommend budgeting to replace with dimensional shingles upon failure. Also known as architectural shingles, these types of roofs are typically more durable and wind-resistant than 3-tab shingles. Remaining useful life is based on consideration of installation/replacement date, evident visual conditions, and/or repair history provided by the Client. Unless otherwise noted, costs shown here assume that only a minimal amount of substrate/decking repairs or replacement will be required. For very old roofs or those with significant leak problems, additional repair costs may be incurred.

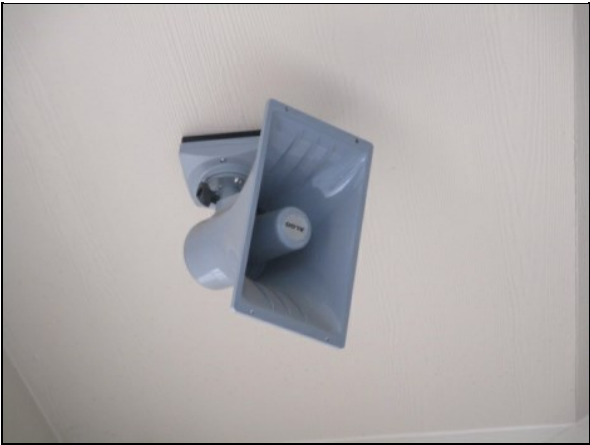
Comp #: 1814 Siren Speakers - Replace

Comments: The association installed a siren speaker system in 2023. The system is functional at this time. Funding provided for the replacement or modernization of the system.
