Windstone Colony CAI

Katy, TX

Report #: 37292-6

Beginning: January 1, 2026

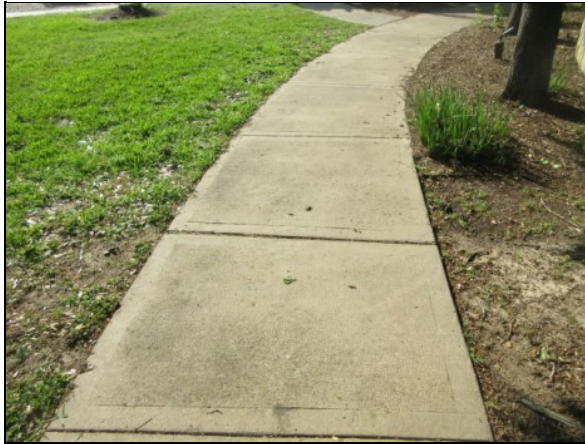
Comp #: 210 Concrete: Sidewalks - Repair**Approx Quantity: 6,000 GSF****Location:** Common area walkways**Funded?:** Yes.**History:****Comments:** Funding to repair 5% of the total surface area or ~ 300 GSF.

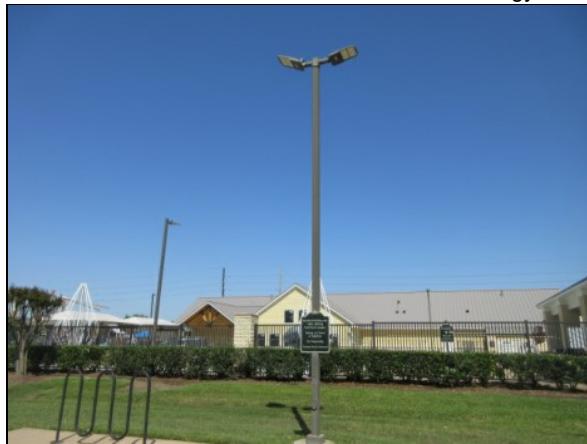
Comp #: 356 Lighting: Exterior - Replace**Approx Quantity: 12 Assorted Fixtures****Location:** Exterior walls and ceilings**Funded?:** Yes.**History:****Comments:** Includes: (5) wall lights, (6) recessed lights, (1) ceiling light.

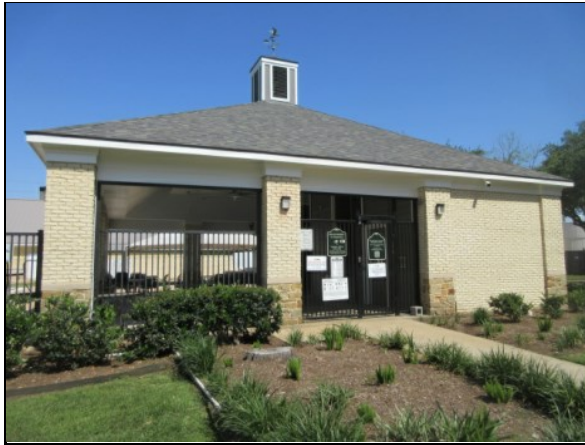
Comp #: 1115 Building Exteriors - Seal/Paint**Approx Quantity: 2,000 GSF****Location:** Building exteriors, including pool equipment cover**Funded?:** Yes.**History:** Painted in 2025 for \$10,000**Comments:** Fair condition: Painted exterior surfaces determined to be in fair condition typically exhibit some minor to moderate signs of wear and age such as chalking, peeling, blistering, etc. Problems tend to develop in more exposed areas first. Hairline cracks may be present at this stage. Overall appearance is satisfactory.

There are two important reasons for painting and waterproofing a building: to protect the structure from damage caused by exposure to the elements, and to restore or maintain good aesthetic standards for curb appeal. As routine maintenance, we recommend that regular inspections, spot repairs and touch-up painting be included in the operating budget. Typical paint cycles can vary greatly depending upon many factors including; type of material painted, surface preparations, quality of material, application methods, weather conditions during application, moisture beneath paint, and exposure to weather conditions. Proper sealant/caulking at window and door perimeters and other "gaps" in the building structure are critical to preventing water intrusion and resulting damage. The general rule of thumb is that sealant/caulking should be in place wherever two dissimilar building surfaces meet, such as window frame to concrete structure junctions. For best results, the client may want to consult with a paint company representative, building envelope specialist and/or structural engineer to specify the types of materials to be used and define complete scope of work before bidding. In our experience, cost estimates for painting and waterproofing can vary widely, even when based on the same prescribed scope of work. Estimates shown here should be updated and revised as needed based on actual bids obtained or project cost history during future Reserve Study updates.

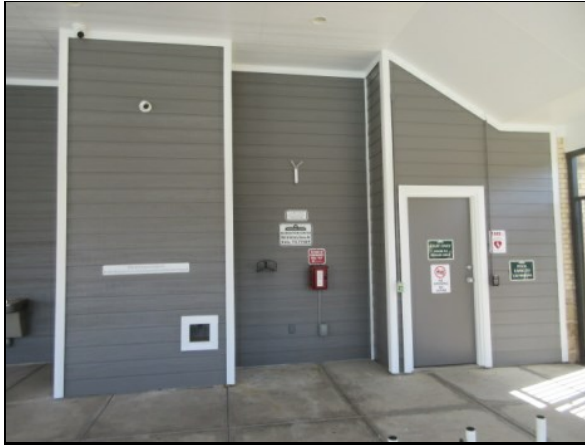
Comments: Good condition: Fiber cement siding/trim sections determined to be in good condition typically exhibit vibrant, consistent color and little or no signs of damage, deterioration, etc.

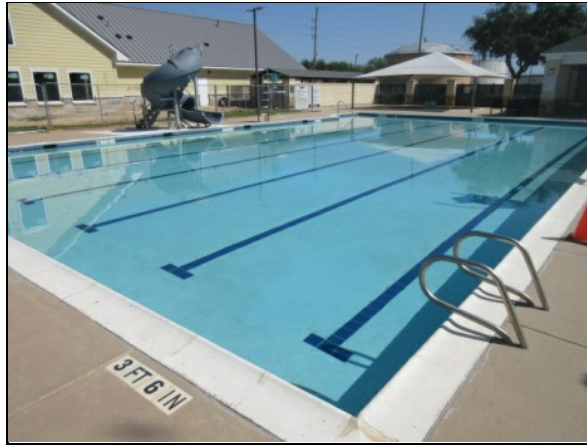
Comments: Fair condition: Swimming pools determined to be in fair condition typically exhibit some color fade/discoloration, and roughening of the surface, often more noticeable in the shallow areas and/or at steps. Waterline tiles are declining. Generally believed to be aging normally.

Minor repairs and routine cleaning/maintenance should be considered an Operating expense. Pool resurfacing will restore the aesthetic quality of the pool while protecting the actual concrete shell of the pool from deterioration. This type of project is best suited for slow/offseason to minimize downtime during periods when pool is used heavily. Should be expected at the approximate interval shown below; in some cases, schedule may need to be accelerated due to improper chemical balances or aesthetic preferences of the Client. While drained for resurfacing, any other repairs to lighting, handrails, stairs, ladders, etc. should be conducted as needed.

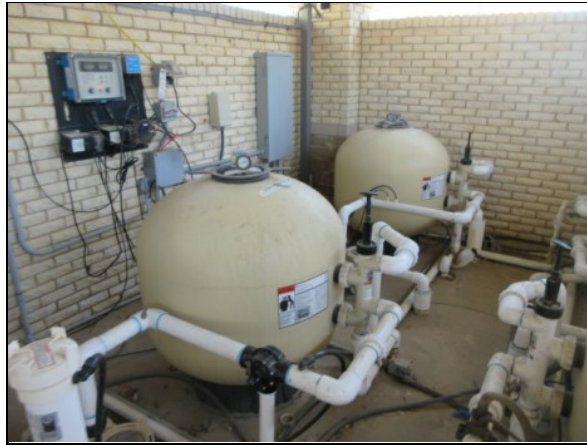
Comp #: 1207 Pool Filters (2021) - Replace**Approx Quantity: 4 Sand Filters****Location:** Pool equipment area; exposed**Funded?:** Yes.**History:****Comments:** P/N: 140316

Filters are in good condition at this time. No reported issues. Pool vendor should inspect regularly for optimal performance and address any repairs or preventive maintenance as needed. Minimal or no subjective/aesthetic value for pool and spa equipment and useful life is based primarily on normal expectations for service/performance life in this location. Life expectancy can vary depending on location, as well as level of use and preventive maintenance. Unless otherwise noted, remaining useful life expectancy is based primarily on original installation or last replacement/purchase date, our experience with similar systems/components, and assuming normal amount of usage and good preventive maintenance. Cost estimates shown below assume replacement with similar filter types/sizes as existing.

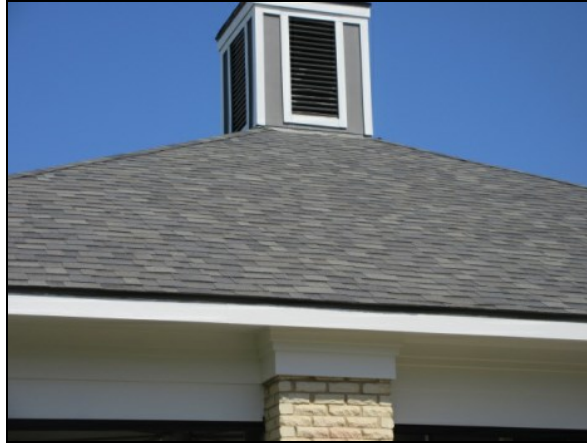
Comments: Good condition: Asphalt shingle roofs determined to be in good condition typically exhibit few or no signs of curling/cupping of shingles, and granule cover appears to be thick and consistent. Little to no organic growth or staining patterns evident, and no unusual or significant leaks reported. Shingles and flashing appear to provide good coverage to all areas, especially at intersection points and around any penetrations.

As routine maintenance, many manufacturers recommend inspections at least twice annually and after large storm events. Promptly replace any damaged/missing sections or conduct any other repair needed to ensure waterproof integrity of roof. Keep roof surface, gutters and downspouts clear and free of moss or debris. Moss growth can decrease the life of the roofing shingles and should be removed promptly. We recommend having roof inspected in greater detail (including conditions of sub-surface materials) by an independent roofing consultant prior to replacement. There is a wealth of information available through organizations such as the Roof Consultant Institute <http://www.rci-online.org/> and the National Roofing Contractors Assn. (NRCA) <http://www.nrca.net/>. If the roof has a warranty, be sure to review terms and conduct proper inspections/repairs as needed to keep warranty in force. Dimensional shingles typically have longer useful lives and are generally considered to be more valuable from an aesthetic standpoint. We recommend budgeting to replace with dimensional shingles upon failure. Also known as architectural shingles, these types of roofs are typically more durable and wind-resistant than 3-tab shingles. Remaining useful life is based on consideration of installation/replacement date, evident visual conditions, and/or repair history provided by the Client. Unless otherwise noted, costs shown here assume that only a minimal amount of substrate/decking repairs or replacement will be required. For very old roofs or those with significant leak problems, additional repair costs may be incurred.

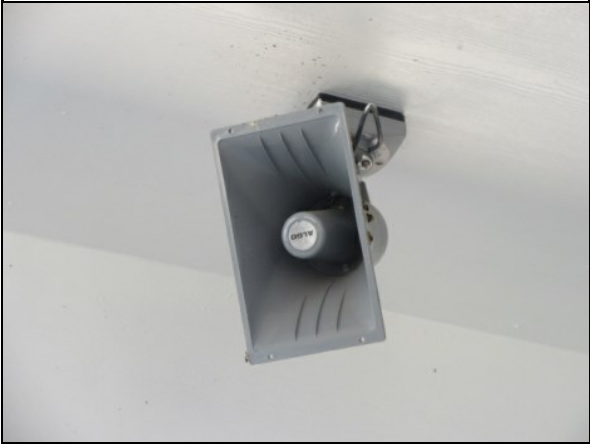
Comments: The association installed a siren speaker system in 2023. The system is functional at this time. Funding provided for the replacement or modernization of the system.

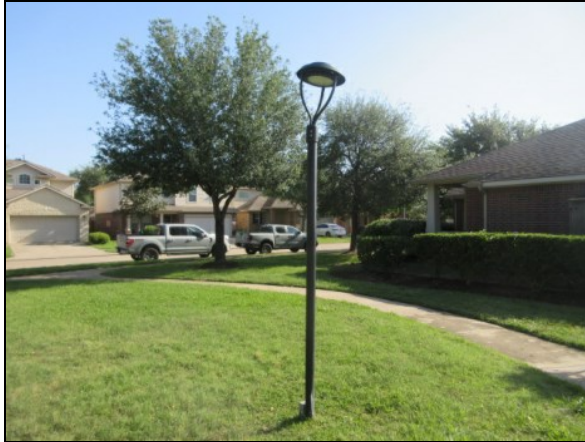
Lights were inspected during daylight hours but are assumed to be functional. As routine maintenance, inspect, repair/change bulbs as needed as an operating expense. Replacement should be considered at the approximate interval shown below to ensure good function and maintain good appearance in the common areas. Replacement costs can vary greatly depending on replacement type; estimates shown here are based on replacement with a comparable size and design as are currently in place, unless otherwise noted. We recommend consideration of LED fixtures or other energy-saving options whenever possible.
