RESERVE FUND STUDY
REPORT

***SIERRAS ON THE LAKE
CONDOMINIUM CORPORATION***

CONDOMINIUM PLAN No. 032 3690

April 2021
Final

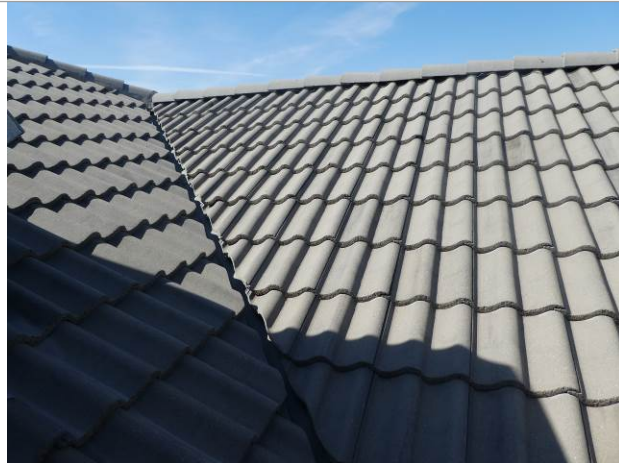
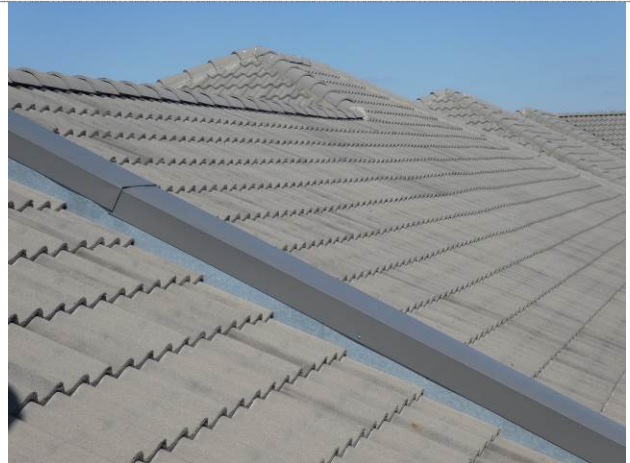
- Roof consists of concrete tiles over a membrane. Concrete tiles generally are a life item and could last indefinitely. However, the membrane under the tiles will wear and weather over time. The roof system appears to be in good condition with no anomalies noted.
- There is a small section of SBS roofing under the mechanical unit. This roofing is also in good condition.

Concrete roof tiles

Roofing - continued		
Recommendations for Replacement and/or Maintenance		
– Funds are allocated every 6 years to complete major repairs to the roofing. This includes replacing the SBS membrane under the mechanical when required.		
Projection		
<i>Year Replacement Required:</i>		<i>Cost of Replacement with Inflation:</i>
Batten & Underlayment - 1/3	2048	\$425,767
Batten & Underlayment - 1/3	2049	\$433,431
Batten & Underlayment - 1/3	2050	\$441,232
Major Repair	2027	\$29,273

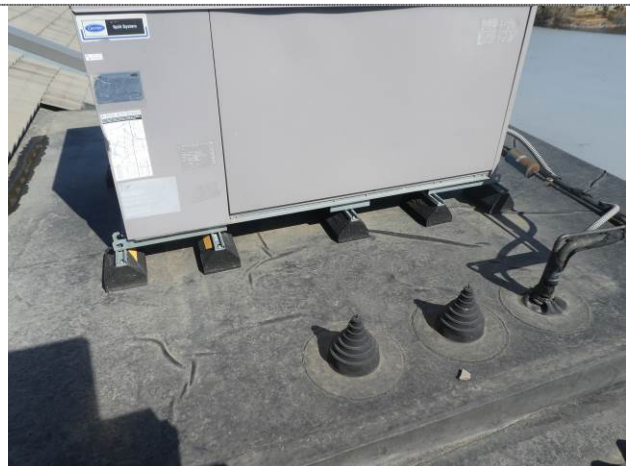
SBS roofing under mechanical

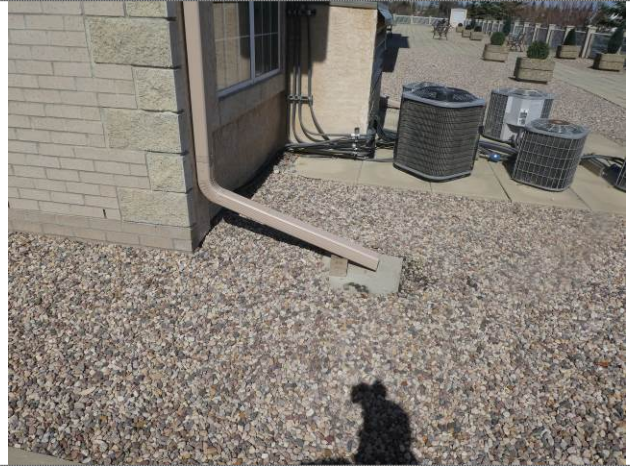
- Eavestroughs are securely fastened to fascia with ferrules (nails).
- Eavestroughs had only minor dust debris.
- The majority of the downspouts terminate onto the landscaping. A few downspouts terminate into drains.
- Eavestroughs and downspouts are in fair condition.

Typical downspout termination

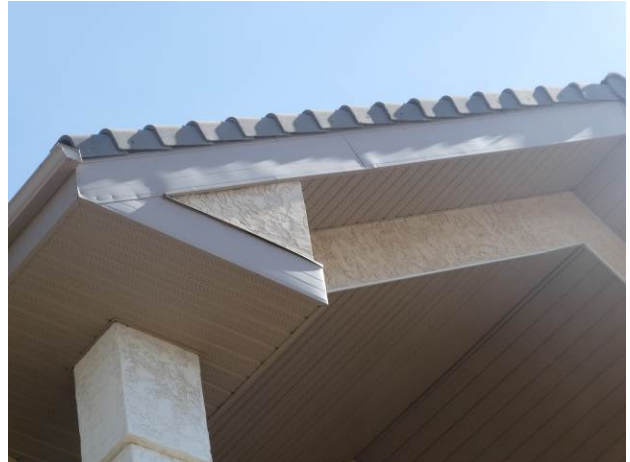
- Fascia is prefinished metal and is installed at all roof terminations. Fascia is in good condition.
- Soffit is prefinished vented metal and is installed at all roof overhangs and below balconies. Vented soffit allows air into the attic space. Soffit is in good condition.

Fascia and soffit

Fascia & Soffit – continued		
Recommendations for Replacement and/or Maintenance		
– Repair damaged fascia on east building immediately.		
Projection		
<i>Year Replacement Required:</i>		<i>Cost of Replacement with Inflation:</i>
Fascia	2044	\$13,292
Soffit	2044	\$124,918

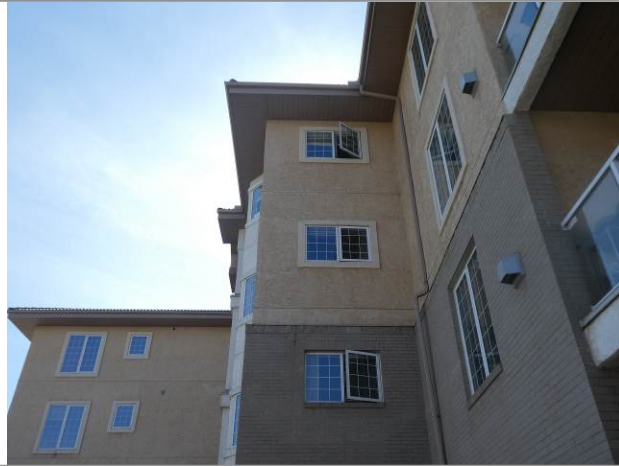
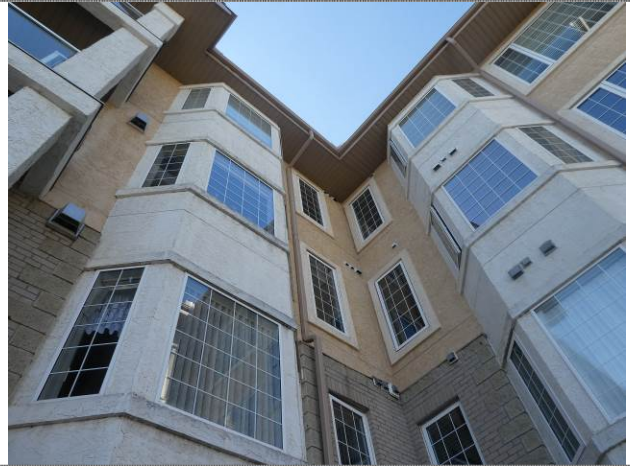
- The building is clad with stucco and brick.
- Stucco and brick are in fair condition with a few areas of premature deterioration.
 - Balcony fascia
 - Interior corners
- Complete replacement should not be required if maintenance is completed regularly.

Stucco on exterior of building

- Funds are allocated every 4 years to complete major repairs to stucco and brick. Repairs should be completed within the next year. Continuous patching and repairing will ensure the life of the stucco.
- Funds are allocated in 40 years to refurbish the stucco. Refurbishment would include further patching, cleaning and applying a thin fog coat over the existing stucco. It is not recommended that stucco be painted.

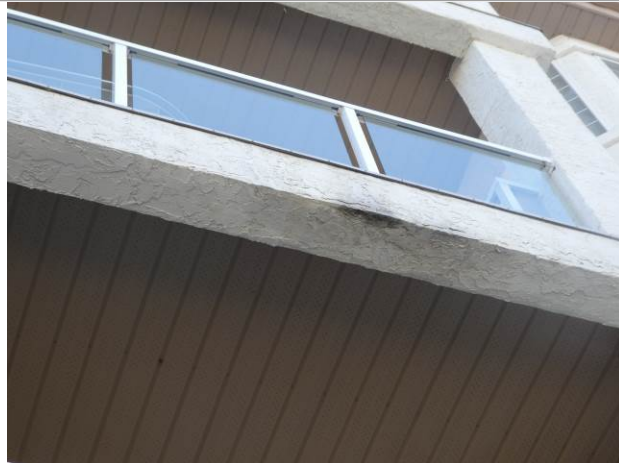
Stained stucco on balcony fascia – indicative of poor water drainage

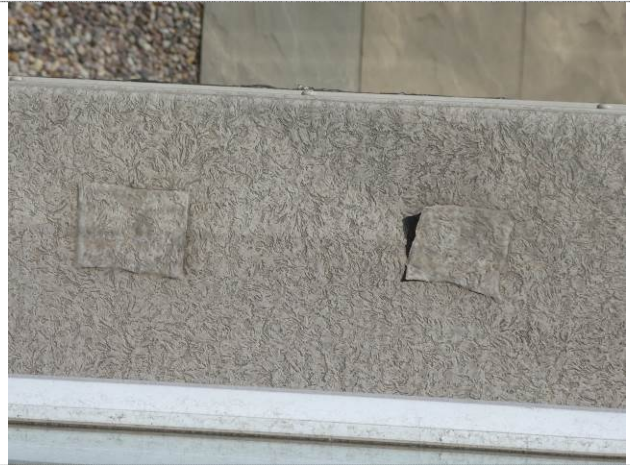
- Balconies are covered with a PVC membrane. This membrane is original. Railings are glass and metal. Membrane is also installed on the main floor patios over the concrete base.
- Recent repairs were completed on the membranes. Patching was completed and a metal clamping bar installed at the drip edge.
- Balcony membranes are in fair condition.

Membrane patches

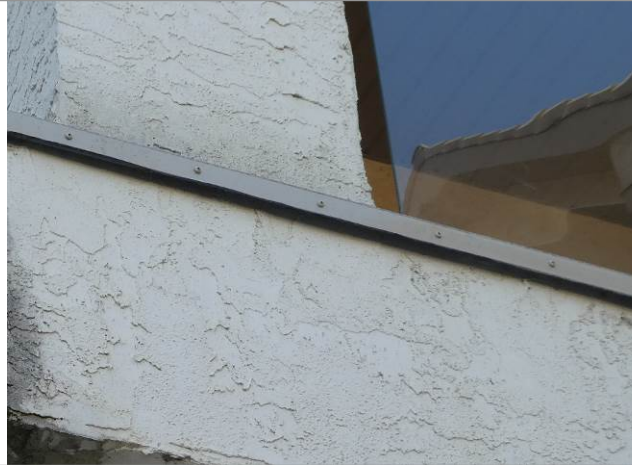
Clamping bar installed at drip edge

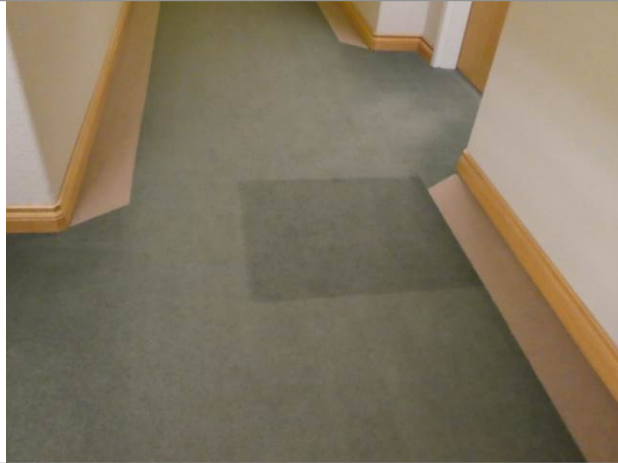
- Carpet is installed in the hallways, stairwells and amenities rooms. Carpet is original and in fair condition.
- Laminate was installed in the party room. Laminate has been removed due to a water issue that has been repaired.
- Linoleum is installed in the washrooms, kitchen areas and garbage rooms. Linoleum is also original and in fair condition.
- Tile is installed in the pool area, front lobby and entrance. Tile is in good condition.
- The pool has a painted finish. This finish is in fair condition.

Hallway carpet with patch

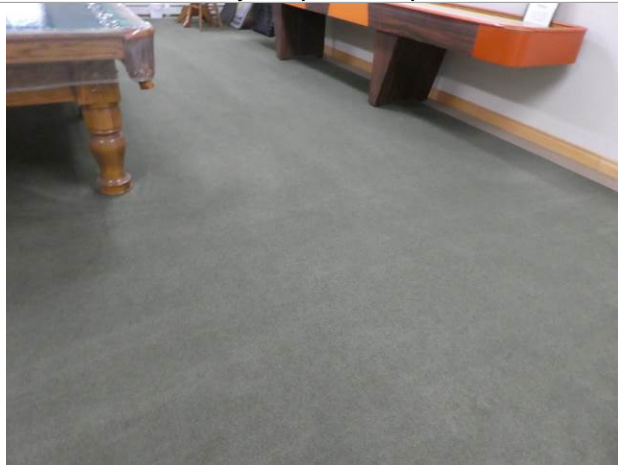
Lifting seam in carpet

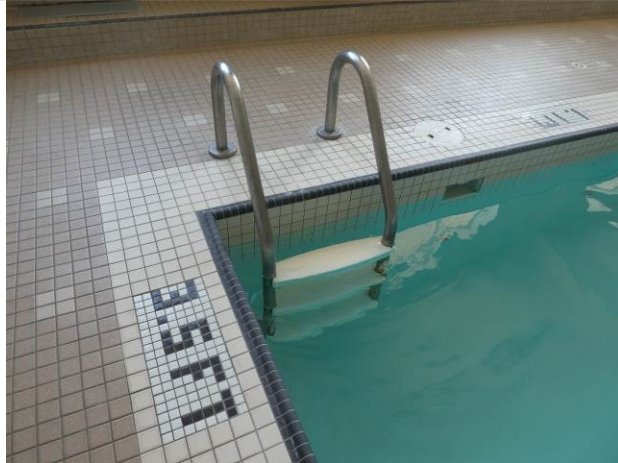
Pool finish and surrounding tile

- Follow manufacturer's recommendations for care and cleaning of all flooring finishes.
- Pool should be painted within the next 3 years.
- Laminate should be installed on dance floor this year.
- Funds are allocated every 10 years to repair pool tile.

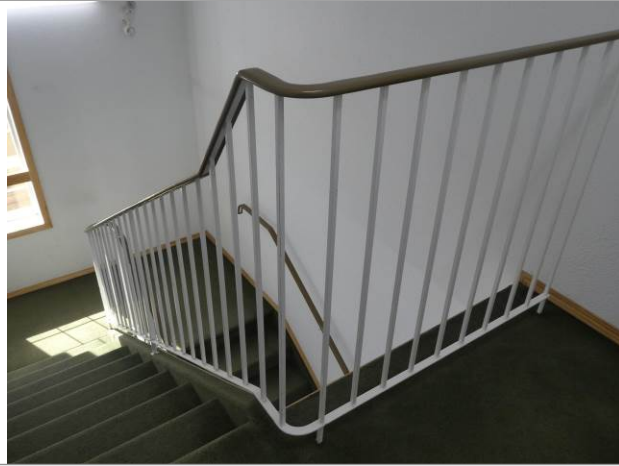
- Paint finishes include walls & ceilings. Some settlement cracking and wear were noted.
- The ceiling has been removed in the party room to repair a pipe leak.

Stairwell paint finish

- Repair ceiling in party room this year.
- All walls & ceilings in the hallways, main floor common rooms & pool should be painted within the next 5 – 8 years.

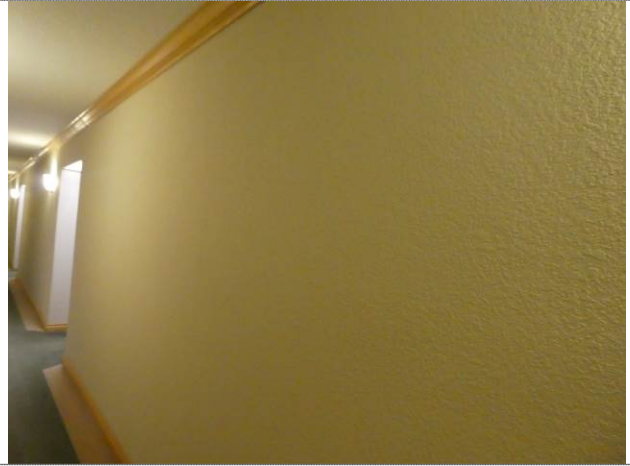
Hallway wall paint finish

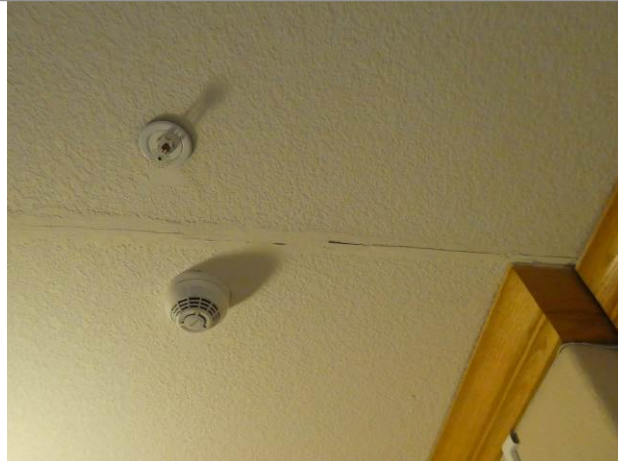
Cracking in ceiling finish

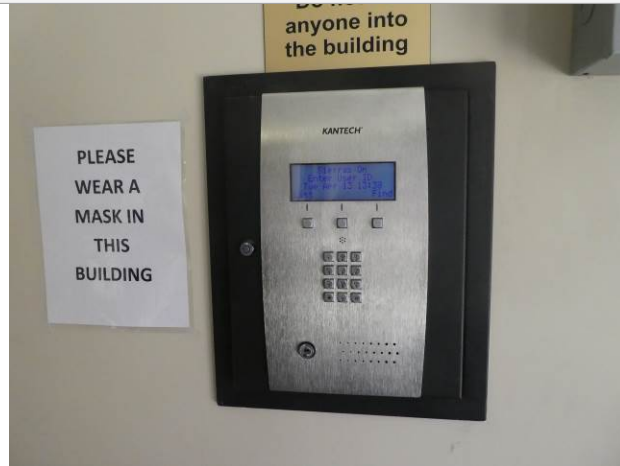
- Intercom panel is located at the front entrance. This panel was replaced recently and is in good condition.
- A fob proximity system is installed for access. This system is in fair condition.
- Security camera system is in fair condition. Cameras are located throughout the interior of the building, exterior and parkade.

New intercom panel

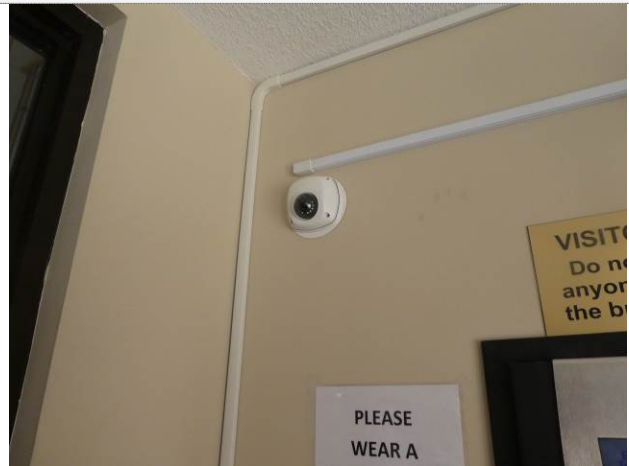
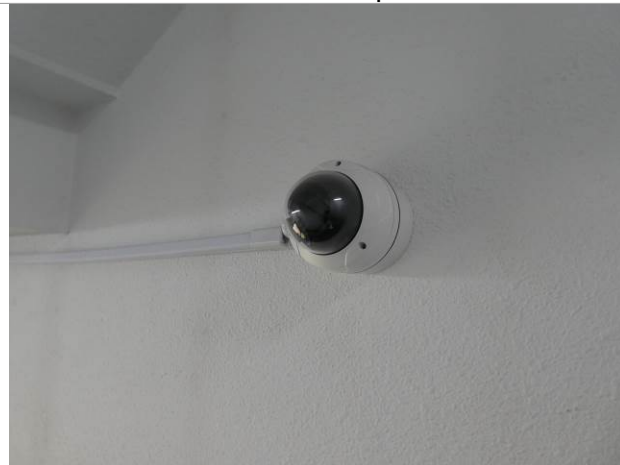
Security camera

Intercom & Security Systems – continued		
Recommendations for Replacement and/or Maintenance		
– Funds are allocated every 10 years to upgrade the security camera system. Upgrade as necessary.		
Projection		
<i>Year Replacement Required:</i>		<i>Cost of Replacement with Inflation:</i>
Intercom System	2046	\$7,734
Access System	2028	\$7,304
Security Camera System	2027	\$5,740

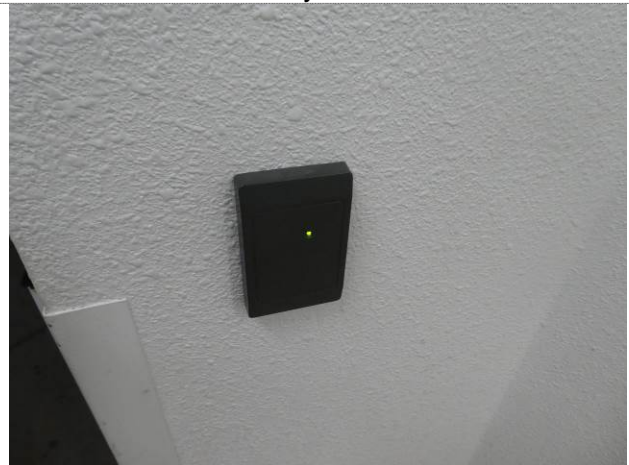
Fob proximity reader

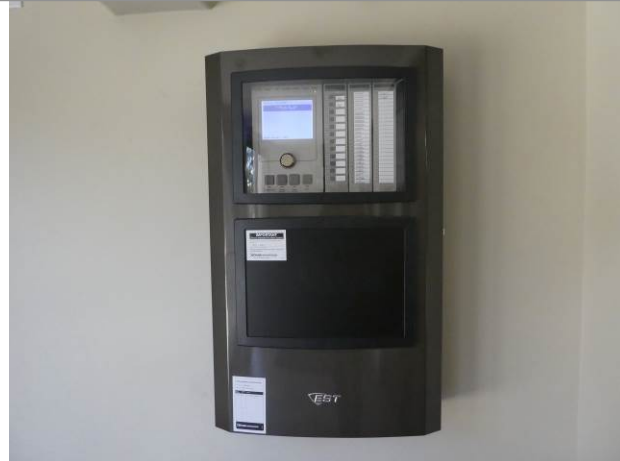
- Fire alarm system consists of extinguishers, sprinkler heads, smoke detectors, pull stations, and alarms throughout the building.
- EST fire alarm panel is installed at the front entrance. This panel is new.
- Fire alarm system appears to be in good condition.

EST fire alarm panel

- Fire alarm drills should be completed annually.
- Regular inspections and testing should be completed by a qualified technician annually.
- Complete replacement of the entire fire alarm system all at one time should not be required. Funds are allocated to replace/upgrade fire alarm components every 5 years, replace as needed.
- Funds are allocated every 5 years to upgrade/repair sprinklers as needed.
- The flapper valve on the fire sprinkler system will require replacement every 30 years.

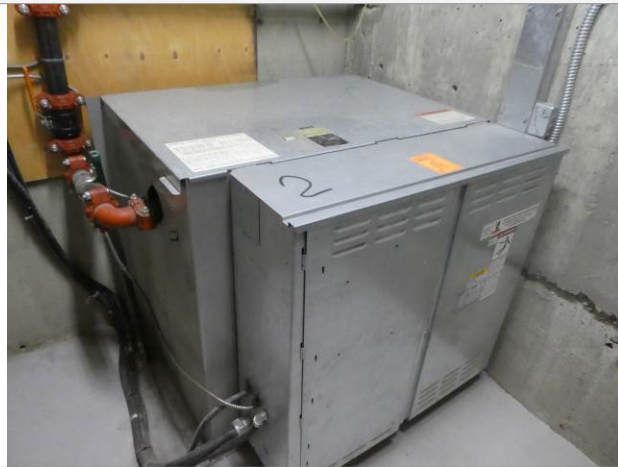
- There are 3 Otis elevators servicing the building. Each elevator travels 4 residential floors and the parkade. Elevator systems appear to be in fair condition.

Elevator hydraulics

- Funds are allocated within the next 5 years to complete major repairs to the elevators. Continuous repairs and maintenance will ensure that elevators reach their expected life.

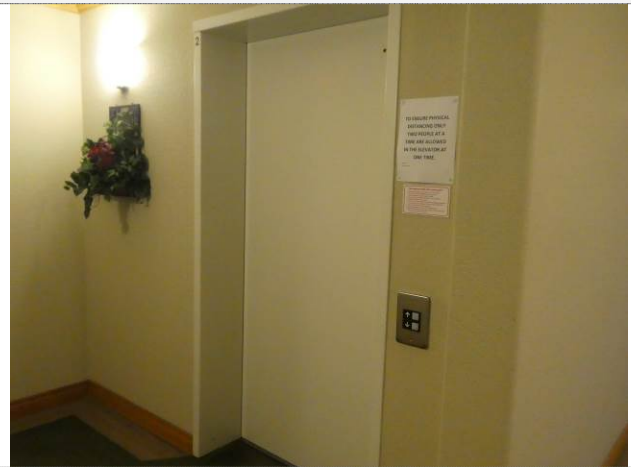
Elevator

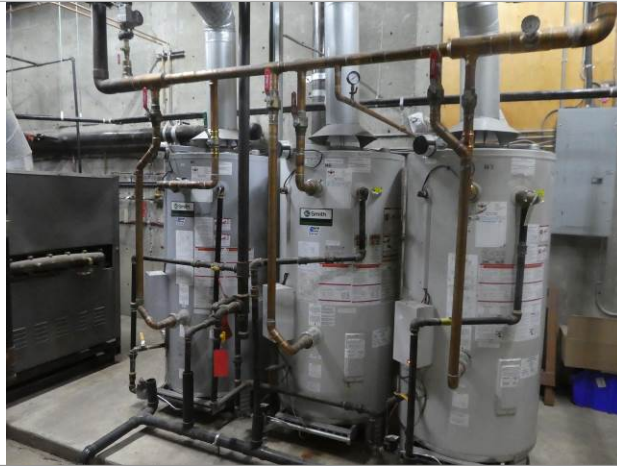
- The building is serviced by 3 hot water tanks.
- All mechanical components are in fair condition.

A.O. Smith hot water heaters/tanks - 100 gal
M: BTRC400A118
S: 1527M00217, 1220M001330 &
1408M001824

- Regular maintenance and inspection is required.
- Hot water tanks should be replaced within the next 3 – 6 years.
- Money has been budgeted for the entire property to replace damaged sections of both the heat loop and domestic water piping as required. Complete replacement of both systems should not be required.
- Funds have been allocated to replace 20 thermostats and zone valves every 10 years – replace as necessary.
- Funds are allocated every 5 years to replace/repair miscellaneous mechanical components that are not listed individually in this report. These are generally mechanical components costing less than \$1,000.00 to replace.

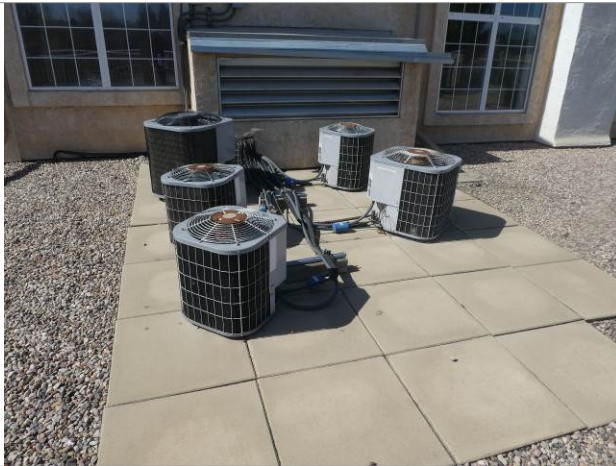
- There are 2 Eng A furnaces located in the parkade. These furnaces assist the hallway makeup air system.
- The hallway makeup air unit is located in the attic.
- The pool makeup air unit is located in the boiler room.
- There is a large Carrier A/C unit installed on the roof. There are several smaller A/C units located outside.
- All makeup air systems are in fair to good condition.

Exterior A/C units

- Regular maintenance and inspection is required.
- Funds are allocated to replace 3 exterior A/C units every 5 years. Replace as needed.

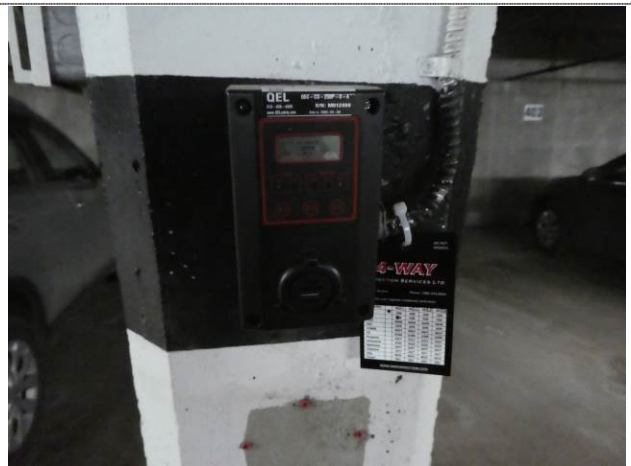
- Parkade makeup air consists of an Ice system, exhaust fans and fan coil heaters.
- The parkade also has a CO2 gas detection system. The sensors have been replaced recently.
- All parkade makeup air systems appear to be in good condition.

CO2 sensor

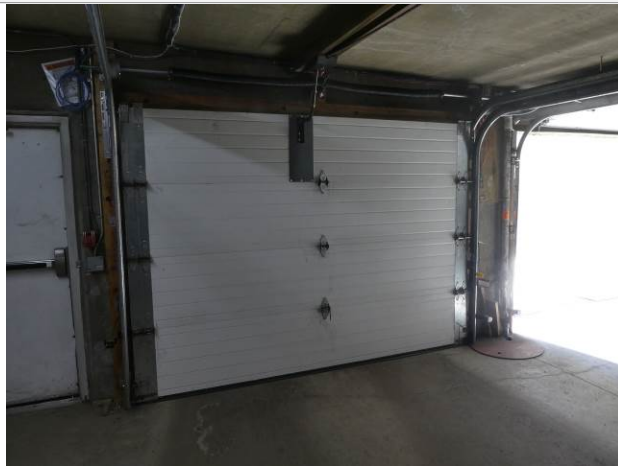
- There are two overhead parkade doors. One for entrance and one for exit.
- Both doors and motors have been recently replaced and appear to be in good condition.

Parkade doors

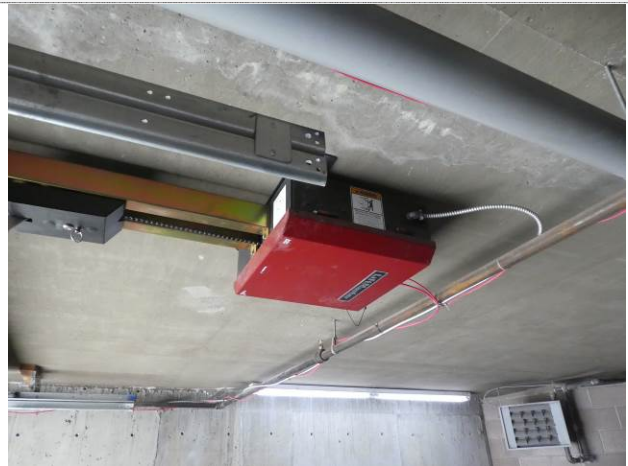
Motor for parkade door

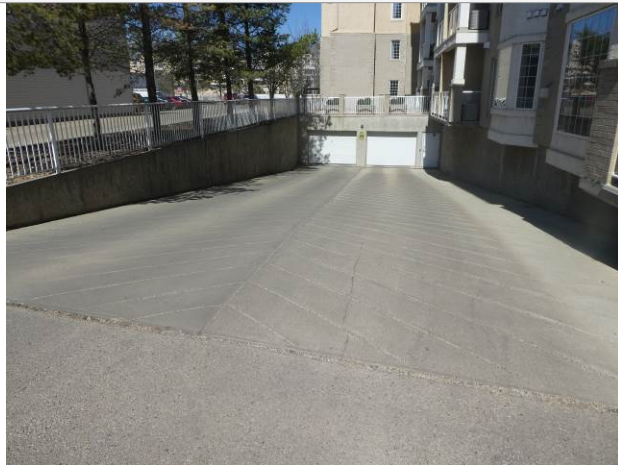
- Underground piping is installed under the parkade ramp. Hot water/glycol is pumped through these pipes to ensure that the ramp does not freeze up in the winter months. System appears to be in good condition.
- Concrete parkade ramp also appears to be in fair to good condition.

Parkade ramp

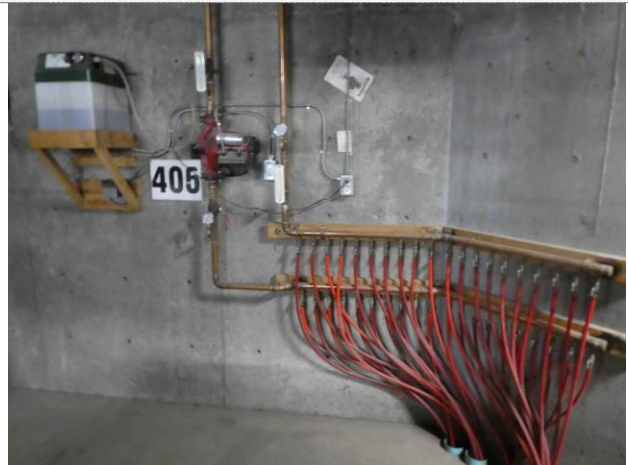
Heat loop system for ramp

- Regular maintenance and inspection is required.
- Funds are allocated every 10 years to replace visible mechanical components of the heat loop system.

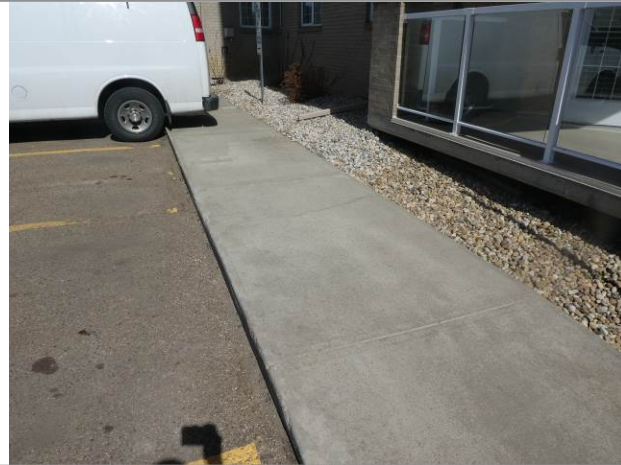
- Concrete walkways are in fair condition.
- Some minor deterioration was noted. Previous patch was noted.

Concrete walkway

- Monitor concrete. Repair is cracking or heaving become a tripping hazard.
- It is not recommended that salt based ice melt products be used. These products will cause premature deterioration of the concrete finish.

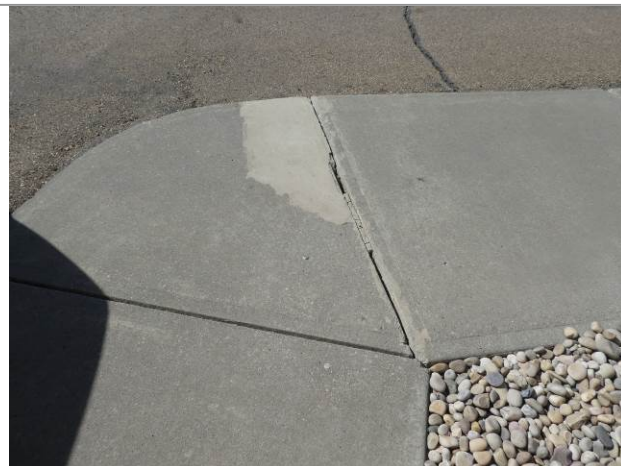
Patched walkway

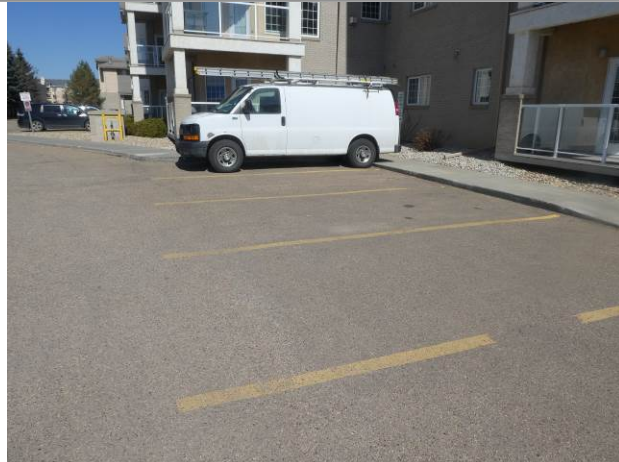
- An asphalt roadway with visitor parking is installed on the west side of the building.
- Asphalt is original and evidencing some deterioration and wear.
- Poured concrete curbing is installed around the perimeter of the asphalt. Curbing is in good condition.

Asphalt in front of building

Parking & Roadways – continued		
Recommendations for Replacement and/or Maintenance		
<ul style="list-style-type: none"> – Funds are allocated every 5 years to patch and repair asphalt surfaces. Repairs to damaged/deteriorated areas should be completed within the next 3 years. – Complete resurfacing should be done within the next 7 years. 		
Projection		
Year Replacement Required:		Cost of Replacement with Inflation:
Curbs	30+	NA
Parking & Roadways	2028	\$104,767
Major Repair	2024	\$10,881

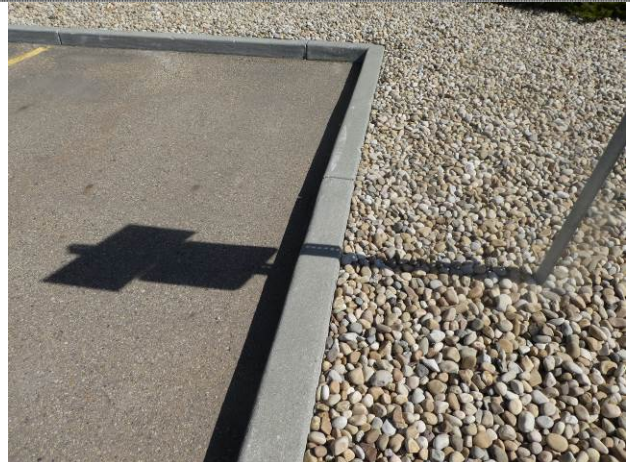
Curb

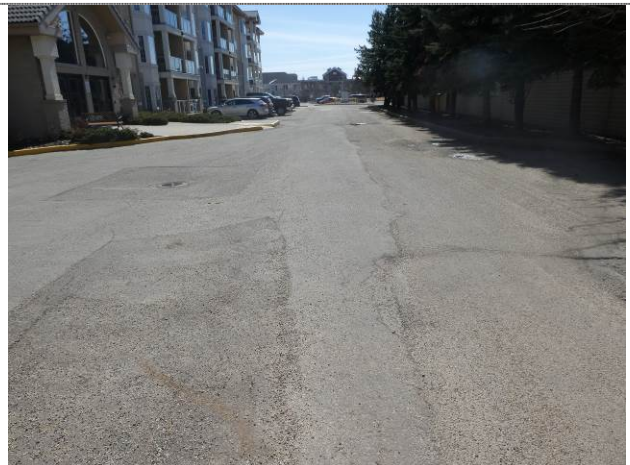
Roadway in front of building

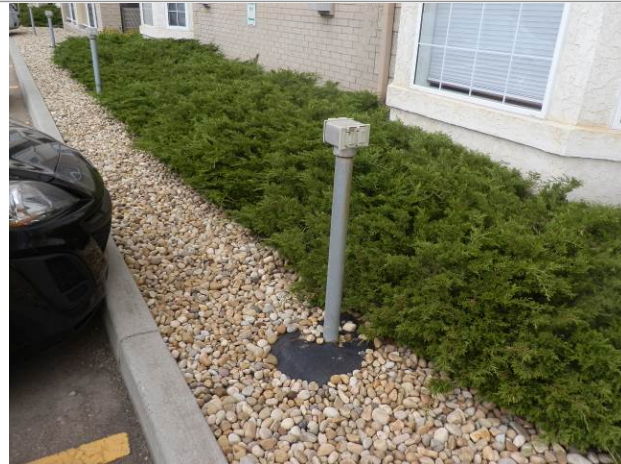
- There are 8 vehicle outlets installed in the landscaping adjacent to the parking area. These outlets are installed on pedestals. Outlets are original and appear to be in good condition.
- There is one exterior light standard in the parking area.
- Underground electrical lines run to each vehicle outlet and site light. These lines can not be inspected for this report.

Vehicle outlet

- Regular maintenance is recommended.

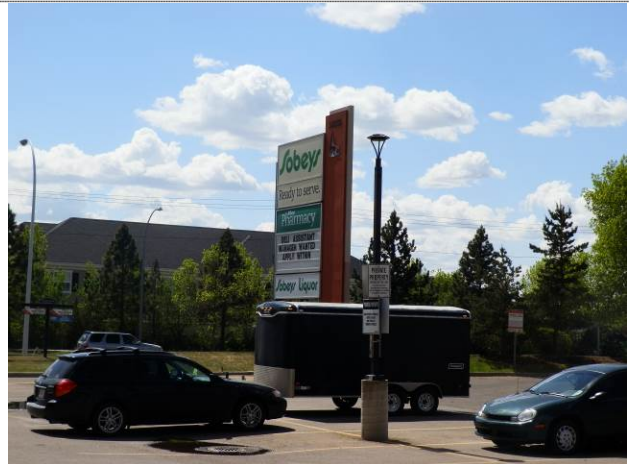
Site lighting

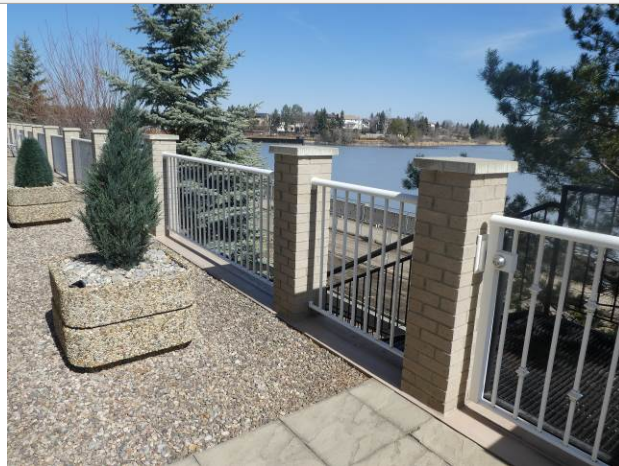
Railings and pillars on plaza deck

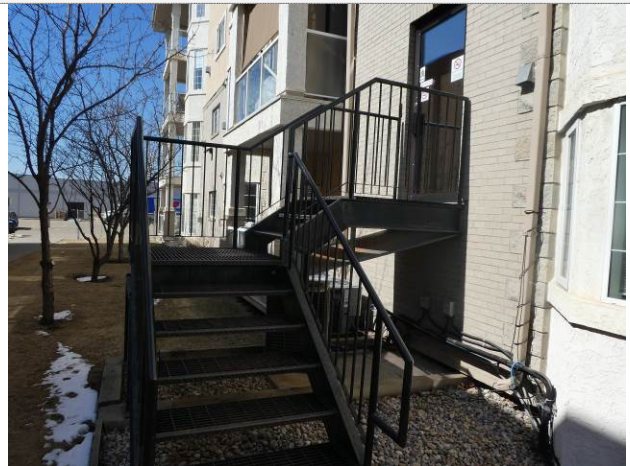
- Metal railings are installed around the plaza decks and on retaining walls. Railings are in good condition.
- Brick pillars are installed with the railings around the perimeter of the plaza deck on the east side of the building. These pillars are in good condition.
- Retaining walls are installed on each side of the parkade ramp, and on the northeast corner of the property. Retaining walls are in good condition. Complete replacement will not be required.
- Chain link fencing is installed on the southeast and southwest sides of the building. Fencing is in good condition.
- Metal stairs are installed at 2 entrances and to access the plaza deck. Metal stairs are in good condition. Some rusting was noted.

Metal stairs

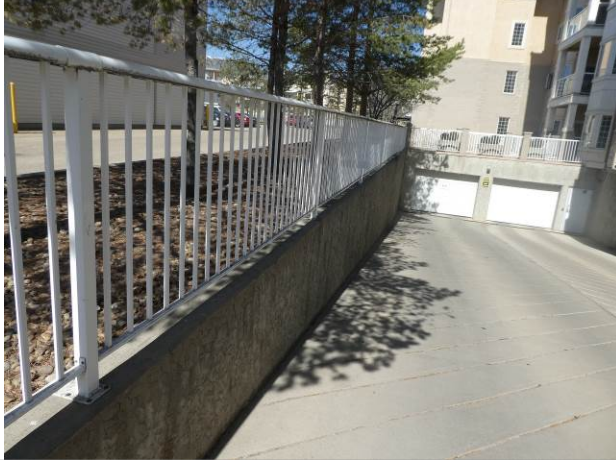
Railings and retaining wall at parkade ramp

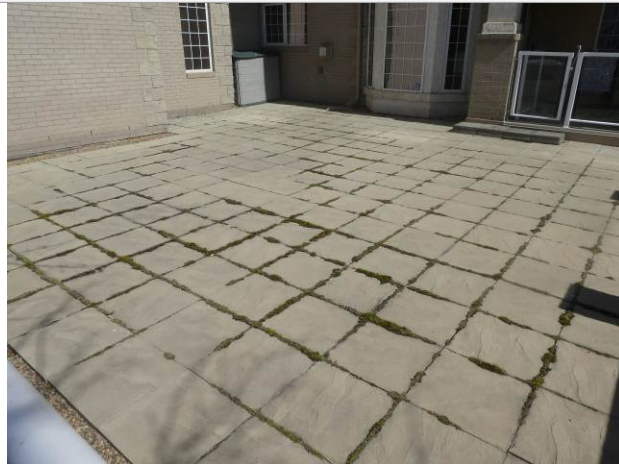
Front plaza deck with concrete pavers

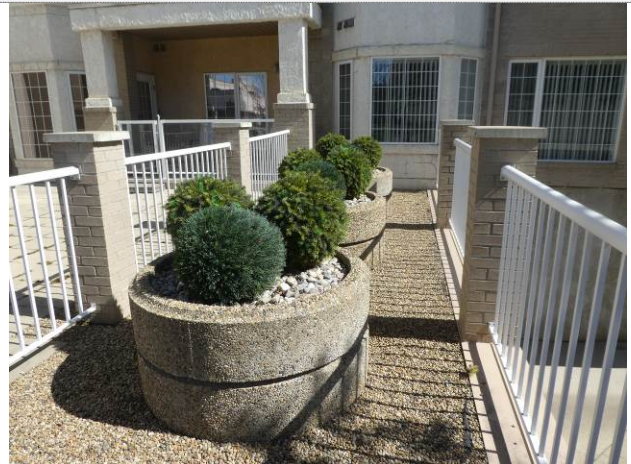
- A membrane is installed between the ceiling of the parkade and the plaza decks. This membrane is not a life item and will require replacement at some time. Although it can not be inspected, industry standard and experience advise that it will last approximately 30 - 35 years. When it does fail the parkade ceiling will start to leak and cause concrete deterioration. No evidence of water entry is noted at this time. In order to replace this membrane all components above it will need to be removed (concrete plaza deck tiles).
- The parkade flooring is concrete. This concrete is in good condition.

Parkade membrane under landscaping

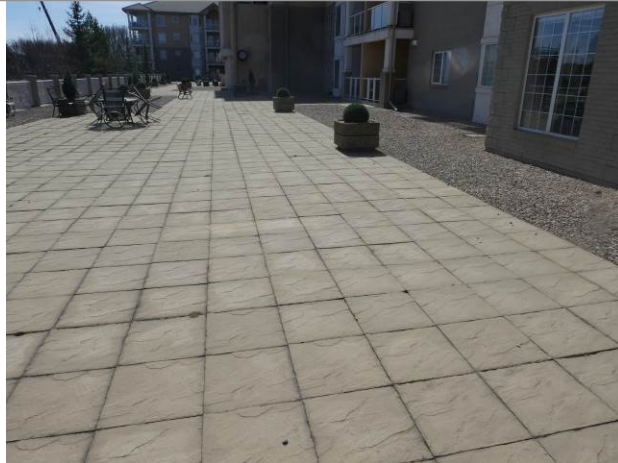
Back plaza deck with parkade membrane below

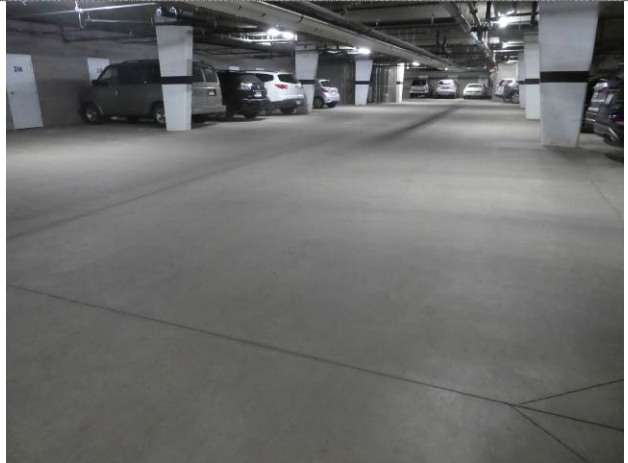
Parkade flooring

- Funds are allocated to repair/refurbish approximately 400 sqft of parkade flooring every 5 years. Repair as necessary.

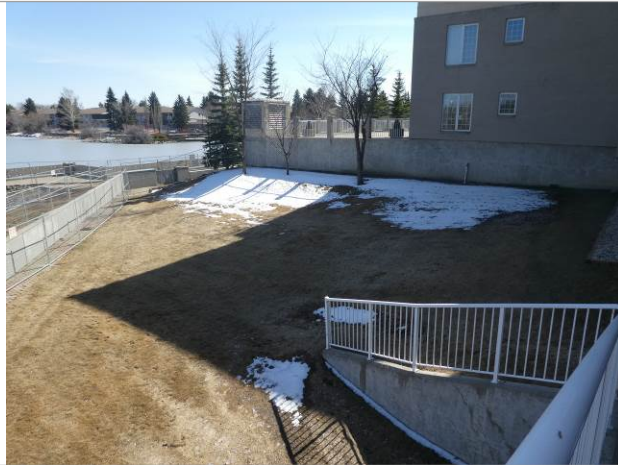
- An irrigation system is installed. This system appears to be in good condition and should not require complete replacement.
- Landscaping consists of trees, shrubs, grass, rock beds, mulch beds and concrete planters. Landscaping appears to be in fair condition.
- The slope of the landscaping may be suspect in a few locations. Landscaping should slope away from the building to ensure water drains away properly.

Landscaping on north side of building

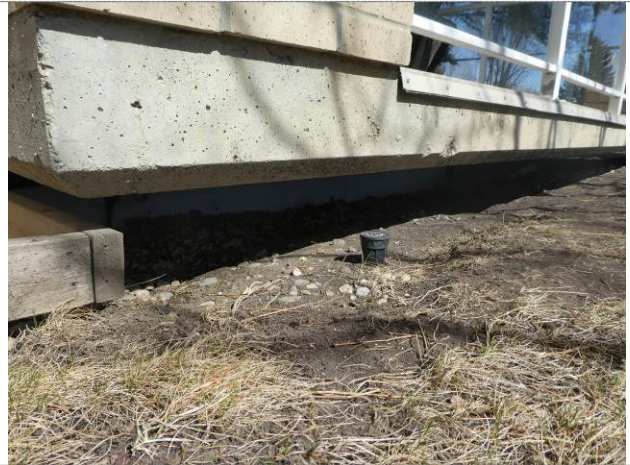
Sprinkler head

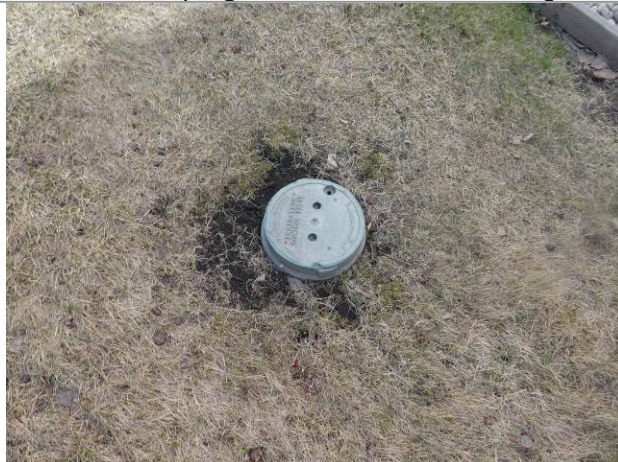
Irrigation controls

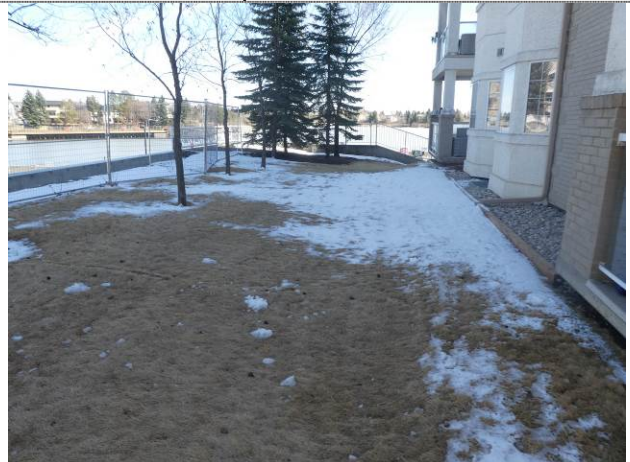
Landscaping

Landscaping – continued		
Recommendations for Replacement and/or Maintenance		
– Funds are allocated every 5 years to address landscaping concerns that are not of an annual nature.		
Projection		
<i>Year Replacement Required:</i>		<i>Cost of Replacement with Inflation:</i>
Landscaping	2026	\$13,532
Irrigation System	2043	\$22,908

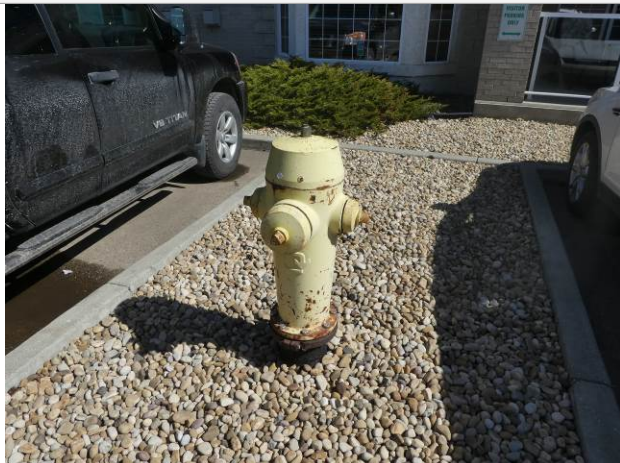
Fire hydrant			
Recommendations for Replacement and/or Maintenance					
<ul style="list-style-type: none">– Money is budgeted to repair damaged underground water & sewer systems as needed.					
Projection					
<i>Year Replacement Required:</i>				<i>Cost of Replacement with Inflation:</i>	
2031				\$24,658

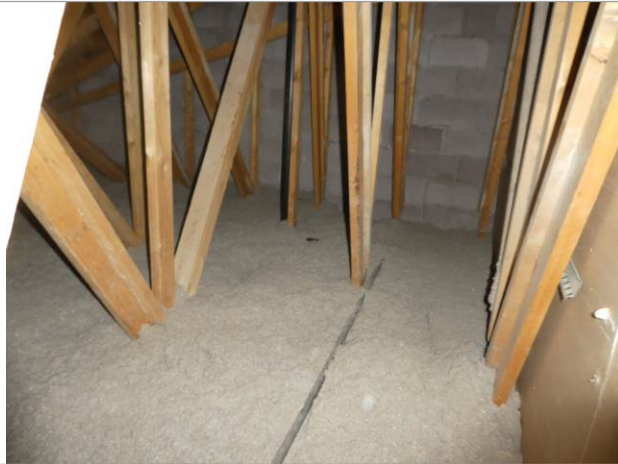
- Attic had sufficient insulation. Soffits were free of insulation and proper air flow was noted. No staining on the underside of the roof sheathing was noted.

Attic space
