## RESERVE FUND STUDY REPORT

# ***SIERRAS ON THE LAKE CONDOMINIUM CORPORATION***

CONDOMINIUM PLAN No. 022 6881

MAY 2026  
FINAL

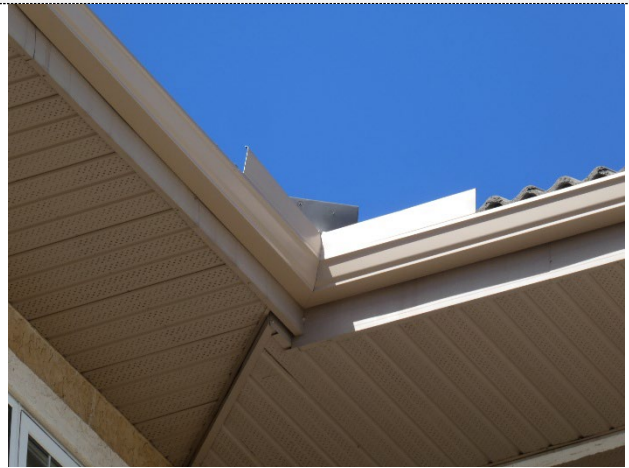
Flashing installed at inside corner

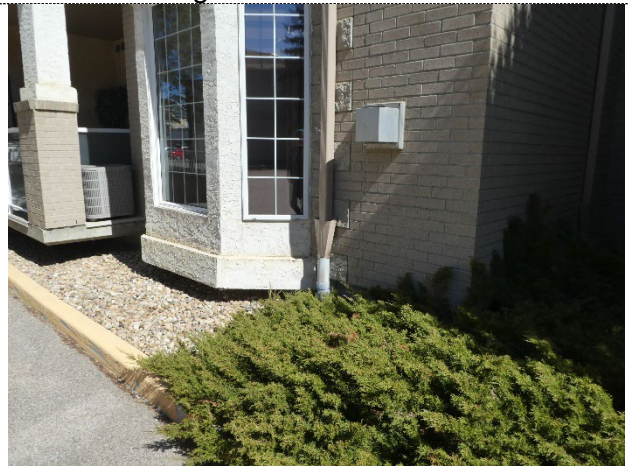
Downspout terminating into drain

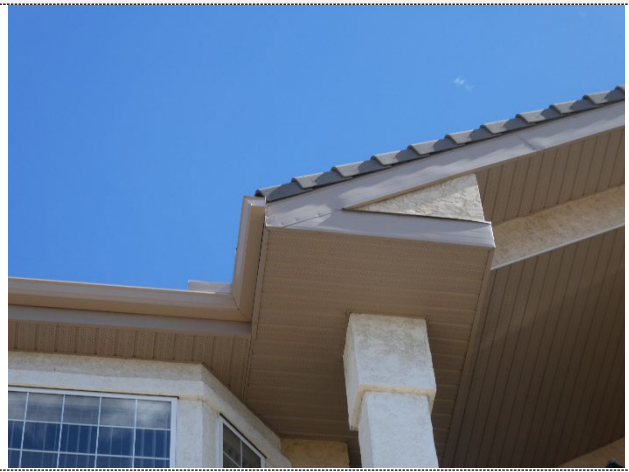
Fascia & soffit at roof overhang

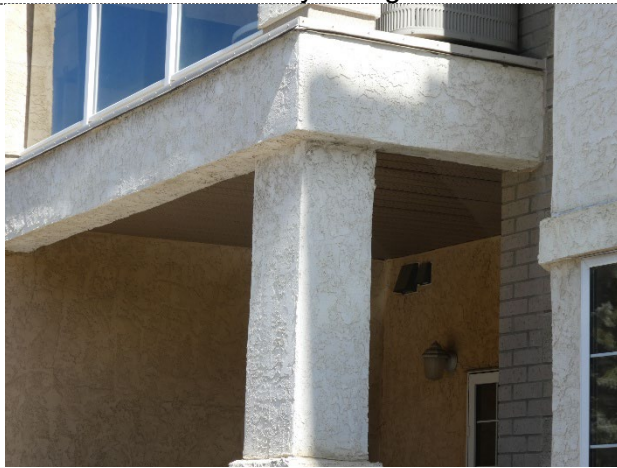
Balcony fascia & post cladding

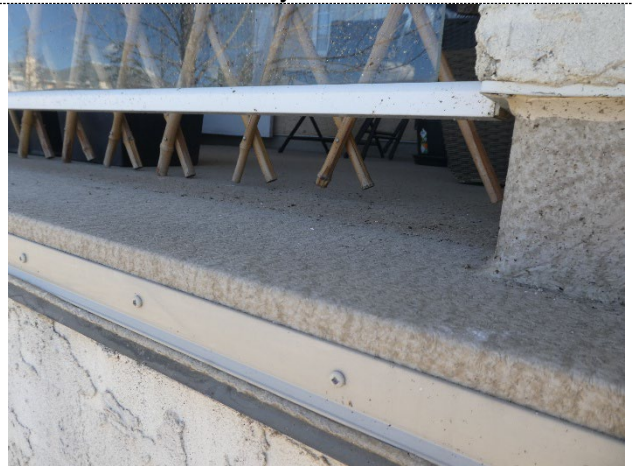
Clamping bar installation on balcony membrane

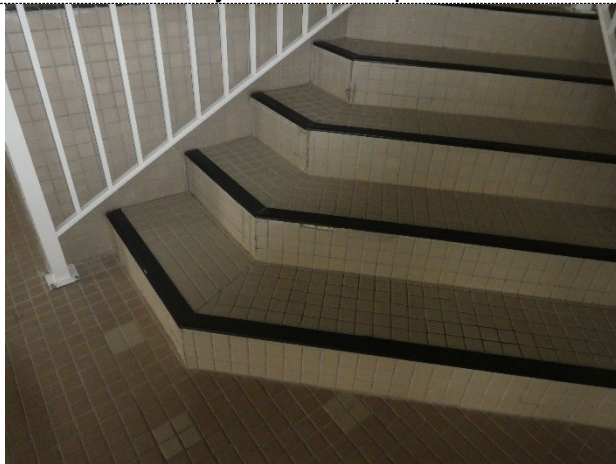
Minor damage to tile

| <b>Interior Flooring Finishes – continued</b> | | |
|---|---|---|
| <ul style="list-style-type: none"> <li>– Follow manufacturer’s recommendations for care and cleaning of all flooring finishes.</li> <li>– Replace carpet in all common rooms this year.</li> <li>– Replace hallway &amp; stairwell carpet within the next year.</li> <li>– Funds are allocated next year and every 5 years to repair damage tile flooring in the pool area.</li> </ul> | | |

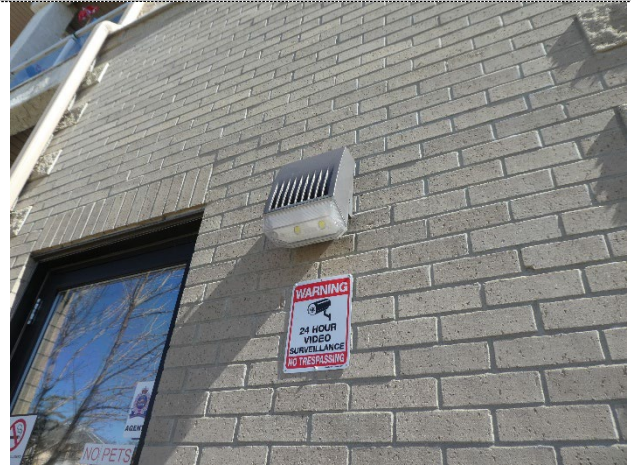
- Exterior building lighting was upgraded in 2016 and is in good condition.

Exterior building lighting

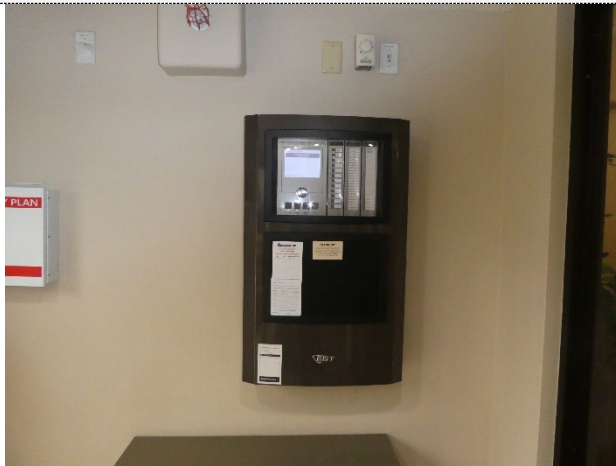
- Fire alarm system consists of an EST notifier panel at the front entrance.
- Extinguishers, smoke detectors, alarms, pull stations & sprinklers are installed throughout the building.
- Hallway doors have release mechanisms that automatically shut the doors.
- Fire alarm system is in good condition.

EST notifier panel

- Funds are allocated every 5 years to upgrade alarm components such as extinguishers, alarms, smoke detectors, etc as needed.
- Funds are allocated every 5 years to repair/upgrade damaged sprinklers.

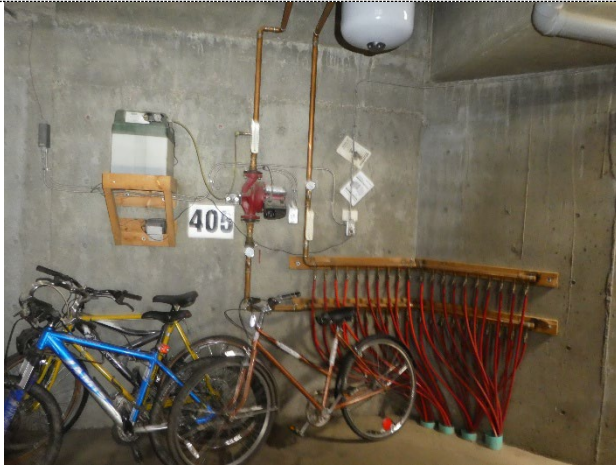
- A glycol heat loop system is installed in the concrete to ensure that the concrete does not ice up in the winter months. Inspection of the piping is not possible for this report. When failure occurs, the ramp will start to freeze in areas. Generally, these systems last about 35 years.
- The concrete ramp is original and in fair condition.

Glycol heat loop mechanical components

- Miscellaneous small mechanical components of the heat loop system should be replaced as needed.

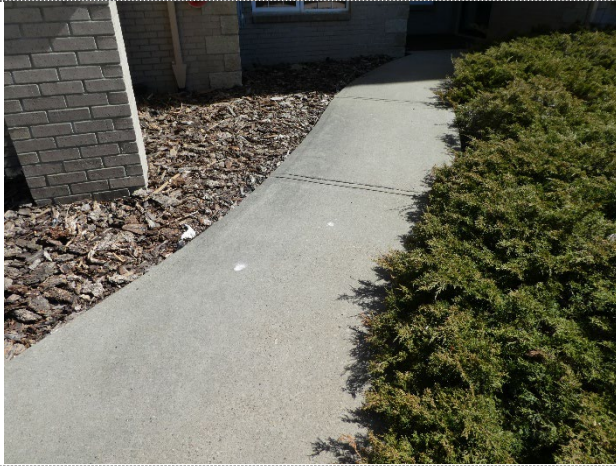
- Poured concrete walkways are installed at the west & south sides of the building.
- Concrete walkways are original and evidencing deterioration.

Walkway in fair condition

- Walkways should be replaced in a phased program. Funds are allocated to replace 1/3 of the concrete walkways every 5 years.
- It is recommended that salt based ice melt products not be used.

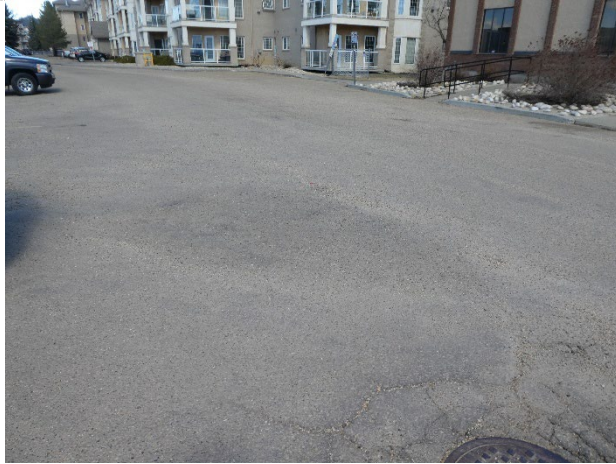
- Poured concrete curbing is installed around the perimeter of the asphalt. Curbing is original and in good condition.
- Asphalt parking & roadways are also original and evidencing wear.

Asphalt parking & roadways

- Parking & roadways should be completely resurfaced within the next 4 years. If resurfacing is postponed, a complete replacement at double the cost may be necessary.
- Funds are allocated to patch and repair asphalt every 5 years thereafter.
- It is recommended that salt based ice melt products not be used.

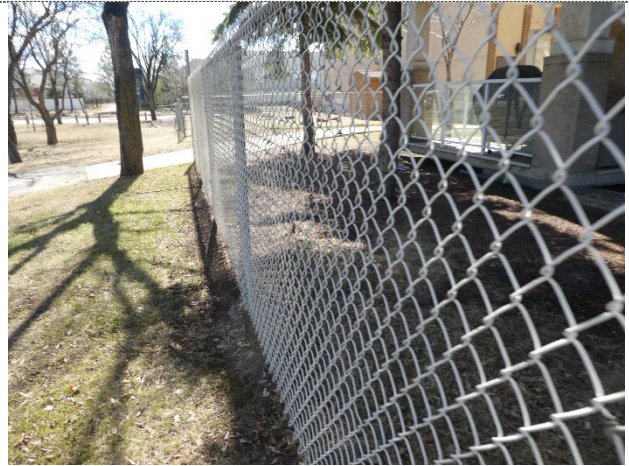
Chain link fencing

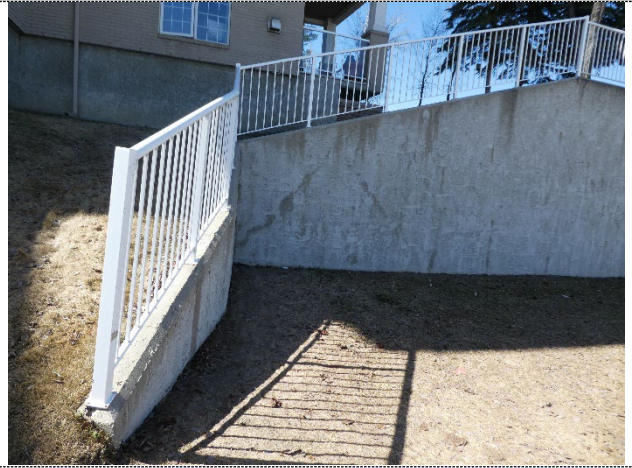
Railings & retaining wall – north

| <b>Fencing &amp; Exterior Stairs – continued</b> | | |
|---|---|---|
| <ul style="list-style-type: none"> <li>– Funds are allocated every 10 years to repair/paint railings &amp; repair brick pillars. Repair/refurbish as needed.</li> <li>– Funds are allocated every 10 years to refurbish metal stairs.</li> </ul> | | |

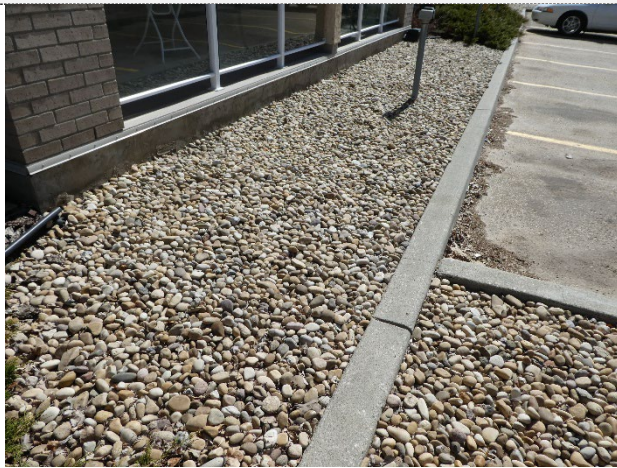
Stone installed at front of building

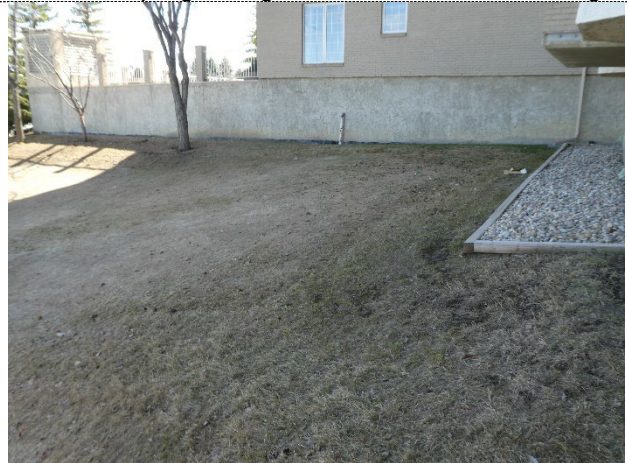
Landscaping along northeast corner of building
