National Transportation Safety Board

Aircraft Accident Brief

Accident Number:	CHI01MA011
Operator/Flight Number:	N/A
Aircraft and Registration:	Cessna 335, N8354N
Location:	Hillsboro, Missouri
Date:	October 16, 2000

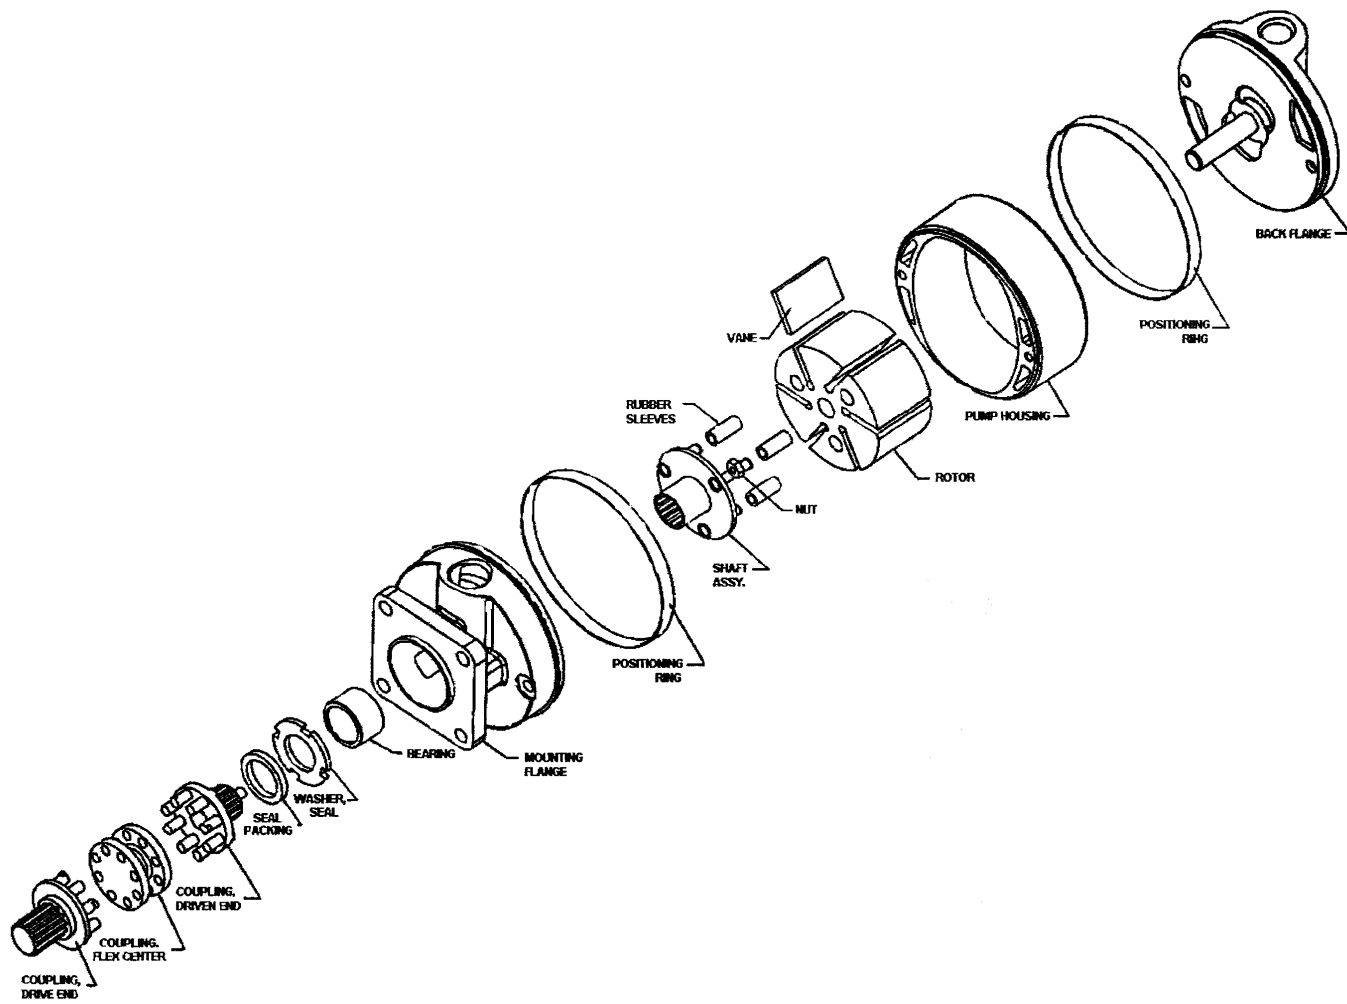
Figure 2. Diagram of a Cessna 335 vacuum pump.

Three pieces of the left engine vacuum pump were found: the mounting flange/pump base, which remained attached to the engine accessory case; the pump housing; and the pump housing back flange. (See figure 2 for a diagram of a Cessna 335 vacuum pump.) Fragments of rotor pieces, between 1 and 2 inches long, were recovered.

The pieces contained short scratches and gouges in the direction of rotor rotation and other scuff marks and scratches in random directions.

The pump mounting was removed from a fragment of the engine case. The drive shaft end coupling did not rotate when light manual force was applied. After it was disassembled, it was determined that the coupling did not rotate because of a fractured braze⁴³ joint between the shaft assembly and the shaft disc. Examination of the braze joint revealed no evidence of rotational scoring. The drive shaft/coupling assembly was further disassembled. The drive coupling, flex coupling (shear coupling), and driven coupling were intact. Four of the six pin shaft drive pins were bent toward one side (not in the direction of rotation) at varying angles. The pump housing was slightly flattened, and no internal rotational score marks were visible around the circumference. The base of the pump housing contained three marks, which encompassed one half of the circumference. All three marks showed metal dislocation toward the same side of the housing. Once the coupling was removed, the carbon bearing under the base of the pump was found broken on the same side. The outside of the pump housing contained numerous impact marks. Wood and dirt were found embedded within the cooling fins.

The right engine vacuum pump was found in two main pieces: the mounting flange and the pump. The drive coupling was found loose from the other components, and two of its pins were missing. The flex coupling (shear coupling) was not recovered. The driven coupling remained attached to the pump assembly and was found intact with pieces of wood embedded between the coupling driven end and the mounting flange. The pump was opened and an even distribution of wear was noted. The interior surface of the drive cap showed no evidence of complete circumferential or lateral marks. Short scratches and gouges were found in the direction of rotation. The rotor was found broken into five major pieces with smaller fragments. The periphery of the rotor was not damaged. The six vanes were found intact with slight chips missing from the outboard corner at the driven end of two of the vanes. The cooling fins sustained impact damage on the side of the pump opposite the OUT port.

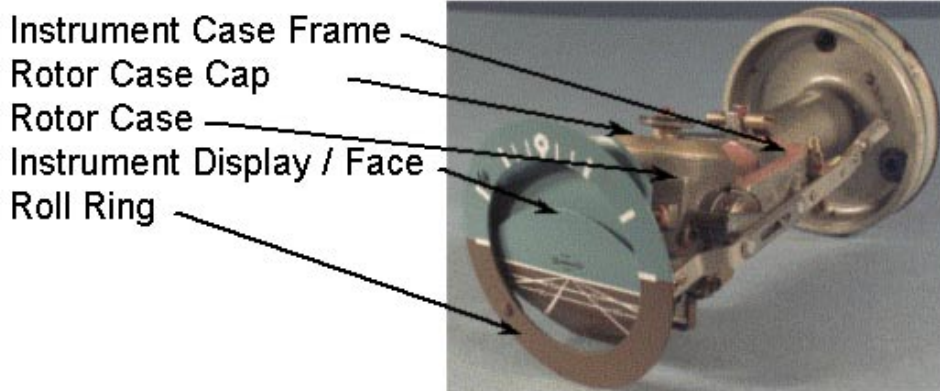
Figure 3. Photograph of an exemplar attitude indicator and its components.

The following components from the left-side attitude indicator/flight director were identified in the wreckage: the gyroscopic rotor, the rotor case cap, two pieces of the rotor case, the instrument face display (including the roll ring), and pieces of the instrument case frame. (See figure 3 for a photograph of an exemplar attitude indicator and its components.) The model of the attitude indicator installed on the accident airplane contained an arm that provides mechanical linkage from the rotor housing to the pilot's display. This arm was located on a fragment of the instrument case frame.

Examination of the interior diameter of the rotor case revealed faint, unevenly spaced diagonal scratches. The measured angle between the scratches and the direction of rotation was between 4.0° and 5.2° . The scratches were consistent with the direction of rotation of the rotor and with the direction the rotor was moving when it exited the case. No other circumferential score marks were found on the inner surface of the case that paralleled the direction of rotation.

Diagonal marks were found on the end of the rotor. Nearly all of the other scratches on the cap were oriented across the direction of rotation at various angles. The center fastener hole on the cap was ripped, with more than half of the periphery remaining. The width of the tears matched the width of the gouges in the rotor. The exterior of the cap contained scratches that resembled the width and approximate locations of the motion-limiting stop wires mounted on an exemplar instrument.

Damage on the facial roll ring resembled the shape of the triangular airplane support housing and the roll index that had been fixed to the instrument case. The relative positions of the damage resembling the triangular support and roll index were on the top and bottom of the ring, respectively, when it was placed at an inverted display of attitude. The face of the instrument was placed behind that of an exemplar instrument and, using the damage on the roll ring for alignment, the marks were within 2° of a wings-level inverted attitude. (See figure 4.)
