# REPAIRING ALUMINUM WIRING

U.S. Consumer Product Safety Commission  
Bethesda, MD  
[www.cpsc.gov](http://www.cpsc.gov)  
[www.SaferProducts.gov](http://www.SaferProducts.gov)

**Publication 516**

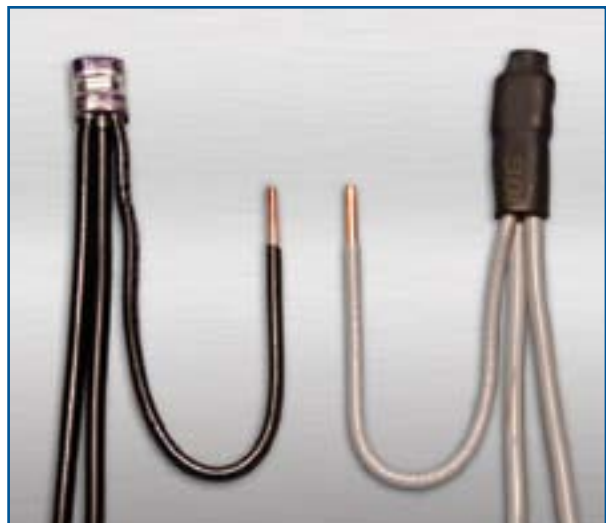
**Recommended COPALUM Connector Repair**

The COPALUM connector is a specially designed system that includes a metal sleeve intended to be installed only with a dedicated power tool and crimping die to make a permanent connection, that is, in effect, a cold weld (the precision dies in the COPALUM tool compress the connector and wires using upwards of 10,000 pounds of force, as required to make the permanent aluminum wire connection).

The tool is shown in the illustration below. An insulating sleeve is placed around the crimp connector to complete the repair. The copper wire pigtail is then connected to the switch, receptacle, or other termination device. An example of a repaired receptacle outlet is also illustrated below.
