# EVERY INCH RV INSPECTION SERVICES

## RV Inspection Report

**Inspection Date / RV Model:  
11-29-2021 / 2010 Fleetwood Bounder 35H**

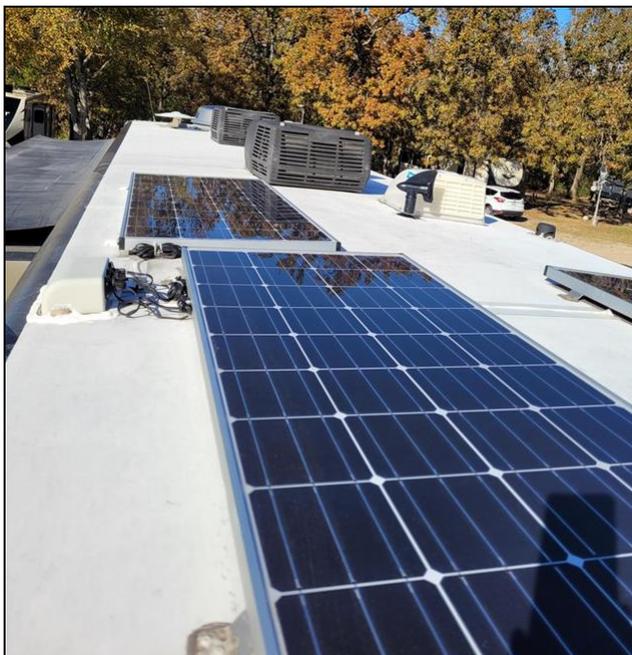
Roof Overview from Rear Looking Forward

The roof inspection is limited in nature and was accomplished by visual inspection only. The area surrounding the RV at the time of inspection was muddy and was not supporting the ladder and weight of the inspector, making it unsafe to access the roof.

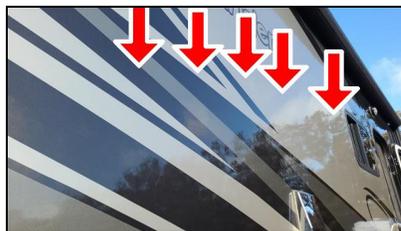
There is a scratch on the curbside sidewall from the rear of the kitchen window, extending about 48" towards the front edge of the slideout.

Scratch On Curbside Sidewall

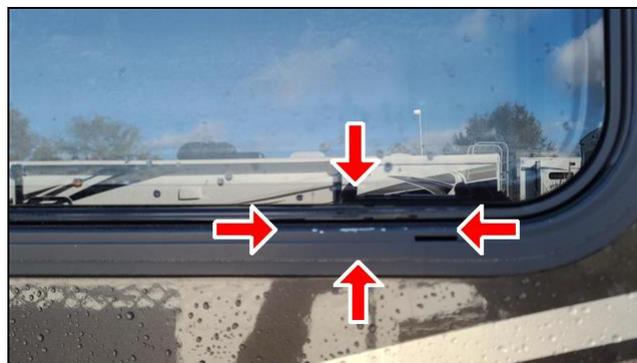
The finish is scraped on the frame of the rear emergency exit window.

Paint Scrape on Window Frame

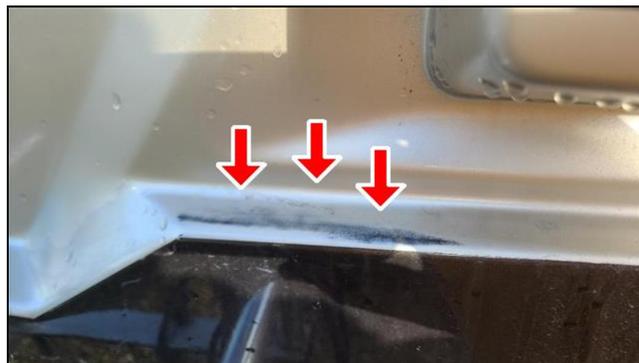
Paint Scrape on Rear Capwall next to Right Taillight Assembly

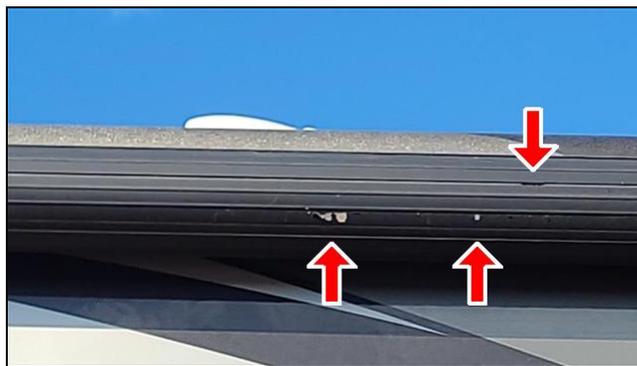
Awning Cover Paint Chipping

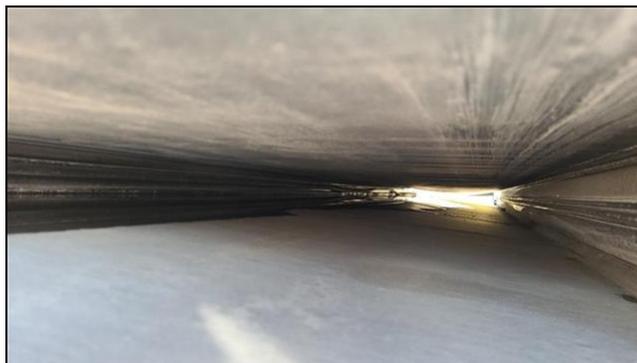
(1) Water has collected and is standing on the top of the streetside slideout under the awning topper.

Standing Water on Slideout Top

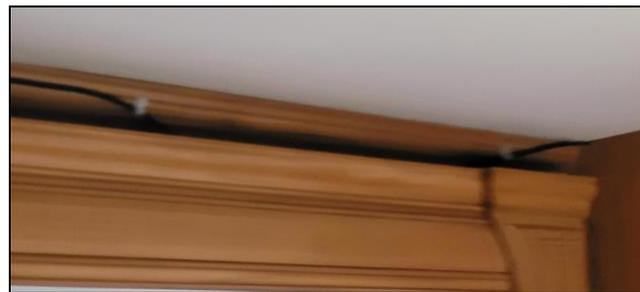
Trim Above Slide in Bedroom

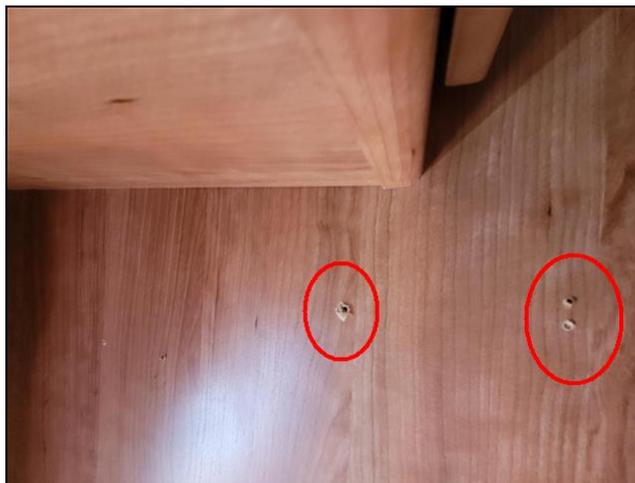
There are screw holes in the cabinet in the bedroom next to the circuit breaker panel

Screw Holes, Cabinet in Bedroom Next to Circuit  
Breaker Panel
