## 201 E 79<sup>TH</sup> STREET 2019

201 EAST 79<sup>TH</sup> STREET  
NEW YORK, NY 10001

### FISP EMERGENCY REPAIRS:

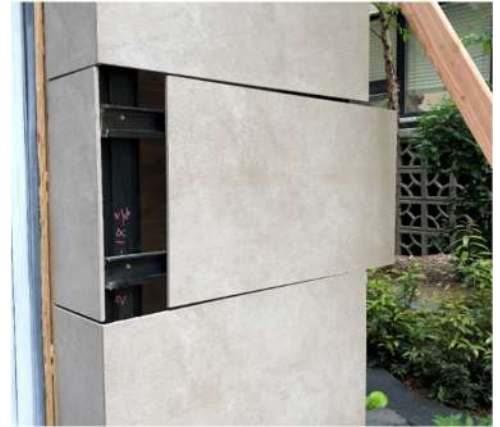
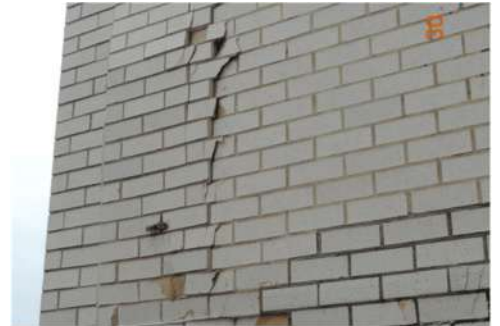
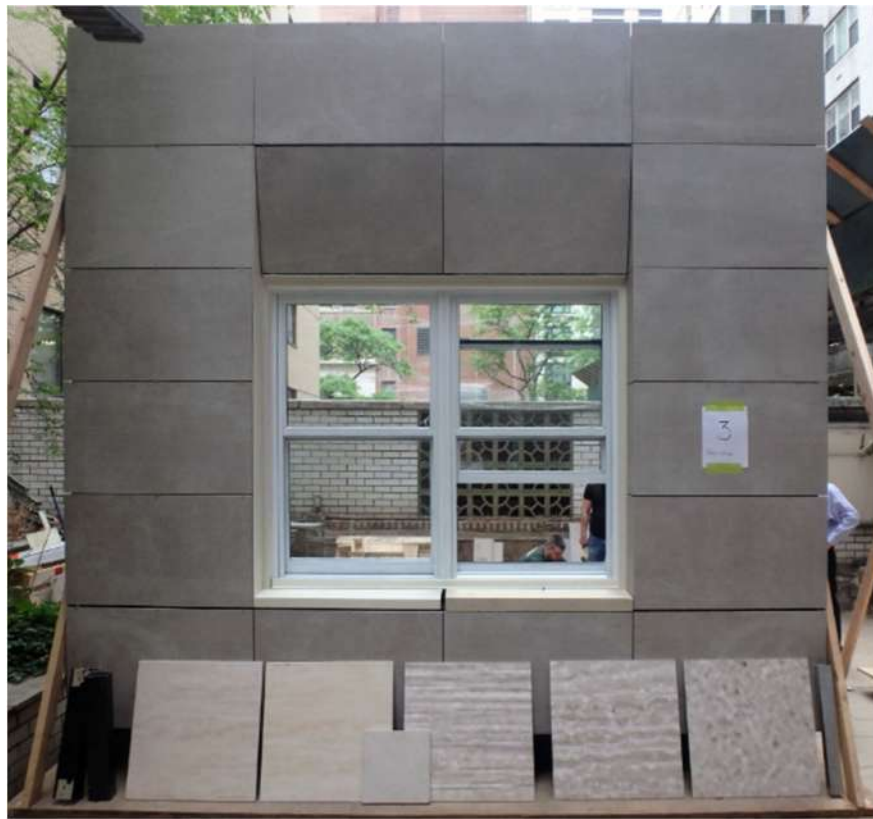
During the initial FISP inspection of this glazed white brick cavity-wall building MVN observed several areas of the façade in UNSAFE conditions. An apparent manufacturing defect in the glazed brick was causing large sections of the face brick to delaminate and spall off. This combined with an underabundance of aged and failing brick anchor ties put several panels at risk of collapse. MVN coordinated the emergency filing, stabilization and repair of these areas including a bulkhead screen. Emergency repairs bought the building time to examine the extent of the problem before deciding on a permanent solution.
