39-60 54TH STREET

2019-2020

39-60 54TH STREET
WOODSIDE, NEW YORK 11377

FISP BUILDING

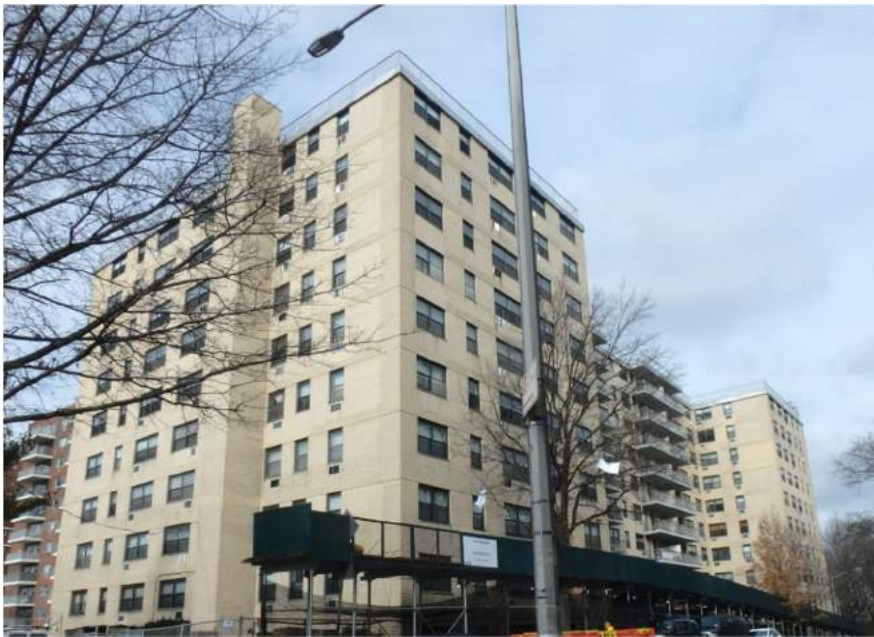
FAÇADE RESTORATION AND REINFORCEMENT: probes conducted early in the project revealed structural deficiencies in the back up masonry of this cavity wall building. Damaged concrete masonry backup was reinforced by introducing rigid steel structural members anchored to the concrete floor spandrels. New brick anchors were installed throughout to increase the stability of the cavity wall system and to bring the density of anchors up to today's standard of practice. Rusted, bowed, and loose steel shelf angles were removed and replaced with new waterproofed galvanized steel angles. The façade repairs were conducted in anticipation of and in compliance with stricter inspection and panel securement standards being implemented for cavity wall buildings in FISP Cycle 9 filings.

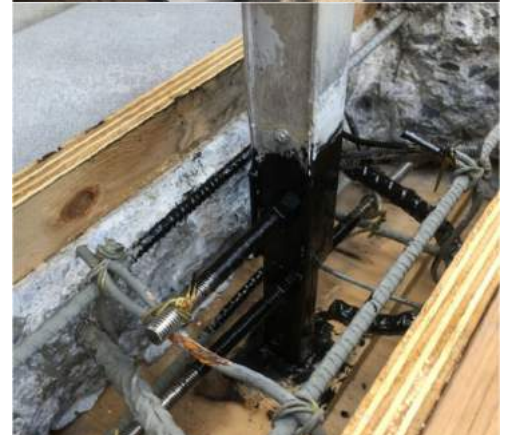
CONCRETE BALCONY REPAIRS: cracked and spalled sections of the existing balcony curbs were removed and replaced with new poured in-place concrete to match the existing profile and appearance. Much of the damage was located at railing post inserts where water became trapped. Deteriorated post inserts were removed and replaced with new that were waterproofed and contained drainage paths to allow any future infiltration to migrate out of the system without causing substantial damage. Existing structural reinforcing bars were scraped, primed, and painted with a rust inhibitive coating to extent their serviceability.

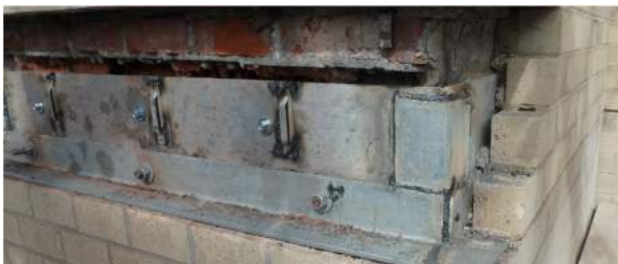
ELEVATOR BULKHEAD REPAIRS: failing of the brick anchors and shelf angles at the masonry cavity wall enclosure around the building's water tank lead to severe cracking and spalling of the outer face brick. The partial demolition and removal of the unnecessary enclosure was recommended to secure the unsafe conditions and remove a recurring maintenance item.
