January 16, 2020

PROPERTY INSPECTION REPORT

Concerning: Sample, Houston, TX 77063

By: Matthew Brading, Lic #TREC # 22654

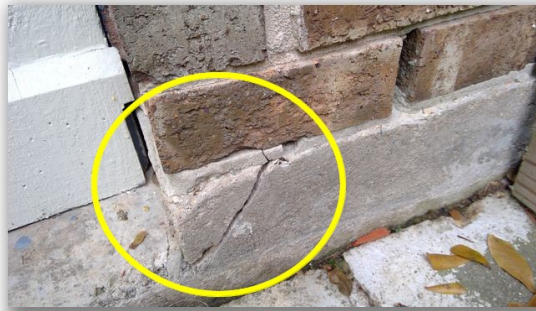
- One or more of the foundation perimeter beam corners were observed to be sheared off (corner pop). This is a common condition to observe and is do to thermal expansion and contraction of the different building materials. This condition does not adversely affect the foundation performance. However, in some cases, some cosmetic improvements may be necessary.

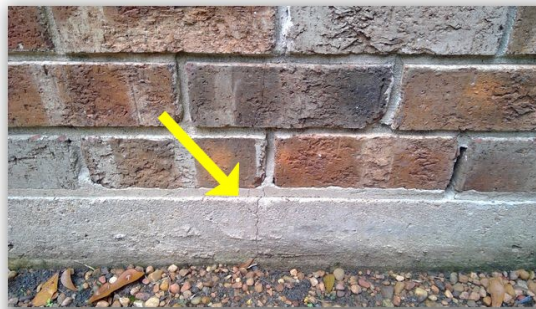
- Hairline crack(s) observed in the foundation grade beam. There was no height differential from one side to the other, and no shearing movement along the crack. We were not able to determine the extent or if this crack continued any distance across the slab due to the floor covering. The degree of visible cracking does not indicate a major structural defect; however, is consistent with a minor to moderate degree of settlement in the foundation system.

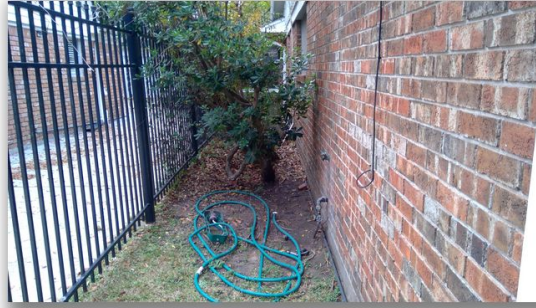
- **Note:** Tree(s) in close proximity of the foundation was observed. Client should consider the installation of a root barrier to reduce the possibility of damage to the foundation from tree roots and moisture removal.

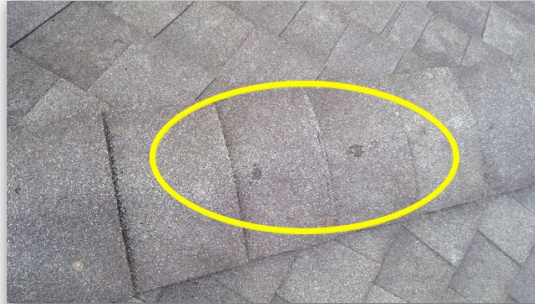
- One or more of the ridge cap shingles were observed to be damaged.

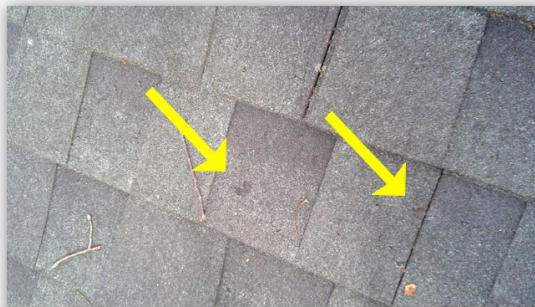
- Damaged shingles were observed on the back side of the roof structure.

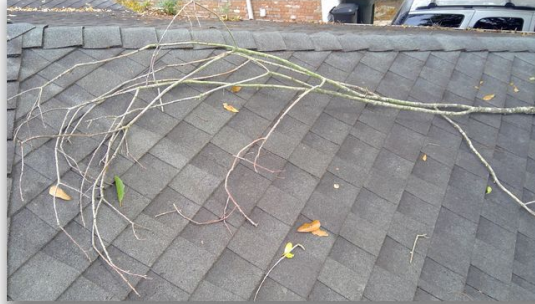
- **Note:** All debris, such as leaf's and branches, should be removed from the roof structure.
- **Note:** The tree and shrub branches should be trimmed away from the roofing material at all times.

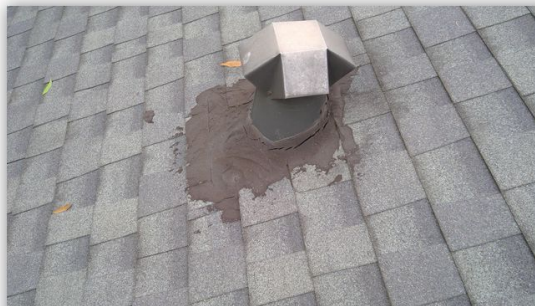
- **Note:** It appears that tar has been used to perform previous roof repairs in one or more locations on the roof. This type of repair is temporary in nature and is not considered to be a long term solution to an existing roofing problem.

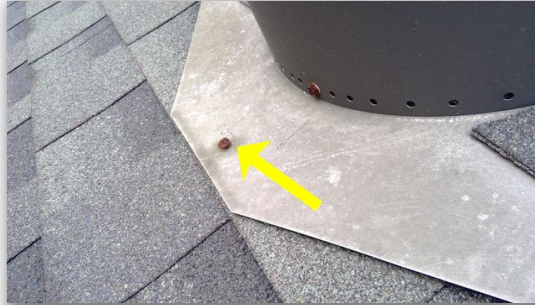
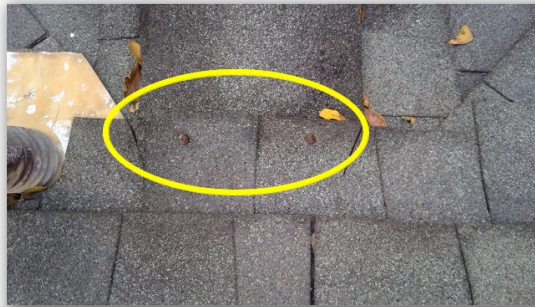
- **Note:** High shingle fasteners (staples and/or nails) were observed in various locations.
- **Note:** Roof fasteners (nails and/or staples) were observed to be exposed and should be properly sealed at the ridge caps and flashing areas.

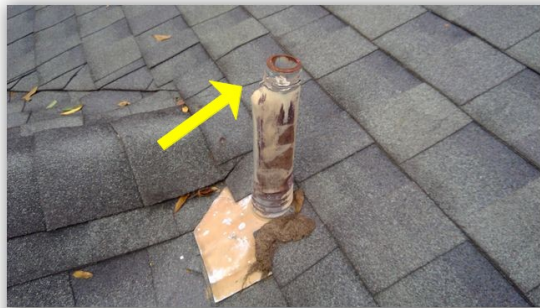
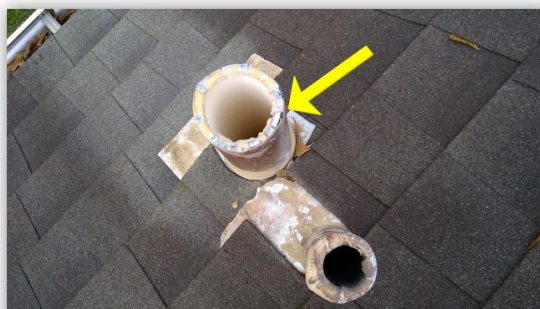
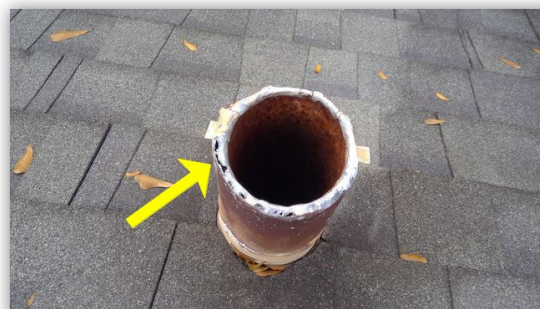
- The lead jack flashing at the plumbing vent stack needs to be checked, reset or repaired as necessary. The lead jack flashing detail was observed to be improperly installed at one or more of the roof level plumbing vent pipes. The lead flashing should run full length of the vent pipe and turn down into the top of the vent pipe to help prevent water intrusion at this point.
- **Damaged roof level lead plumbing jacks observed. This condition can allow for water intrusion.**

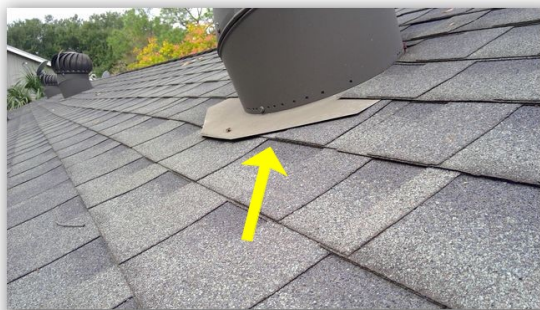
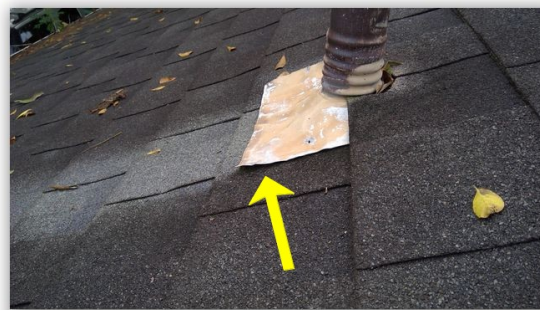
- One or more of the flashing detail flanges are not properly set into the roofing material. This condition needs to be corrected to help prevent water intrusion at this points.

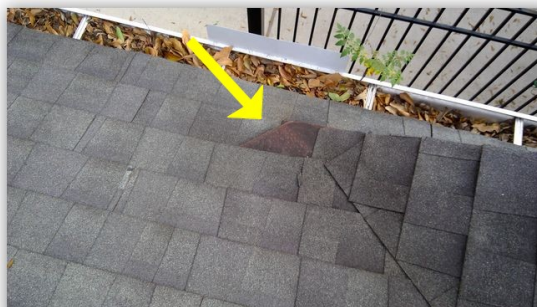
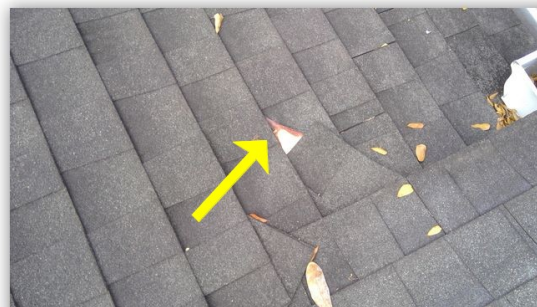
- The metal valley flashing details were observed to be rusted and should be corrected as necessary.

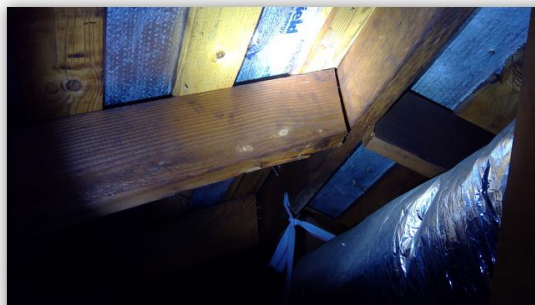
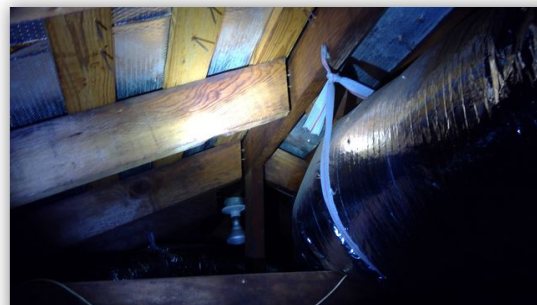
- One or more of the roof structure rafters were observed to be pulling away from the top ridge board.

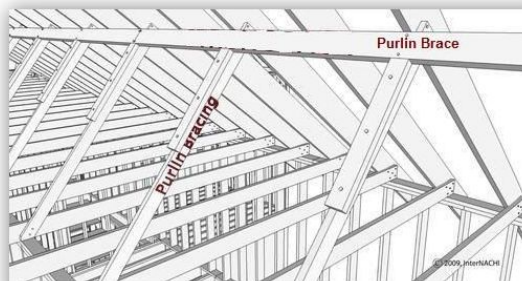
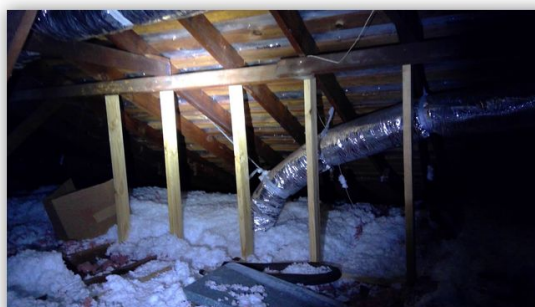
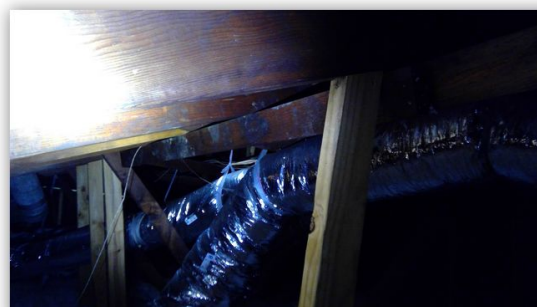
- The roof structure purlins are not properly supported in one or more locations. Under current building standards, the purlins should be supported by 2 x 4 braces installed to load-bearing walls at a slope not less than 45 degrees. The bracing should be spaced not more the 4 feet on center and the unbraced length of brace should not exceed 8 feet.
- Note:** The roof structure purlins are not properly sized to the rafters they support and the purlins are not properly supported. This item met building standards at the time the home was built. The building standards have changed and Per TREC standards of practice we are required to note this item as a deficiency.

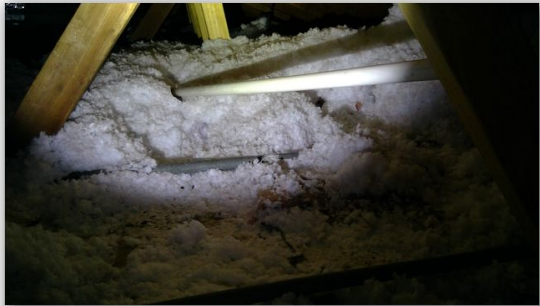
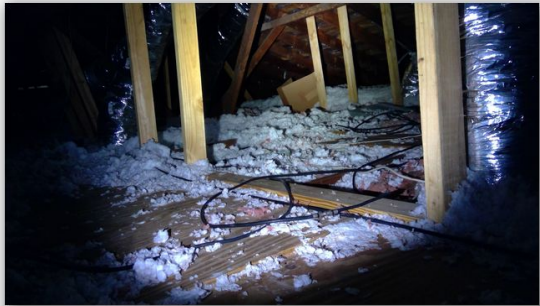
- The roof structure attic space does not appear to be adequately ventilated. It is recommended to increase the amount of lower and upper ventilation to help prevent heat buildup in the attic space area. This condition should be further evaluated and corrected as necessary.

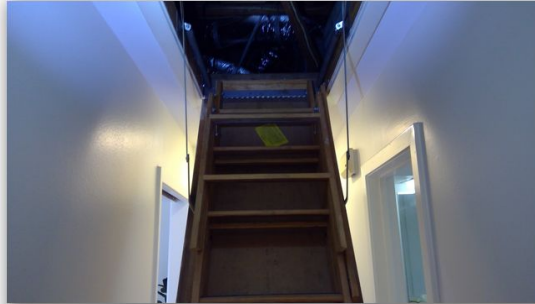
Attic Ladder

- The attic ladder was observed to be installed with improper fasteners. The attic ladder should be secured in place with 16d nails or 3-inch lag bolts. This condition should be further evaluated and corrected as necessary.

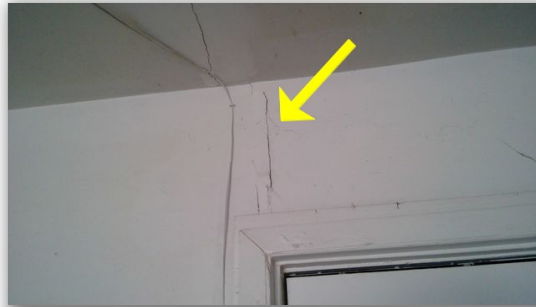
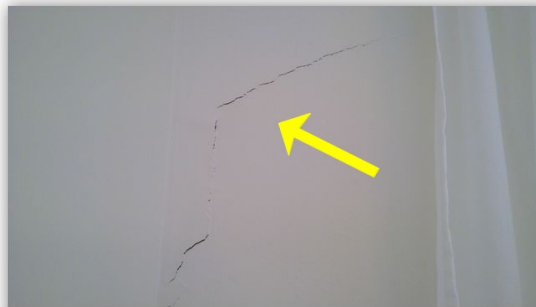
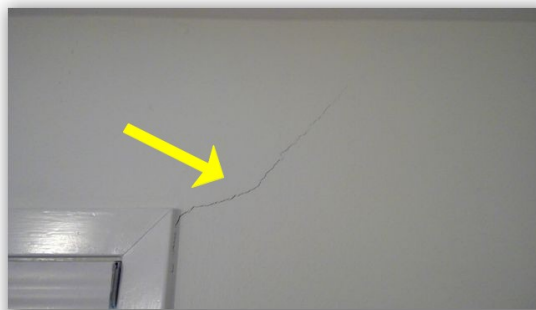
- Interior wall stress cracks were observed in various locations throughout the house.

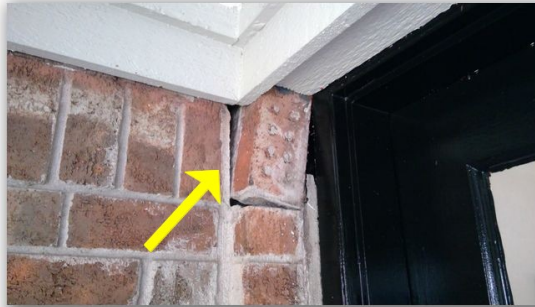
- One or more of the exterior bricks were observed to be loose on the front side of the structure.

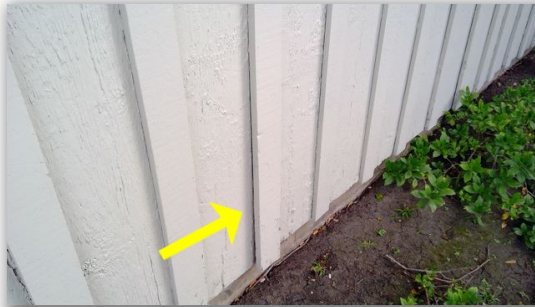
- Siding pulled loose at the back side of the structure.

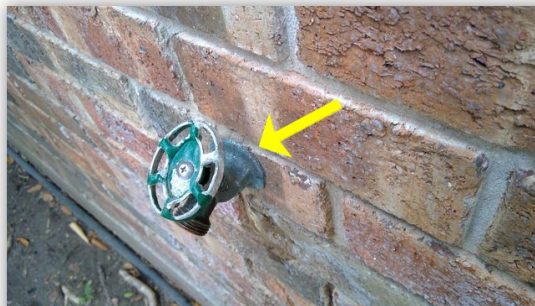
- The area between the exterior cladding / veneer and all of the wall penetrations / openings need to be properly sealed. Areas such as utility connections, downspouts, hose bibbs, lighting fixtures, receptacles etc. It is recommended to use an elastomeric caulking / sealant.

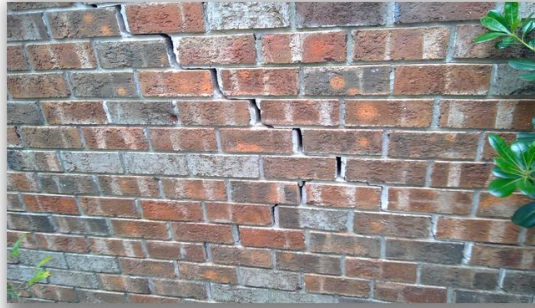
- Cracks observed in the exterior veneer. See foundation section.

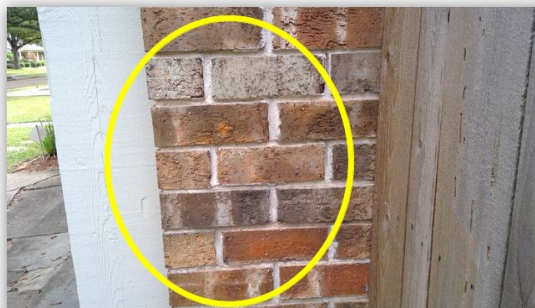
- **Note:** Previous repairs to the exterior masonry mortar / grout was observed on the right side of the structure.

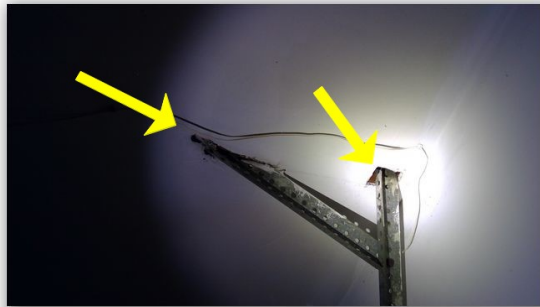
- The garage ceiling is opened to the attic space. Under current building standards the garage ceiling should be enclosed / separated from the attic space.

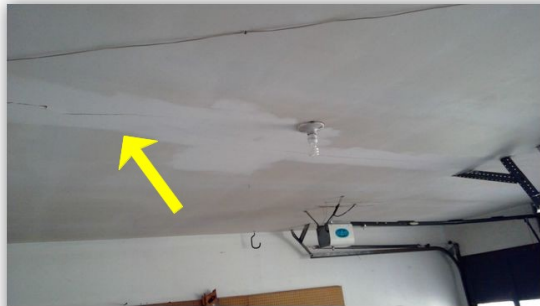
- Ceiling stress cracks were observed in the garage.

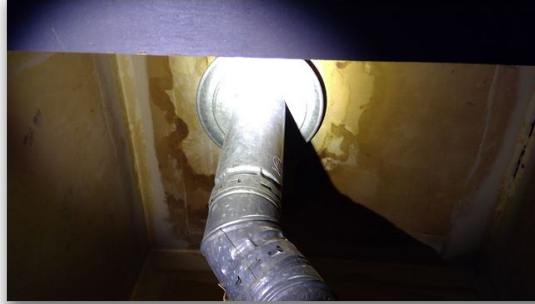
- Water stains observed on the ceiling at and/or around the water heater flue area. The sealant at the flue roof level storm collar needs to be further investigated and corrected as necessary.

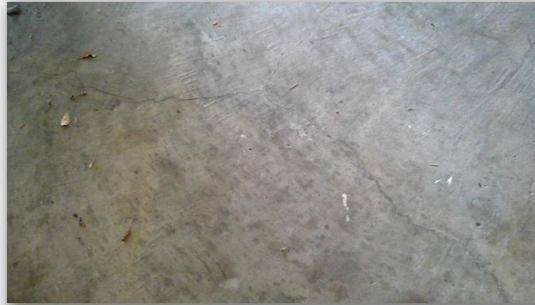
Floors

- **Note:** Some cracking of the garage concrete floor finish was observed.

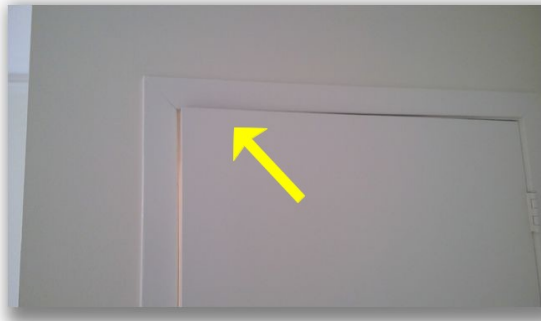
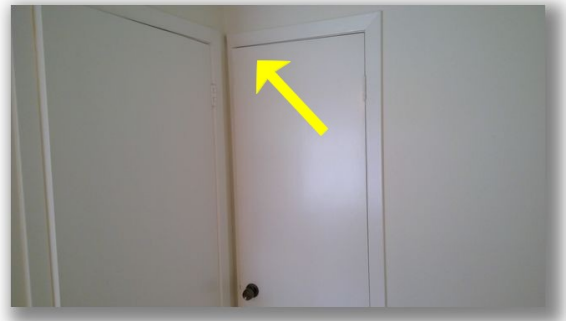
- The door is sticking and will not close properly to the front middle bedroom, front middle bedroom closet.

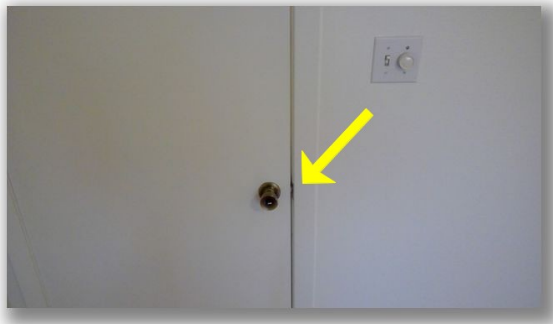
- The door is not latching properly to the side middle bedroom.

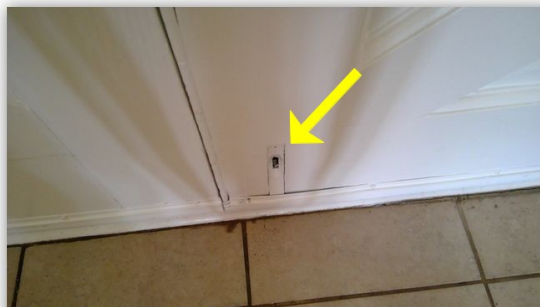
- The door hardware does not function properly to the front entry door.
- The door hardware is damaged and/or is not functioning properly to the front entry door.

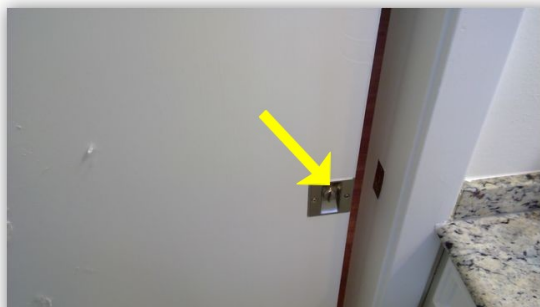
- The pocket door does not appear to be functioning properly to the master bathroom.

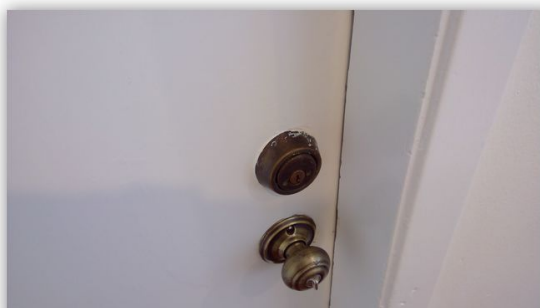
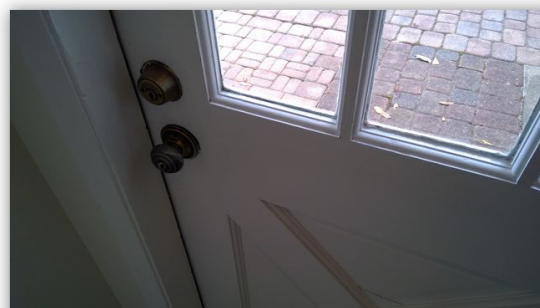
- Double cylinder locks were observed on one or more of the exterior exit (egress) doors. All exterior egress doors should be readily operable from the side from which egress is to be made without the use of a key or special knowledge or effort.
- Unable to open laundry room door without key.

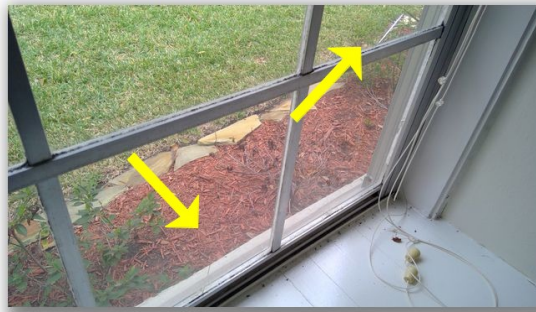
- Cracked and/or broken window glass was observed in the front middle bedroom.

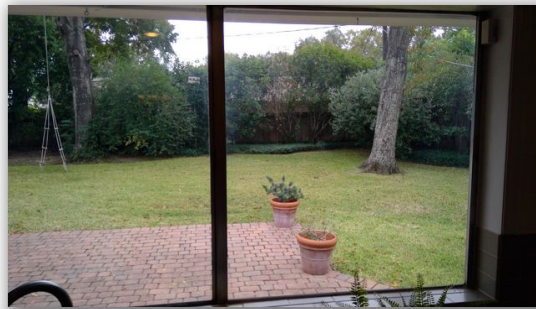
- **Note:** Some of the windows are painted shut and cannot be opened.

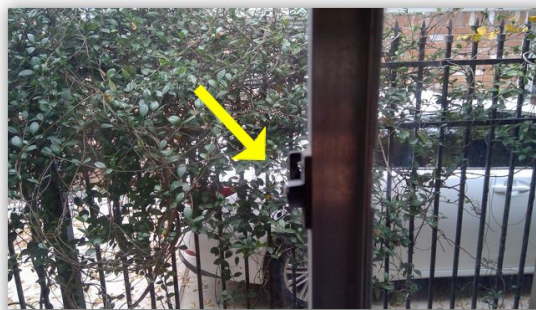
- Window lock(s) were observed to be damaged and/or missing in the hall bathroom.

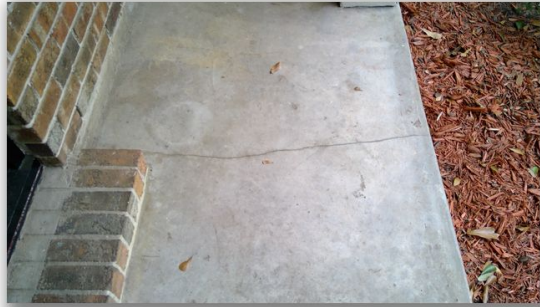
Porches

- Some deflection and/or cracking of the patio concrete flatwork was observed.

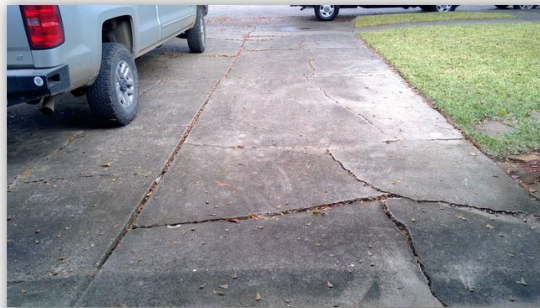
Driveway

- Larger than typical cracks and/or deficiencies were observed in the driveway.

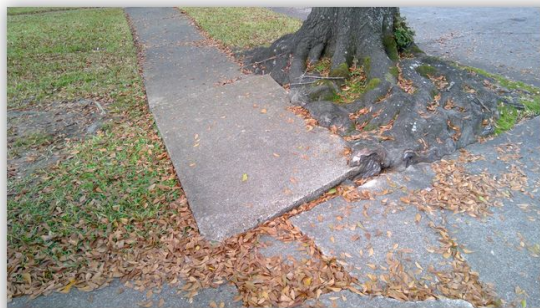
Sidewalk(s)

- The sidewalk was observed to have larger than typical cracks and/or deficiencies.

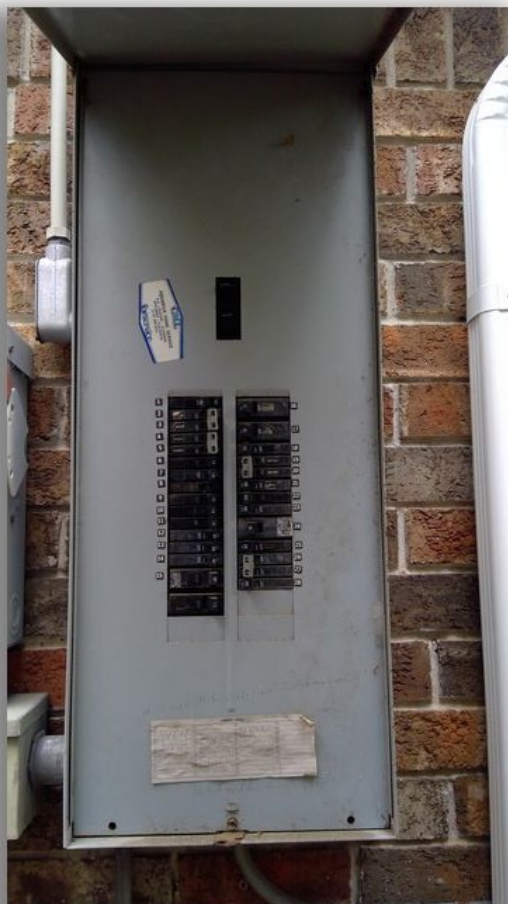
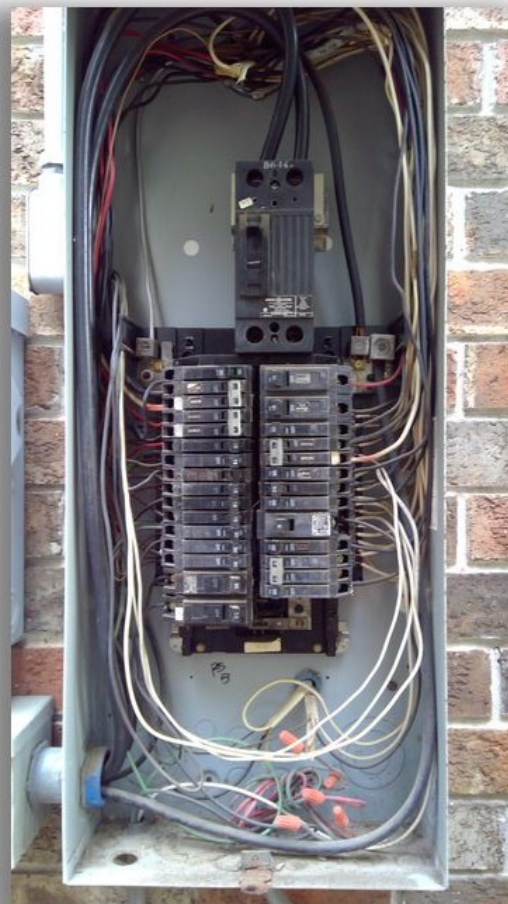
- The breakers (overcurrent devices) in the electrical panel are not properly labeled.

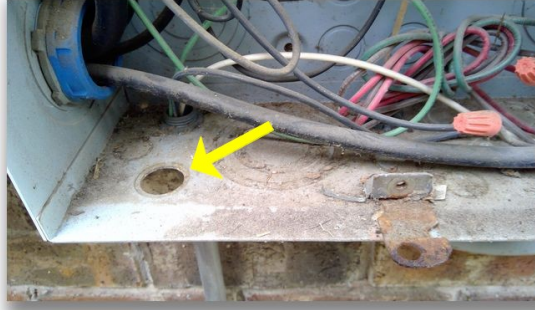
- All openings (missing knockouts) in the electrical cabinet cover plate (dead front) and /or cabinet need to have fillers.
- The electrical cabinet does not appear to be properly bonded to the electrical system. Breaker #1 was observed to be in the off position. When turned on, a buzzing sound can be heard and the breaker then trips to the off position.

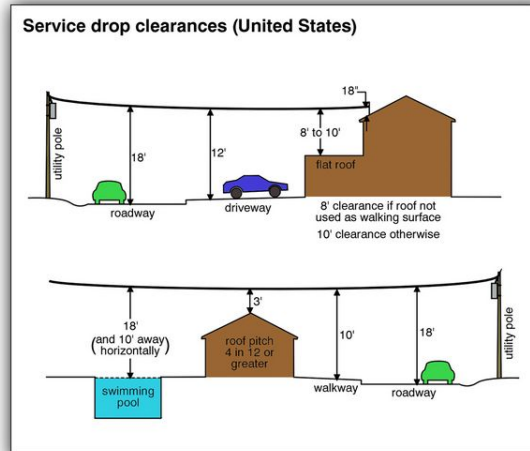
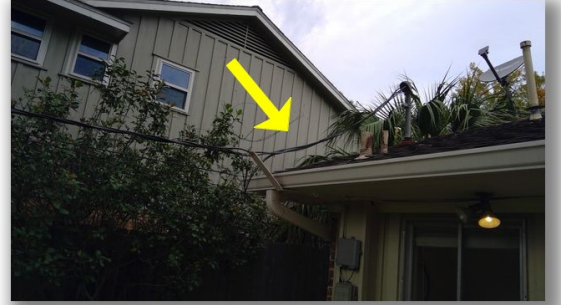
Service Entrance

- The electrical service wires hang to low over the roof structure. The electrical service wires from the service pole to the structure should clear all roof structure components by a minimum of 3-feet.

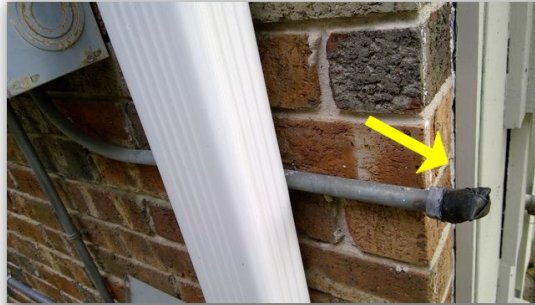
- Unused wires & conduit should be removed and blank spaces filed.

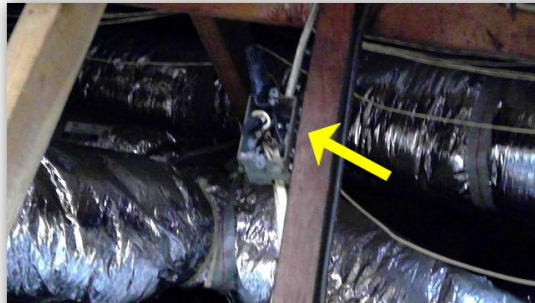
- Open electrical junction box(es) were observed in the attic area. All open junction box(es) in the attic should be properly enclosed. Open junction box(es) were located over the bedroom hallway.

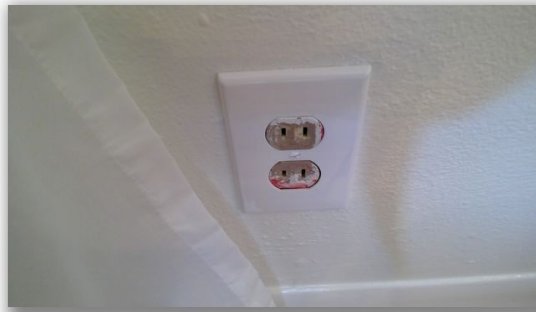
- **Note:** Old style 2 wire system in place in various areas throughout the house. This does not meet the current standard.

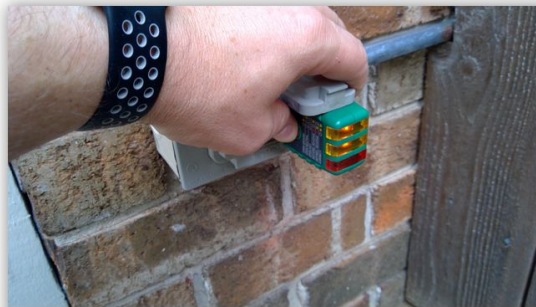
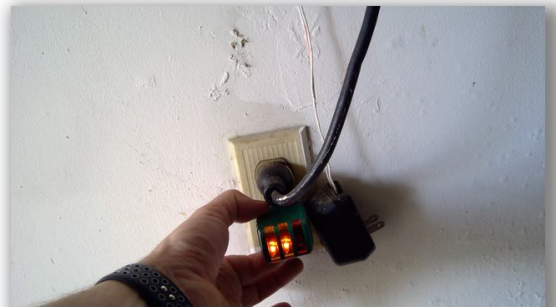
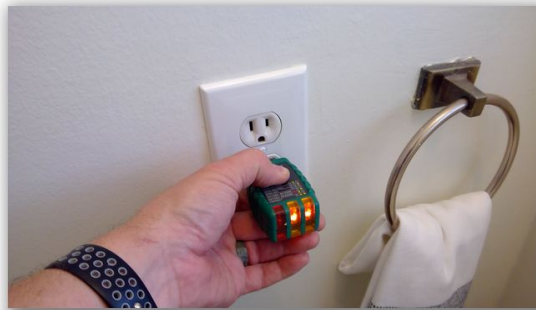
- Not all of the receptacles in the wet/damp areas do not appear to have ground fault circuit interrupter (GFCI) protection. Under current electrical standards all of the exterior receptacles, all kitchen counter top receptacles, all bathroom receptacles, all laundry room receptacles, all garage receptacles, dishwasher receptacle, receptacle in cabinet under kitchen sink, any receptacle within 6-feet of the sink and pool equipment should have GFCI protection.

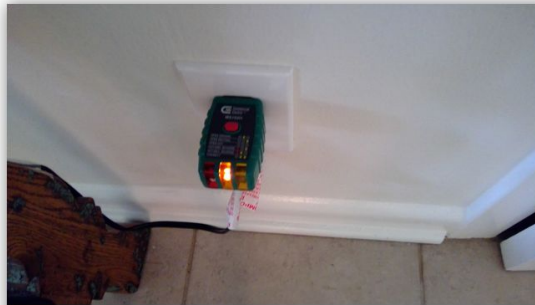
- Most to all of the three-prong receptacles are observed to be ungrounded. This is an older two-wire system. Note: Placing three prong receptacles on an older two-wire system does not meet current National Electrical Code standards.

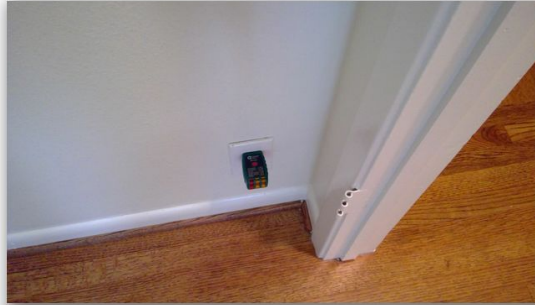
- One or more of the receptacles appears to be inoperative. This receptacle(s) and circuit should be investigated and corrected as necessary. Receptacle(s) were located in the front corner bedroom & kitchen.

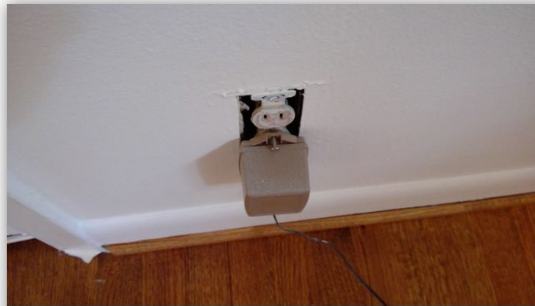
- One or more of the receptacles is missing its cover plate in the side middle bedroom.

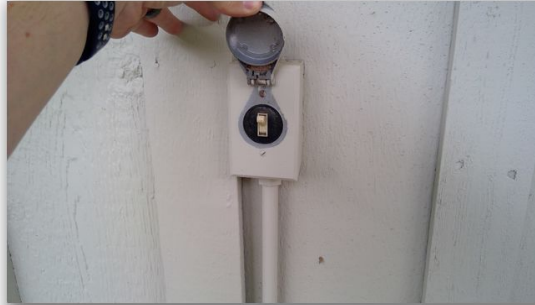
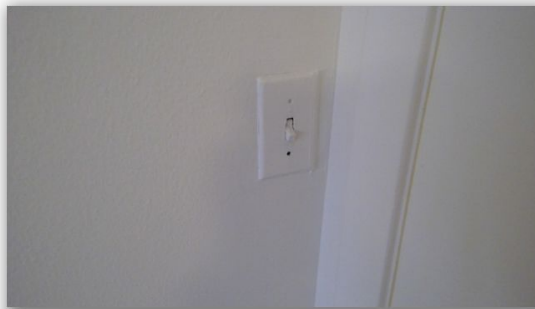
- **Note:** I was unable to determine the operation end of one or more of the switches.

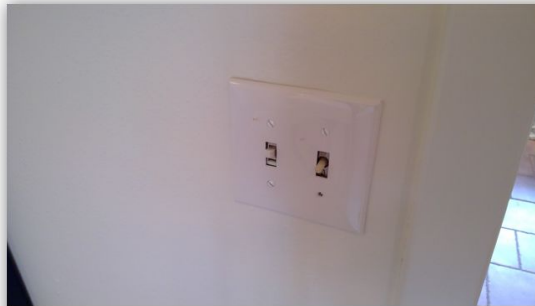
- The switch is damaged in the dining room.

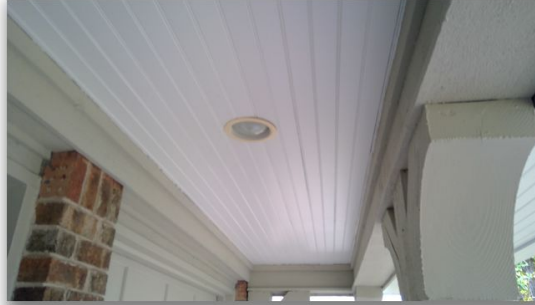
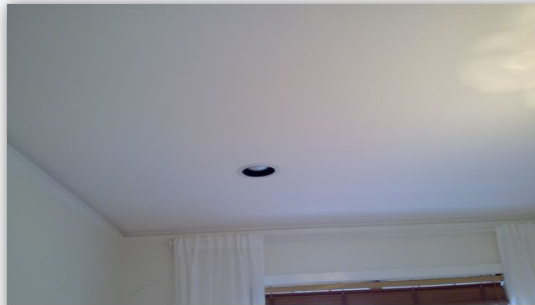
- One or more of the light fixtures appear to be inoperative in various locations throughout the house. This may be due to a bad bulb or some other unknown condition. This condition should be further evaluated and corrected as necessary.

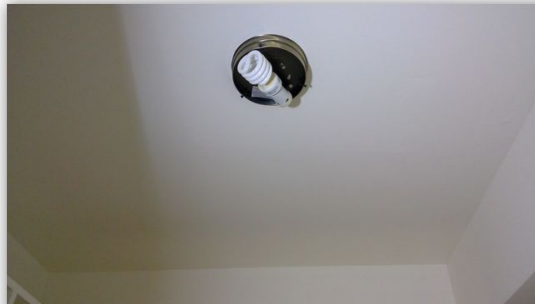
- One or more of the closet light fixtures appear to be installed without globes and/or covers. Safety precautions should be taken around these light fixtures.

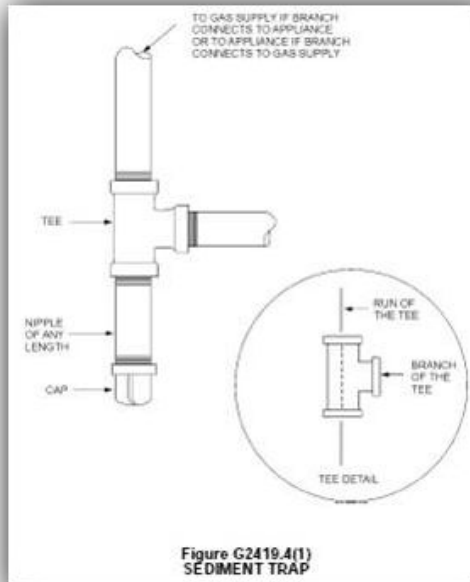
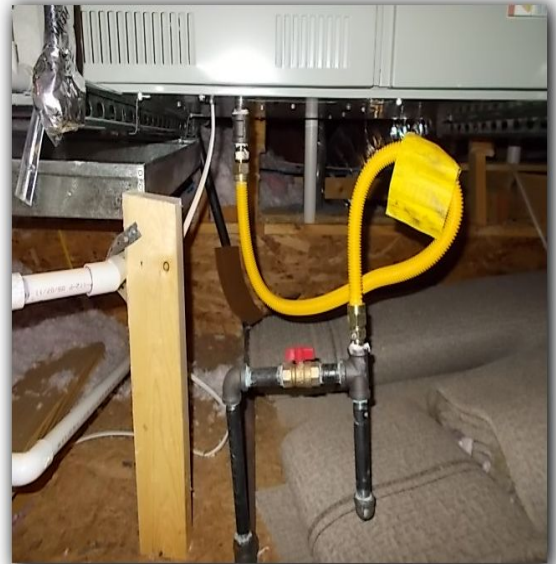
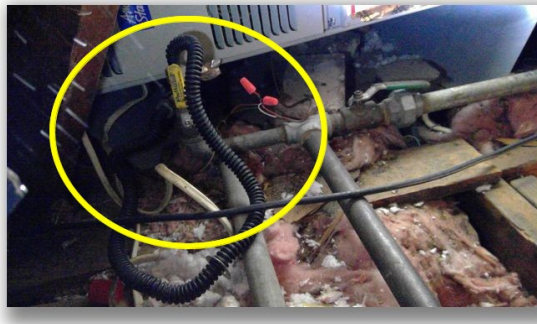
- The heater gas supply line is not equipped with a sediment trap just before the gas appliance connector. This condition does not meet current installation requirements and should be corrected.

Samples of correct sediment trap installation.

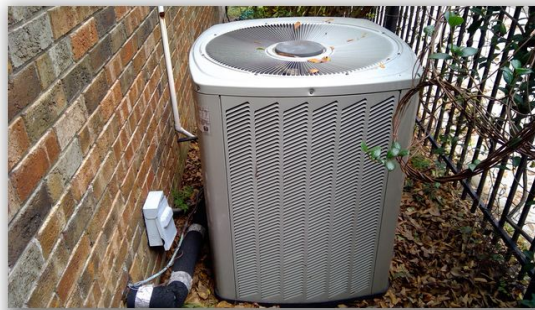
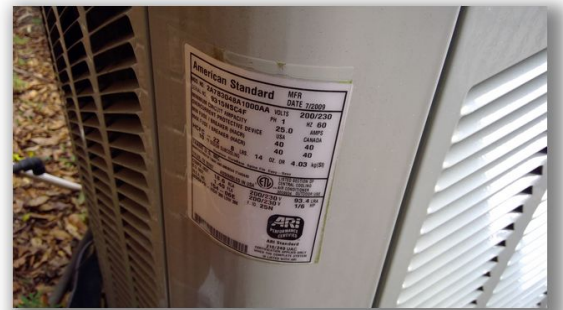
- The temperature differential measured across the evaporative coils of the air conditioning system is higher than considered normal. The cooling system is not performing properly and servicing is needed.

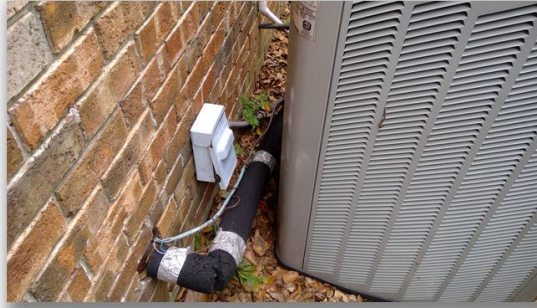
- The electrical service disconnect is installed behind the outside condenser/coil. This does not meet the clearance requirements of the National Electrical Code or the International Residential Code and should be corrected as necessary.
- The electrical disconnect was observed to be damaged.

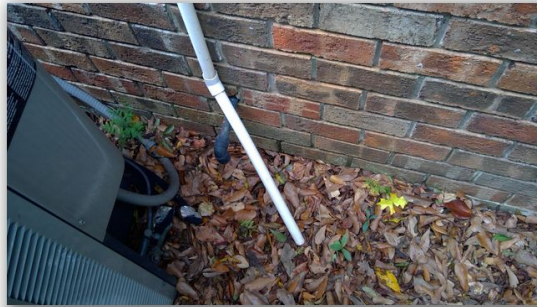
- **Note:** The primary condensate drain line is terminated next to the exterior foundation perimeter beam. It is recommended that the drain line terminate further away from the foundation beam or to an approved waste system.

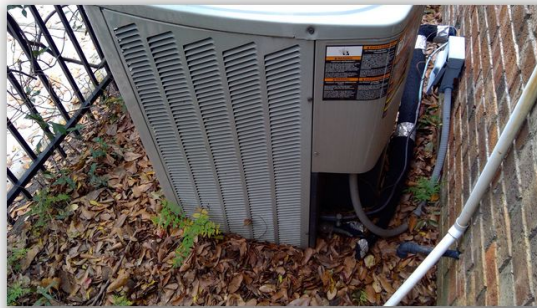
- The outside condenser/coil does not appear to have proper clearance above the finish grade (ground). The outside unit should have a minimum of 3-inches of clearance above finish grade (ground). This condition should be corrected to help prevent damage to the unit.

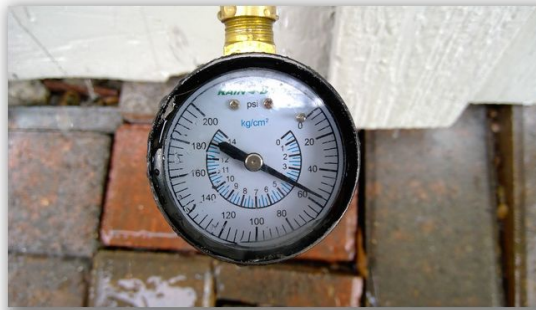
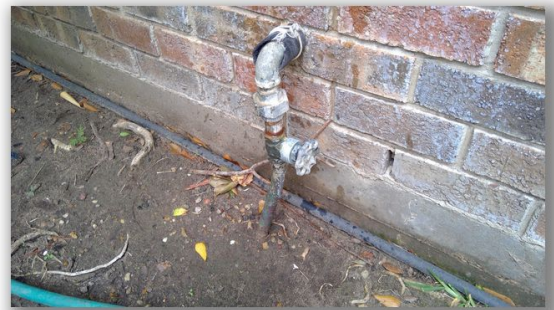
- There are galvanized water lines in use at the time of this inspection. This is an older obsolete water supply system that is prone to water leaks. Full evaluation of all of the galvanized water line components and the integrity of those components are beyond the scope of this inspection. You are strongly encouraged to have the integrity of all of the galvanized water line components further evaluated by a qualified plumber prior to the expiration of any time limitations such as option or warranty periods. All plumber recommended repairs should be made.
It would be wise to budget for replacement of all the older galvanized water supply system and to make a conversion over to a newer type of water supply system as soon as it is financially feasible.

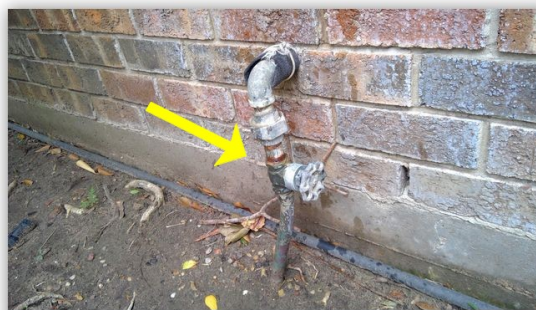
- Dissimilar metals observed to be in use in the water supply system in one or more locations. In some cases this will cause electrolysis to occur which will result in water leaks at these connections. It is recommended to install dielectric fitting at any dissimilar metal connection locations.

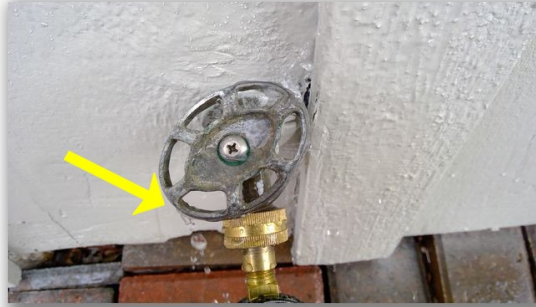
- One or more of the exterior water hose bibbs (faucet) do not have a back-flow or anti-siphon device (Vacuum Breakers) in place. **Note:** *This is not uncommon to observe with a home of this age.*
- The exterior water hose bibb (faucet) is leaking at the handle when operated on various locations of the structure.

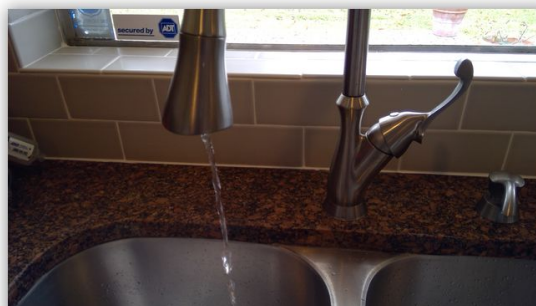
- The faucet appears to have low water pressure on the hot and cold sides of the faucet when operated. The cause and remedy should be further evaluated and corrected as necessary.

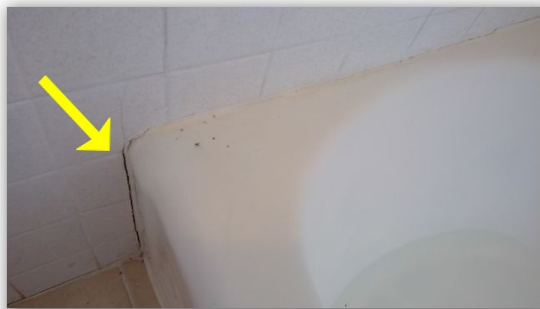
- Cracked, deteriorated and/or missing bathtub enclosure grout and/or caulking should be repaired or replaced as necessary.
- The bathtub was observed to drain slowly, suggesting that an obstruction may exist.

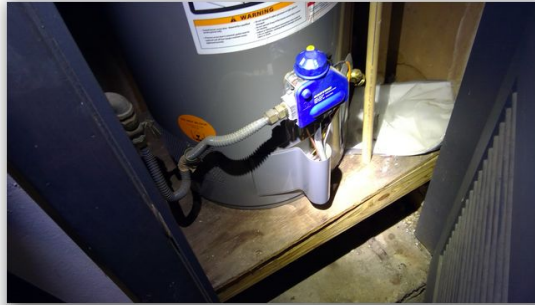
- There is no pan installed under the water heater.

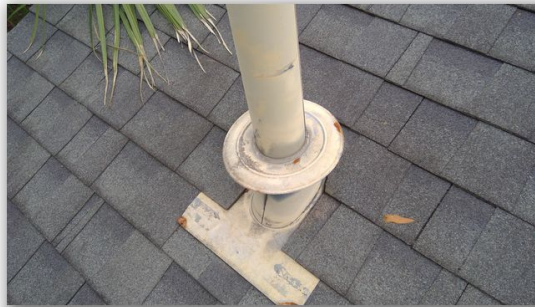
- Improper material used as storm collar on water heater exhaust flue.

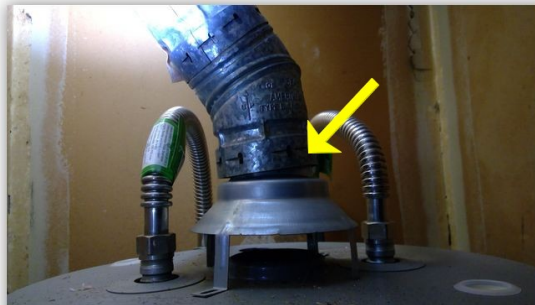
- The water heater flue connector should be mechanically attached to the draft hood with a minimum of three sheet metal screws.

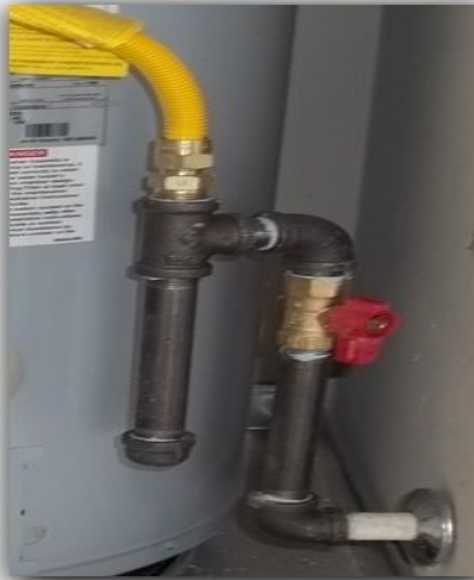
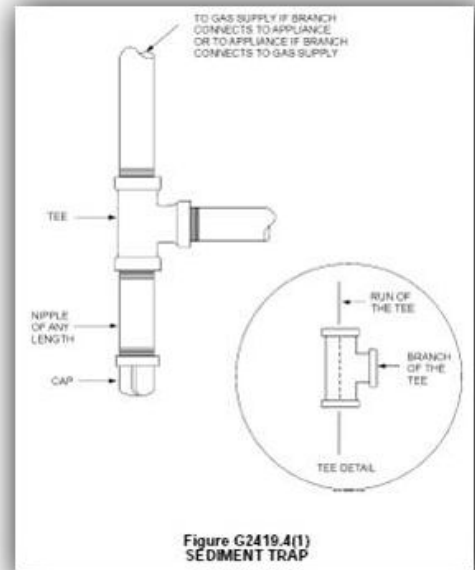
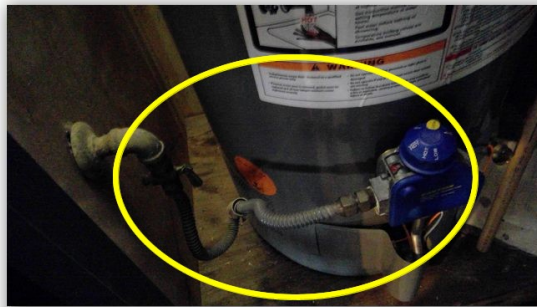
Samples of correct sediment trap installations

- The water heater gas supply line is not equipped with a sediment trap just before the gas appliance connector. This condition does not meet current installation requirements and should be corrected.

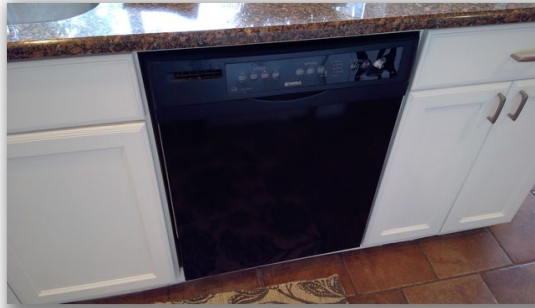
- Some rusting of the dishwasher interior components was observed.

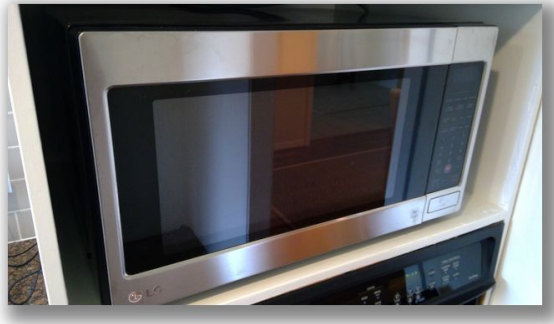
- The microwave oven was inoperative at the time of this inspection.

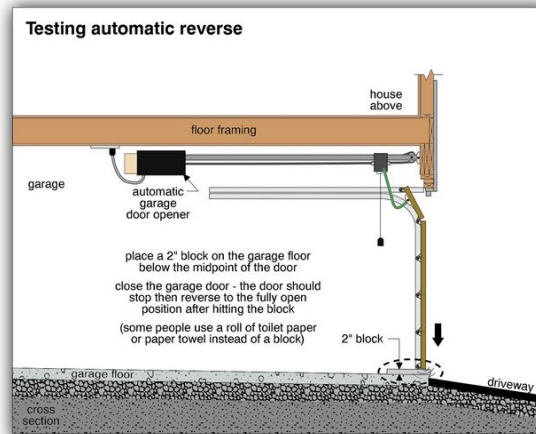
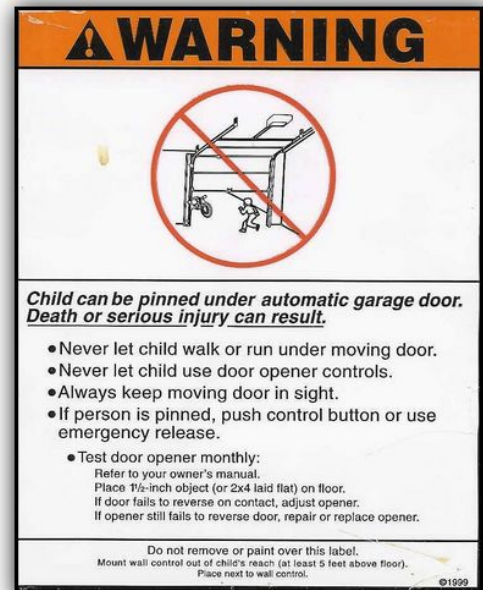
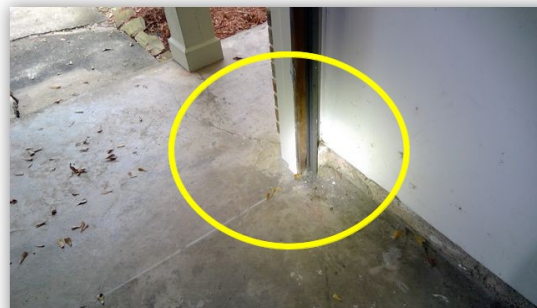
- The garage door reverse photo electric sensor is not properly secured in place.
- The garage door opener ***DID NOT*** automatically reverse under reasonable resistance when closing. Improvement may be as simple as adjusting the sensitivity control on the opener.

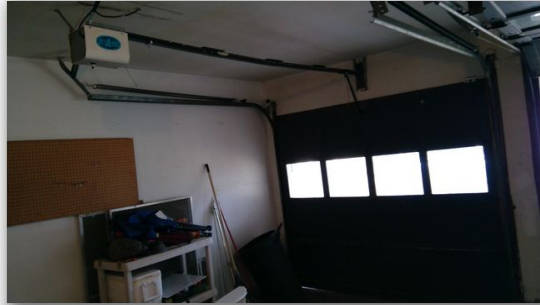
- The left garage door opener is inoperative. The cause and remedy should be further evaluated and corrected as necessary.
- When an automatic garage door opener is in use, the manual lock should be disabled or removed.

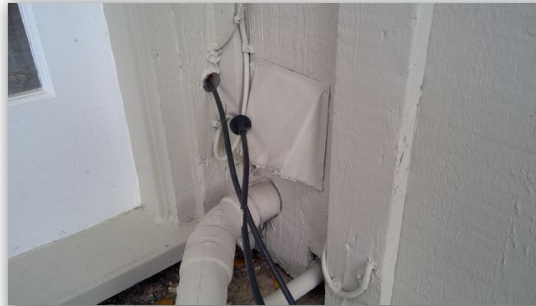
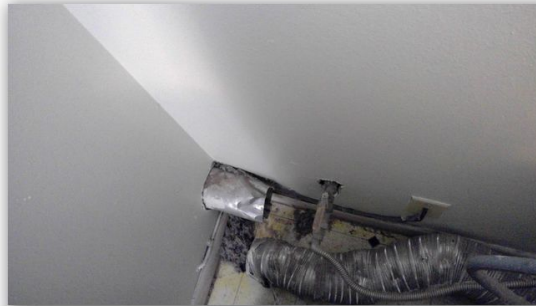
- The exterior dryer duct termination cover is damaged.
- The damper at the dryer exhaust termination does not function properly. The damper does not reset to the closed position when not in use.
