Beau Brown
7894 Salt Lake Dr
Conroe, TX 77304

October 16, 2025

PROPERTY INSPECTION REPORT FORM

Beau Brown <i>Name of Client</i>	10/16/2025 <i>Date of Inspection</i>
7894 Salt Lake Dr, Conroe, TX 77304 <i>Address of Inspected Property</i>	
Louis Escobar <i>Name of Inspector</i>	25708 <i>TREC License #</i>
<i>Name of Sponsor (if applicable)</i>	<i>TREC License #</i>

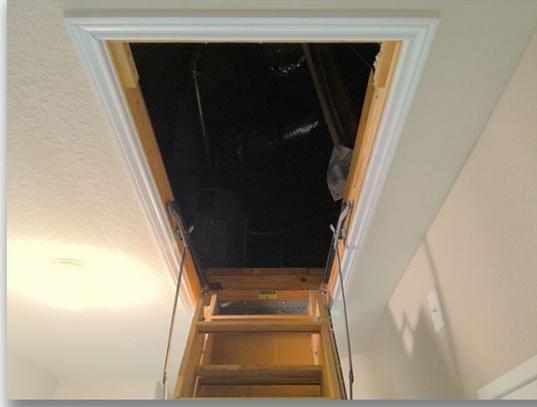
Note: Attic space above the ceiling was not accessible due to obstructions at the access point. As a result, the attic could not be inspected for framing, insulation, ventilation, or other conditions. Recommend clearing the obstruction and re-evaluating the attic space as needed.

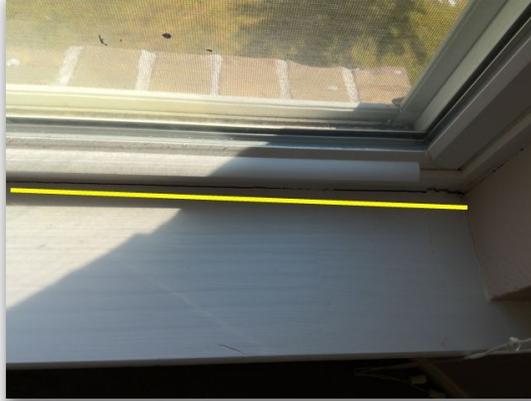
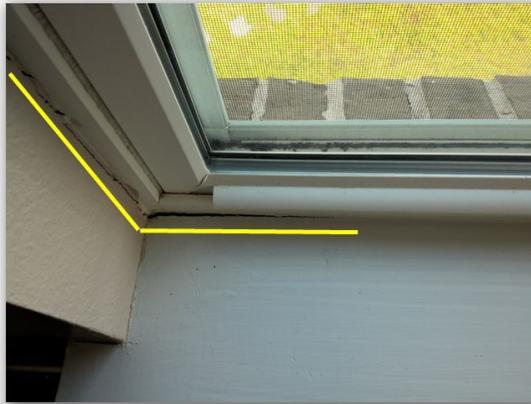
- Caulking improvements are recommended at one or more of the interior windows. Examples are pictured below but not limited to:

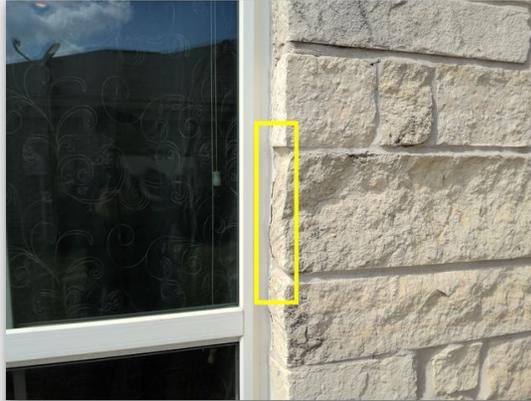
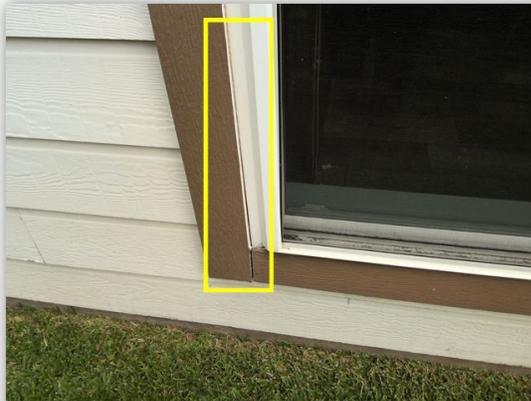
- Caulking improvements are recommended for the area between the exterior veneer and the window frames. It is recommended to use an elastomeric caulking. Examples are pictured below but not limited to:

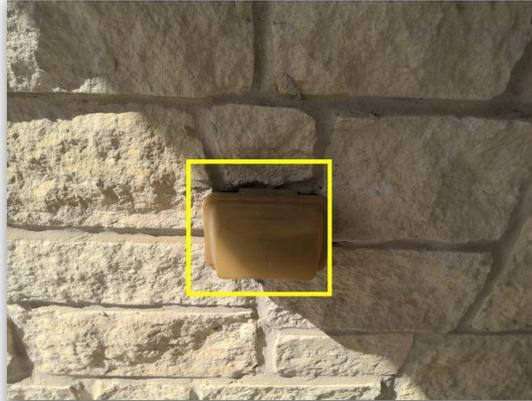
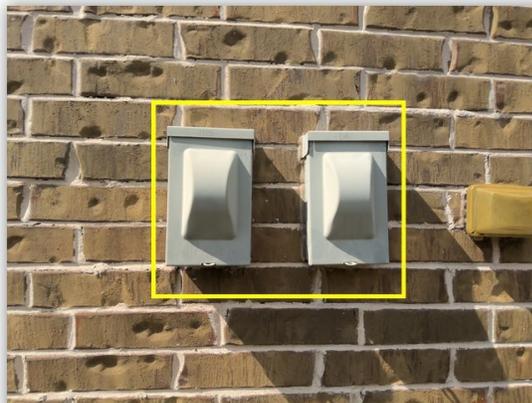
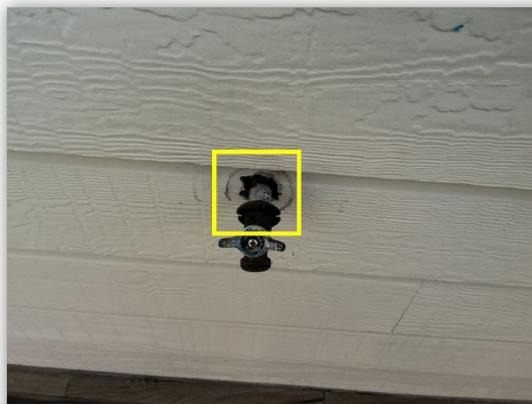
- The area between the exterior cladding / veneer and all of the wall penetrations / openings need to be properly sealed. Areas such as utility connections, downspouts, hose bibbs, lighting fixtures, receptacles etc. It is recommended to use an elastomeric caulking / sealant. Examples are pictured below but not limited to:

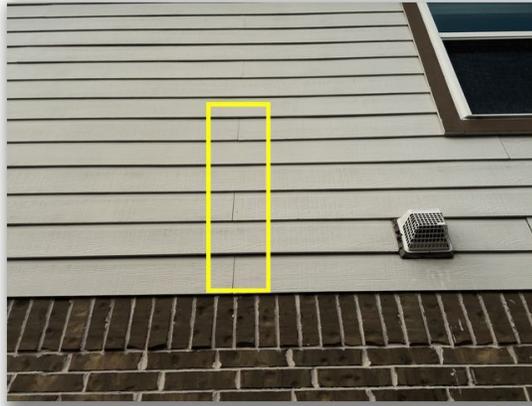
- Caulking improvements are recommended for the area between the exterior fiber cement board joints in various locations. It is recommended to use an elastomeric caulking. Examples are pictured below but not limited to:

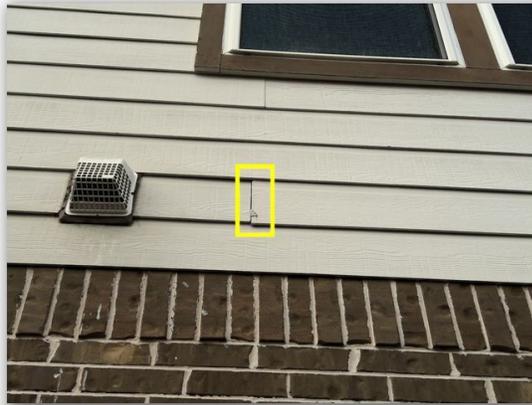
- The exterior veneer / cladding appears to have impact damage on the right side of the structure. This condition needs to be further evaluated and corrected as necessary.

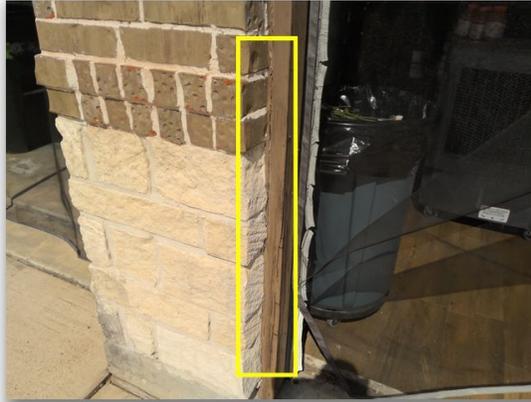
- Caulking improvements are recommended for the area between the exterior veneer and the garage door trim boards. It is recommended to use an elastomeric caulking. Examples are pictured below but not limited to:

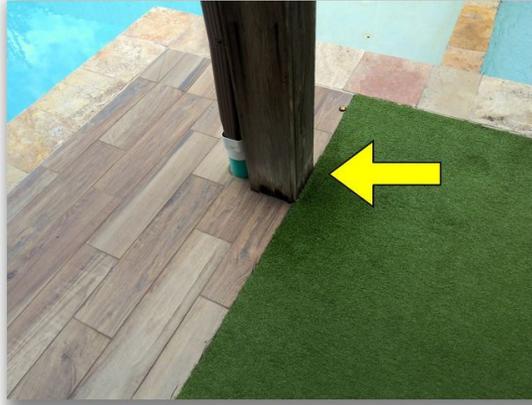
- All wood to ground contact at the base of the siding should be eliminated. Rotted or damaged siding that is uncovered should be repaired. The siding was observed to be in contact with the finish grade (ground) on the back side of the structure.

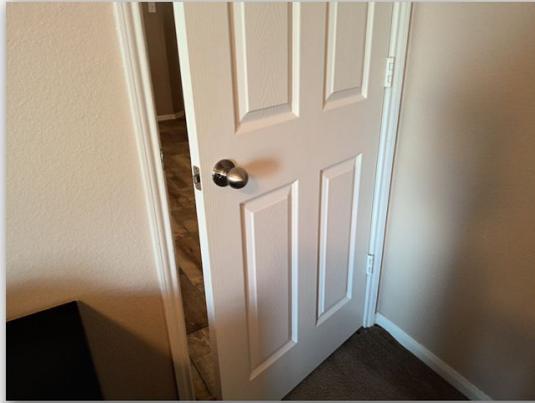
- The door to the upstairs front corner bedroom was observed to close by itself. Adjustments are recommend.

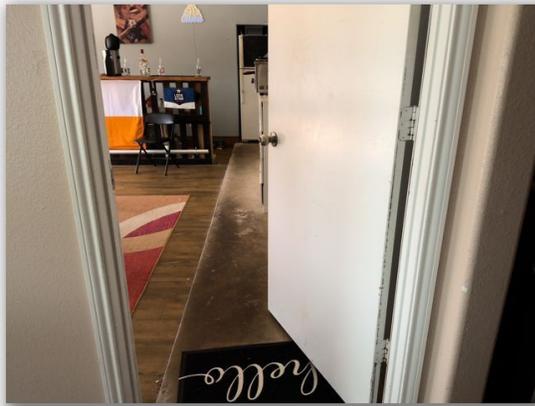
- The garage entry door is not equipped with a self-closing device.

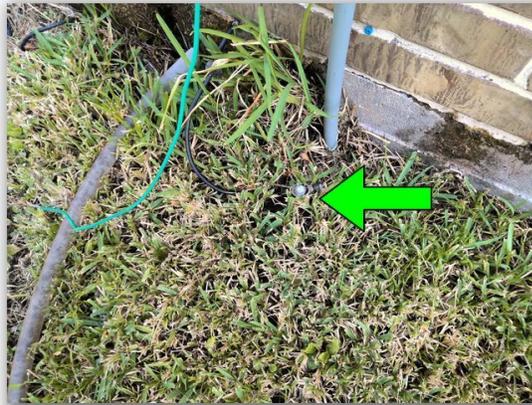
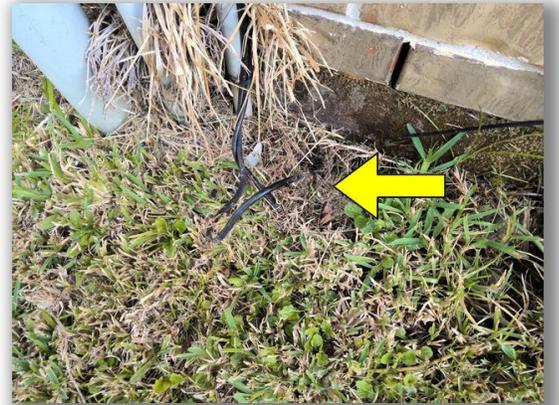
- **Note:** The connection to the ground electrode rod is below finished grade. The connection should be made above finished grade or with an approved clamp listed for burial. The connector in place is inaccessible and cannot be determined for proper use at the time of this inspection.

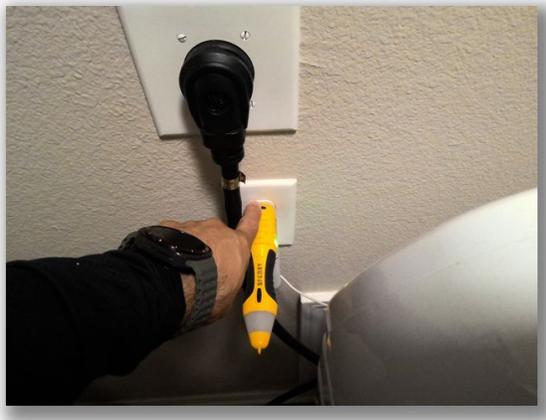
- The laundry room area receptacles do not appear to be connected to a ground fault circuit interrupter (GFCI) device. Under current electrical standards, all of the receptacles in the laundry room area should have GFCI protection.

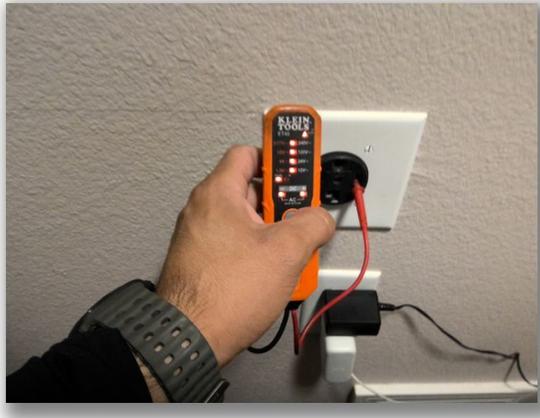
- The ground prong was observed to be obstructed for the outlet in the upstairs living room.

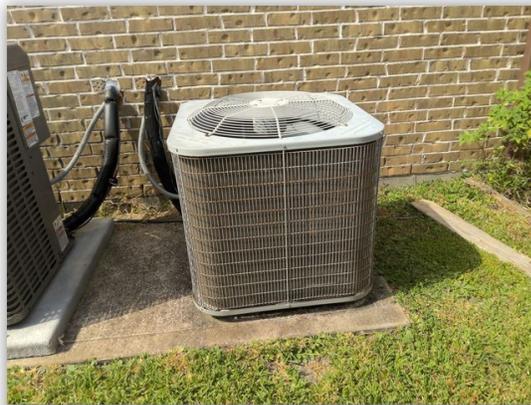
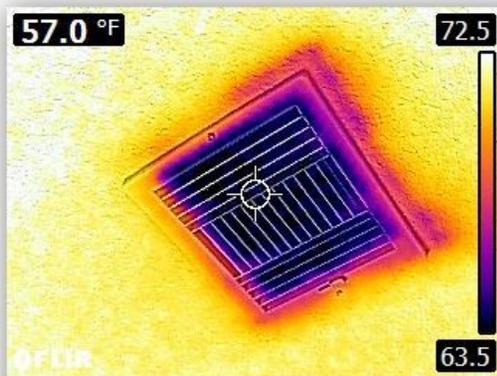
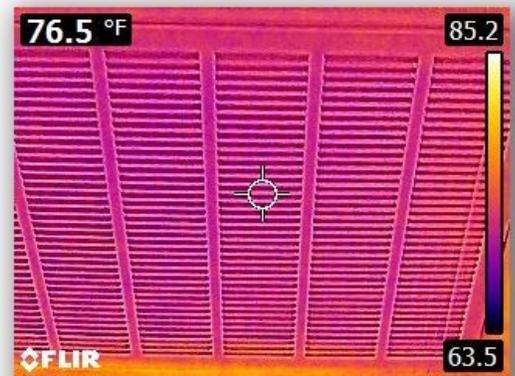
- The dirty air filter should be replaced.

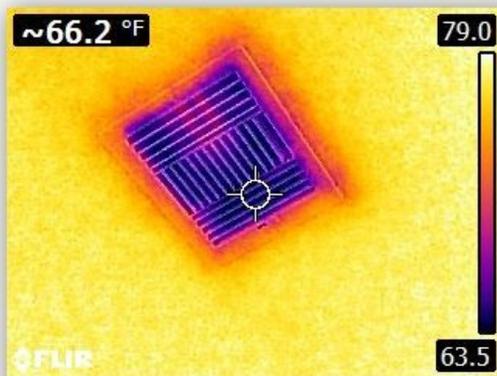
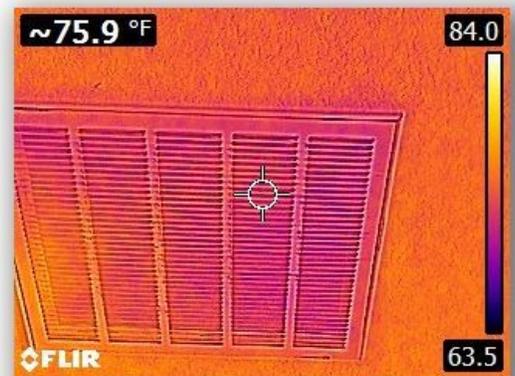
- The temperature drop measured across the evaporative coils of the air conditioning system is lower than considered typical. The unit is not cooling properly and servicing is needed.
- The dirty air filter should be replaced.

The HVAC system and equipment needs to be checked and serviced by a Qualified / Licensed HVAC Technician. The observations made to support the rendering of this opinion are listed but may not be limited to the following:

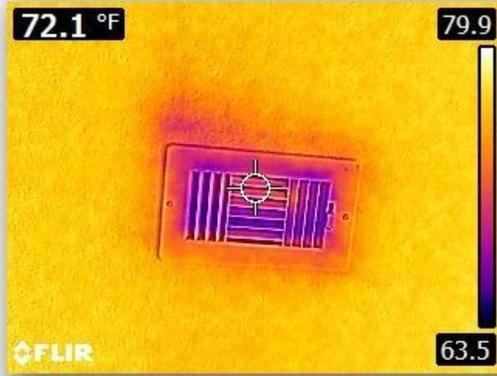
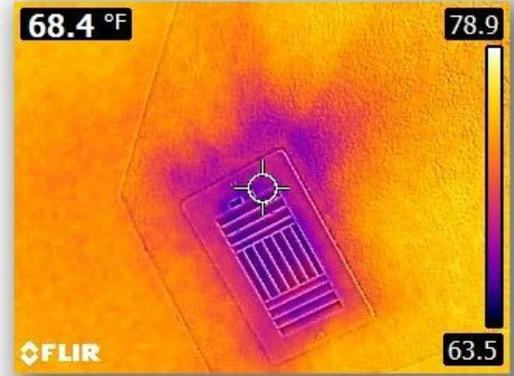
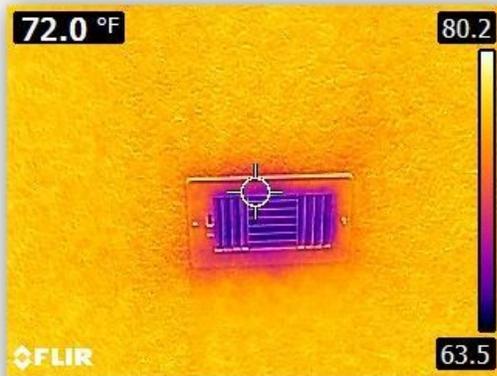
- The air register was observed to read a significant difference in the master bedroom closet, master bathroom. This may indicate poor air flow to this area. *****Temperatures taken with AC running*** SEE COOLING SECTION**

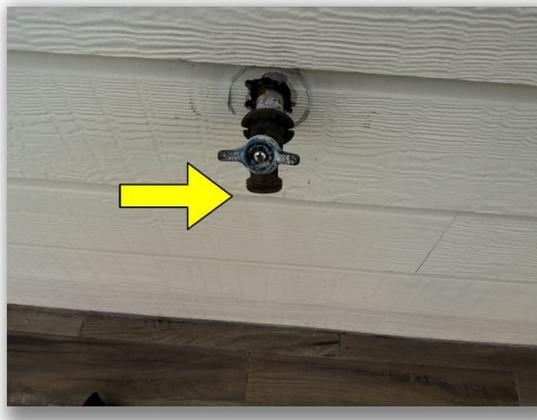
Exterior Faucets/Fixtures

- One or more of the exterior water hose bibbs (faucet) do not have a back-flow or anti-siphon device (Vacuum Breakers) in place.

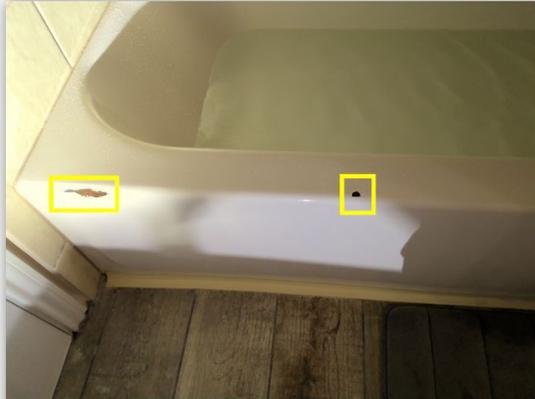
Bathtub

- The bathtub has some surface damage.

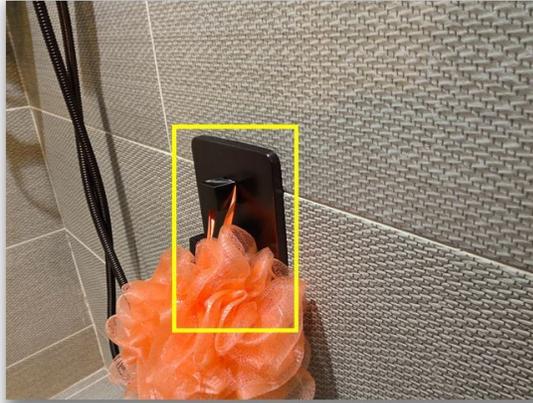
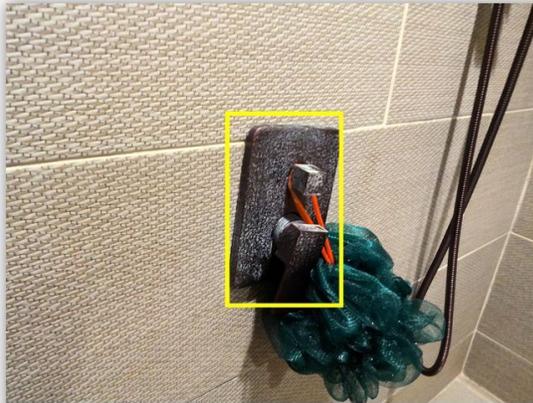
Shower

- The shower head escutcheon is loose/not sealed at the wall.
- The faucet assembly is not sealed at the wall. This condition has the potential to allow water to leak back into the wall cavity.

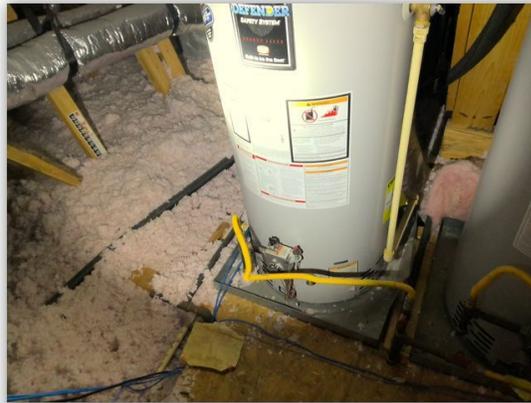
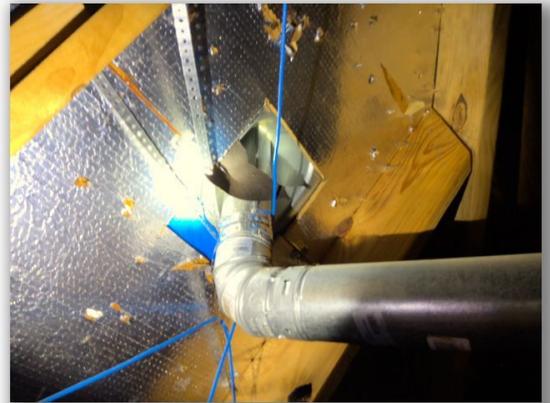
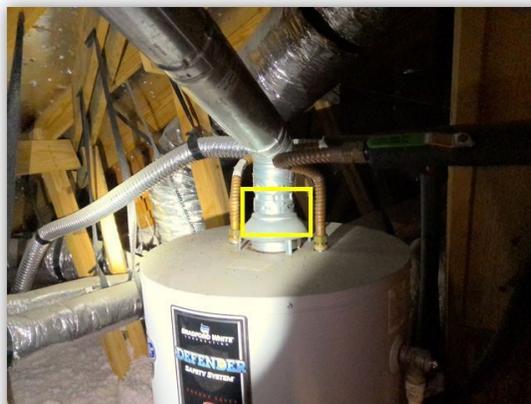
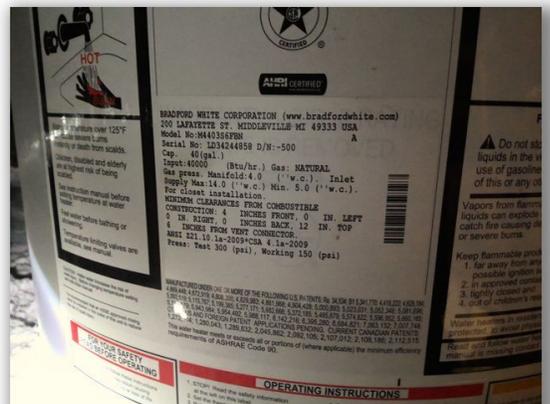
- The water heater flue connector should be mechanically attached to the draft hood or attached with a minimum of three sheet metal screws.

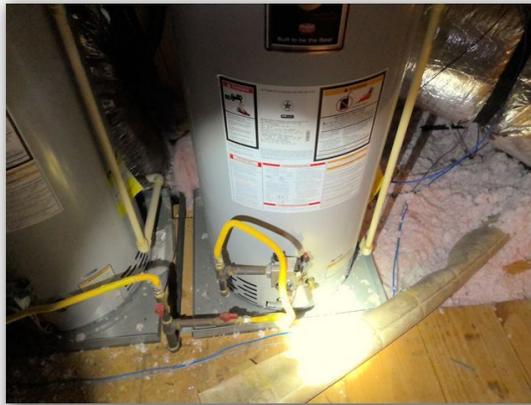
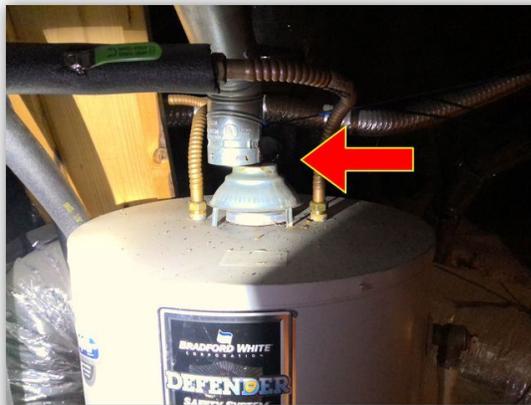
- The water heater vent pipe is separated in the attic. This configuration will emit Carbon Monoxide into the attic area, which is a known safety hazard.

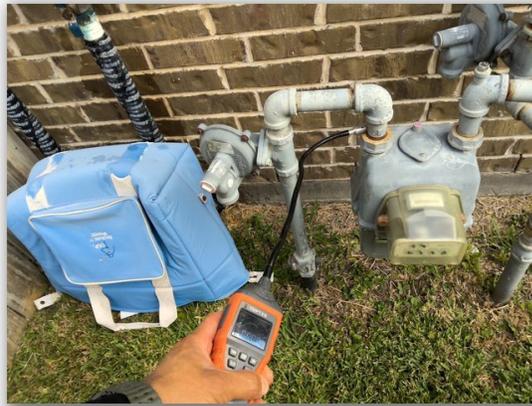
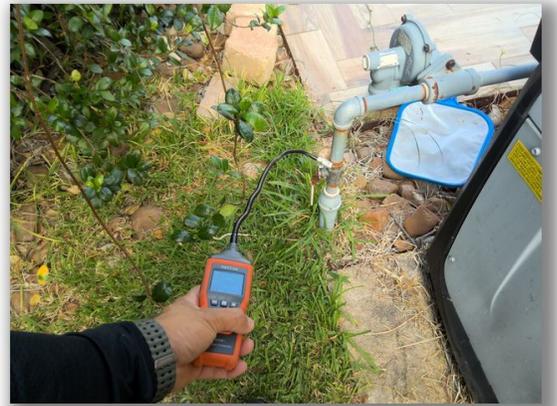
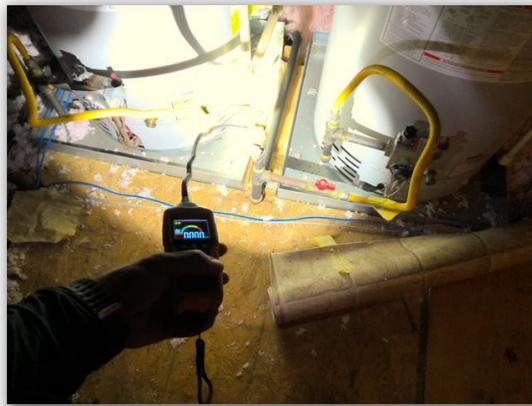
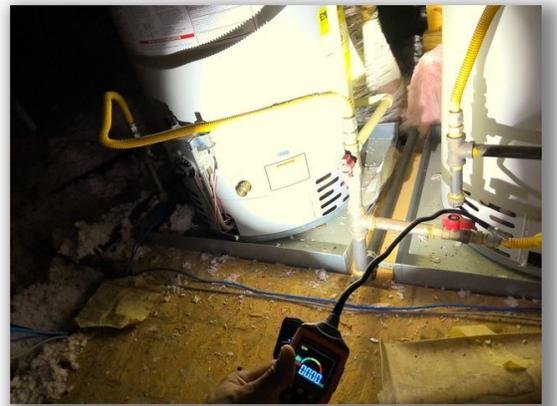
General Photo(s) of Inspector Checking Gas Lines

This component appears to be performing adequately at the time of this inspection.

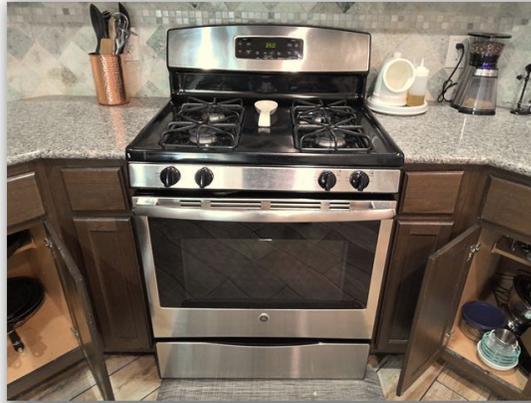
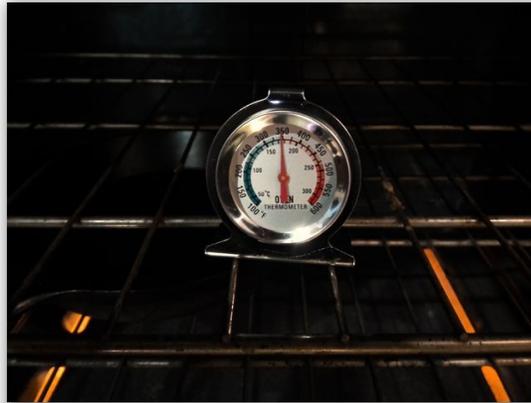
- One or more of the cooktop burners would not light by the pilot and should be further evaluated.

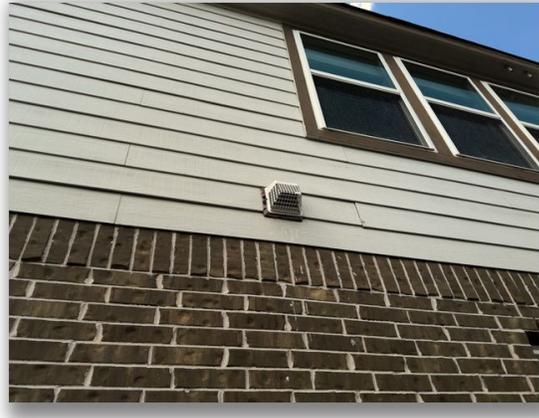
General Photo(s) of Mechanical Exhaust Vents

This component appears to be performing adequately at the time of this inspection.

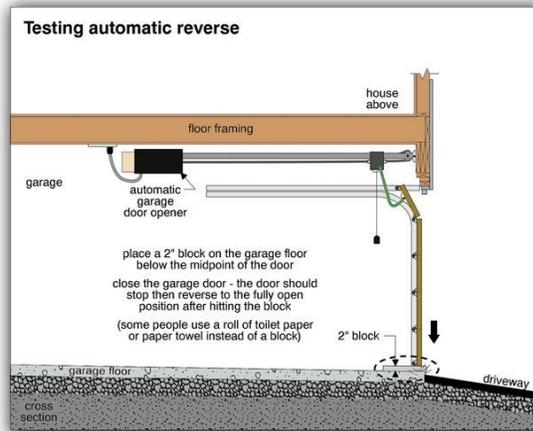
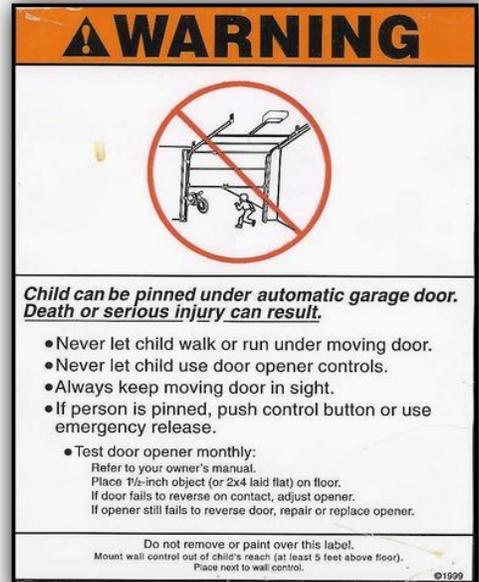
- The garage door opener ***DID NOT*** automatically reverse under reasonable resistance when closing. Improvement may be as simple as adjusting the sensitivity control on the opener.

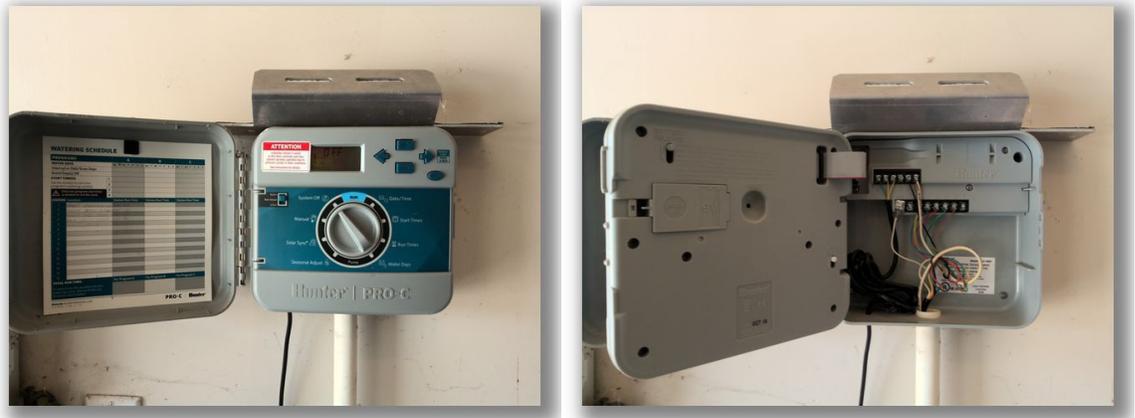
General Pictures of Sprinkler System Back-flow Preventer, Control Box, & Rain Sensor

- I was unable to locate a moisture (rain / freeze) sensor device for the sprinkler system. This is an “*as-built*” condition, but *Per TREC standards of practice we are required to report this condition as a deficiency.*

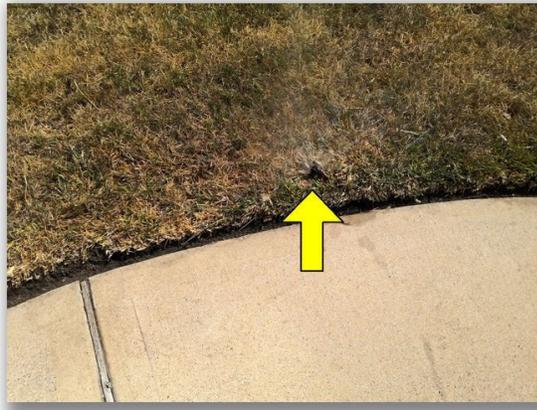
- One or more of the sprinkler heads do not pop-up high enough to disperse water properly in station(s); 3.

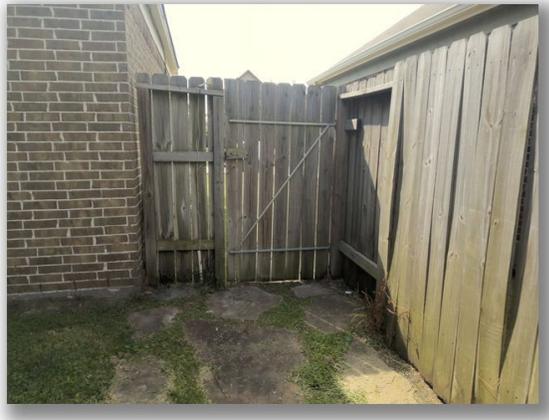
Barriers

- All pedestrian access gates should open outward away from the pool and should be self-closing and have a self-latching device. Where the release mechanism is located less than 54 inches from the bottom of the gate. A second release mechanism should be located on the poolside of the gate at least 3 inches below the top of the gate.
- Under current standards, all of the homes entry doors that give access to the pool area should be equipped with an audible alarm that can be heard throughout the house, sound continuously for 30-seconds, and be mounted at least 54-inches from the doors threshold. A self-closing and self-latch door device can be used in lieu of the audible alarm system as long as the protection is not less than the audible alarm.
