Reserve Study

*The Oak  
Hammock Preserve*

October 30, 2024  
November 12, 2024 rev.

Reference: **The Oak Hammock Preserve  
Reserve Study  
Kipcon Project No. 15735-01**

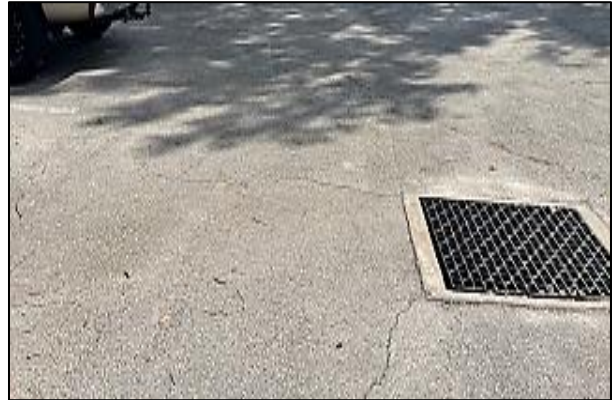
## 1. Asphalt Parking Lot

1. The asphalt pavement for the parking lot at the pool amenity was observed to be in fair condition at the time of inspection. There was cracking, low areas holding water and worn asphalt. It is recommended that the association include the asphalt in annual inspections and a preventive maintenance program to address repairs in a timely manner to prevent further damage to the asphalt. The cost shown for the is component is to address remediation as needed.

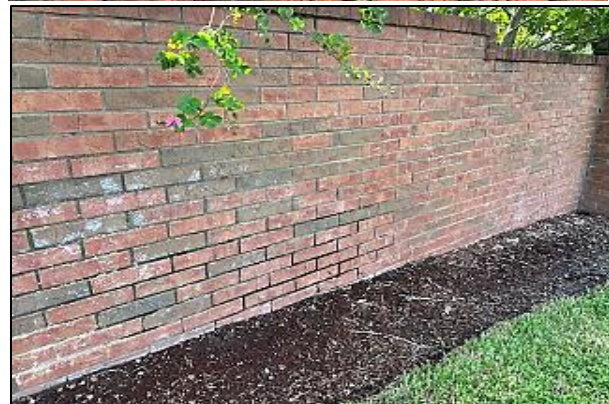
4. Efflorescence

4. The retaining wall around the community was observed to be in poor to fair condition at the time of inspection. There were areas cracked, separating, missing mortar, efflorescence present, algae and environmental growth present. This will reduce the integrity of the structure and reduce the useful life expected. It is recommended that annual inspections should be performed to allow the community to address issues as needed. A preventative maintenance program should be implemented to determine the type of maintenance that is required at that time. This may include power washing the wall, re-pointing the mortar, addressing cracks so they don't damage the walls integrity over time. By performing these inspections and maintenance will assist the community in improving the useful life, appearance and reducing the cost that may be required to replace larger sections of the wall. At this time the Association is working on getting proposals to perform repairs that are currently needed based on the conditions observed.

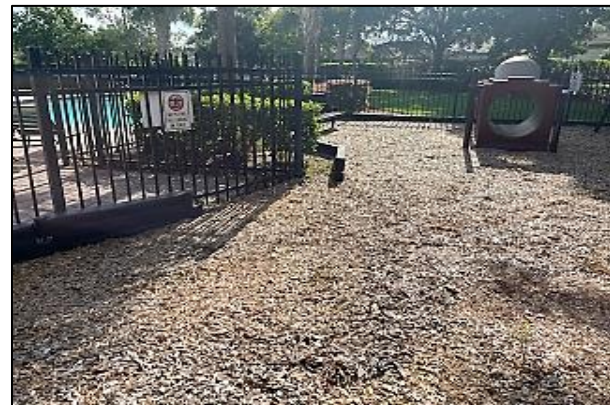
## 7. Fencing at Tot-Lot

7. The metal fencing and gates for the community are located at the pool area, tot-lot and the pool mechanical equipment area. The metal fencing was observed to be in fair to good condition at the time of inspection. The gates are locked on the outside and inside of the areas they can be unlocked with a key. It is recommended that the fencing and gates should be included in annual inspections and maintenance which includes cleaning, removal of rust, tightening hardware and bolts, lubrication of hardware, painting as needed. This improves it's appearance, provided the community with safe fencing and gates, reduces overall costs by improving the life expectancy of the equipment. The cost shown represents removal and replacement of sections as needed.

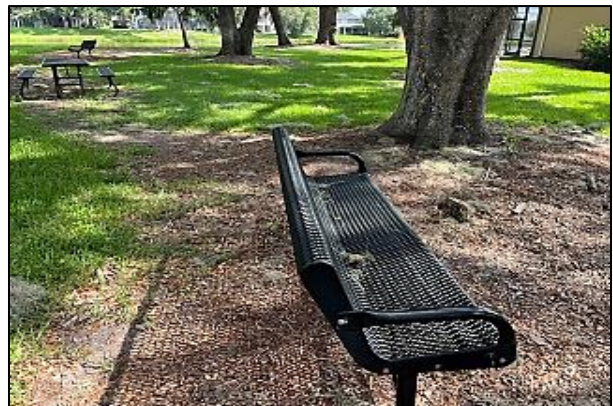
## 8. Bike Rack

8. There are benches, picnic tables, a water fountain and bike rack for the community. Thee community should only have to replace items as needed or upgrade based on the needs of the community. These items are currently in good condition. All misc. items and equipment for the community should be inspected annually and maintained as needed.

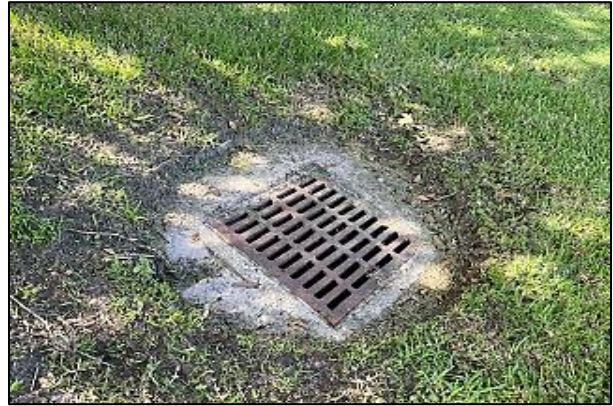
## 10. Yard Drain-Common Area

10. There are yard drains located in various locations of the community. The purpose is to allow the area to water to flow over ground into the yard drain and improve the drainage system in that area. Yard drains will drain into the stormwater system or ponds located within the area. Because the yard drains can collect debris and garbage it is recommended to have them inspected and cleaned as needed or at a minimum of every 5 years.

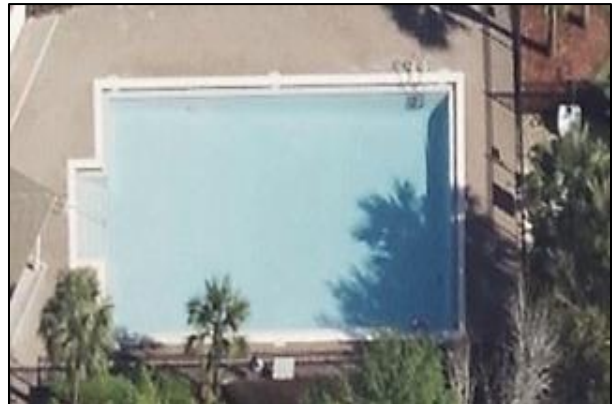
## 14. Aerial View Pool

14. The resurfacing of a pool is a process that includes cleaning, prepping and then applying a new finish to the current existing swimming pool. A good service and maintenance program should be implemented to keep the pool in good condition and safe. Proper use of chemicals and reduce the life expectancy of the pool surface and allow algae, staining of the grout and tiles and erode the pool surface over time.

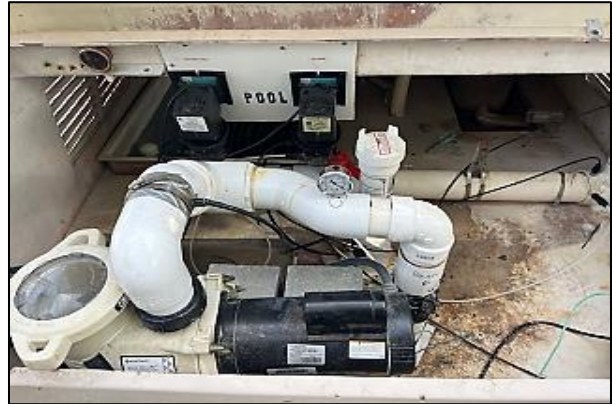
## 16. Filtration System

16. The cost of the pool filtration system is to remove and replace the system. It was reported that black spots were observed in the pool several times. This could be an indication that the system is not being serviced properly. Since improper use of the chemicals for the pool could lead to black spots. Black spots are sometimes associated with algae growth, mineral deposits, metal staining or even organic debris. Some reasons for this may be low phosphate levels, high pH levels, low chlorine levels or even pool water circulation caused by the filtration system not functioning as intended. It is recommended to have the filtration system tested along with the water to find the underlying cause of the issue.

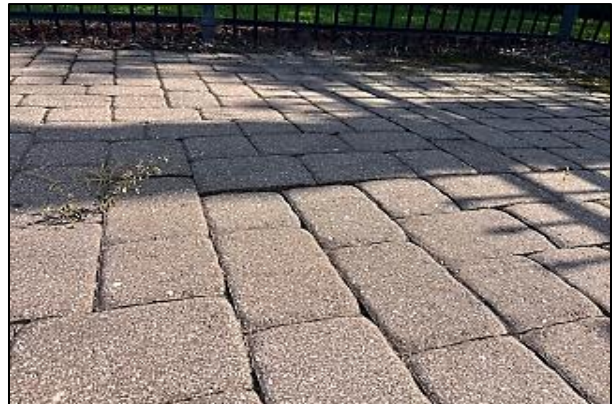
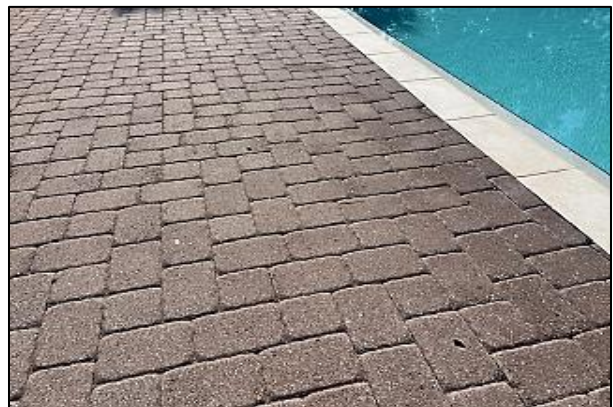
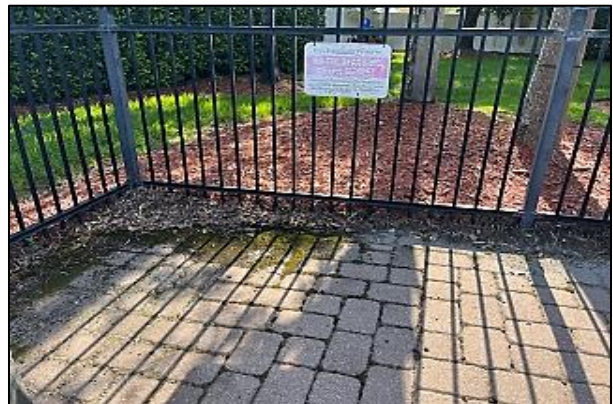
19. Pool Pavers

19. The pool pavers were observed to be in good condition at the time of inspection. The pavers should be included in annual inspections to determine any maintenance issues that need to be addressed. A good preventative maintenance program is recommended to keep the area safe and in good condition.

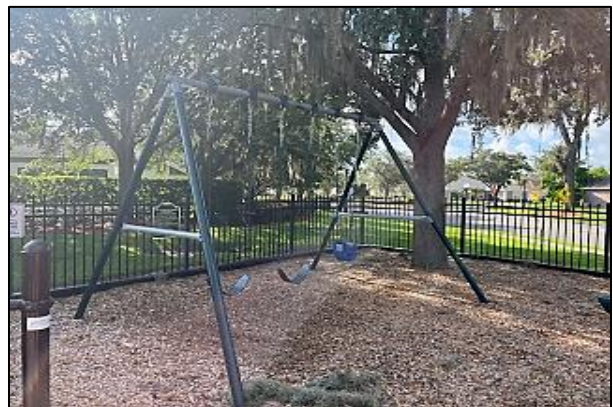
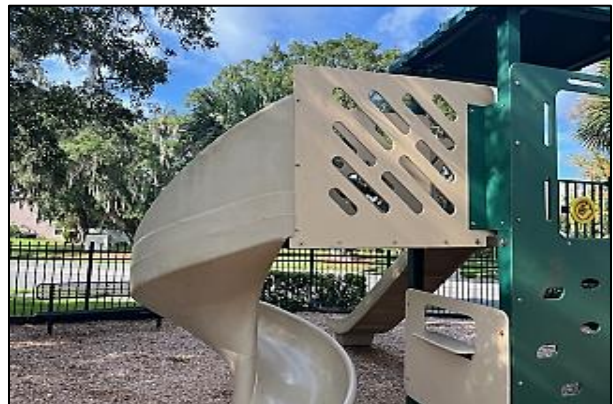
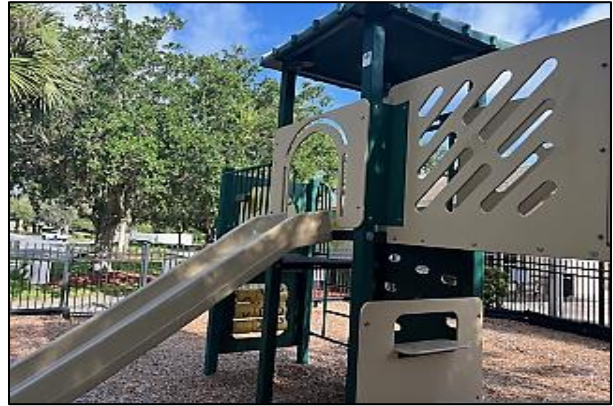
21. Tot Lot Equipment

21. The tot lot for the community was observed to be in good condition. Regular inspections and maintenance is required to keep the equipment safe and in good condition. It is recommended that the equipment should be power washed to remove dirt and algae. During the inspection any loose fasteners, should be tightened, rust removed and damaged equipment replaced.

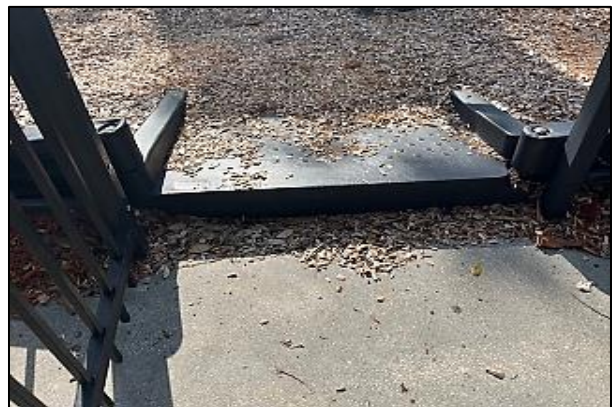
## 22. ADA Ramp

22. The tot-lot is edged with a rubber edging and an ADA Ramp. The ADA ramp is currently constructed to allow a person in a wheelchair to access the tot-lot. The edging should be addressed as needed to keep the area safe and in good condition.

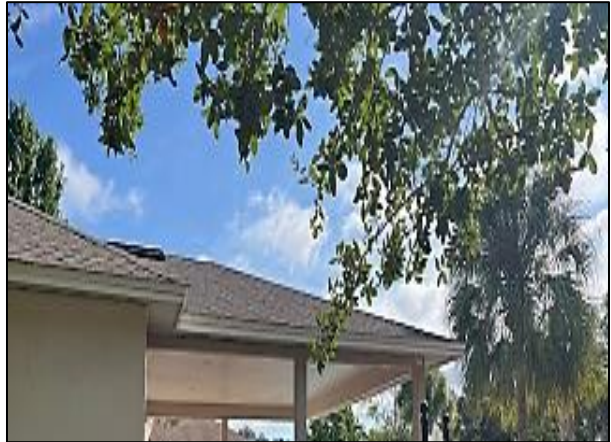
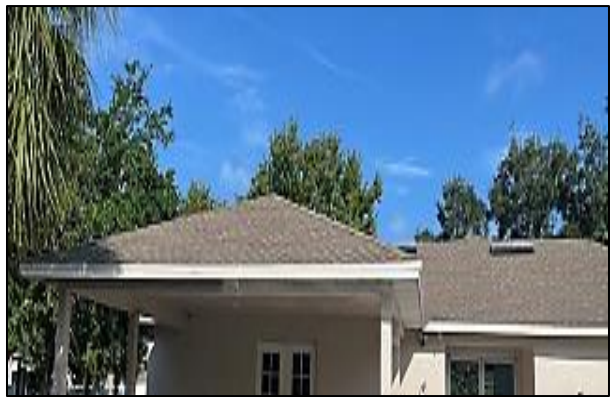
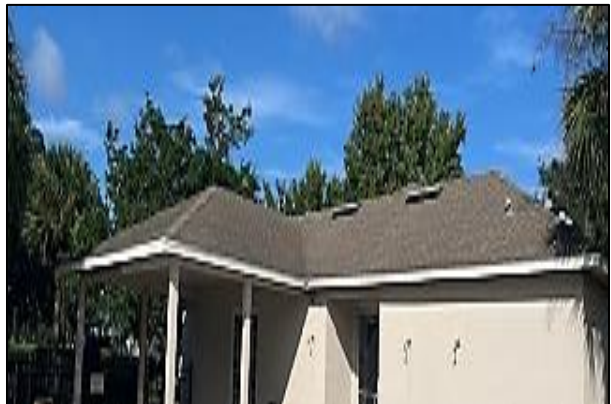
23. Roof

23. The roof of the pool cabana is asphalt shingles. The roof was observed to be in good condition at the time of inspection. The cost shown is for the removal and replacement of the roof as needed. It is recommended that annual inspection be performed especially after a storm event to determine if any areas need to be sealed, repaired, blow off shingles or damage to the roof.

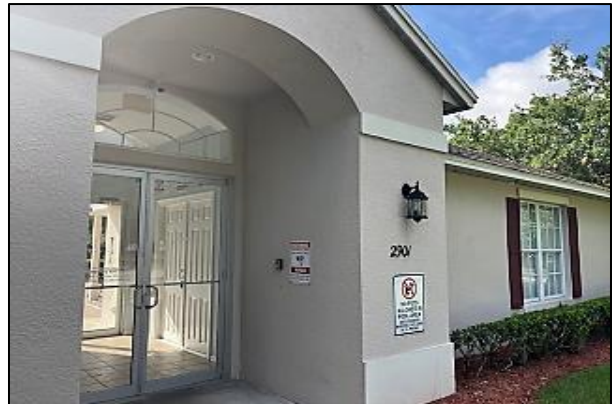
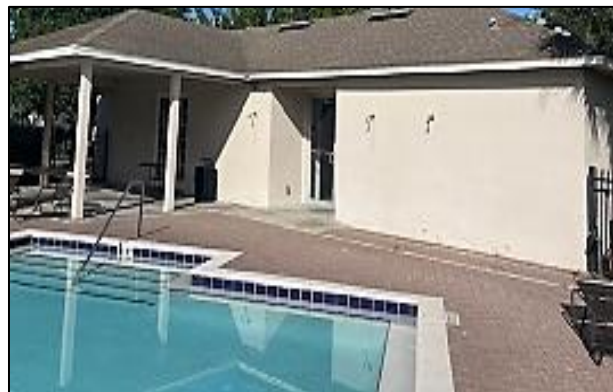
24. Exterior painting

24. The cost show is for the caulking, sealing and painting of the pool cabana building. It is recommended that the structure should be power washed once a year to remove algae and environmental conditions. This not only improves the appearance but allows the association to inspect for cracks or areas that may require repairs as needed.

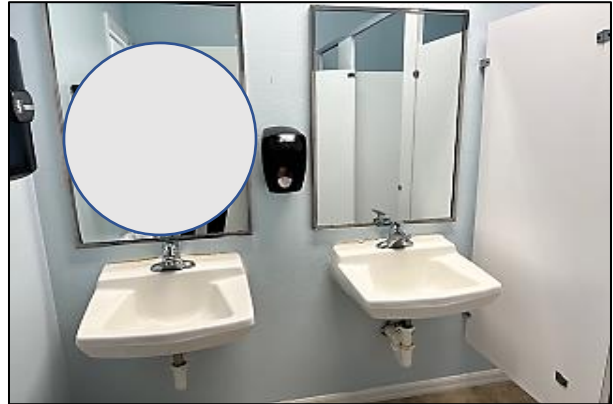
## 25. Restroom Accessories

25. The pool cabana restrooms are utilized by the homeowners at the pool. They are currently in fair condition and any upgrades or changes should be addressed based on the needs of the community. The cost shown represents restroom accessories, handicap accessories, flooring, and lighting.

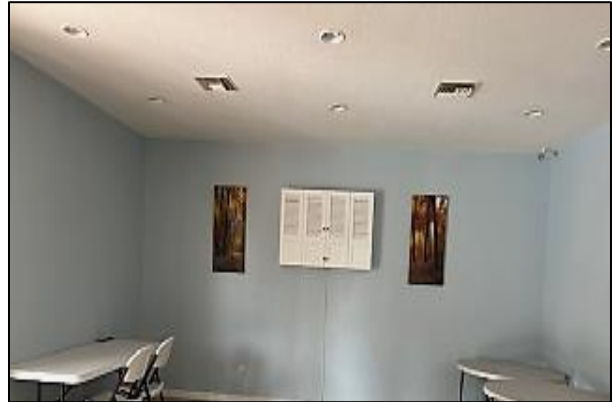
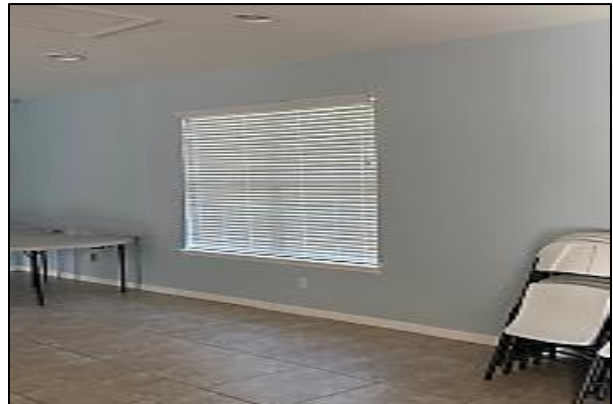
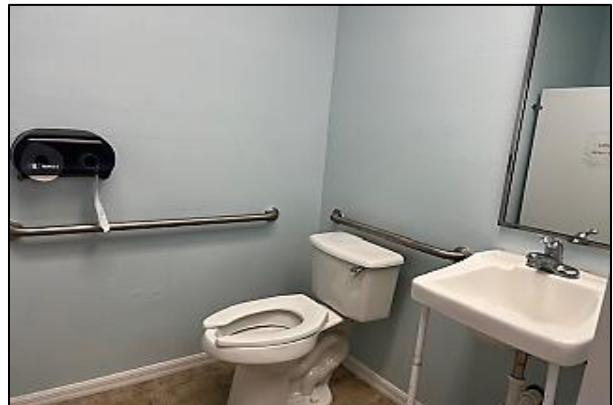
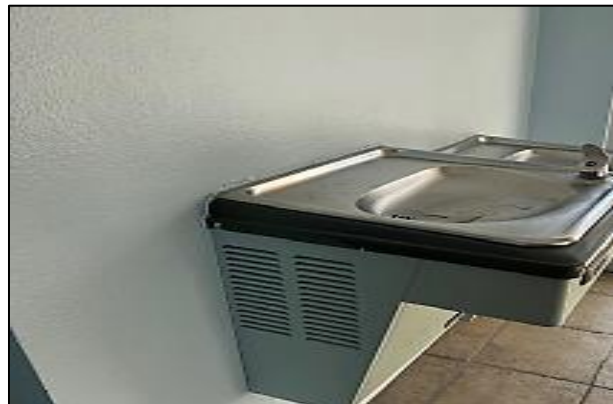
27. Painting

27. The painting of the interior portions of the pool cabana include the meeting room the restrooms and the vestibule.

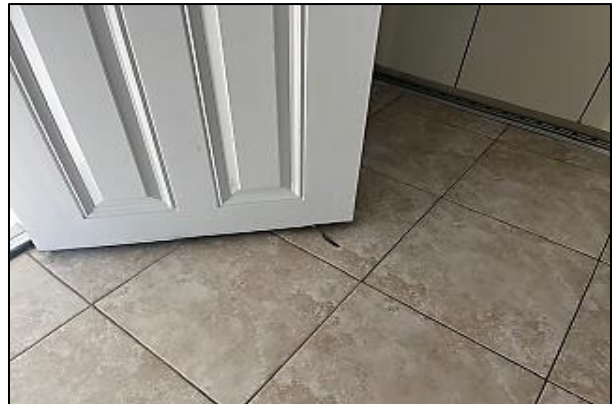
28. The tile flooring in the meeting room and vestibule was observed to be in fair to good condition at this time. The cost shown is for the removal and replacement as needed for the community.

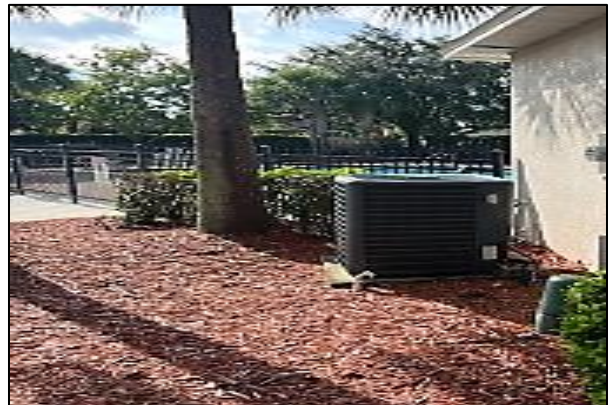
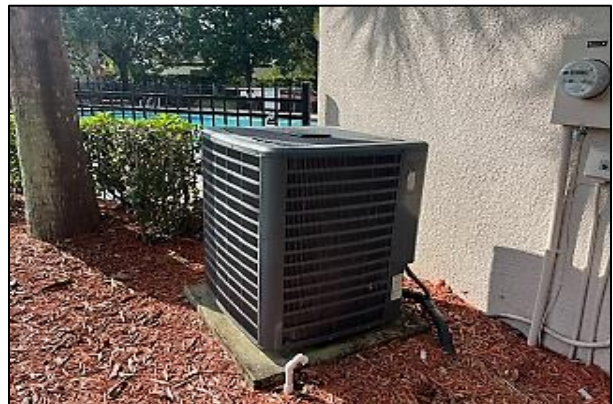
## 29. HVAC Unit

29. The cost shown for the removal and replacement of the HVAC unit that services the Cabana building. No issues were reported or identified during our inspection. It is recommended that a good service contract should be implemented to provide the community with the best useful life for the unit.
